# The Arcade and 18-20 Corporation Street and 17 Foundry Street, Dewsbury

## Summary of Amendments

Doc No. 1705-BDP-AD-XX-RG-Z-00005  
Revision: P01  
Date: 18 June 2026

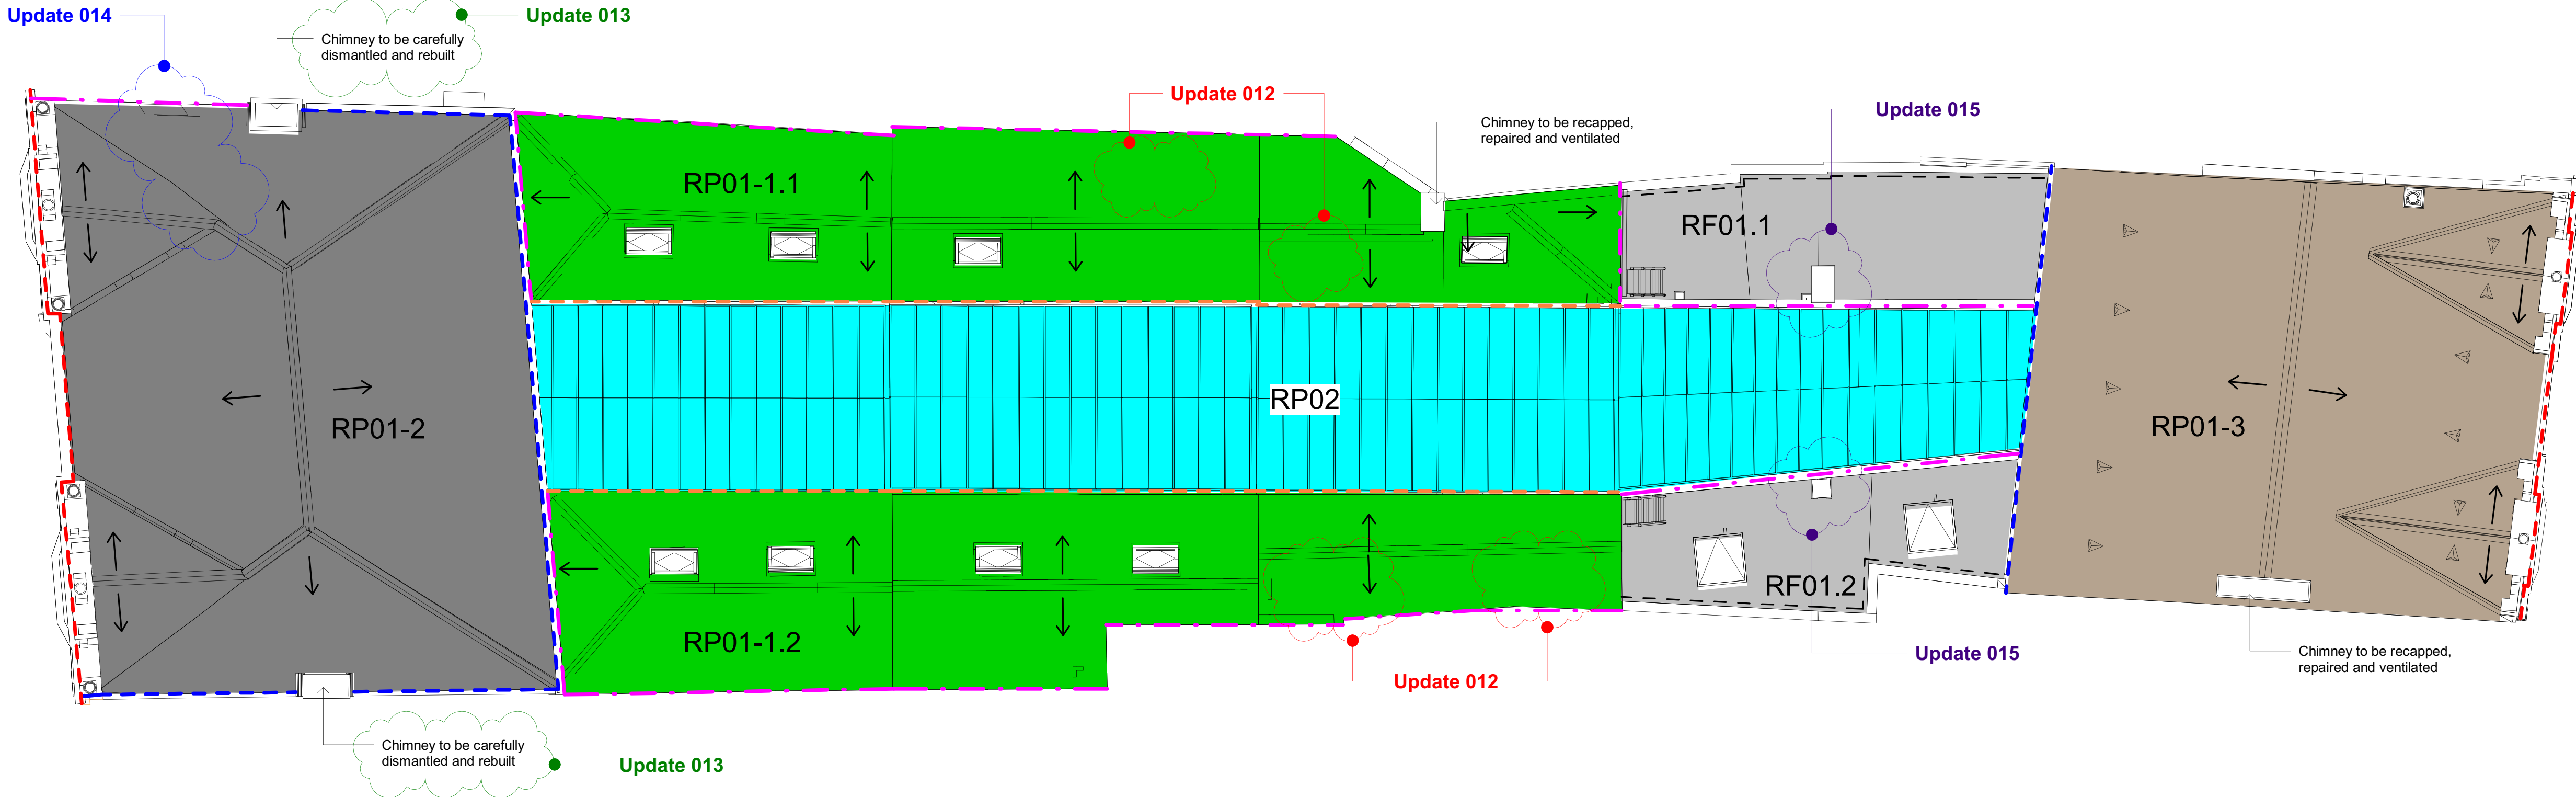
1 Roof Plan\_Proposed  
1 : 100

| 013 | 14-16 Corporation Street | Chimneys | The two chimneys were intended to be repointed and recapped. | Following a fingertip survey of the existing, these chimneys were found to be in a poor condition, with suspected sulphate attack to the masonry, causing leaning. | Leaving the chimneys in this condition would pose a safety risk. They would potentially also be a weak point for further moisture to enter the building, and are not easily accessible for ongoing repairs. | Carefully dismantle and rebuild the chimneys straight and plumb, reusing the existing stone wherever possible and supplementing with new to match. | 1705-BDP-AD-RF-PL-A-20005_P01<br>1705-BDP-AD-XX-EL-A-20001_P01<br>1705-BDP-AD-XX-SE-A-20001_P01 | 1705-BDP-AD-RF-PL-A-27001_P02<br>1705-BDP-AD-XX-EL-A-20001_T02<br>1705-BDP-AD-XX-SE-A-20001_T02 |
| 014 | 14-16 Corporation Street | Rooftop walkway | A covered rooftop walkway had been added to connect this roof storage deck to the third floor of 18-20 Corporation Street. This was shown as remaining in location. | This walkway was found to be built using modern materials and was in a poor condition. | Opportunity to remove an inappropriate modern addition and return the profile of the roof to its original state. This is also on the principal elevation of the building, facing onto Corporation Street. | Carefully remove the modern walkway and continue the form of the original slate roof covering over this area of the roof. | 1705-BDP-AD-RF-PL-A-20005_P01 | 1705-BDP-AD-RF-PL-A-27001_P02 |
| 015 | Central Arcade<br>Units 3-6 | Brick piers over these units | These brick piers were previously assumed to be chimneys which were to be ventilated and recapped. | On close inspection, these have been found to be piers reinforcing the external brick walls at first floor level | n/a | No ventilation or recapping is required. | 1705-BDP-AD-RF-PL-A-20005_P01 | 1705-BDP-AD-RF-PL-A-27001_P02 |

| 025 | Central Arcade | Glazed roof structure | Timber ridge beams, wall plates and principal rafters to be redecorated. | Extensive wet rot to end bearings of ridge beams and principal rafters. Wet rot to exposed faces of wall plates. | The timber surveyor and structural engineer confirmed the existing timber structure was unsuitable for the proposed roof loading. | Replace the timber with new where decayed, using the same profiles, and decorated to match the existing. | 1705-BDP-AD-RF-PL-A-20005_P01 | 1705-BDP-AD-RF-PL-A-27001_P02 |
| 026 | Central Arcade | Glazed roof structure | Cast iron trusses to be redecorated. | Cracking was noted to the top and bottom chords of several of the cast iron trusses. | The cast iron structure was unsafe in its existing condition. | Install additional steel principal rafters to carry the roof load and relieve the existing cast iron trusses of their existing load. Cast iron trusses to remain in location and be resupported from the new steel rafters. | 1705-BDP-AD-RF-PL-A-20005_P01 | 1705-BDP-AD-RF-PL-A-27001_P02 |

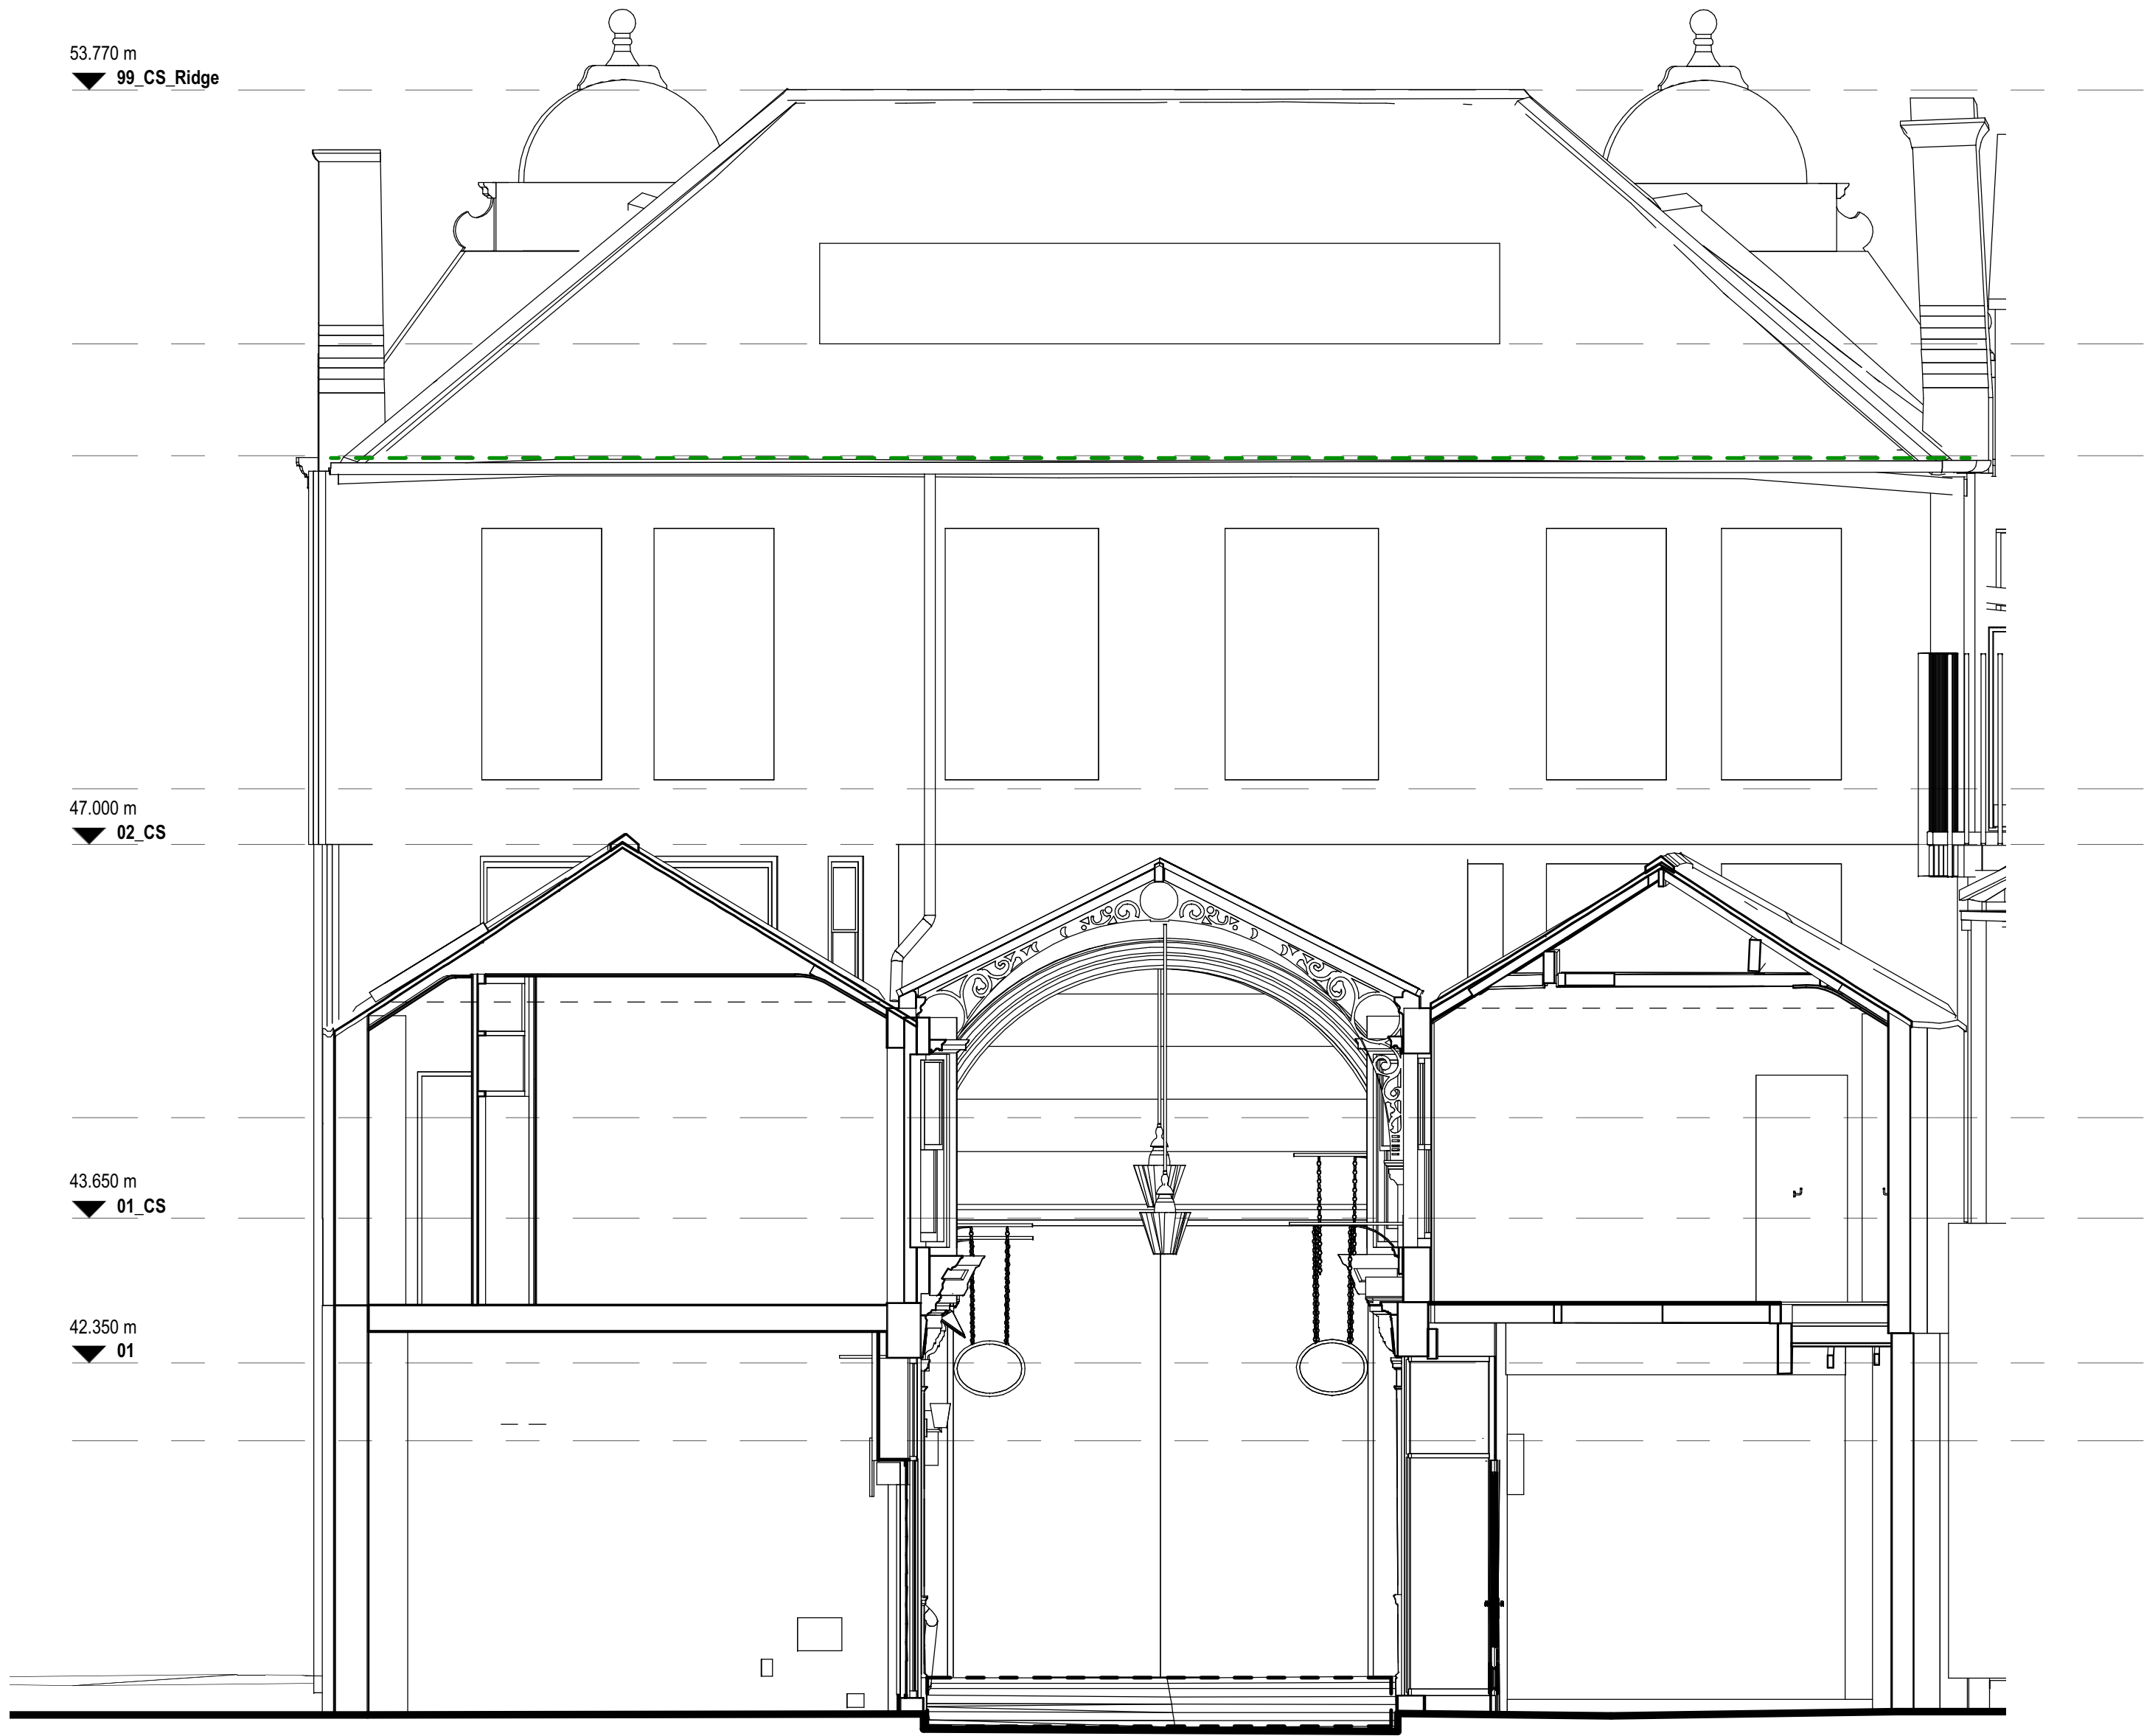
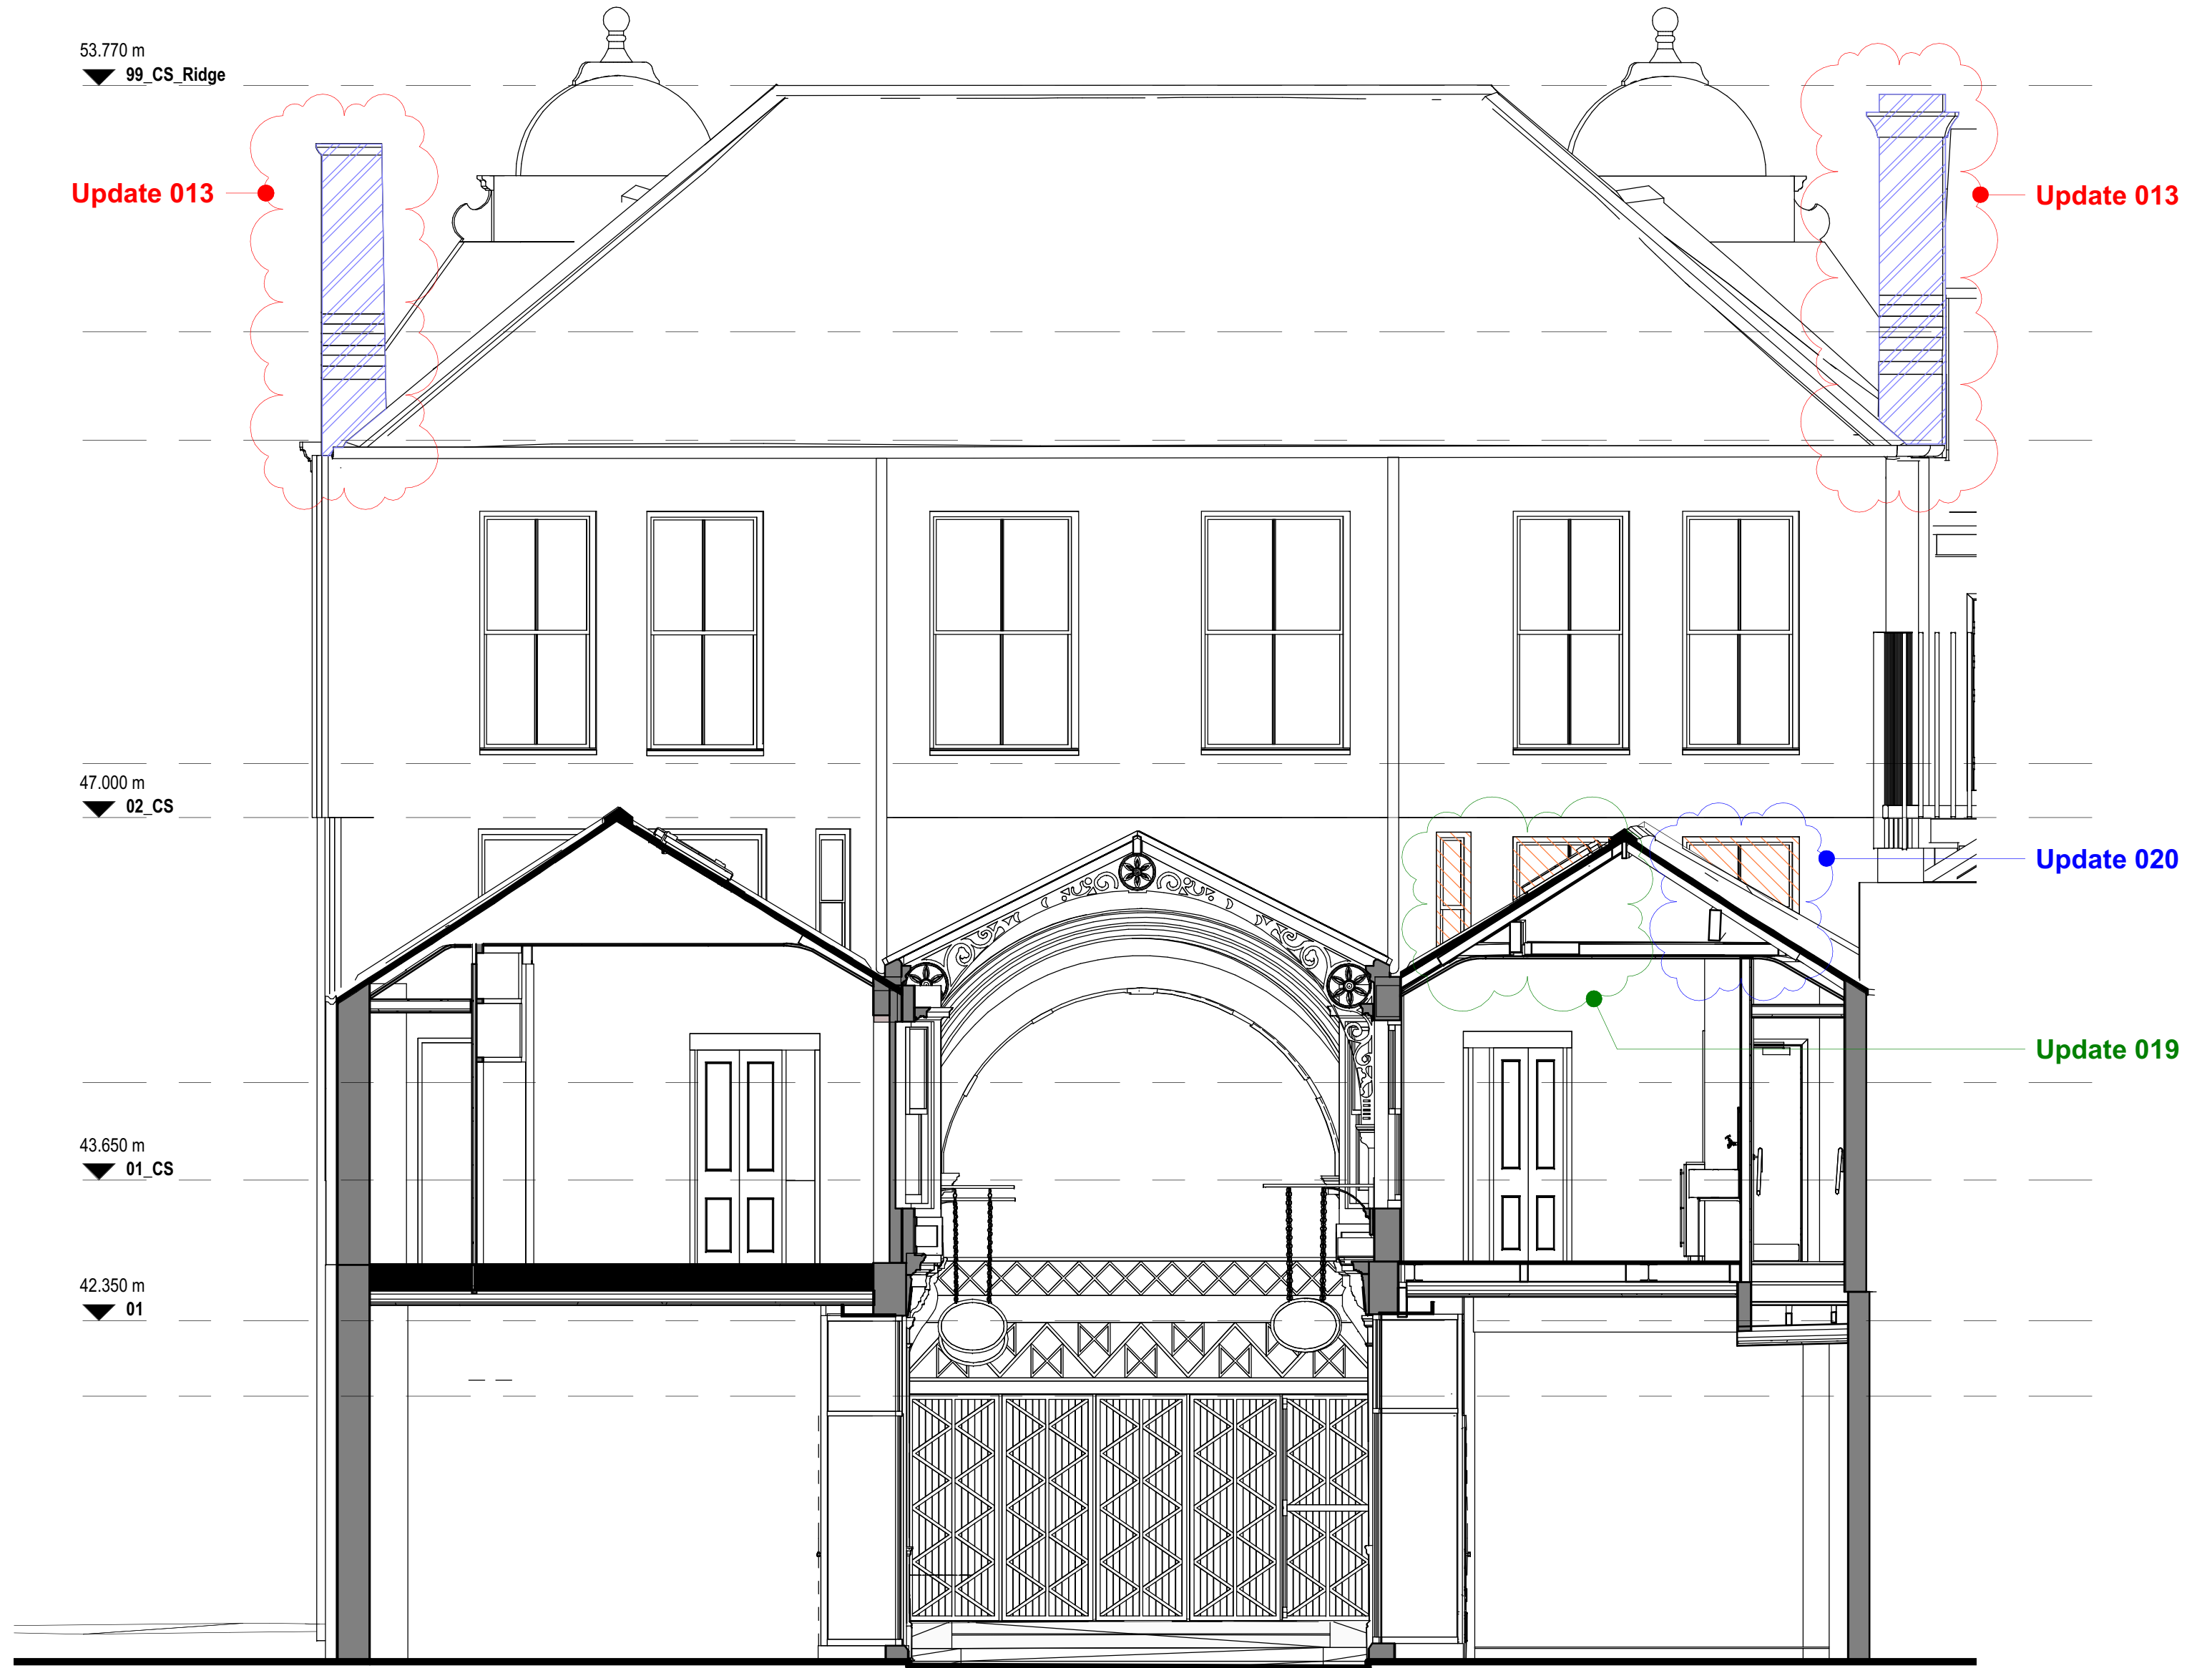
| 019 | 14-16 Corporation Street<br>Unit 26 | 2no. high level windows to rear of unit - over central arcade | Remove the existing concrete blockwork and internal wall linings. Infill opening with new brick to match existing wall. | During construction, the original windows were found encapsulated between the blockwork and internal linings. | There is the opportunity to retain the original timber sash windows in this location. | Repair the original sash windows to the same specification as the other window repairs. Omit the brickwork infill. | 1705-BDP-AD-XX-SE-A-20001_P01 | 1705-BDP-AD-XX-SE-A-20001_T02 |
| 020 | 14-16 Corporation Street<br>Unit 26 | 1no. high level windows to rear of unit - over central arcade | Repair the decayed existing timber sash window. | Since this original window was installed, the second floor has been replaced with a filler joist floor at a lower level than the original floor, which includes a supporting steel beam across this window. | Because of the position of the new floor and the supporting beam, it is no longer possible to remove the sash frame from the window, or to replace it once repaired. | Remove the decayed sliding sash window and replace with a fixed sash window, which has the same external appearance as the existing sash window. | 1705-BDP-AD-XX-SE-A-20001_P01 | 1705-BDP-AD-XX-SE-A-20001_T02 |

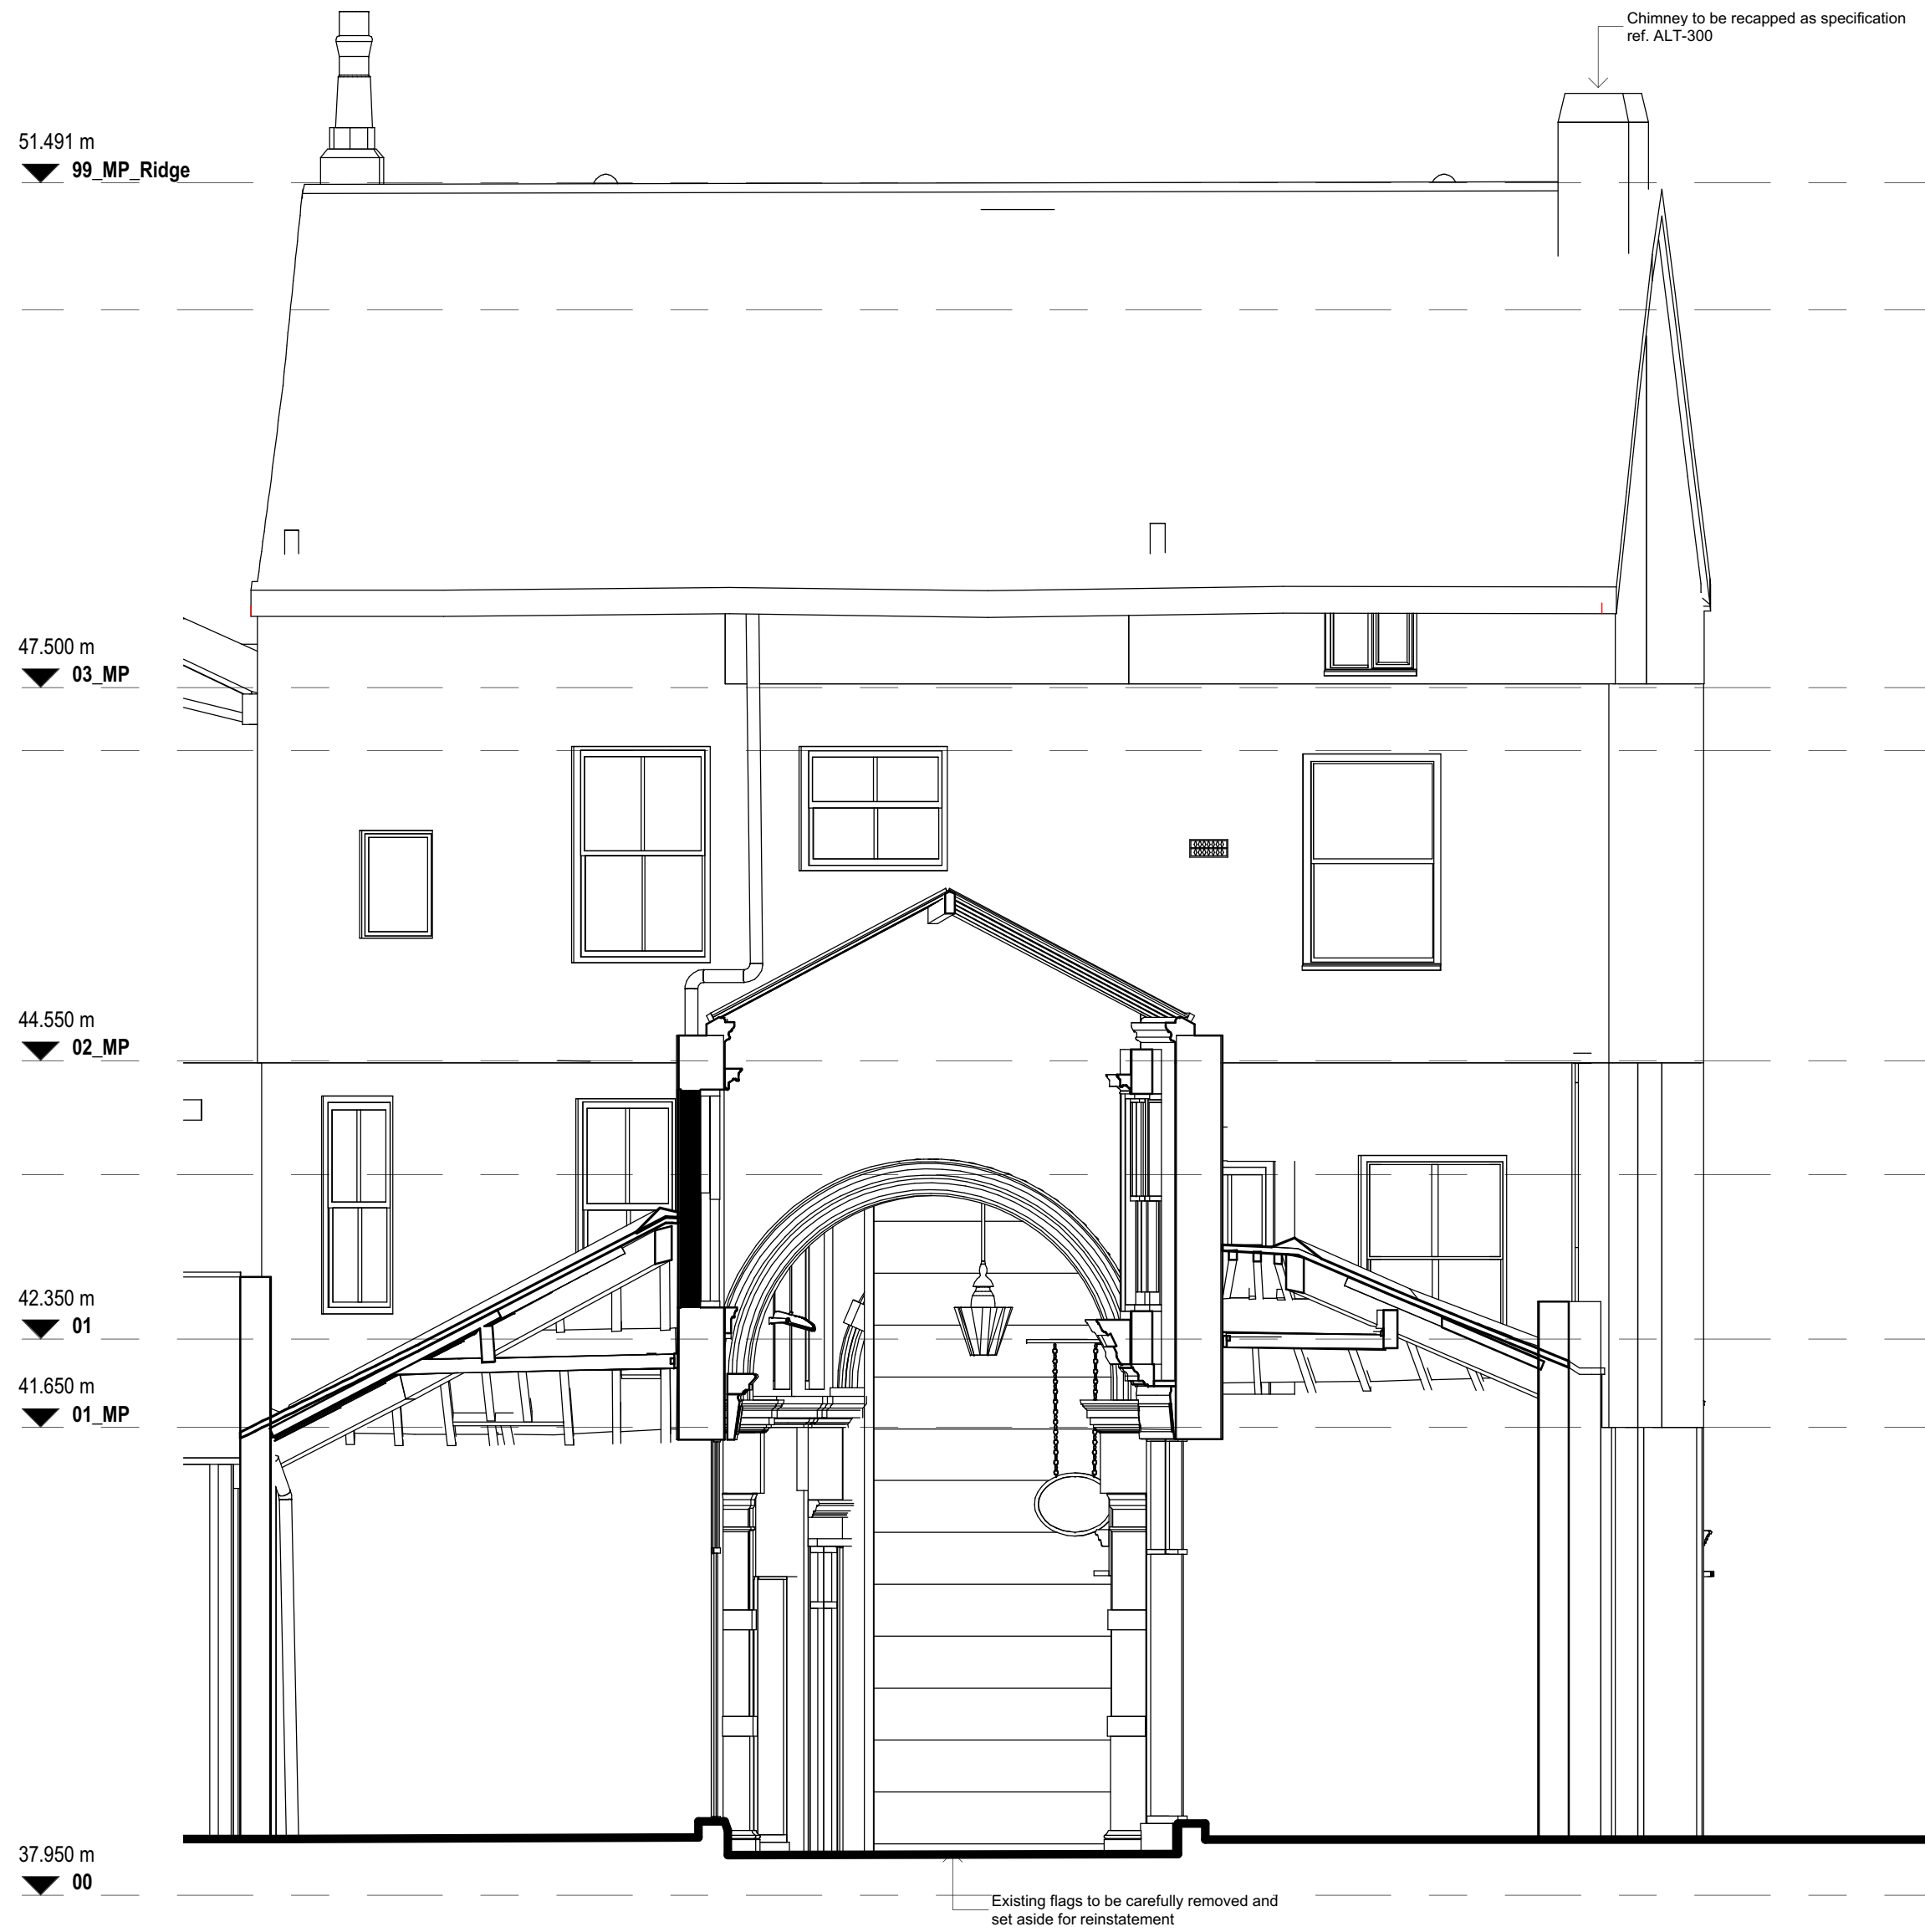
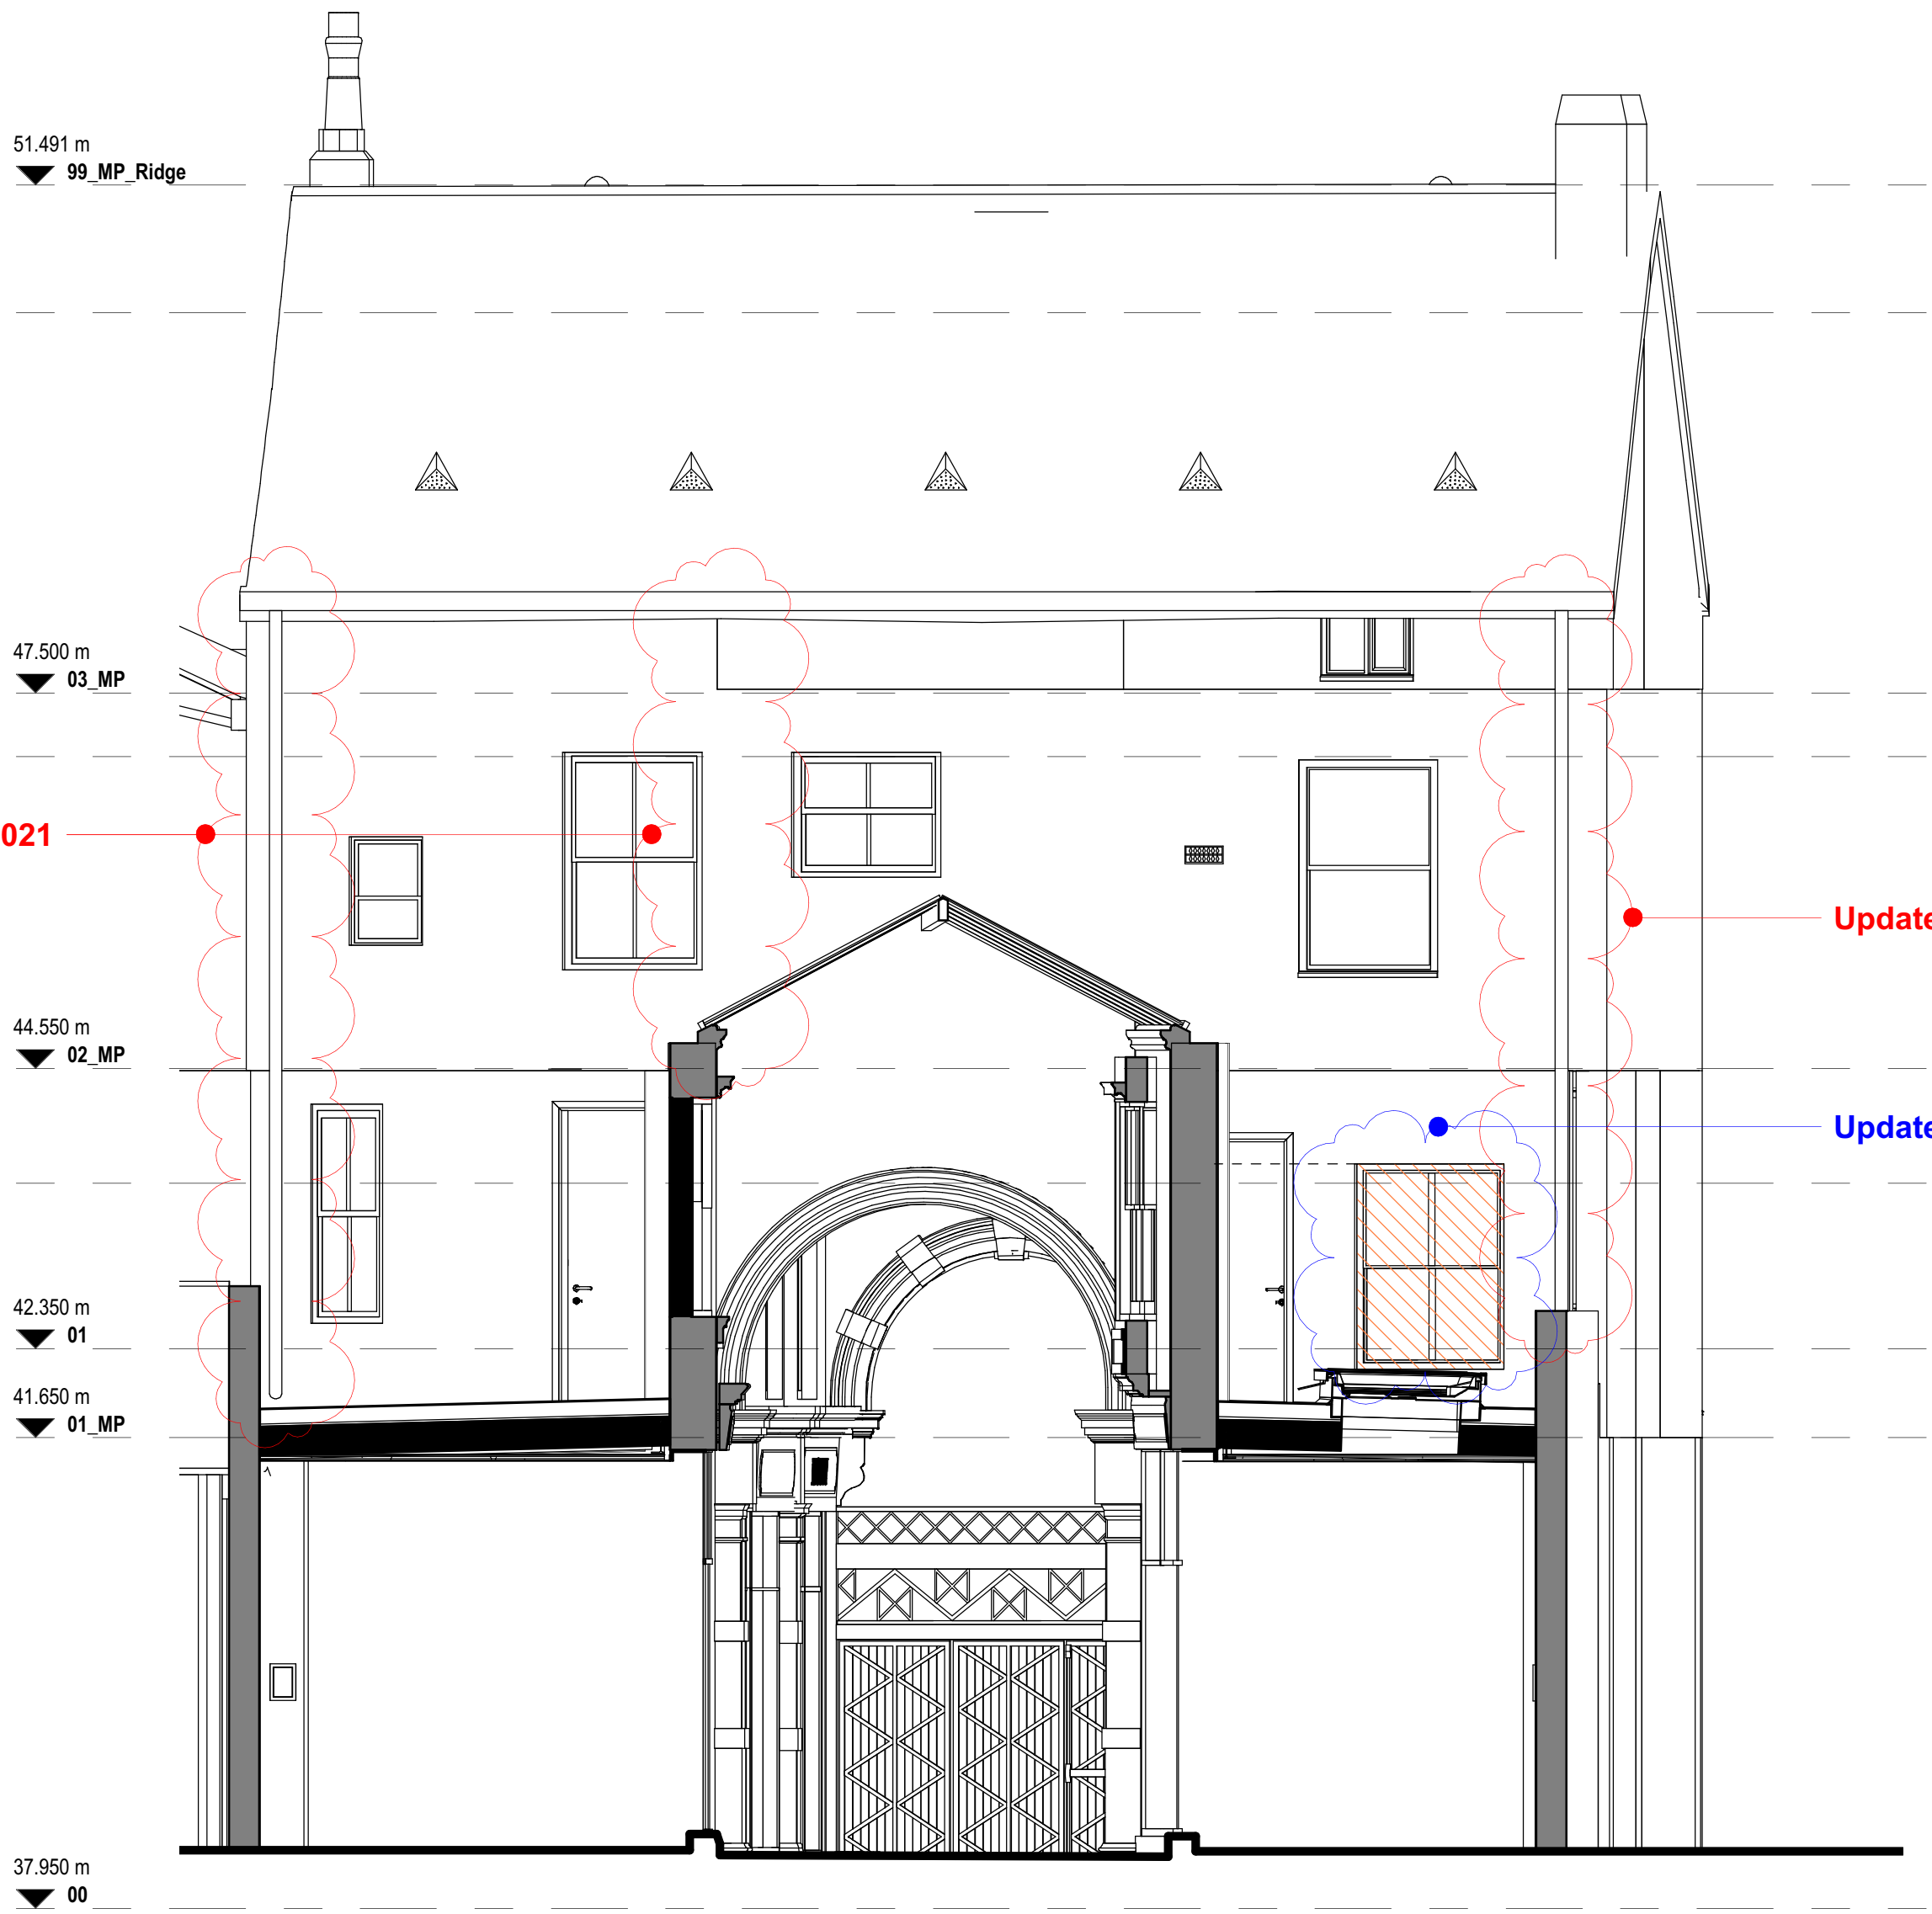
| 021 | 23-25 Market Place<br>Rear elevation of Market Place building | Gutter and rainwater pipe | Replace the existing cast iron gutter and rainwater pipe in the same size, profile and material. | Rainwater falling on the rear pitch of the Market Place roof falls into valley gutters and the eaves gutter, then into a single rainwater pipe which discharges into the glazed roof gutter, which transports rainwater back towards Corporation Street, into another rainwater pipe, onto the top of a slate roof, into another gutter, into an outlet, and then into an internal rainwater pipe. | This route is extremely convoluted, and has multiple junctions. There is evidence of past leaks in some areas below. A single rainwater pipe for this large area of roof provides no secondary resilience. It also seems unlikely that this was the original route for rainwater discharge. | Remove the existing single rainwater pipe, provide new cast iron rainwater pipes (to match existing profile) at both ends of this gutter discharging directly to the flat roof drainage. | 1705-BDP-AD-XX-SE-A-20002_P01 | 1705-BDP-AD-XX-SE-A-20002_T02 |
