# The Arcade and 18-20 Corporation Street and 17 Foundry Street, Dewsbury

## Summary of Amendments

Doc No. 1705-BDP-AD-XX-RG-Z-00005  
Revision: P01  
Date: 18 June 2026

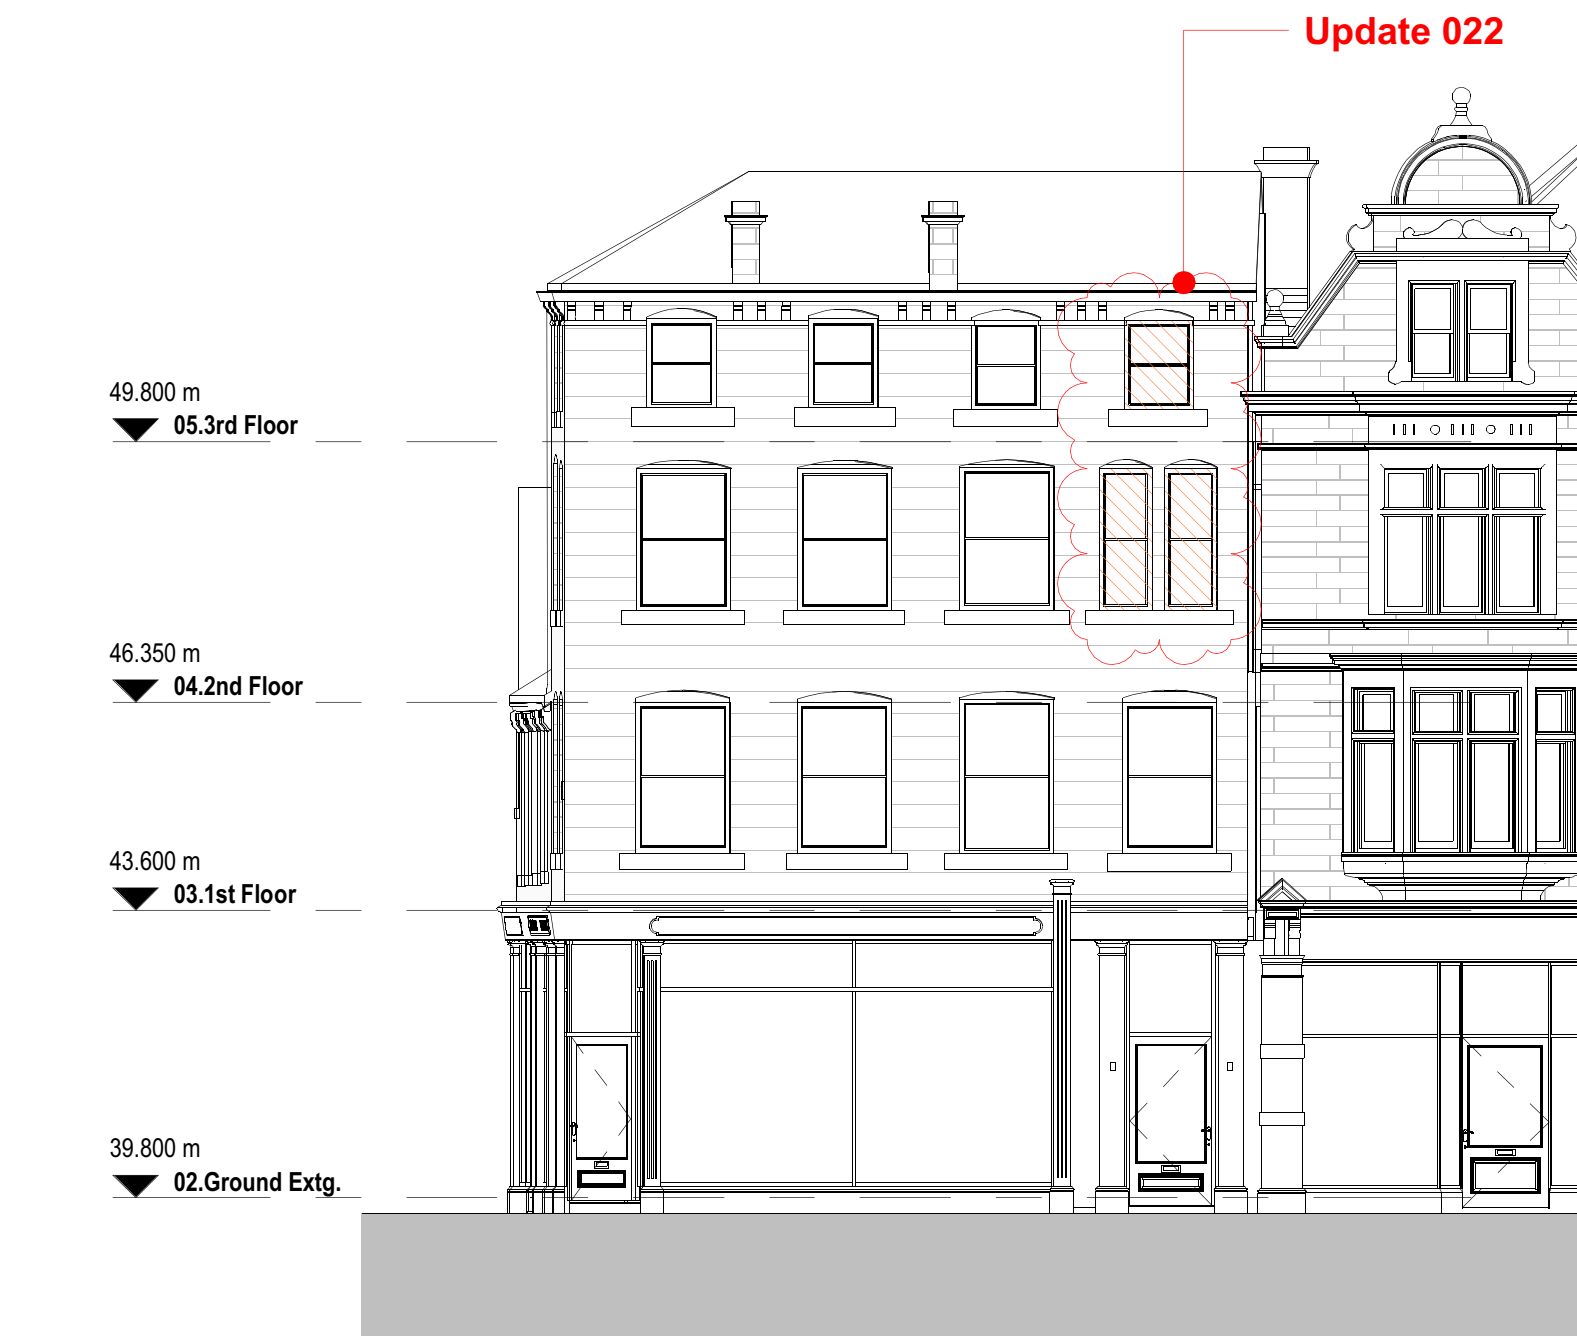
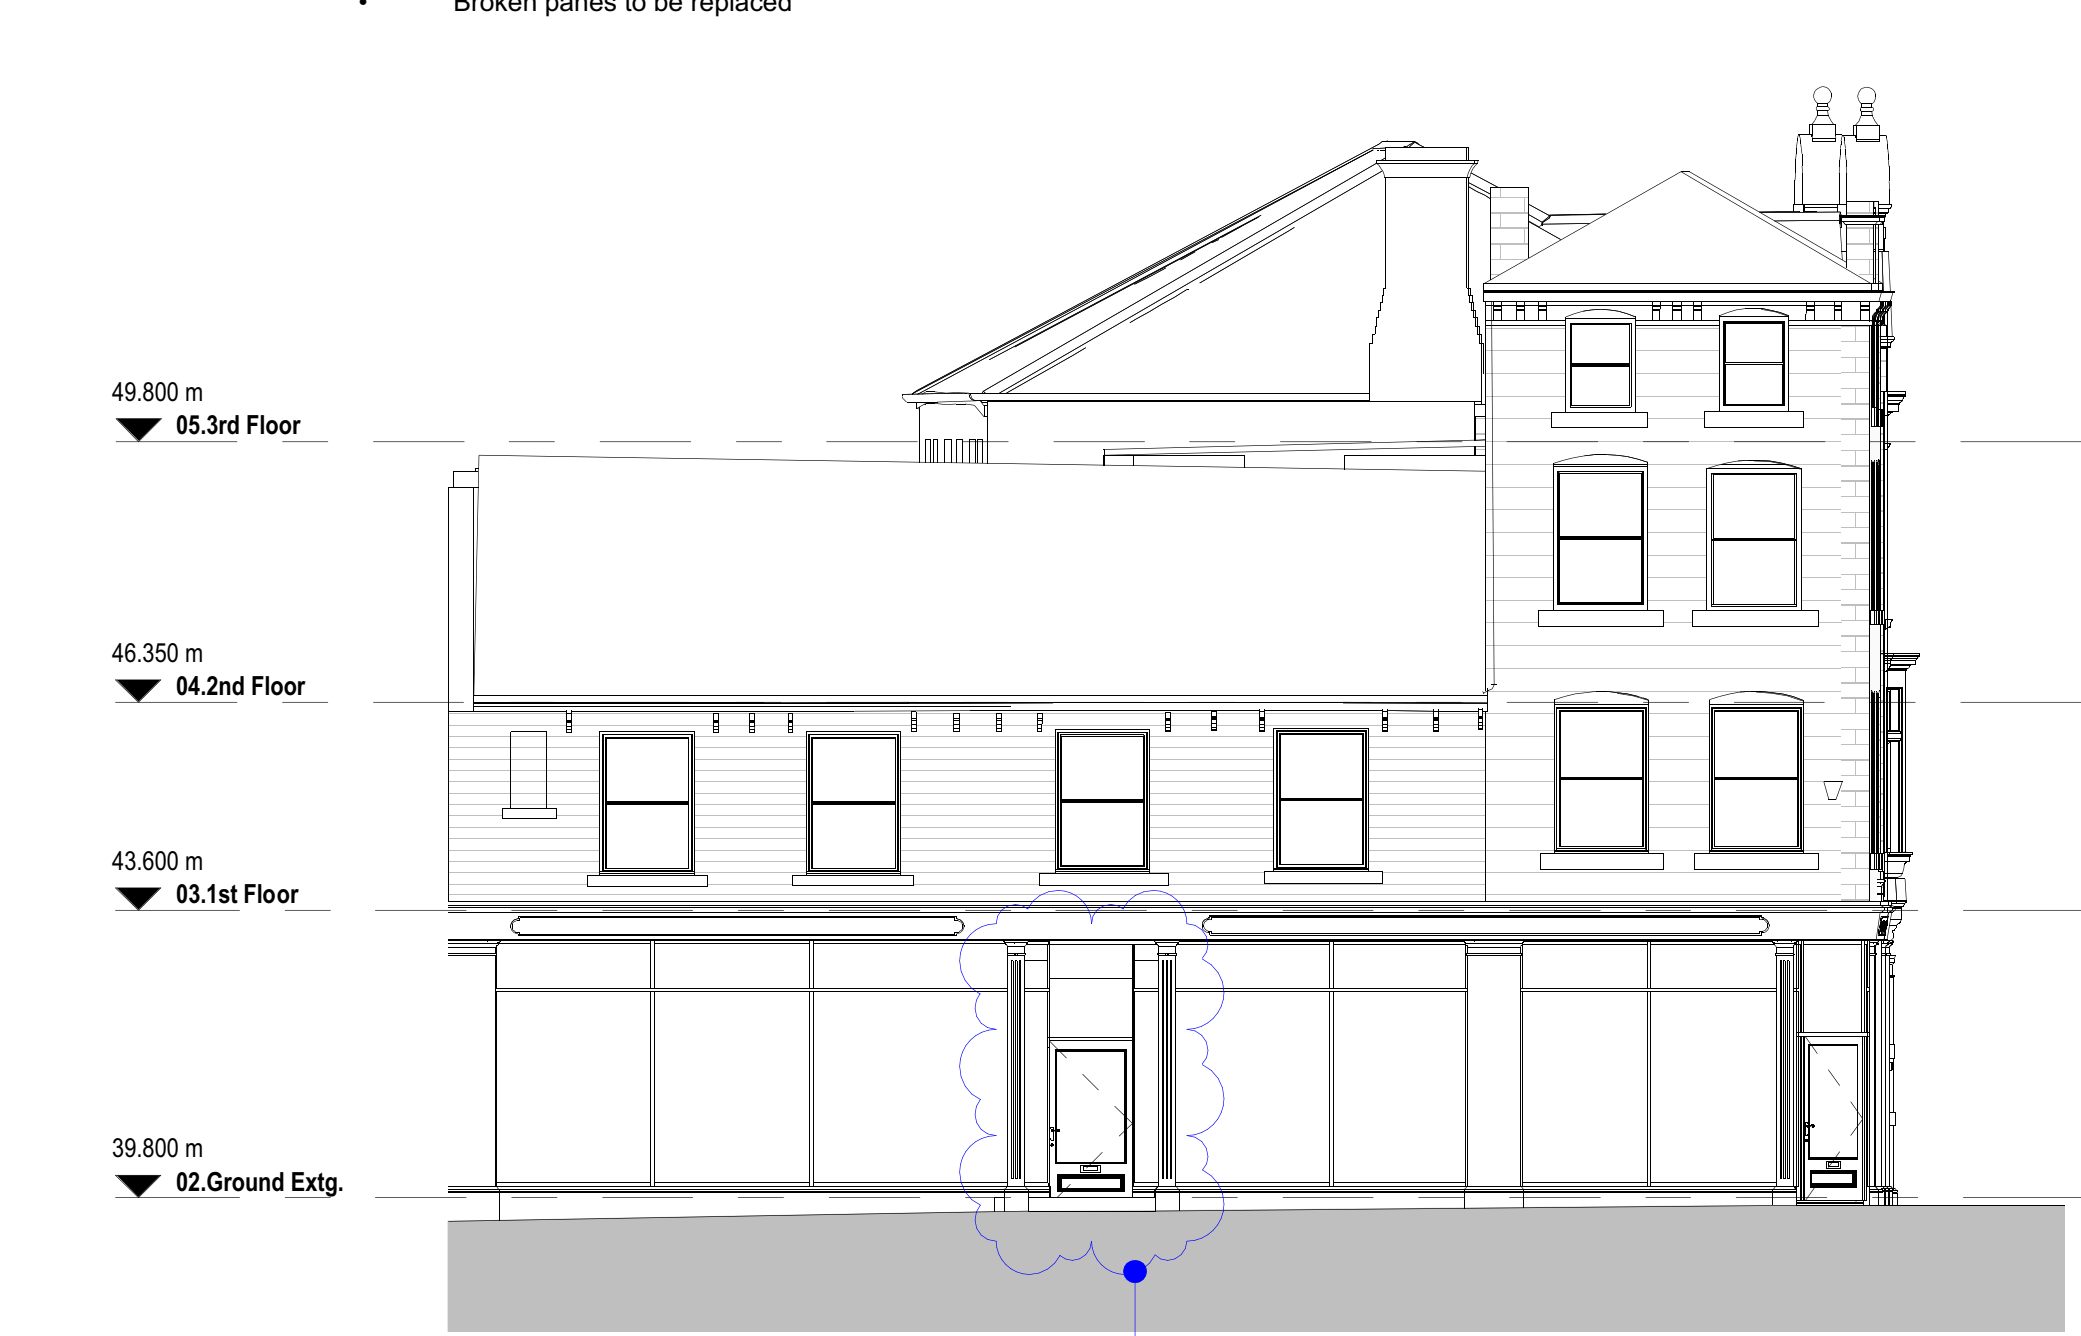
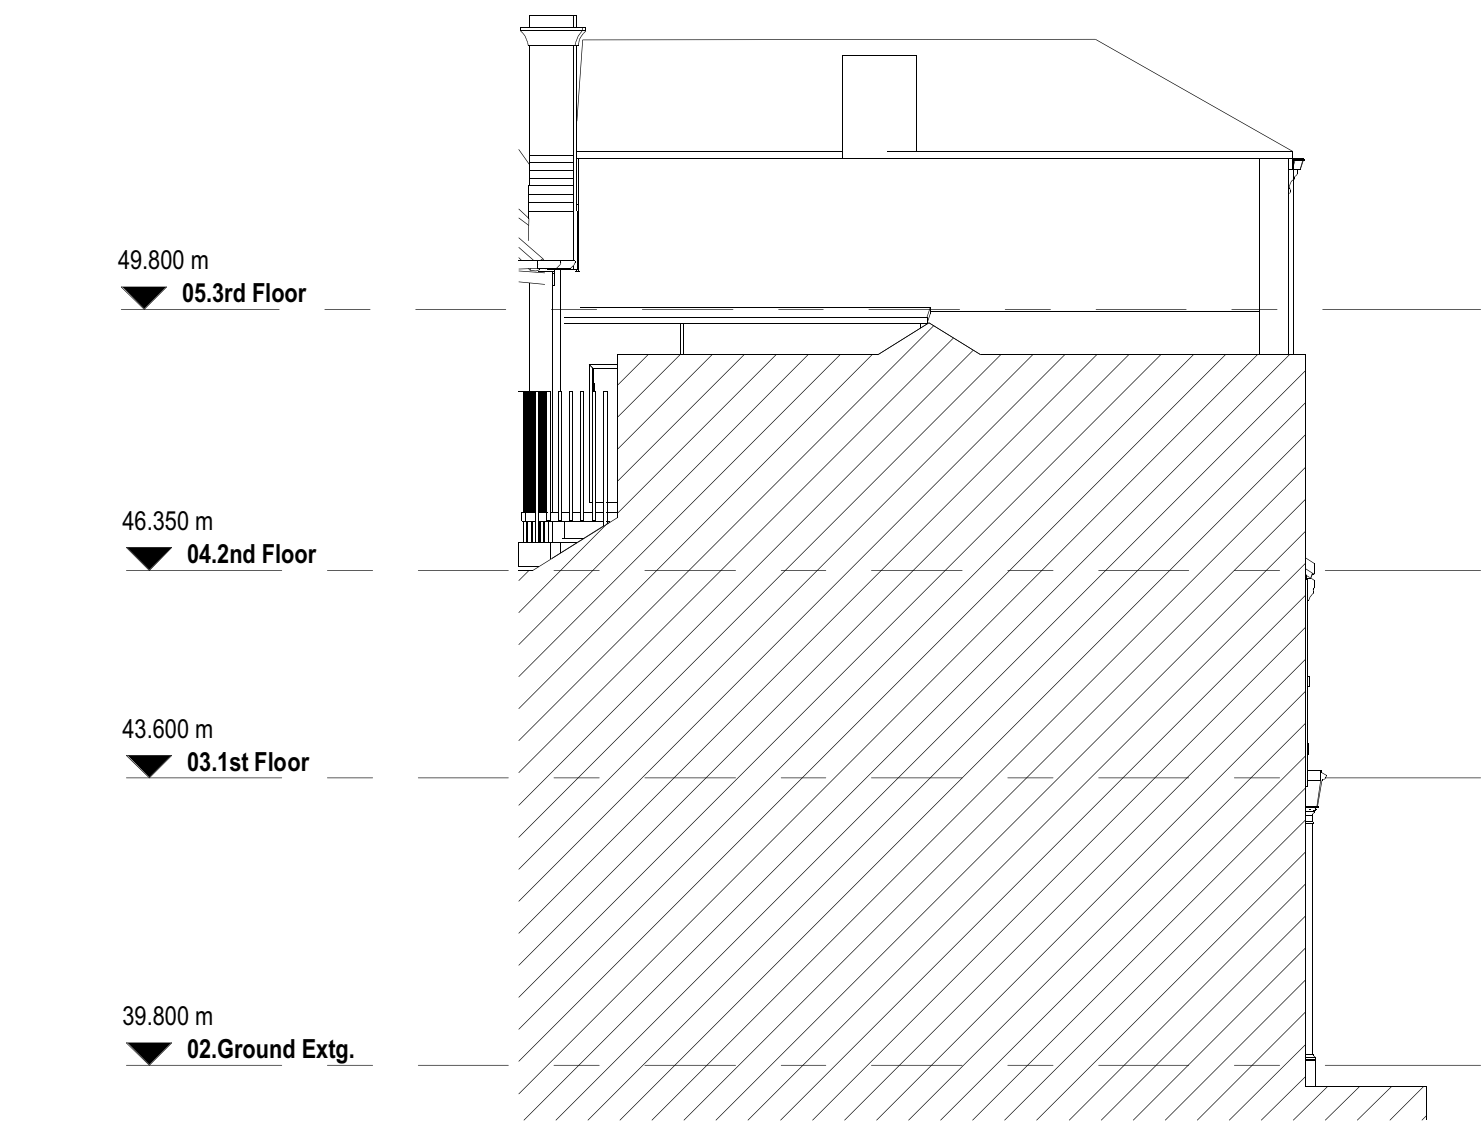
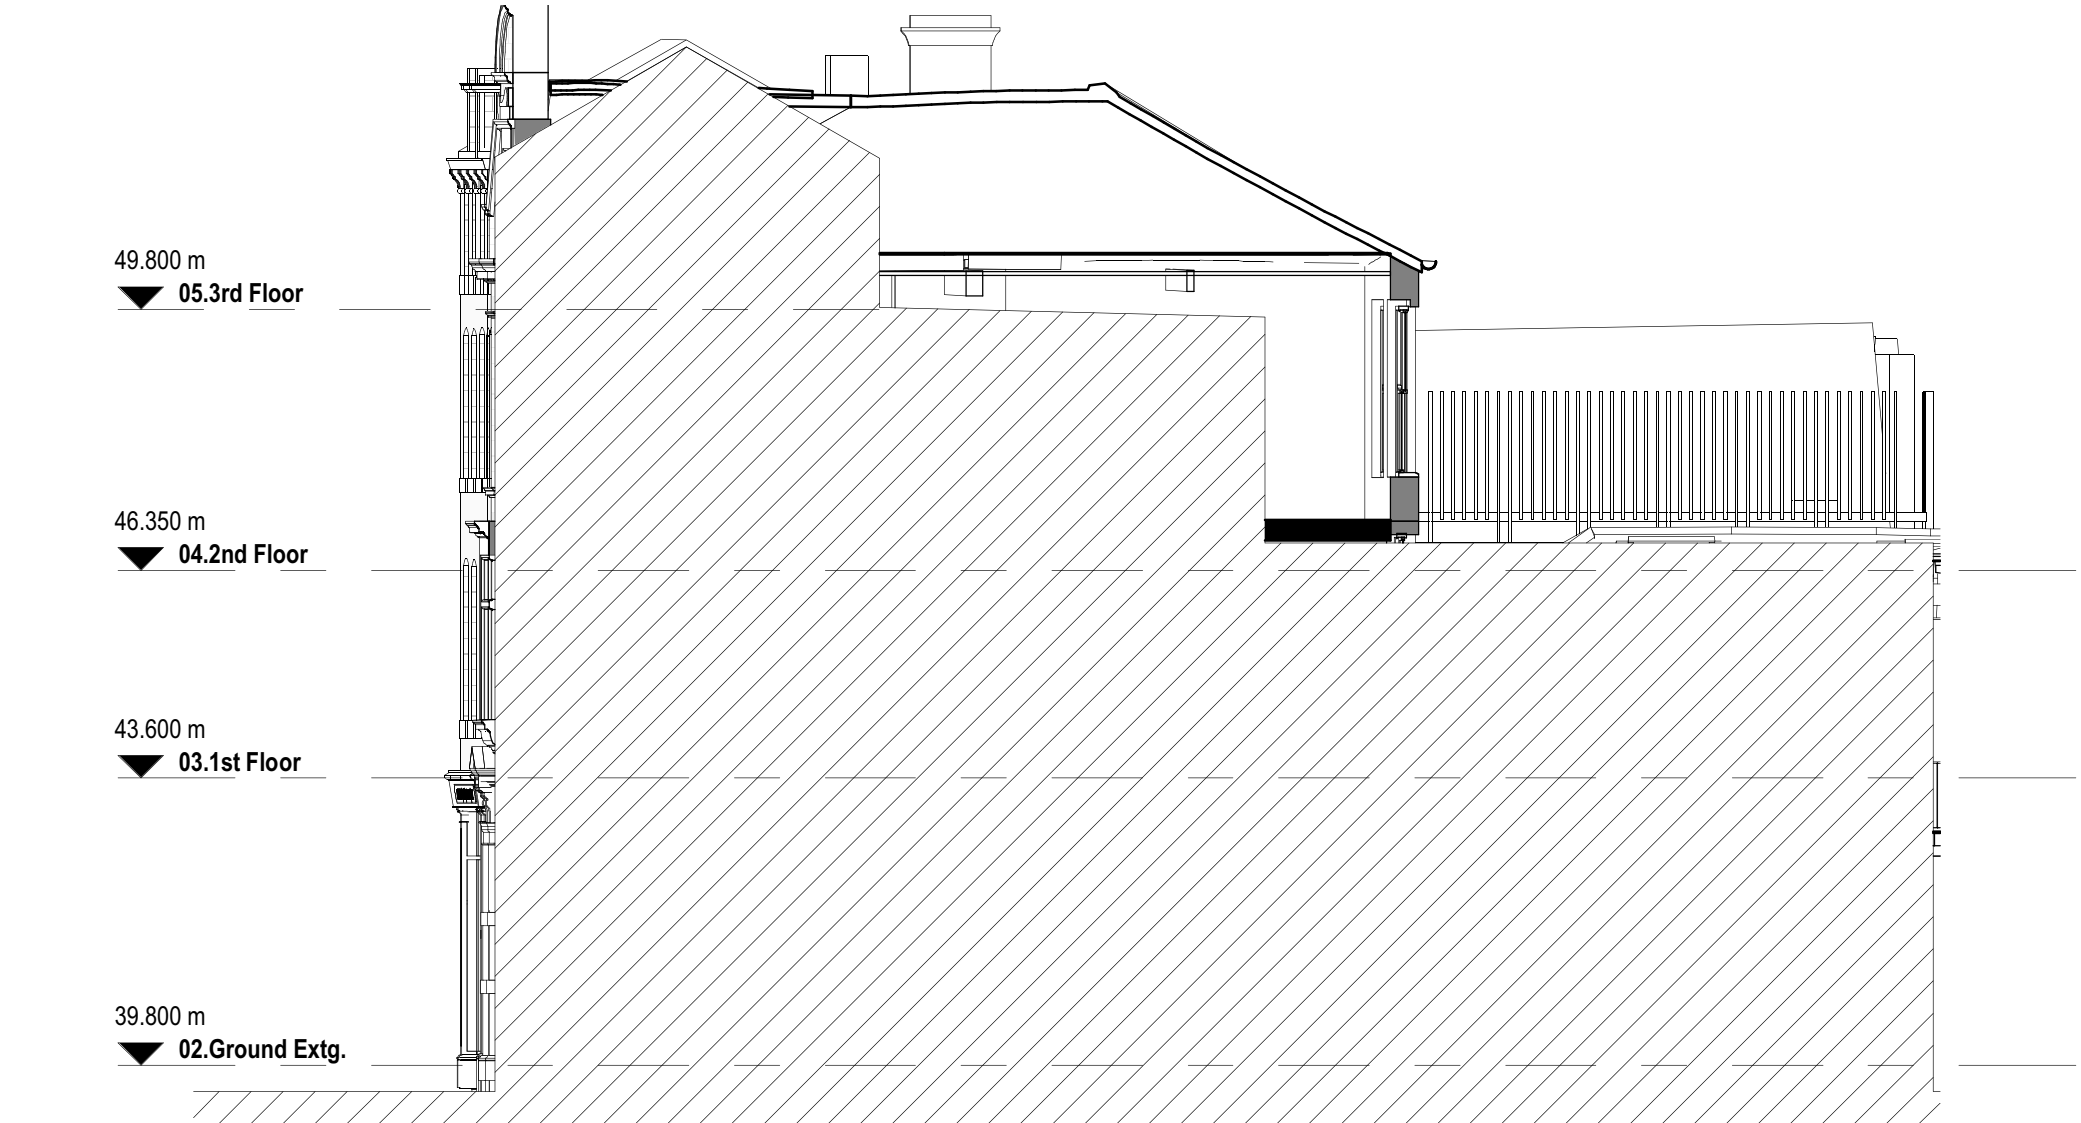
| 022 | Central Arcade, 14-16 Corporation Street and 18-20 Corporation Street<br>Refer to elevation drawings | Windows | Repair windows where possible using traditional techniques. Some windows were known to have extensive wet or dry rot, or were absent and were therefore proposed to be replaced. | Additional windows were found to have extensive wet and dry rot. (2 to 14-16 Corporation Street North Elevation, 2 to Central Arcade East Elevation, and 2 to Central Arcade West Elevation, 3 to 18-20 Corporation Street North Elevation) | These additional windows are so extensively decayed that they are unsuitable for repair. | Replace 6 no. windows, in addition to the 3 no. already proposed to be replaced (in unit 30, shown on Section AA). Replacement windows to match existing in size, proportions and timber profiles. | 1705-BDP-AD-XX-EL-A-20001_P01<br>1705-BDP-AD-XX-EL-A-20005_T01<br>1705-BDP-AD-XX-EL-A-20004_P01<br>1705-BDP-AD-XX-SE-A-20002_P01<br><br>1705-BDP-18-ZZ-EL-A-00002_P04 | 1705-BDP-AD-XX-EL-A-20001_T02<br>1705-BDP-AD-XX-EL-A-20003_T02<br>1705-BDP-AD-XX-EL-A-20004_T02<br>1705-BDP-AD-XX-SE-A-20002_T02<br><br>1705-BDP-18-ZZ-EL-A-00002_P05 |
