## PROPOSED RESIDENTIAL ACCESSES

DOWKER STREET, MILNSBRIDGE, HUDDERSFIELD

### STAGE 1 – ROAD SAFETY AUDIT

REPORT REF: 23-1535-RSA1

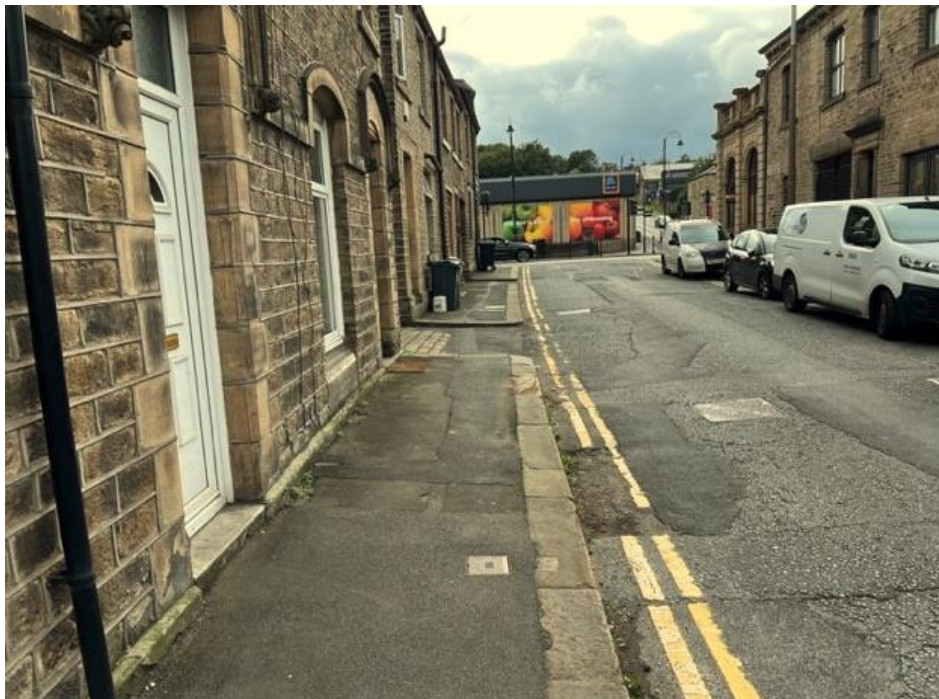
3.2. **Problem 1**

Location: George Street – Opposite southern access.

Summary: Location of sign may increase the risk of pedestrians entering the carriageway.

A sign indicating the one way street is proposed on the southern side of George Street in an already narrow footway. Should this sign be placed as indicated at the kerb edge, the clear footway width would be reduced such that a double width pram or wide mobility scooter may not be able to pass without entering the adjacent carriageway area. This problem could be exacerbated by utilities in the footway further influencing the placement of the sign. This may consequentially increase the risk of collisions between pedestrians and passing vehicles.

Recommendation:

It is recommended that the one way sign is placed to the rear of the footway, against the wall of the house.

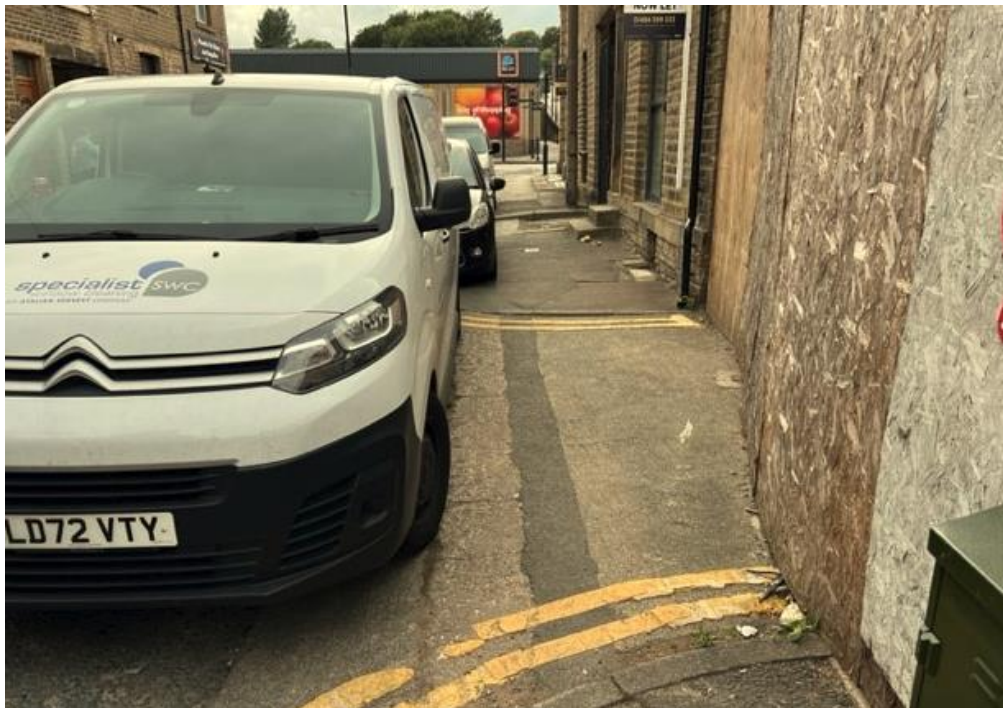
### 3.3. Problem 2

Location: George Street – West of southern access.

Summary: Parked/loading vehicles may increase the risk of junction related collisions.

Double yellow parking restrictions are currently provided on George Street. These appear to be largely abused, as observed on site and through Google Street View images from earlier dates, with vehicles also observed two wheels up on the footway. A visibility splay of 30m is indicated, but the speed of vehicles at this point on George Street is likely to be much closer to 15mph. Should the obstructive parking/loading continue, the junction visibility to the right for vehicles leaving via the southern access may be obscured by parked/loading vehicles. This may increase the risk of junction related collisions.

Recommendation:

It is recommended that sufficient junction visibility is provided to the right for the anticipated speed of vehicles. This could be achieved by means of a kerb buildout, with bollards to prevent parking/loading in the visibility splay.

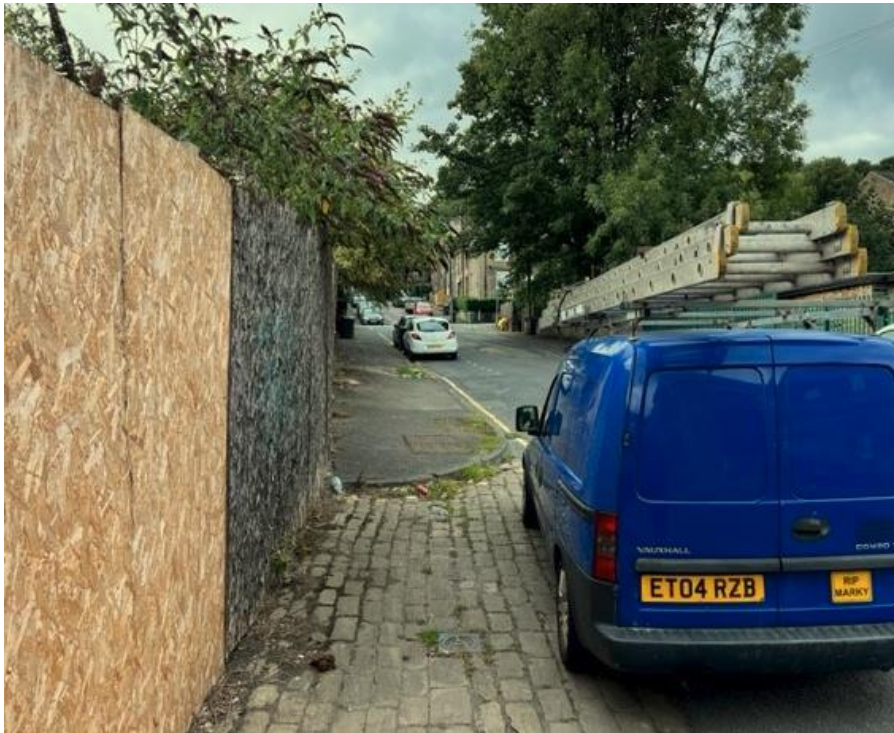
### 3.4. Problem 3

Location: Dowker Street – South of eastern access

Summary: Parked vehicles may increase the risk of junction related collisions.

Limited stay parking restrictions are currently provided on Dowker Street, these currently extend closer to the eastern access than is indicated on the drawings. A visibility splay of 43m is indicated, which is directly from Manual for Streets for 30mph. The speed of vehicles on Dowker Street is likely to be much closer to 15mph than 30mph at this location. Should these restrictions remain in place, the junction visibility to the right for vehicles leaving via the eastern access may be obscured by parked vehicles. This may increase the risk of junction related collisions.

Recommendation:

It is recommended that sufficient junction visibility is provided to the right for the anticipated speed of vehicles.

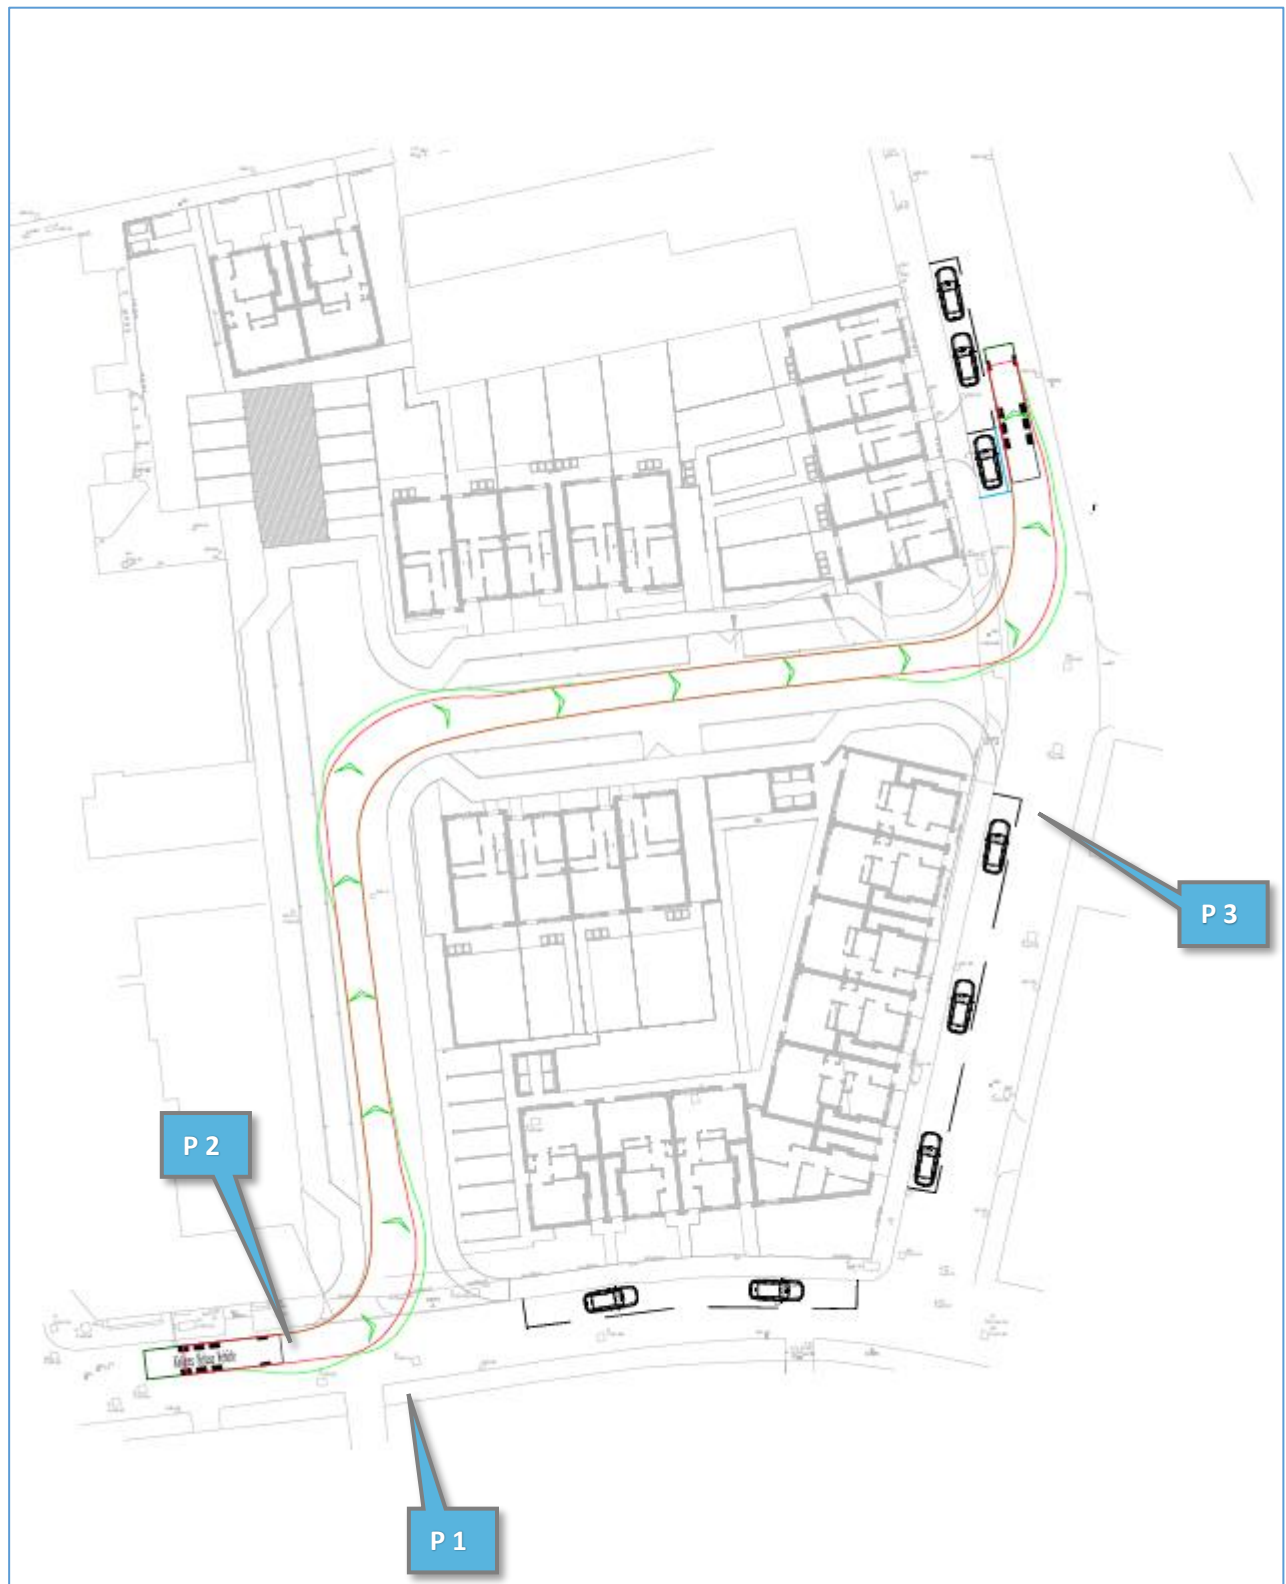
Figure 2 – Problem Location Plan

The location of any problems/observations that have been identified in Section 3 of this report can be seen on the extracts of the drawings supplied to the Audit Team, as listed in Appendix A.
