# Environment agency

## Culvert Conveyance Survey

Longwood brook AIMS 151971  
06/02/2018

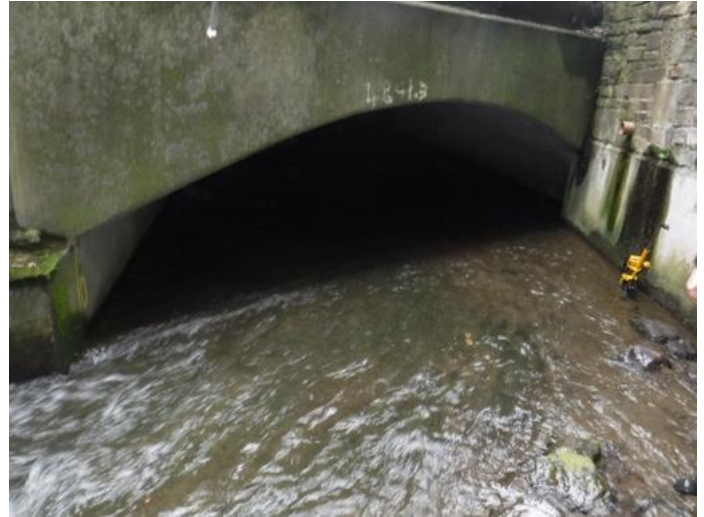
Appendix 4

| Construction type at inlet | | Concrete arch, concrete invert. | |

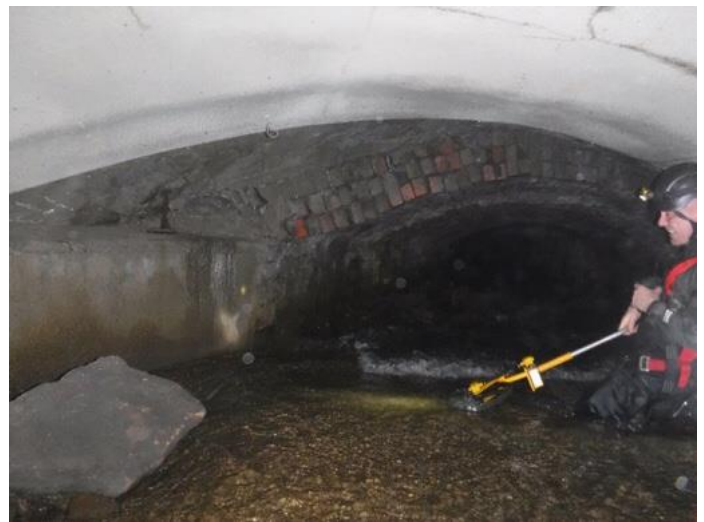
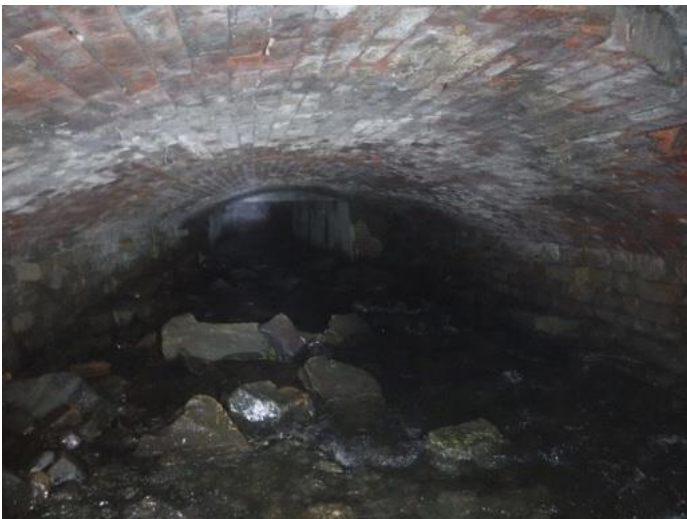
Change in construction

Changes to brick arch, stone walls, concrete invert.

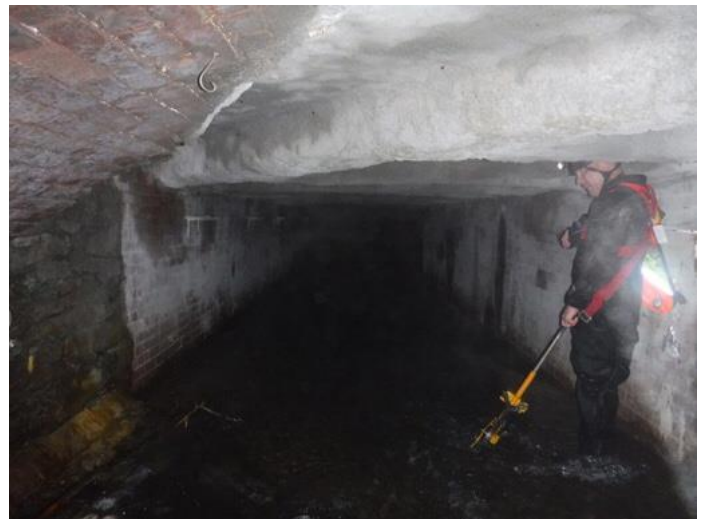
Appendix 8

Changes to brick walls, concrete soffit, concrete invert.

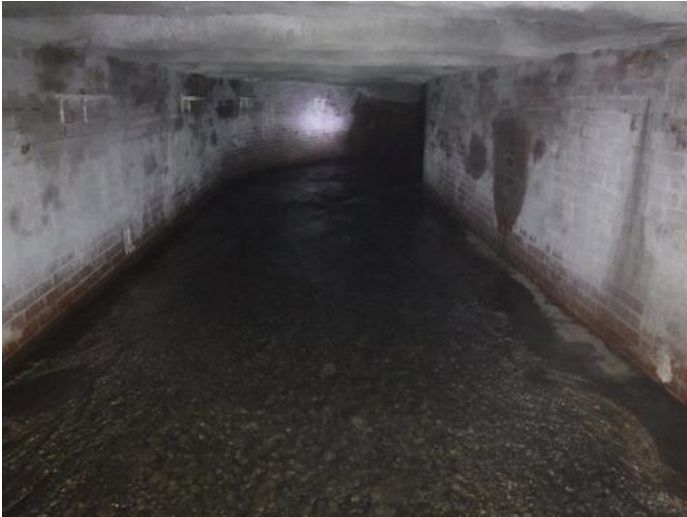
Appendix 9

Change in dimensions

| Width | 2.40m |
| Height | 1.80m |

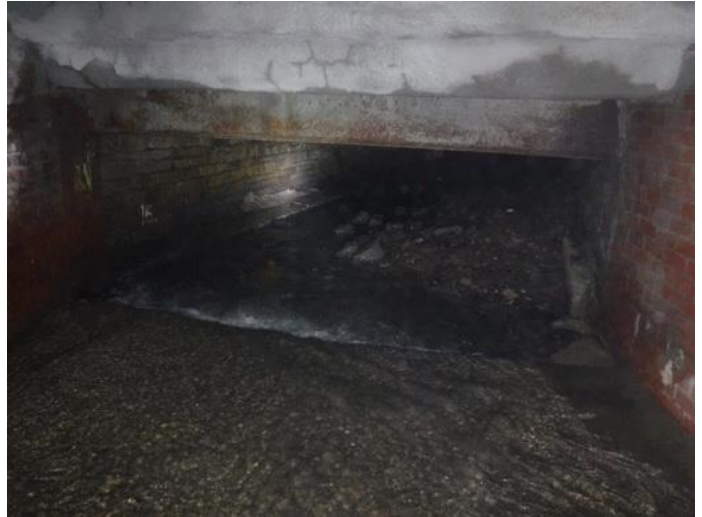
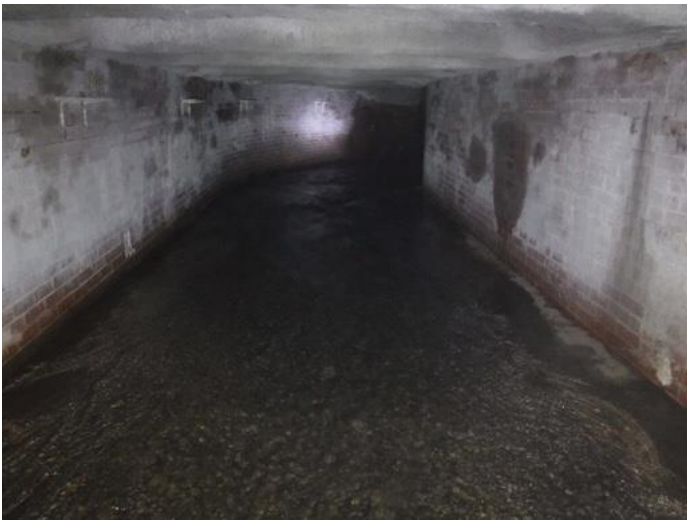
| Direction | Culvert lines right. |

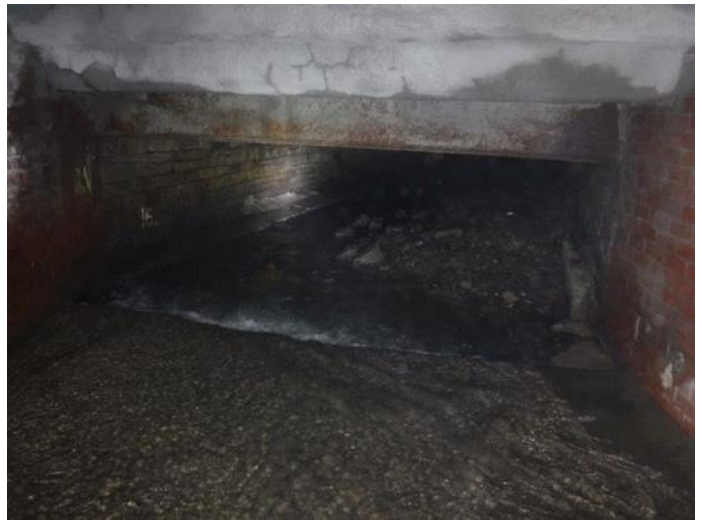
Appendix 12

| Description | Changes to stone walls, RJS soffit, concrete invert. |

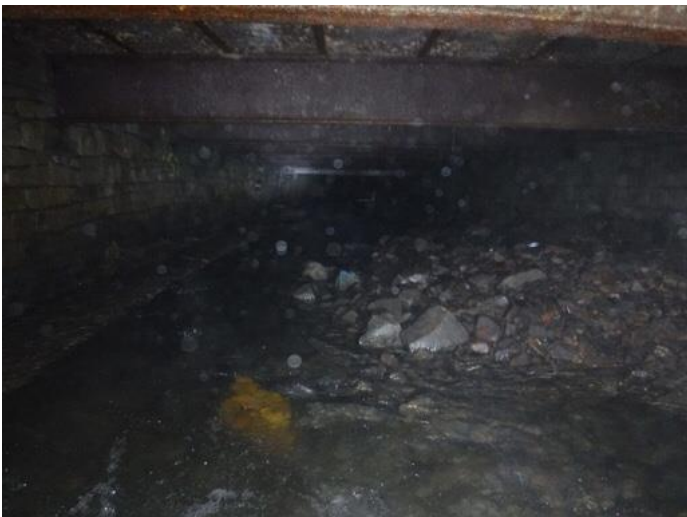
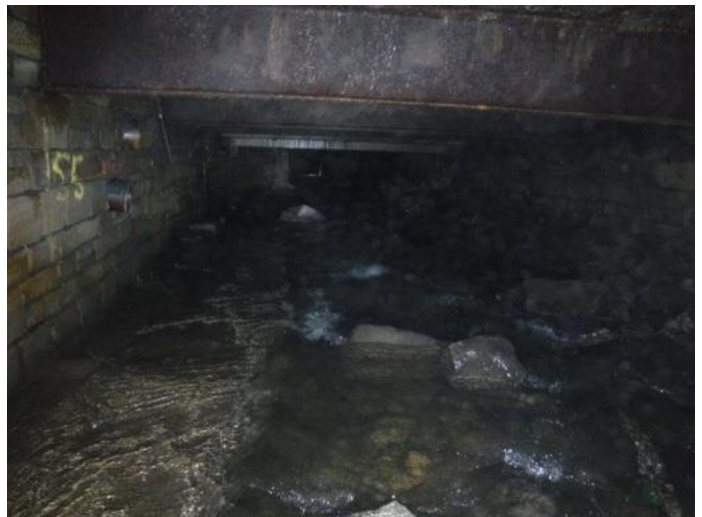
| Width | 4.20m |
| Height | 1.80m |

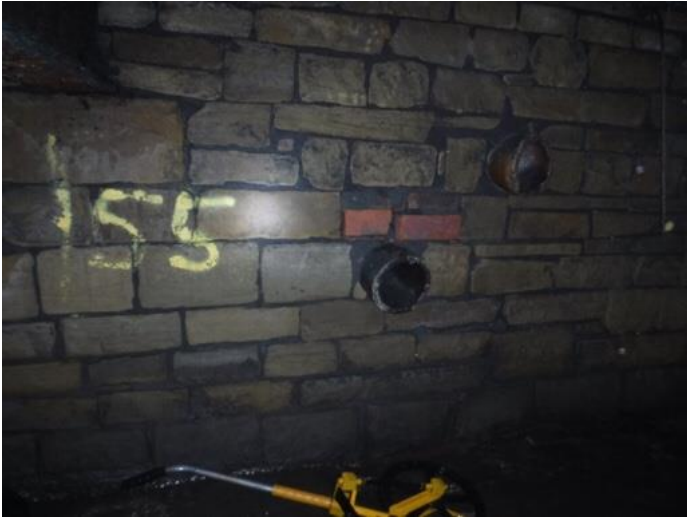
Appendix 15

| Description | Clay Pipe |
| Position | 9 o clock |

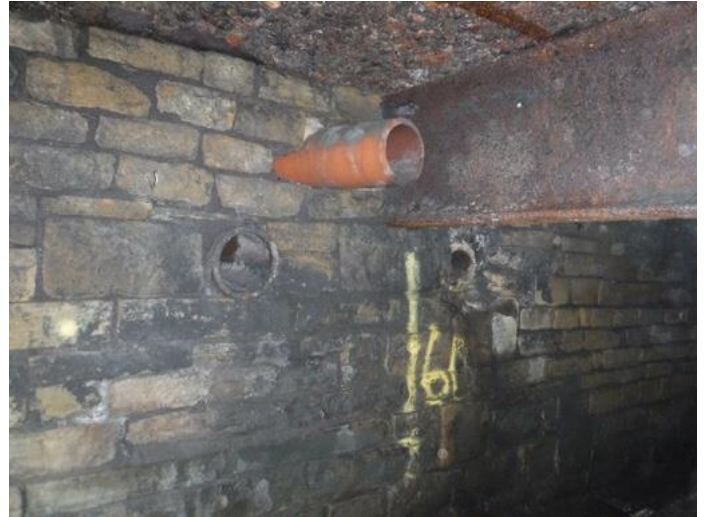
Appendix 16

| Description | Three pipes very close proximity to each other, in wall of culvert. |

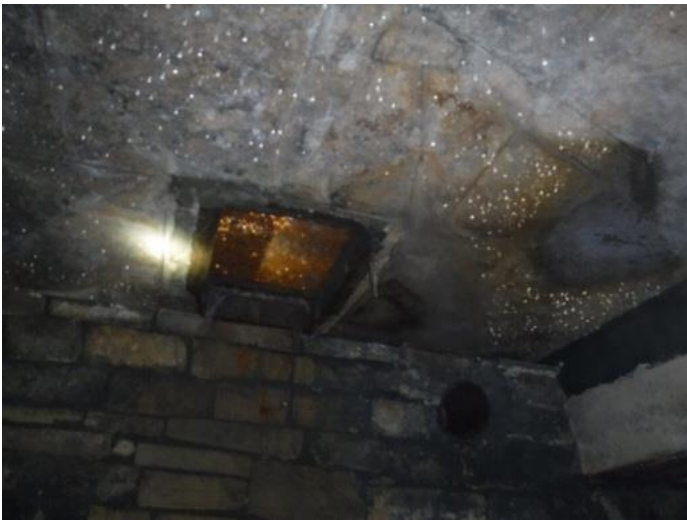
Appendix 17

| Feature | Inspection hatch |
| Height from invert | 1.80m |
| Dimensions | 600mm x 600mm |

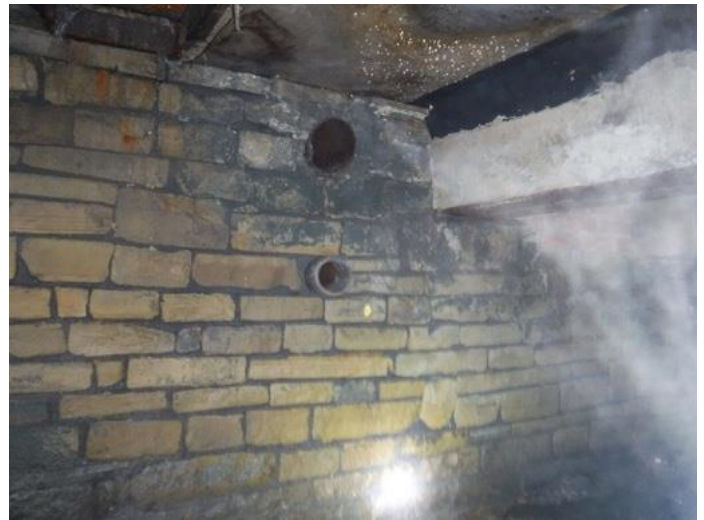
Appendix 18

| Description | Two pipes in close proximity in wall of culvert. |

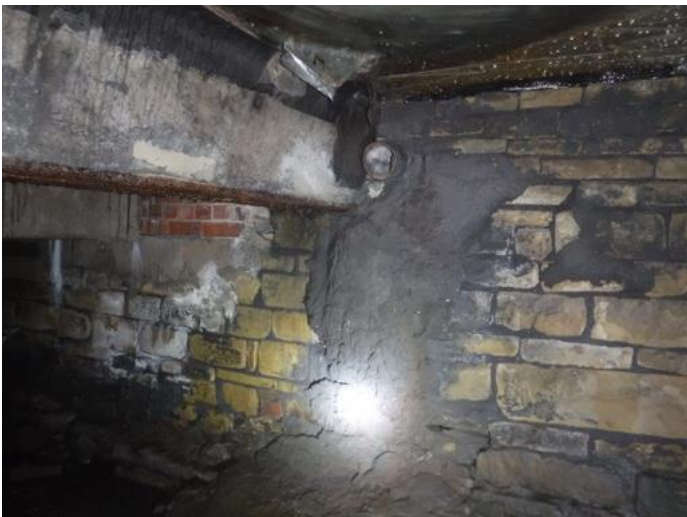
Appendix 19

| Description | Pipe in wall of culvert. |

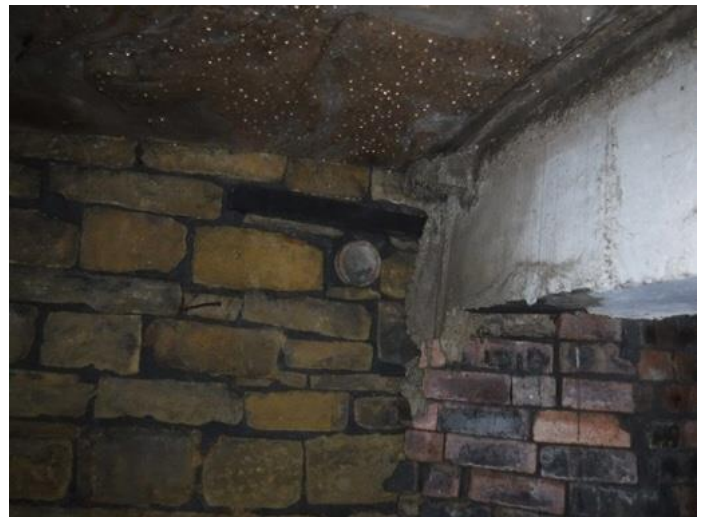
Appendix 20

| Description | Pipe in wall of culvert |

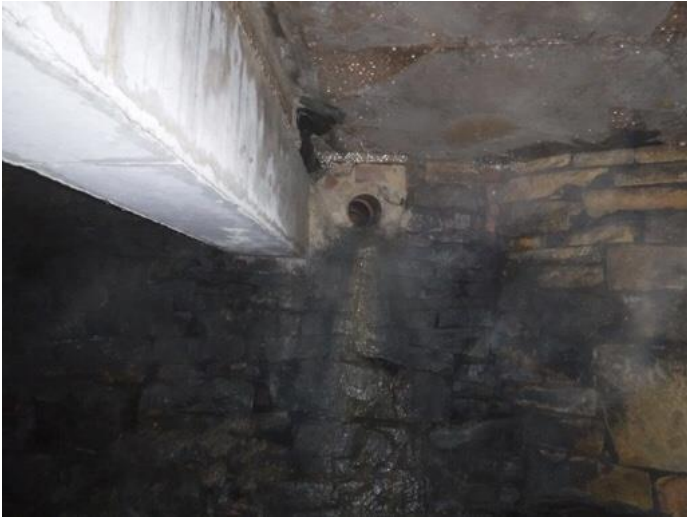
Appendix 21

| Description | Pipe in wall of culvert |

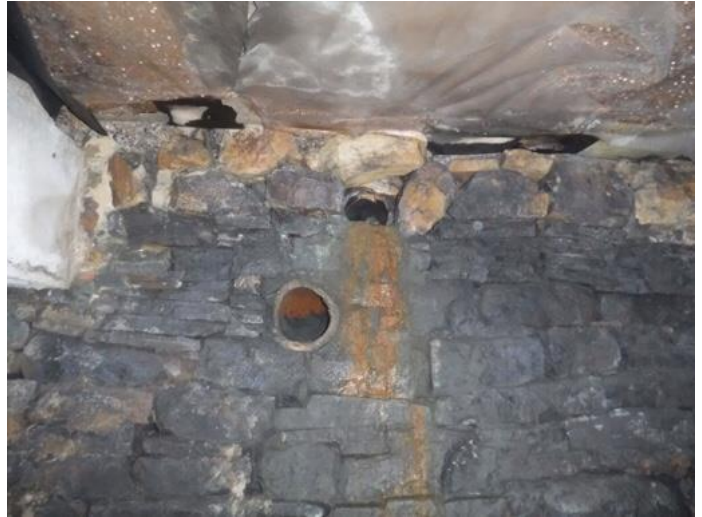
Appendix 22

| Description | Pipe in wall of culvert |

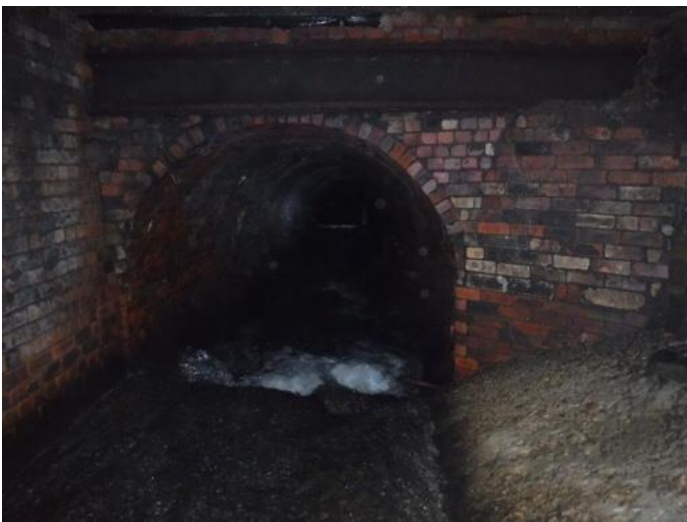
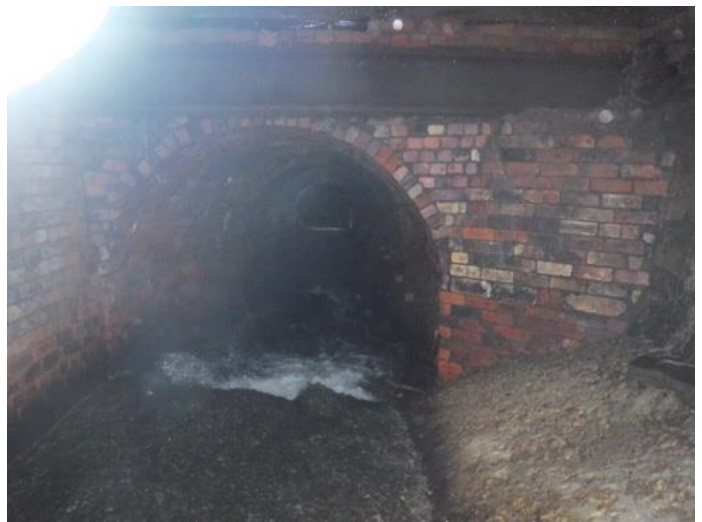
| Description | Changes to brick arch and concrete invert. |

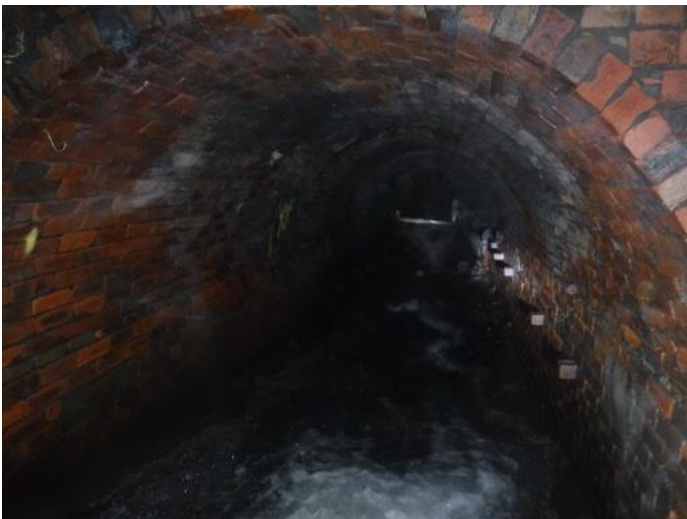
Appendix 25

| Width | 2.40m |
| Height | 2.20m |

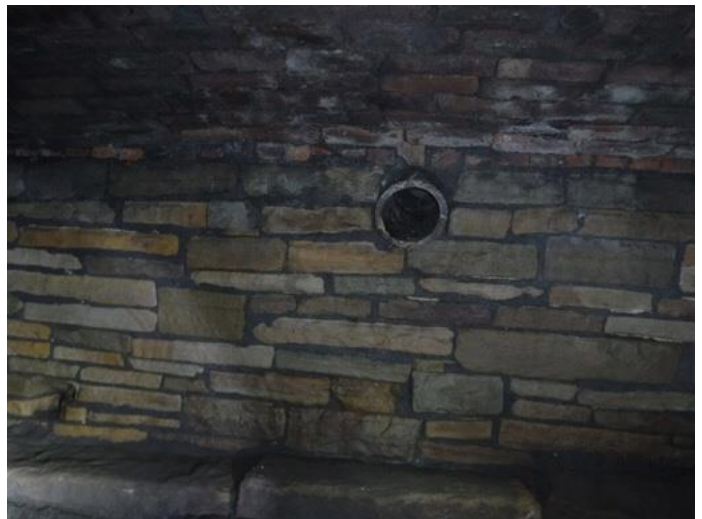
Appendix 26

| Description | Pipe in wall of culvert |
