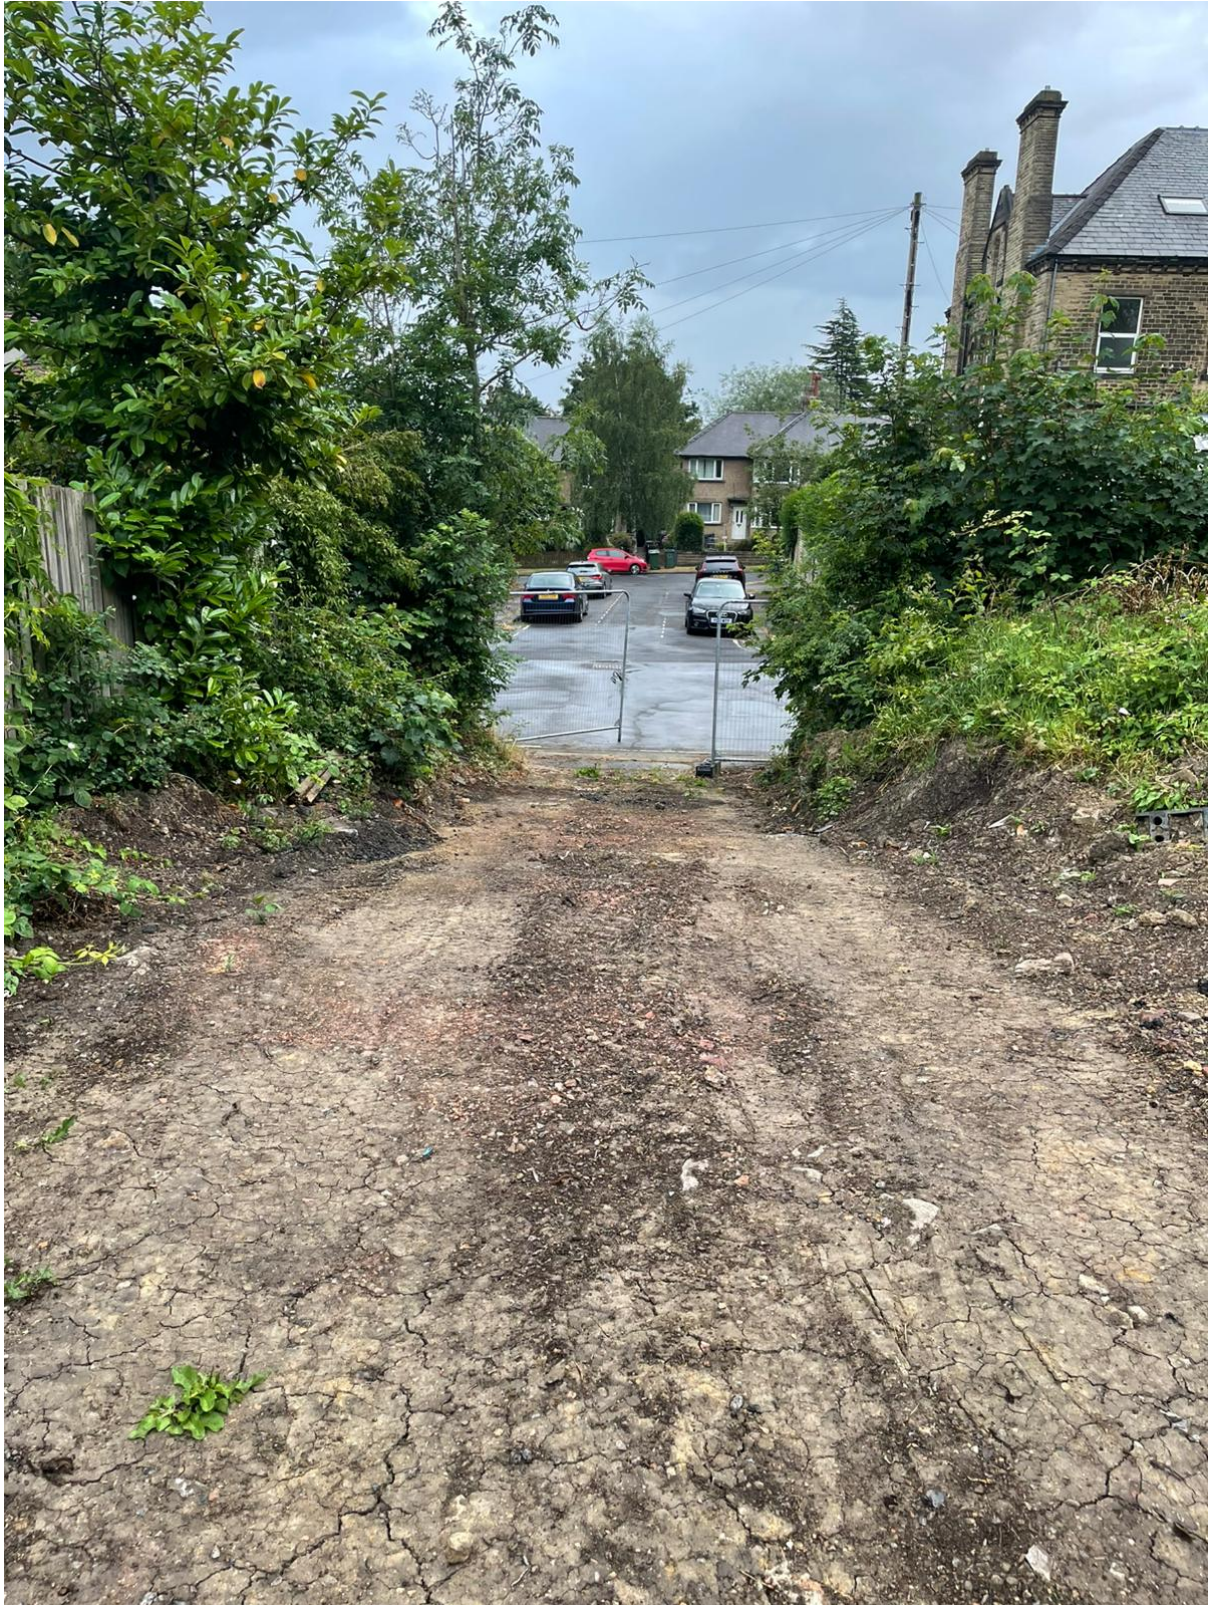
Drive way incline has been reduced and HGV vehicles are able to enter the site to deliver and pick up.

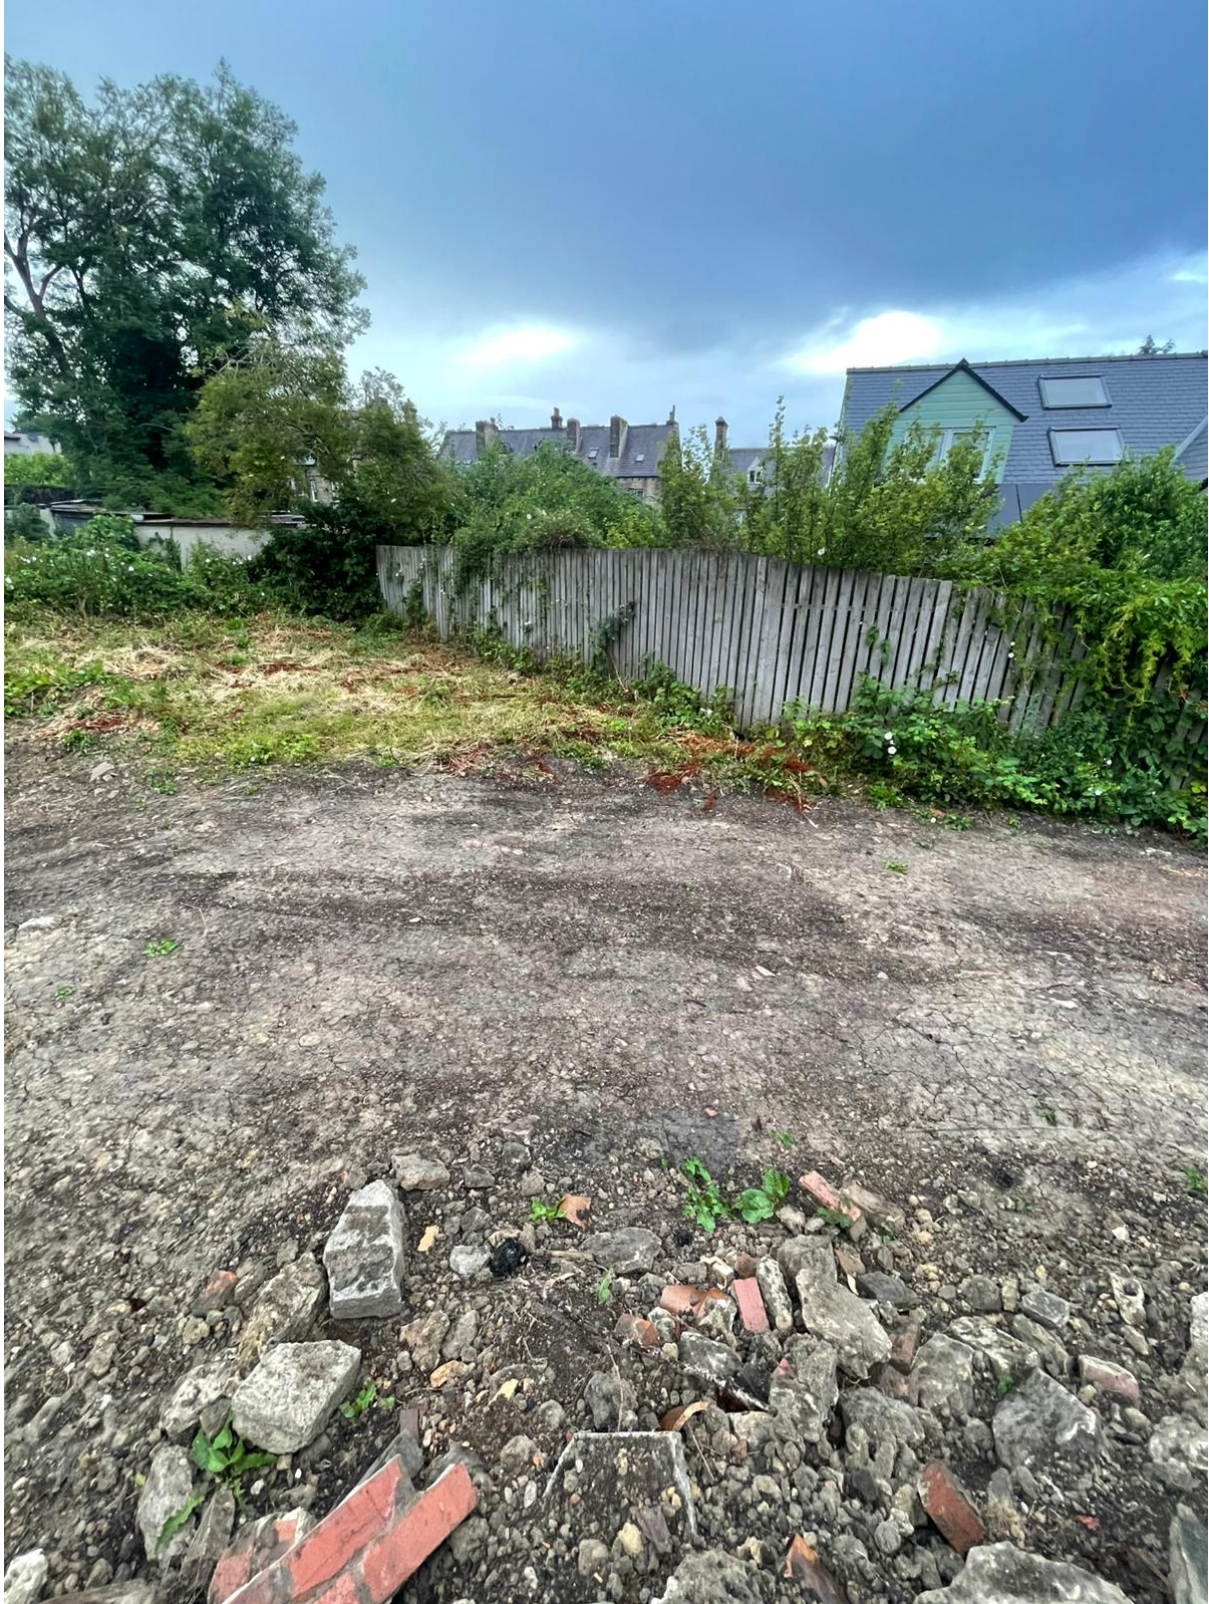
Top of the drive way has been cleared for deliveries.
