# Annual Tree Health & Woodland Inspection

Woodland Place.  
Woodland View,  
Thongsbridge, Holmfirth,  
HD9 3JE.

2689

30<sup>th</sup> June 2026

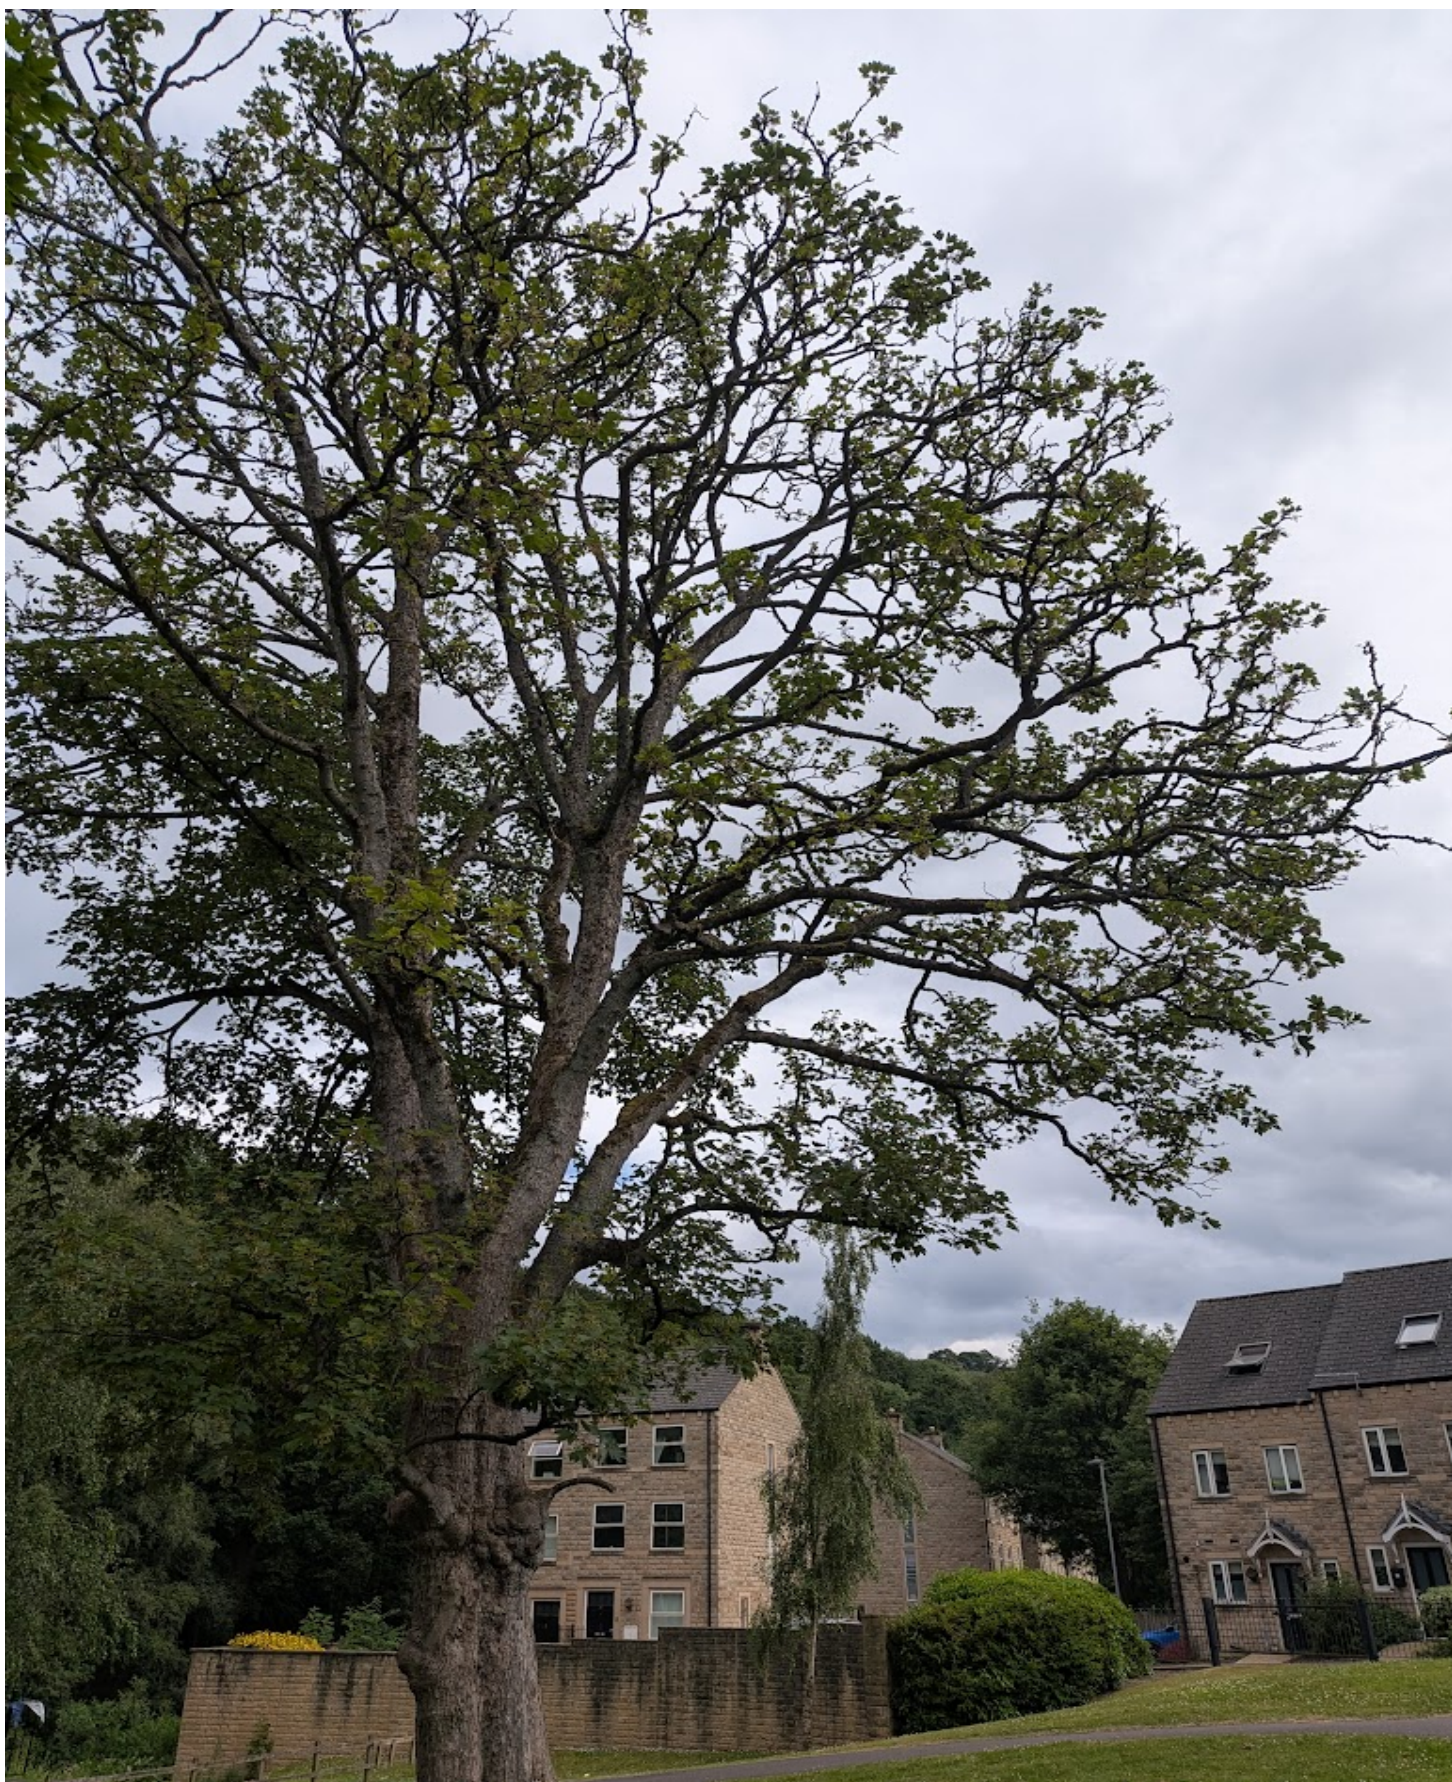
| Tree No | Species | Health | Height approx. | Age | Observations | Recommendations |
|---|---|---|---|---|---|---|
| T2 | Sycamore | Fair | 15m | M | Historic pruning wounds, poor canopy density, leaf size smaller than usual, change in soil levels around the tree, extension growth is poor. High populace of aphid activity. Medium diameter deadwood in the canopies. High target, tree to be removed and replaced. The tree has been in decline for some time, due to the root damage caused by development. Drainage in the area around the tree. | Remove and replant with two birch tree or hornbeam. |

T2, sycamore, to be removed due to health and safety.
