Tree condition survey

Wildspur Mills Developments, Wildspur Mills, New Mill, Holmfirth, HD97BA

Date of site visit: 06 May 2026

Report Date: 07 May 2026

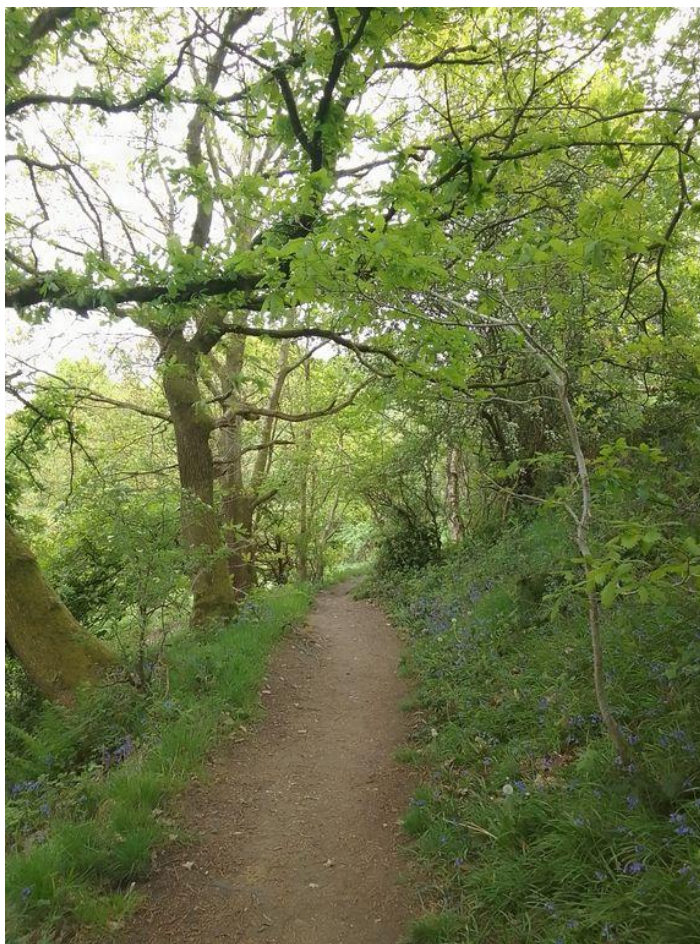
| Ref. | Species | Description | Measurements | Survey Notes | Overall Condition | Risk Rating | Inspect Period | Recommendations | Photos |
|---|---|---|---|---|---|---|---|---|---|
| G003 | Mixed species<br>(Mixed species) | Target # - footpath.<br>Target # - road.<br>- Occupancy - Frequent(3). | Height (m): 13<br>Crown Radius (m): 4<br>DBH (cm): 50<br>Life Stage: Mature | Normal crown development for this species.<br>See specific species listed..<br>Trees looked at from the footpath only. | Fair | Low | 18 Months | No action required.<br>Timescale: 07-May-2027 (1 Year)<br>Work Done: No works completed. | |

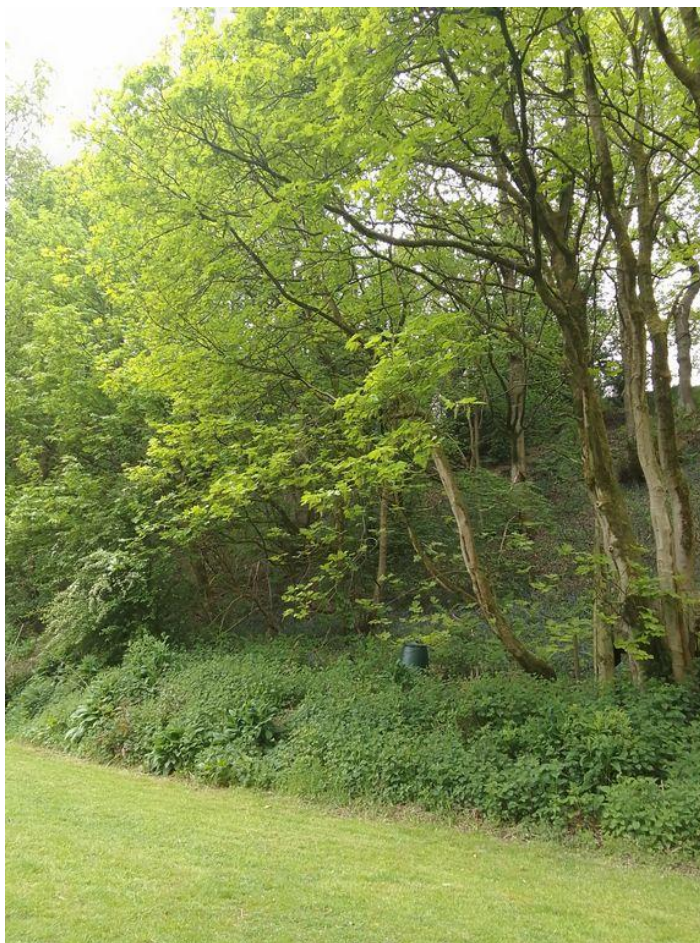
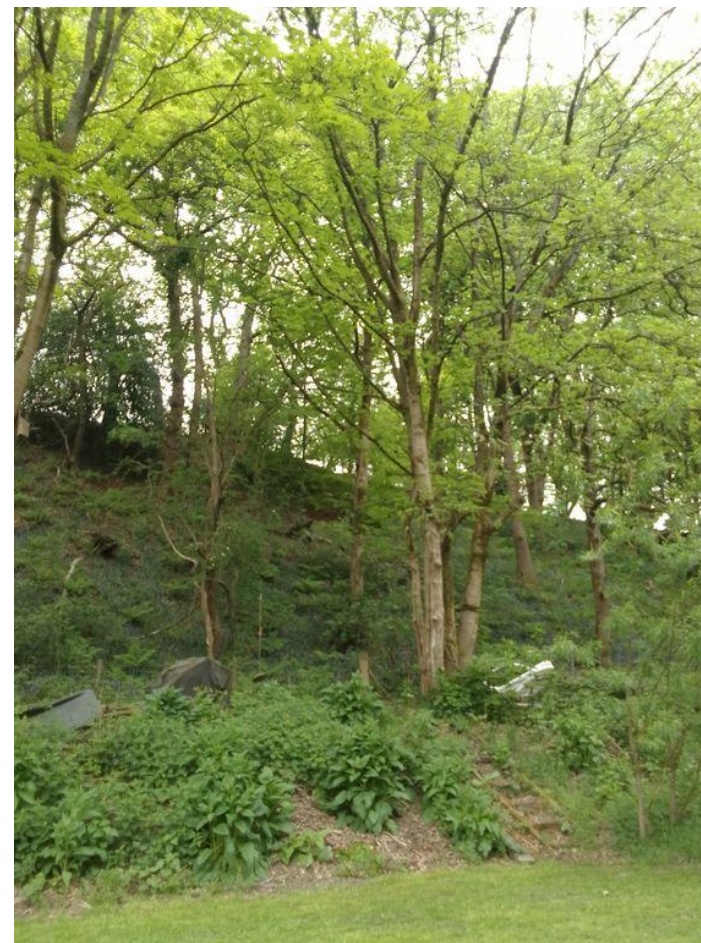
| G004 | Mixed species<br>(Mixed species) | Target # -<br>dwelling.<br>Target # -<br>footpath.<br>Target # -<br>playground.<br>- Occupancy -<br>Constant(4). | Height (m): 15<br>Crown Radius<br>(m): 4<br>DBH (cm): 50<br>Life Stage:<br>Mature | Normal crown<br>development for this<br>species.<br>Specific trees listed<br>separately | Fair | Low | 18<br>Months | No action required.<br>Timescale: 07-<br>May-2027 (1 Year)<br>Work Done: No<br>works completed. | |

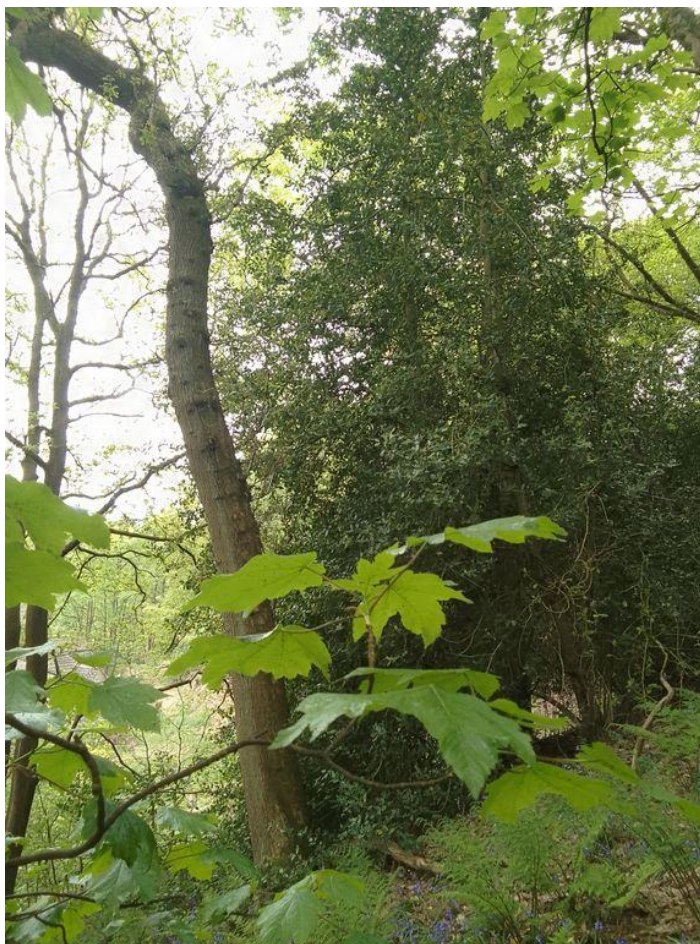
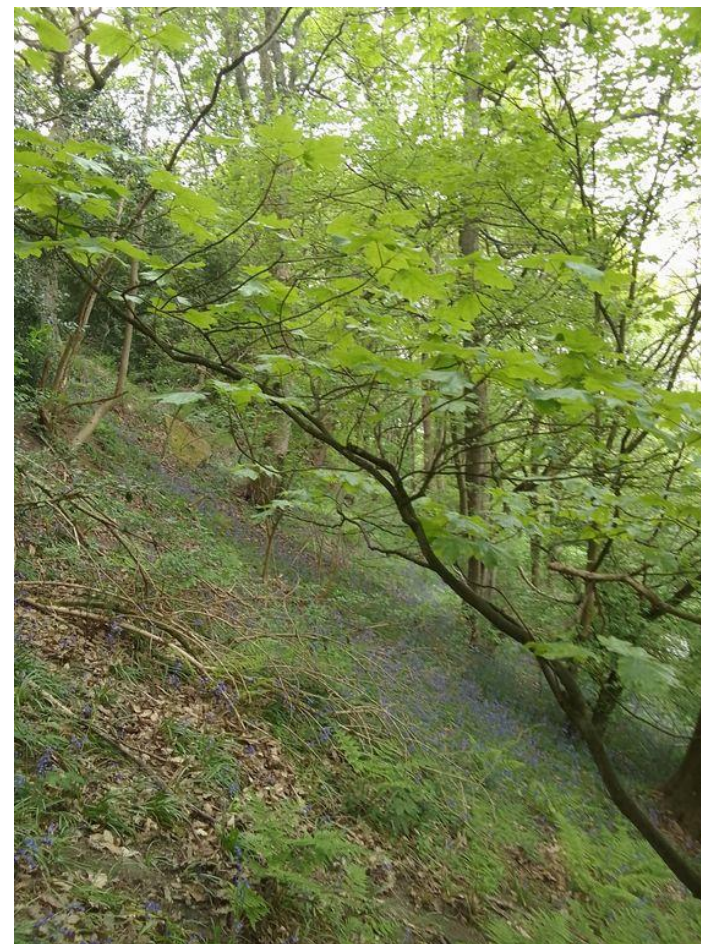
| G005 | Mixed species<br>(Mixed species) | Target # -<br>dwelling.<br>Target # -<br>footpath.<br>- Occupancy -<br>Constant(4). | Height (m): 15<br>Crown Radius<br>(m): 4<br>DBH (cm): 50<br>Life Stage:<br>Mature | Normal crown<br>development for this<br>species.<br>Specific trees listed<br>separately | Fair | Low | 18<br>Months | No action required.<br>Timescale: 07-<br>May-2027 (1 Year)<br>Work Done: No<br>works completed. | |

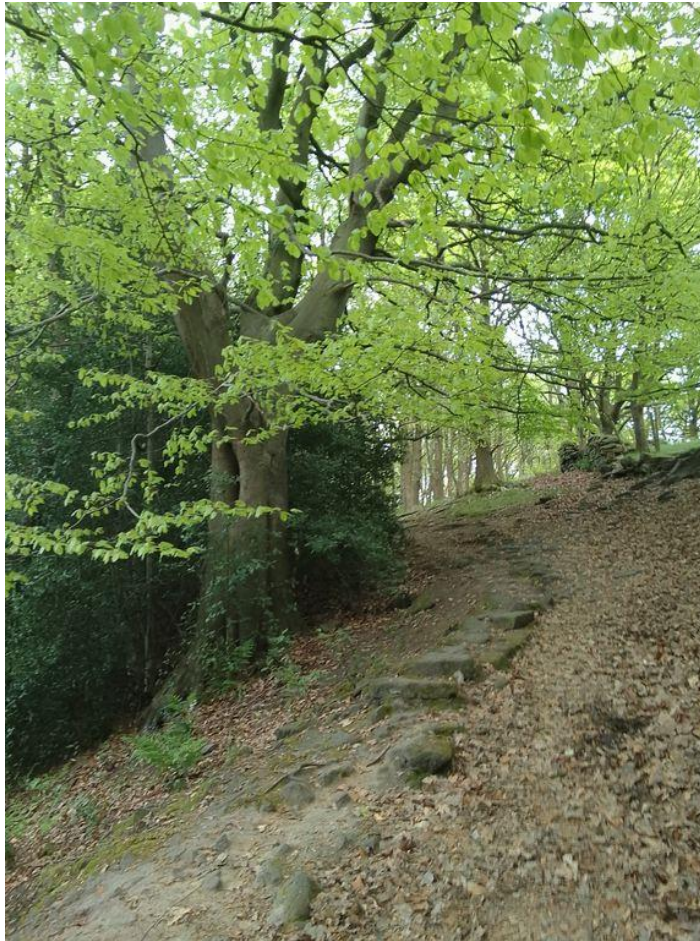
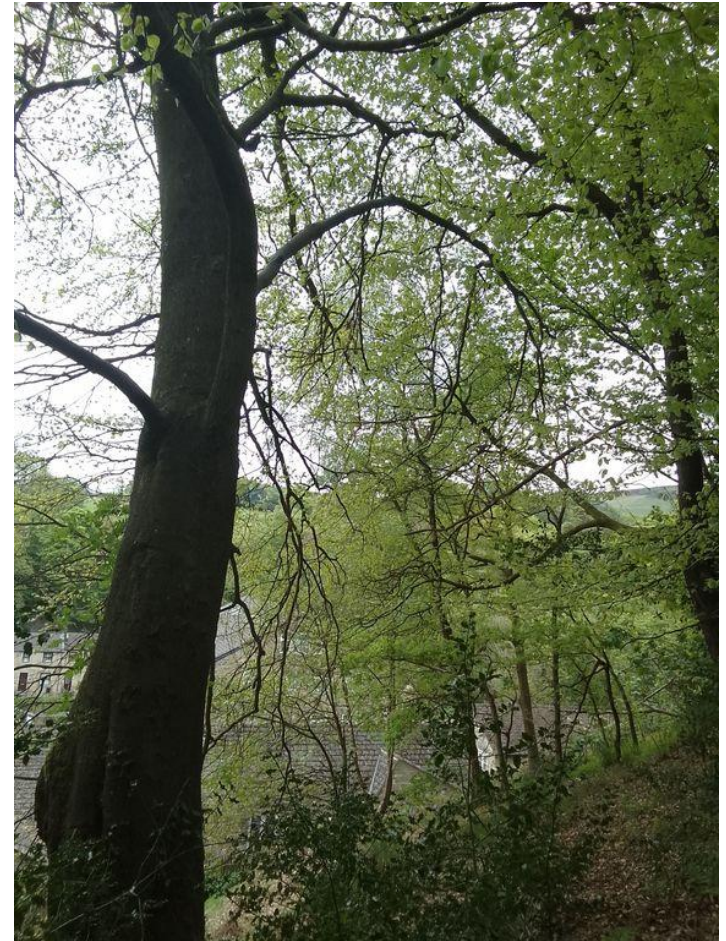
| G006 | Mixed species<br>(Mixed species) | Target # -<br>dwelling.<br>Target # -<br>footpath.<br>- Occupancy -<br>Constant(4). | Height (m): 18<br>Crown Radius<br>(m): 7<br>DBH (cm): 90<br>Life Stage:<br>Mature | Normal crown<br>development for this<br>species.<br>Specific trees listed<br>separately | Fair | Low | 18<br>Months | No action required.<br>Timescale: 07-<br>May-2027 (1 Year)<br>Work Done: No<br>works completed. | |

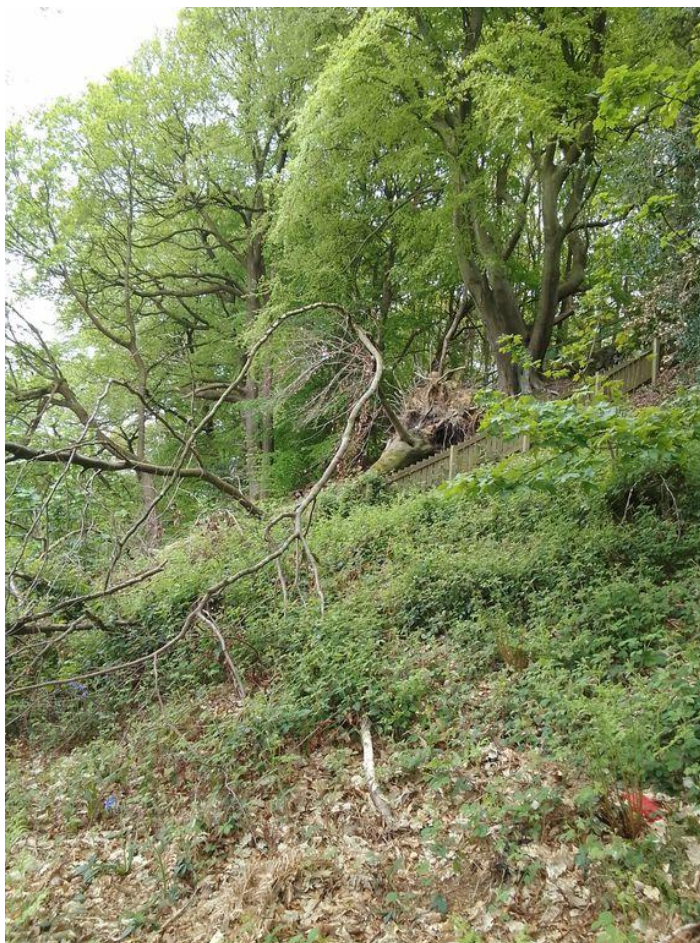
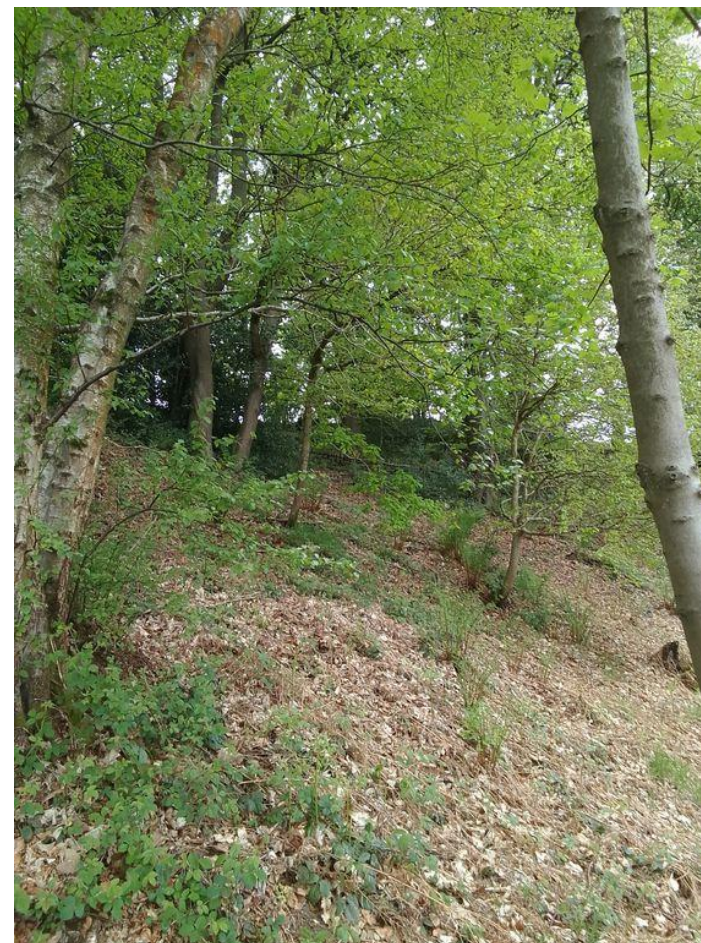
| G007 | Mixed species<br>(Mixed species) | Target # -<br>dwelling.<br>- Occupancy -<br>Constant(4). | Height (m): 15<br>Crown Radius<br>(m): 4<br>DBH (cm): 80<br>Life Stage:<br>Mature | Normal crown<br>development for this<br>species.<br>Specific trees listed<br>separately | Fair | Low | 18<br>Months | No action required.<br>Timescale: 06-<br>May-2027 (1 Year)<br>Work Done: No<br>works completed. | |

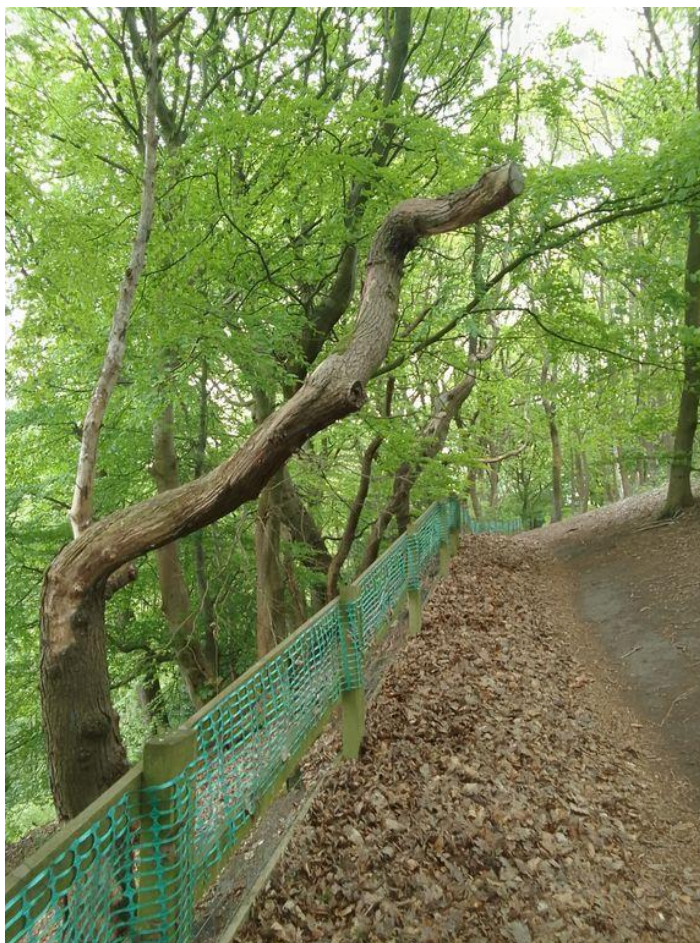
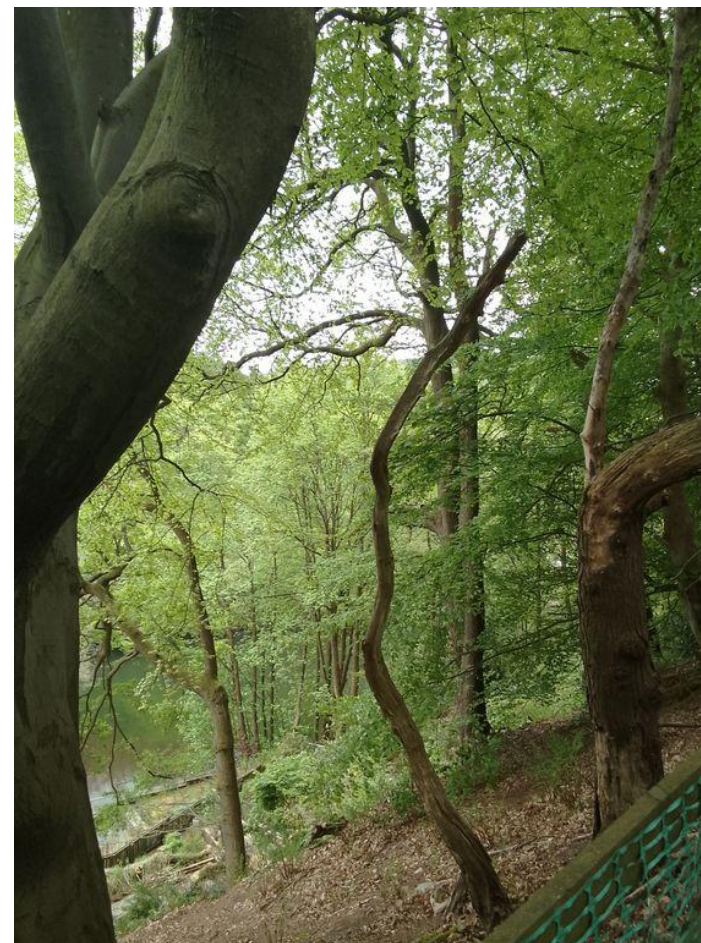
| G008 | Mixed species<br>(Mixed species) | Target # -<br>dwelling.<br>Target # -<br>footpath.<br>- Occupancy -<br>Constant(4). | Height (m): 15<br>Crown Radius<br>(m): 6<br>DBH (cm): 60<br>Life Stage:<br>Mature | Normal crown<br>development for this<br>species.<br>Specific trees listed<br>separately | Fair | Low | 18<br>Months | No action required.<br>Timescale: 06-<br>May-2027 (1 Year)<br>Work Done: No<br>works completed. | |

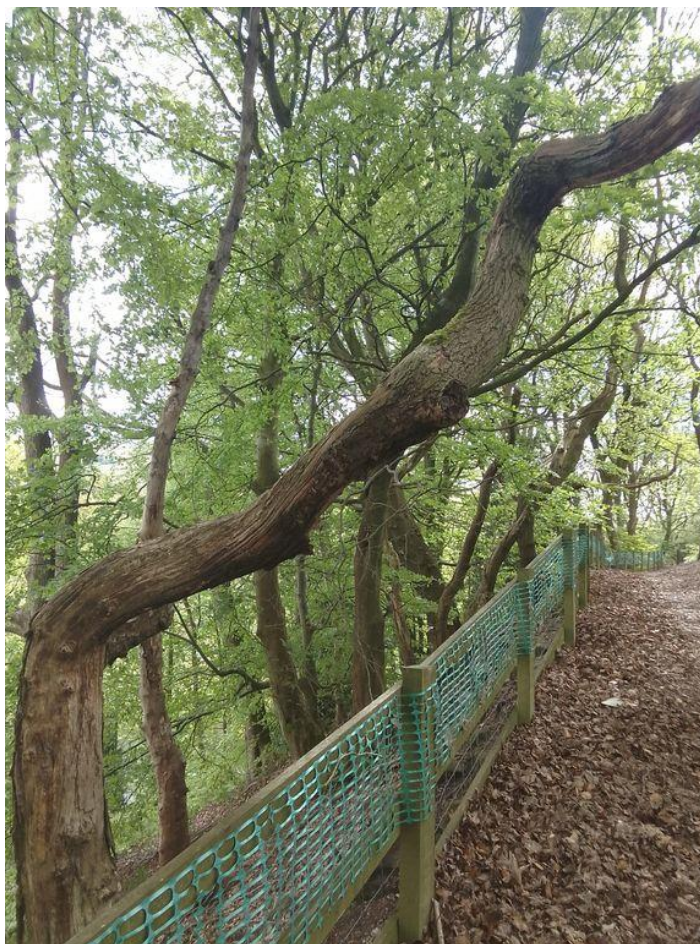
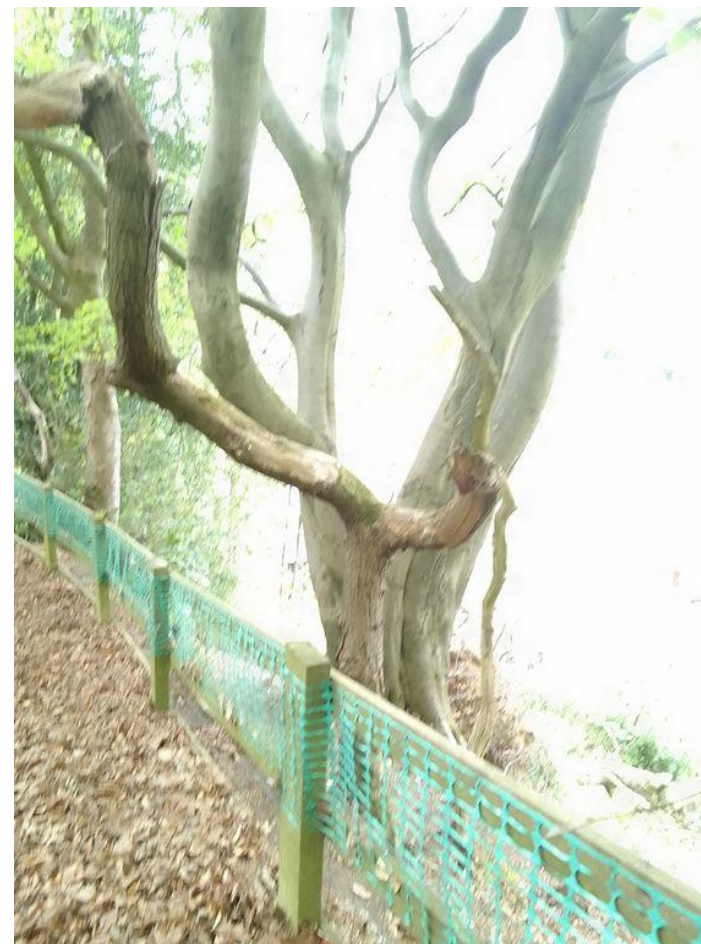
| G009 | Oak x3<br>(Quercus sp.) | Target # -<br>footpath.<br>Target # -<br>dwelling. | Height (m): 8<br>Crown Radius<br>(m): 4<br>DBH (cm): 50<br>Trees: 3<br>Life Stage: Dead | Dead tree with<br>possibility of falling<br>down hill. | Dead | High | 18<br>Months | Tree risk<br>mitigation: remove<br>the tree.<br>Timescale: 06-<br>May-2027 (1 Year)<br>Work Done: No<br>works completed. | |

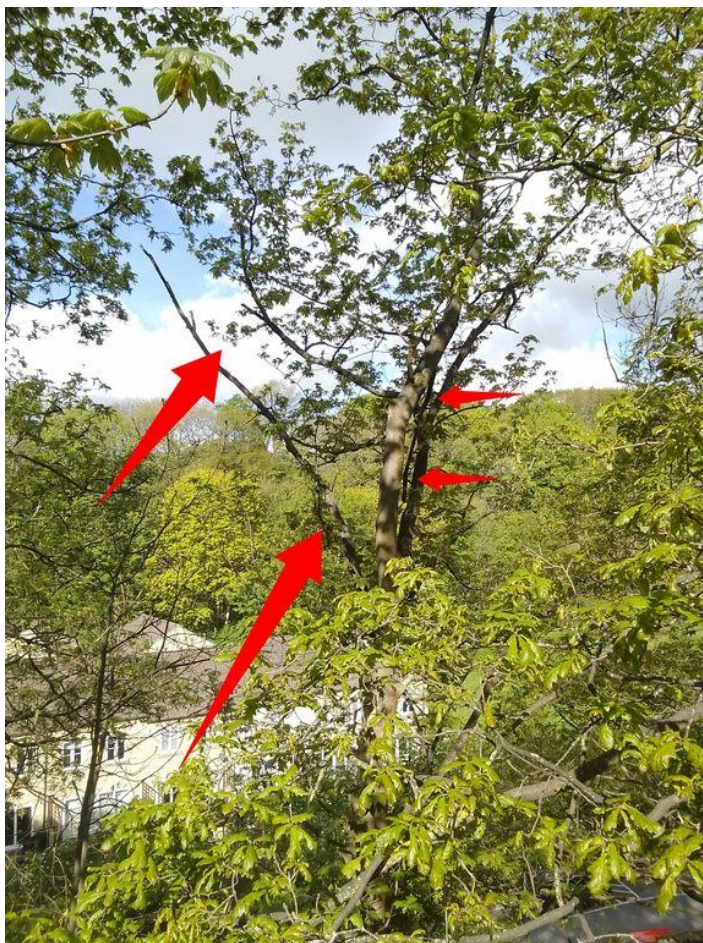
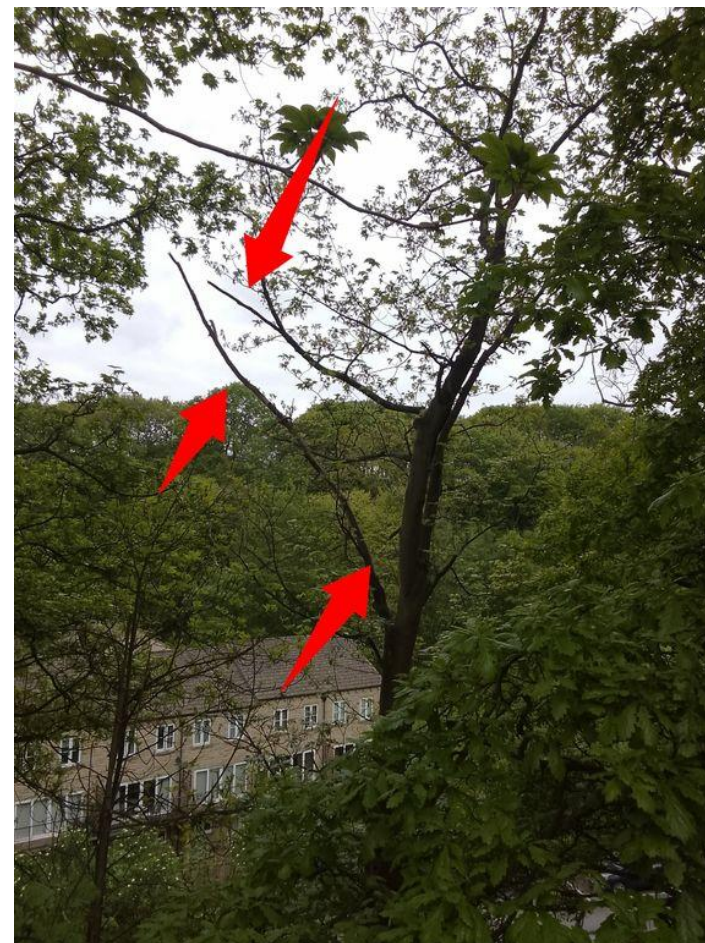
| T001 | Sycamore<br>( <i>Acer pseudoplatanus</i> ) | Target # - road.<br>- Occupancy - Occasionally(2). | Height (m): 15<br>Crown Radius (m): 4<br>DBH (cm): 50<br>Life Stage: Early Mature | Significant dead wood in the crown of the tree | Fair | Low | 18 Months | Tree risk mitigation: remove major Deadwood above 100 mm approximately<br><br>Timescale: 06-May-2027 (1 Year)<br>Work Done: No works completed. | |

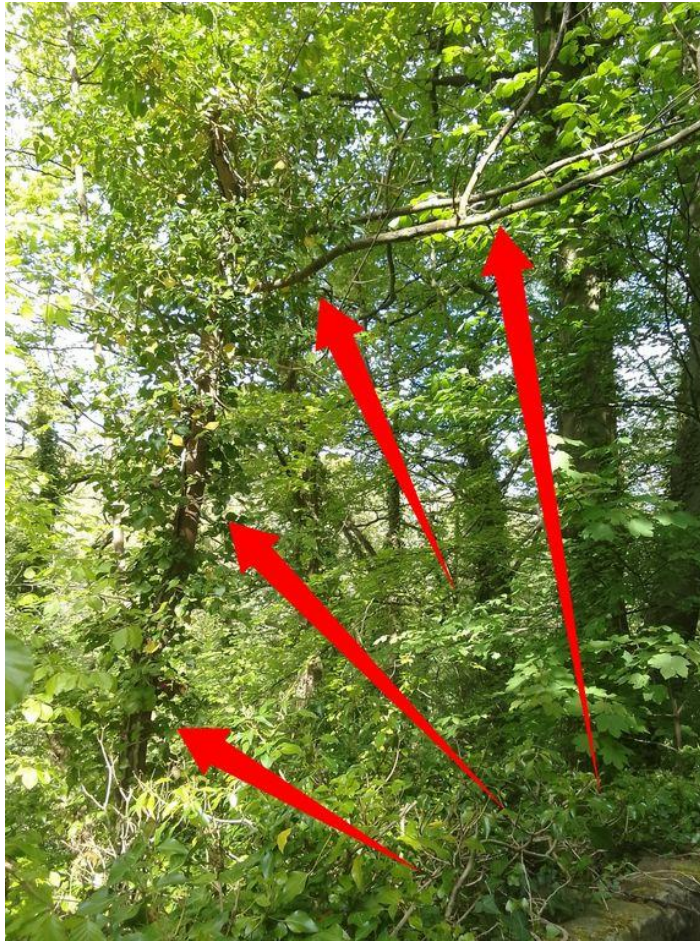
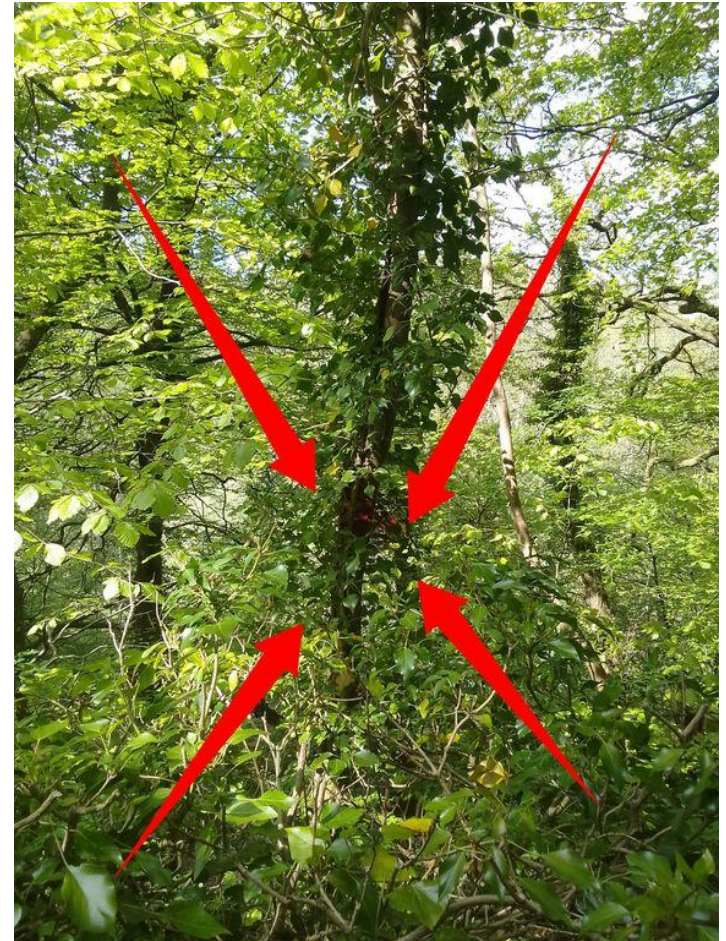
| TT002 | Ash<br>( <i>Fraxinus sp.</i> ) | Target # - footpath.<br>Target # - road.<br>- Occupancy - Frequent(3). | Height (m): 4<br>Crown Radius (m): 2<br>DBH (cm): 10<br>Life Stage: Dead | Dead tree | Dead | Moderate | 1 Year | Tree risk mitigation: remove the tree.<br>Timescale: 06-Nov-2026 (6 Months) | |

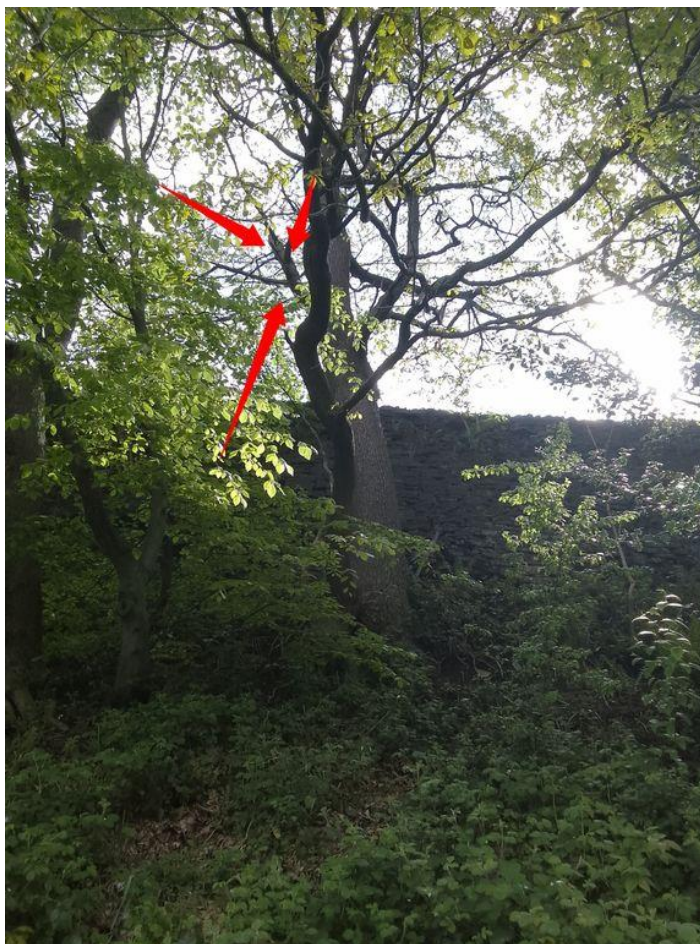
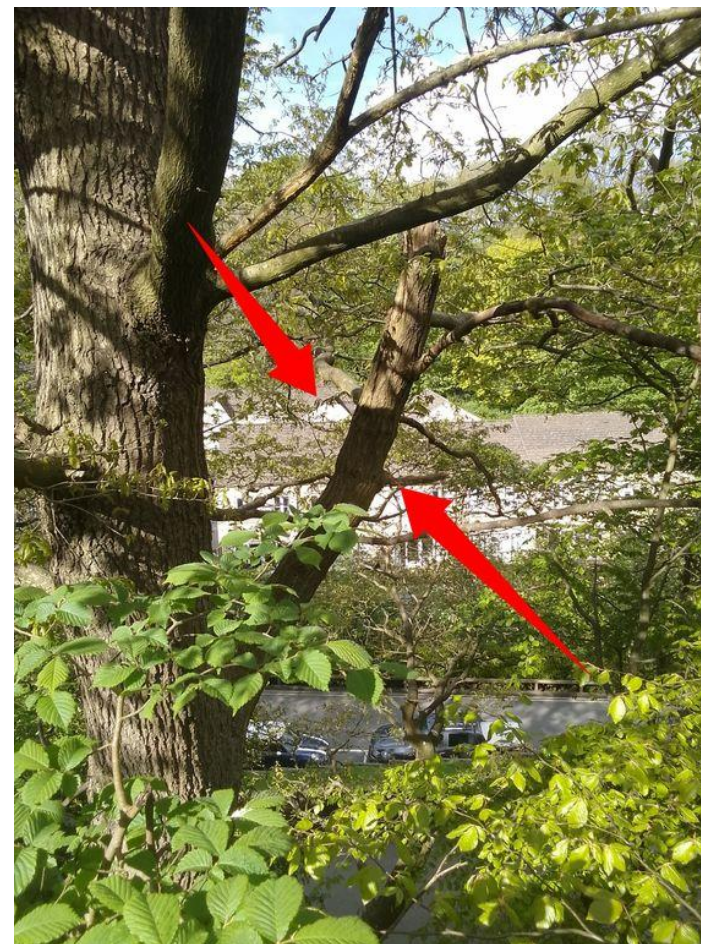
| T002 | Oak<br>( <i>Quercus sp.</i> ) | Target # - road.<br>- Occupancy - Occasionally(2). | Height (m): 16<br>Crown Radius (m): 4<br>DBH (cm): 70<br>Life Stage: Mature | Significant dead wood in the crown of the tree<br>Normal crown development for this species. | Fair | Low | 18 Months | Tree risk mitigation: remove major Deadwood above 100 mm approximately<br><br>Timescale: 06-May-2027 (1 Year)<br>Work Done: No works completed. | |

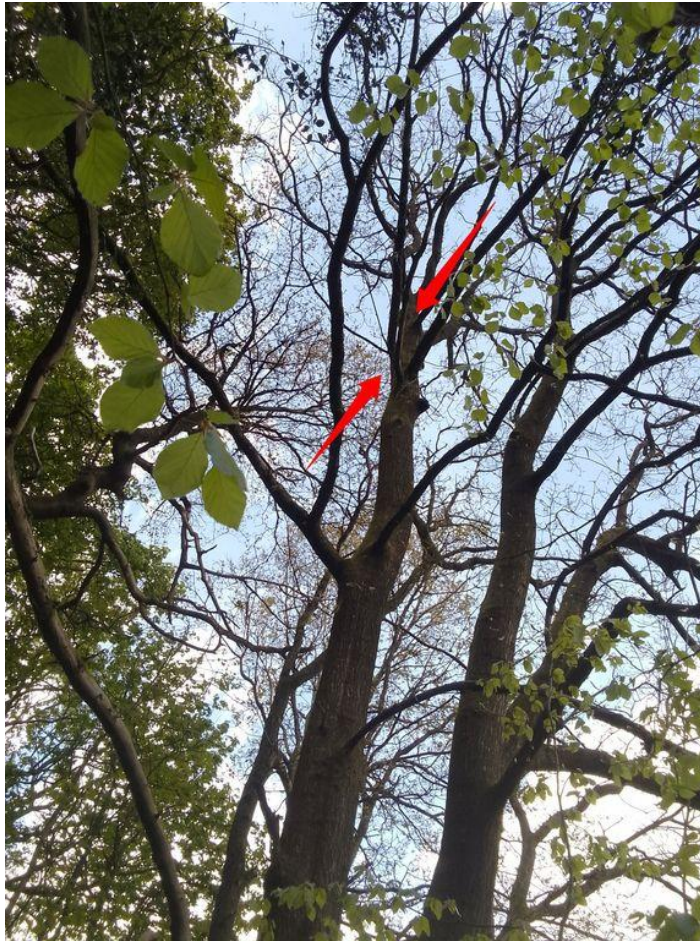
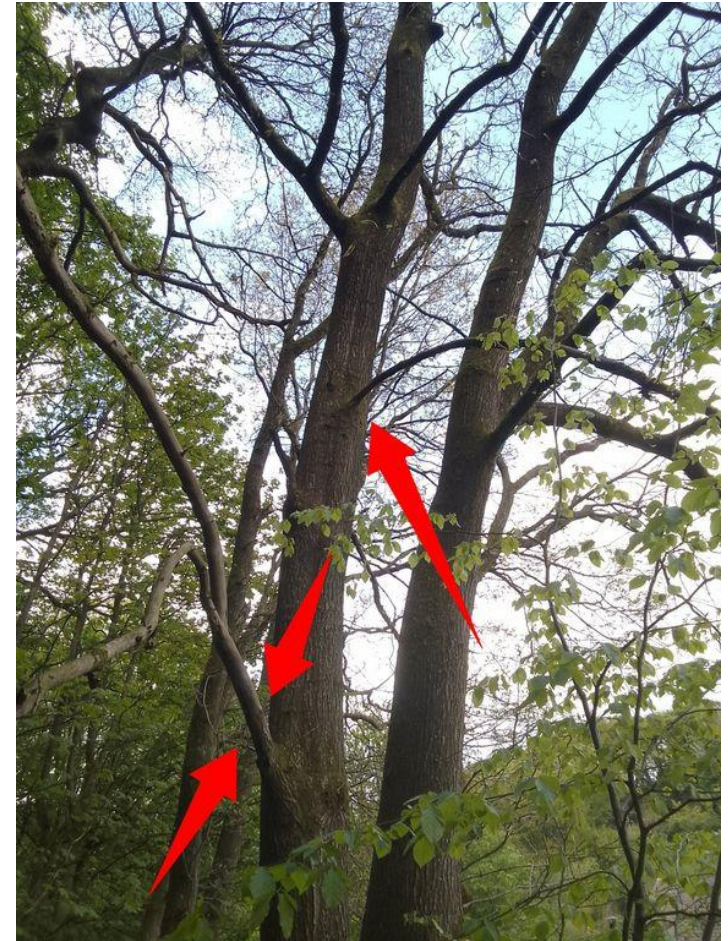
| TT003 | Oak<br>( <i>Quercus sp.</i> ) | Target # - dwelling.<br>Target # - footpath.<br>- Occupancy - Constant(4). | Height (m): 17<br>Crown Radius (m): 7<br>DBH (cm): 70<br>Life Stage: Mature | The tree is late too leaf there is no obvious reason why. I recommend a second visit in the autumn. Major dead wood present in the crown of the tree. Acoustic test revealed a hollow resonance on two trunks. Asymmetrical crown weighted to the north. | Fair | Moderate | 1 Year | Tree risk mitigation: remove the tree.<br><br>Timescale: 06-Nov-2026 (6 Months) | |

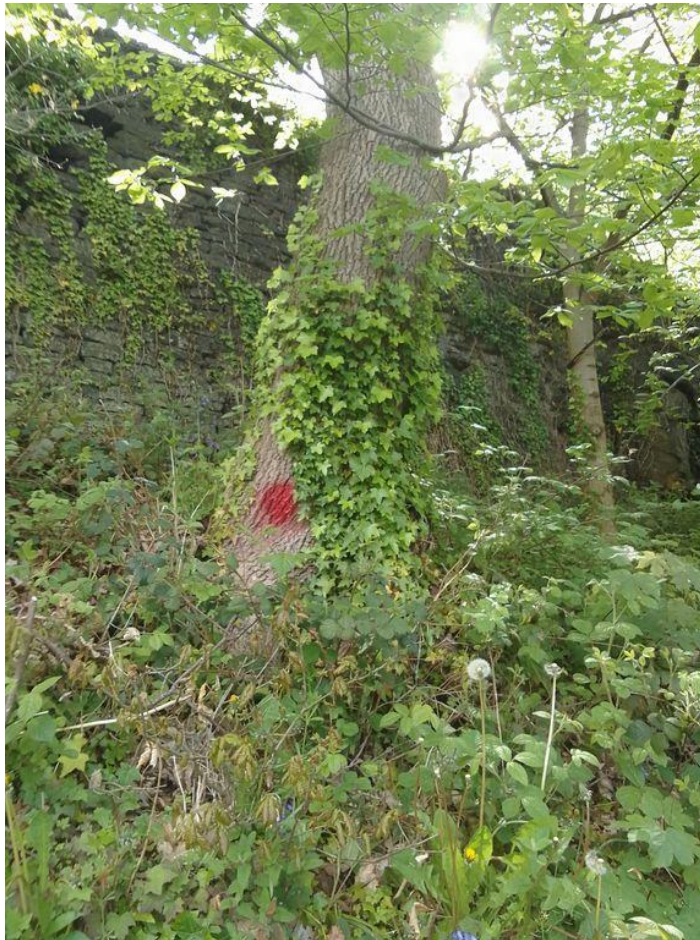
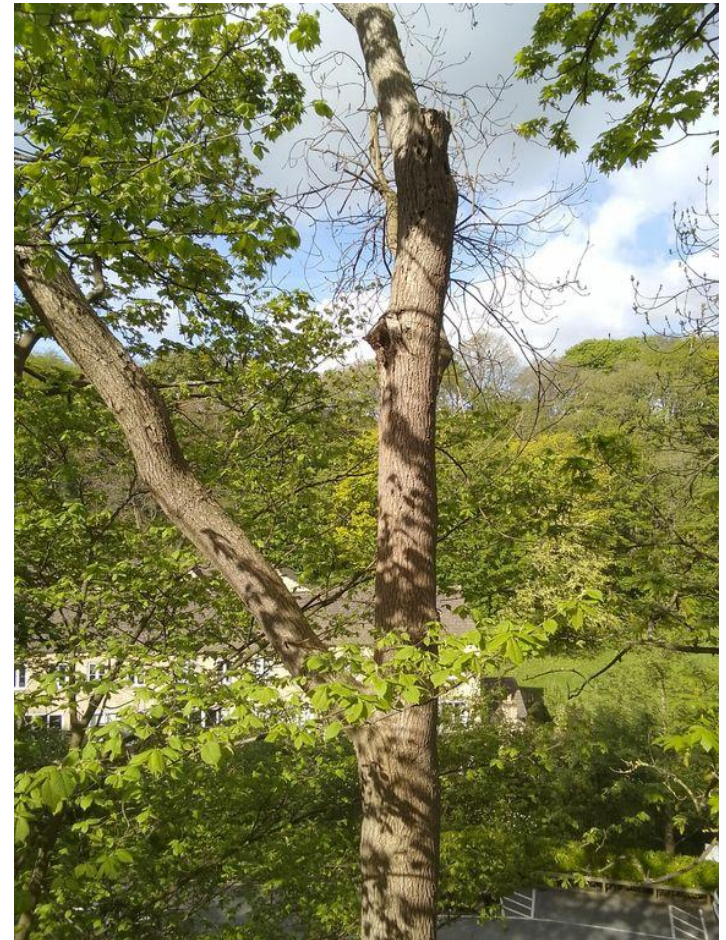
| T003 | Ash<br>( <i>Fraxinus sp.</i> ) | Target # - overhead wires.<br>Target # - road.<br>- Occupancy - Constant(4). | Height (m): 15<br>Crown Radius (m): 4<br>DBH (cm): 60<br>Life Stage: Early Mature | Pruning cuts have not healed over.<br>The trunk bark is missing in two places where the tree has not responded with healing over. | Poor | Moderate | 18 Months | Tree risk mitigation: remove the tree.<br>Timescale: 06-Nov-2026 (6 Months)<br>Work Done: No works completed. | |

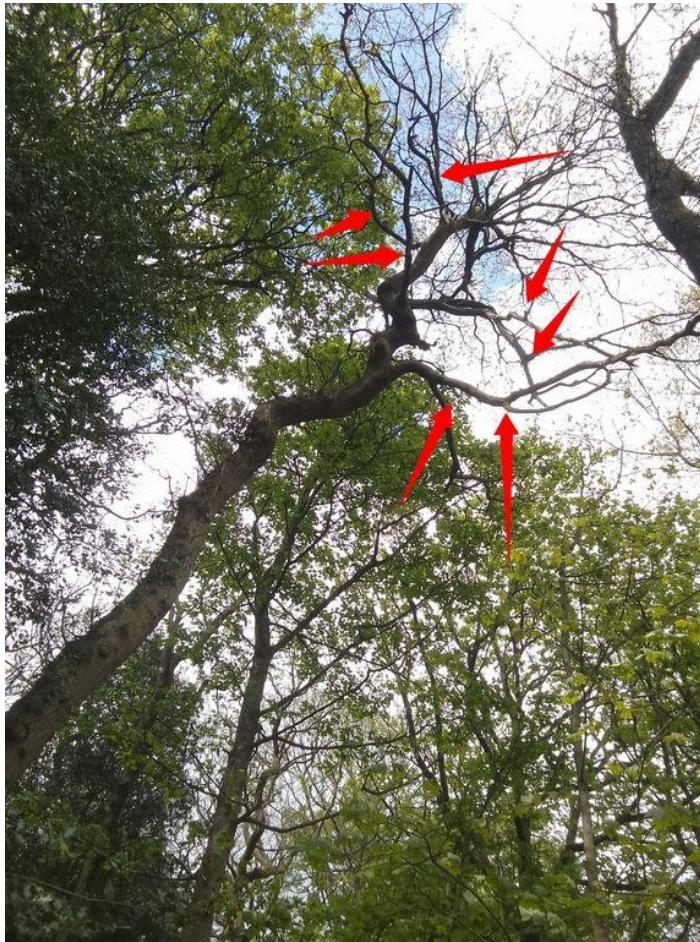
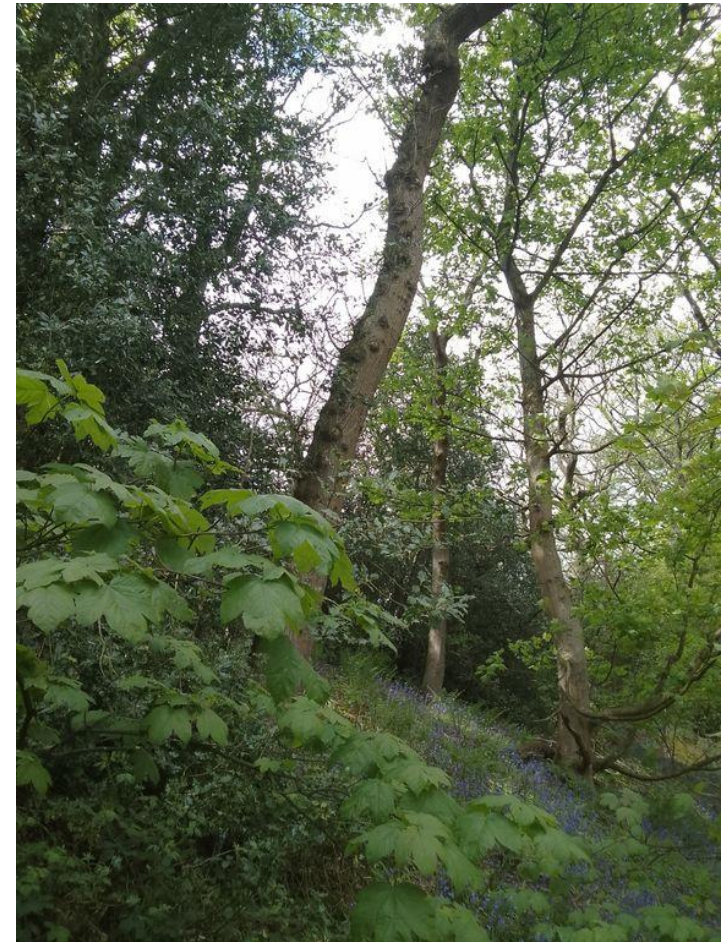
| TT004 | Oak<br>( <i>Quercus sp.</i> ) | Target # - dwelling.<br>Target # - footpath.<br>- Occupancy - Constant(4). | Height (m): 18<br>Crown Radius (m): 4<br>DBH (cm): 60<br>Life Stage: Mature | Major dead wood present in the crown of the tree. | Fair | Moderate | 1 Year | Tree risk mitigation: remove major Deadwood above 50 mm approximately<br><br>Timescale: 06-May-2027 (1 Year) | |

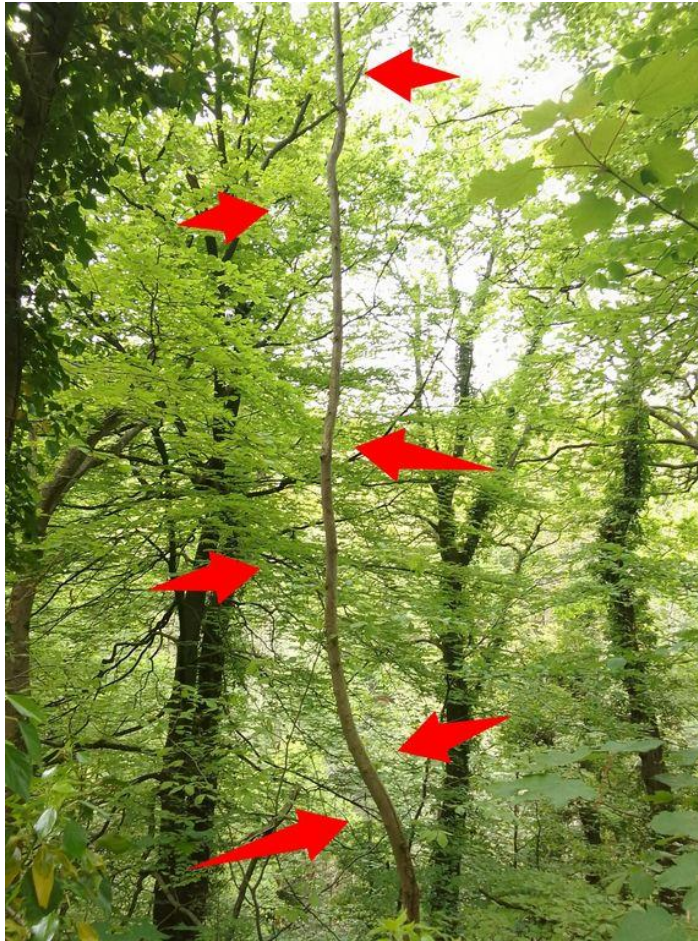
| T004 | Ash<br>( <i>Fraxinus sp.</i> ) | Target # - overhead wires.<br>Target # - road.<br>- Occupancy - Constant(4). | Height (m): 9<br>Crown Radius (m): 1<br>DBH (cm): 10<br>Life Stage: Dead | Dead tree | Dead | Moderate | 18 Months | Tree risk mitigation: remove the tree.<br>Timescale: 06-Nov-2026 (6 Months)<br>Work Done: No works completed. | |

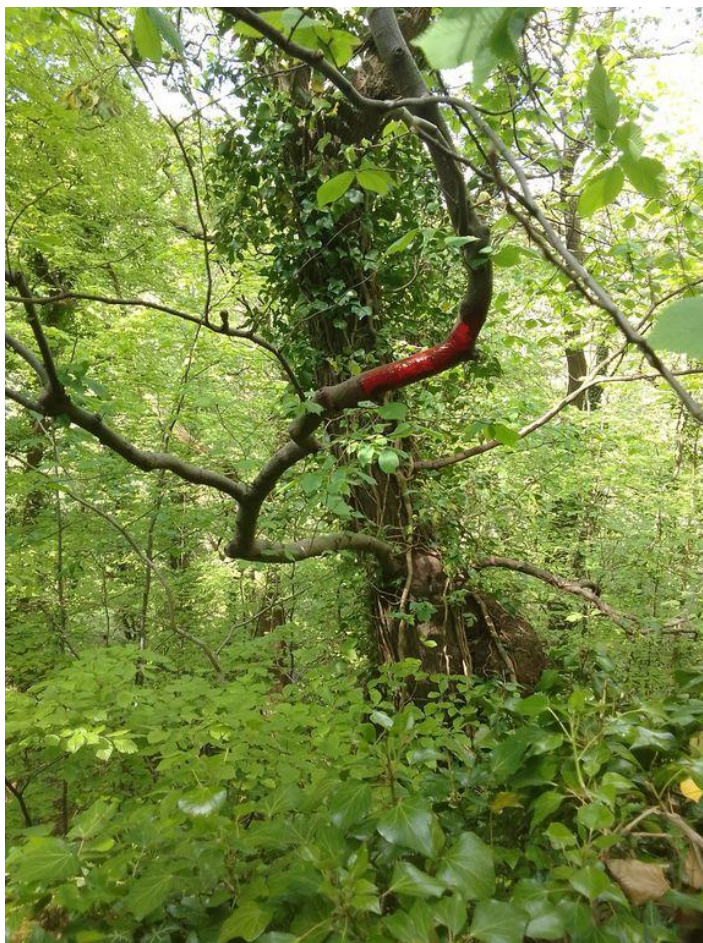
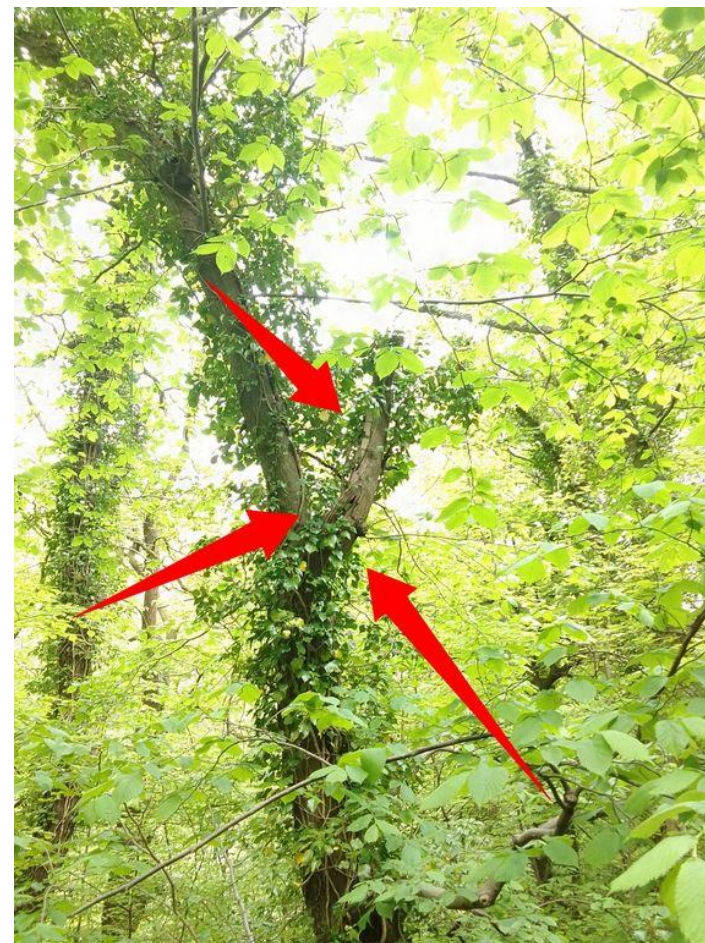
| T006 | Wych elm<br>( <i>Ulmus glabra</i> ) | Target # - overhead wires.<br>Target # - road.<br>- Occupancy - Constant(4). | Height (m): 11<br>Crown Radius (m): 3<br>DBH (cm): 40<br>Life Stage: Early Mature | Significant dead wood that is rotting into the main trunk of the tree | Fair | Low | 18 Months | Tree risk mitigation: remove the tree.<br>Timescale: 06-May-2027 (1 Year)<br>Work Done: No works completed. | |

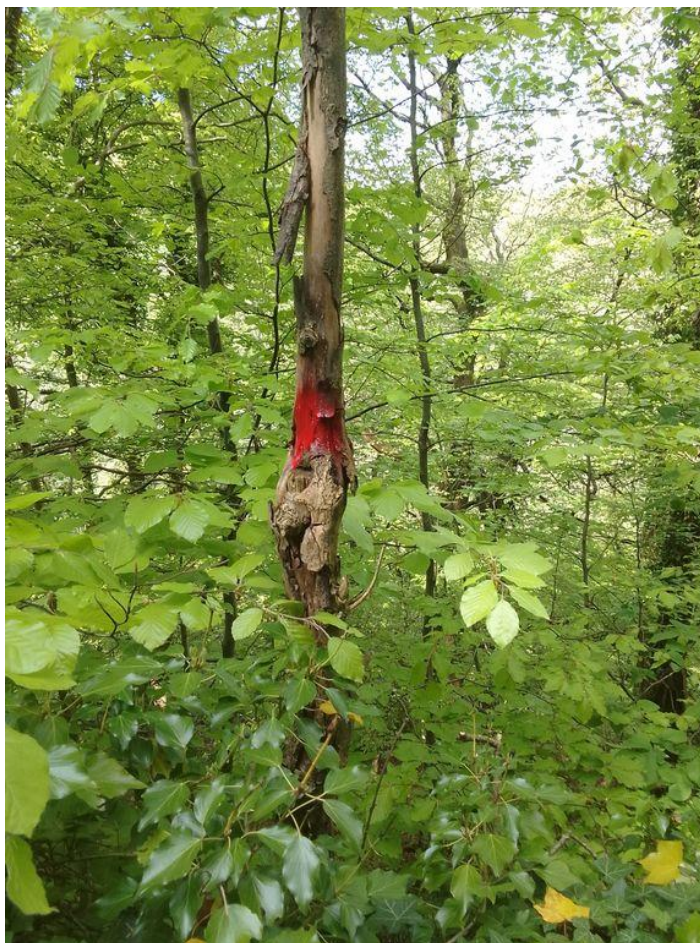
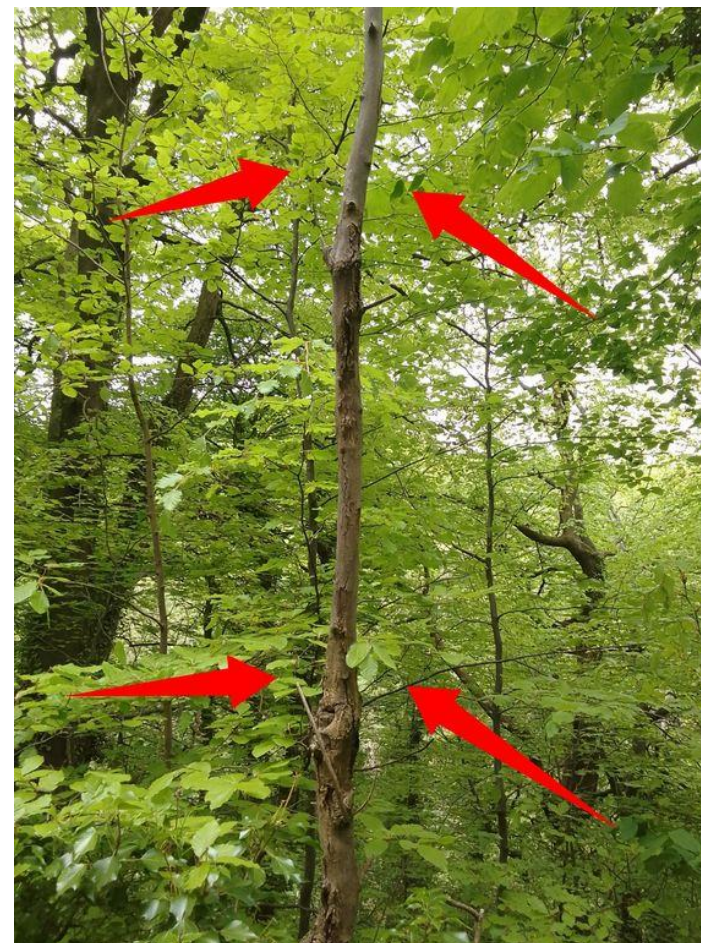
| T007 | Ash<br>( <i>Fraxinus sp.</i> ) | Target # - overhead wires.<br>Target # - road.<br>- Occupancy - Constant(4). | Height (m): 6<br>Crown Radius (m): 1<br>DBH (cm): 10<br>Life Stage: Dead | Dead tree | Dead | Moderate | 18 Months | Tree risk mitigation: remove the tree.<br>Timescale: 06-Nov-2026 (6 Months)<br>Work Done: No works completed. | |

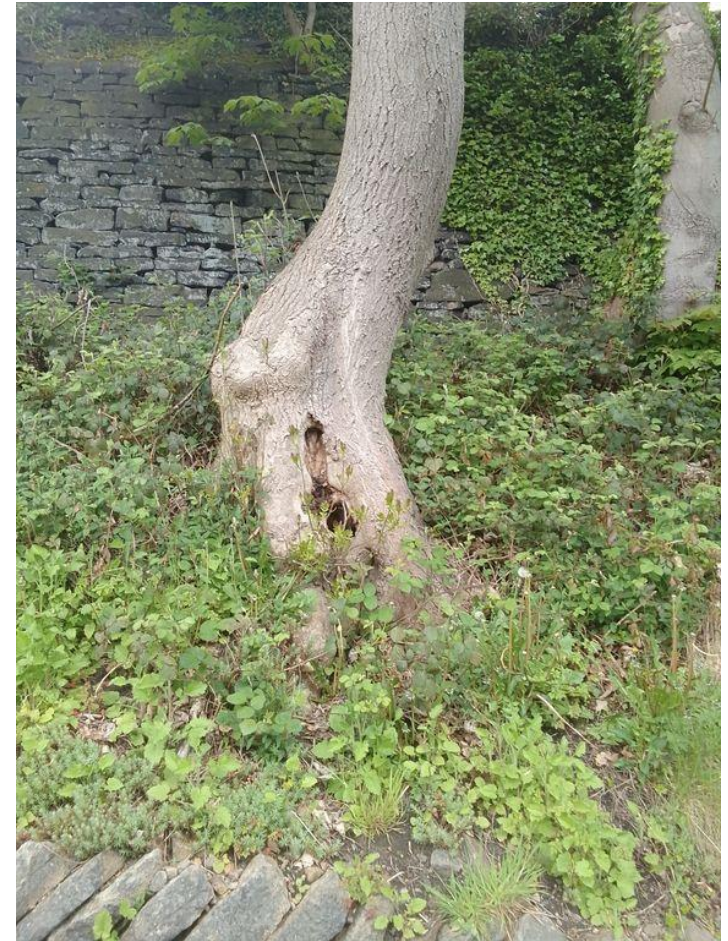
| T008 | Ash<br>( <i>Fraxinus sp.</i> ) | Target # - road.<br>- Occupancy -<br>Frequent(3). | Height (m): 17<br>Crown Radius<br>(m): 4<br>DBH (cm): 50<br>Life Stage:<br>Mature | The tree is situated on<br>a steep slope.<br>There is a deep cavity<br>at the base of the<br>tree.<br>Probe test penetrated<br>thirty three<br>centimetres<br>Dead wood present in<br>the crown of the tree<br>Poor structure at the<br>base of the tree.<br>Asymmetrical crown<br>weighted to the north<br>east residential road<br>side. | Good | Moderate | 18<br>Months | Tree risk<br>mitigation: remove<br>the tree.<br>Timescale: 06-Nov-<br>2026 (6 Months)<br>Work Done: No<br>works completed. | |
