Tree condition survey

Wildspur Mills Developments, Wildspur Mills, New Mill, Holmfirth, HD97BA

Date of site visit: 06 May 2026

Report Date: 07 May 2026

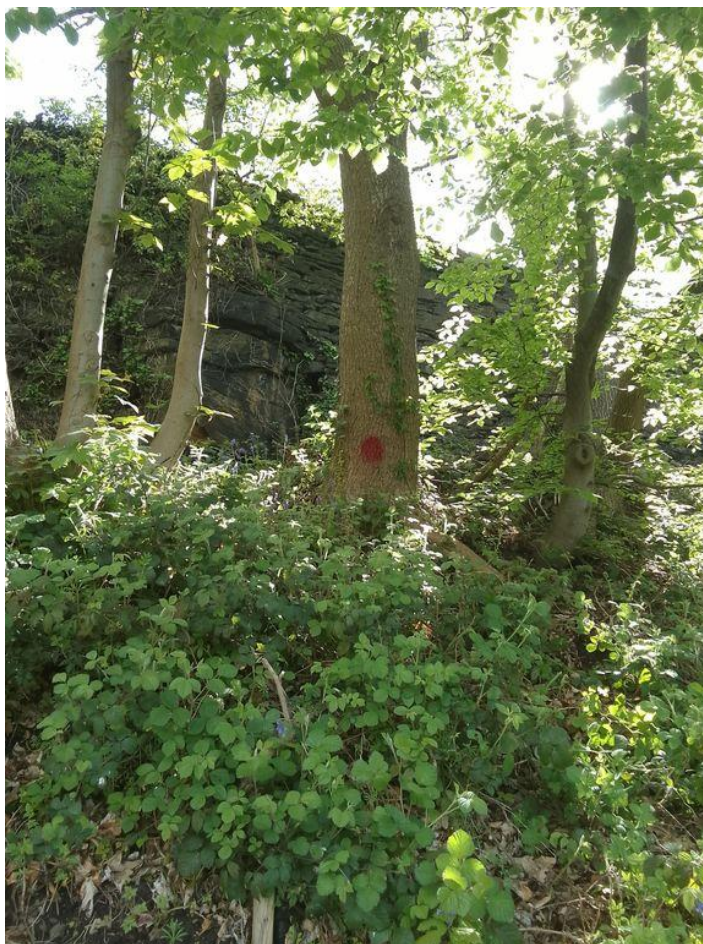
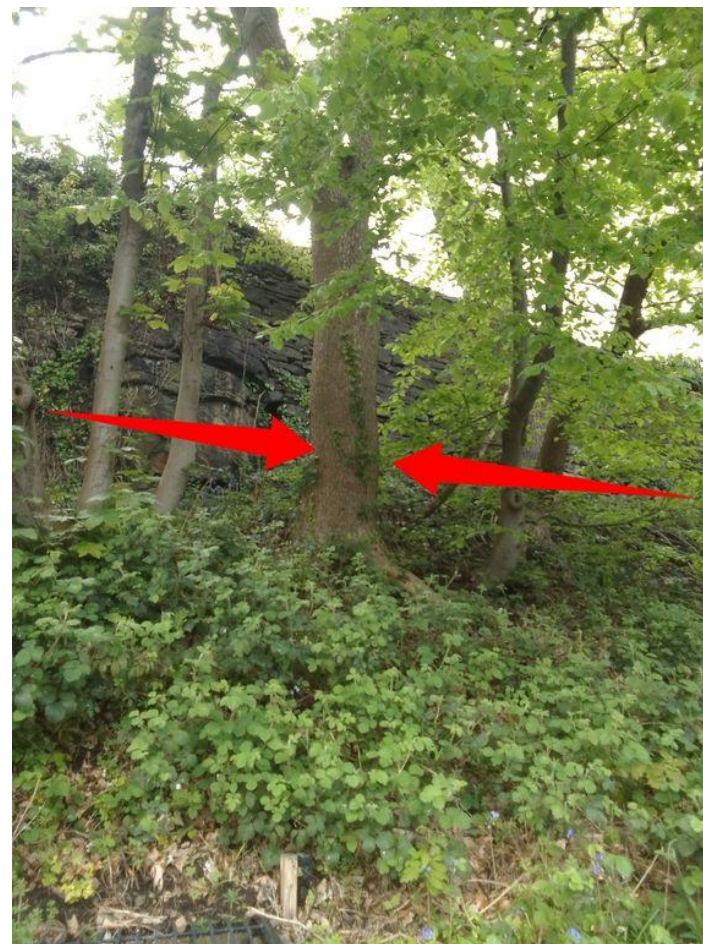
| T009 | Ash<br>( <i>Fraxinus sp.</i> ) | Target # -<br>overhead<br>wires.<br>Target # - road.<br>- Occupancy -<br>Constant(4). | Height (m): 15<br>Crown Radius<br>(m): 3<br>DBH (cm): 50<br>Life Stage: Early<br>Mature | The tree bifurcates at<br>four metres<br>approximately.<br>Large wound on one<br>trunk that is healing<br>over but is very deep.<br>There are no leaves<br>present yet in the<br>crown of the tree.<br>Very late too leaf | Poor | Moderate | 18<br>Months | Tree risk<br>mitigation: remove<br>the tree.<br>Timescale: 06-<br>May-2027 (1 Year)<br>Work Done: No<br>works completed. | |

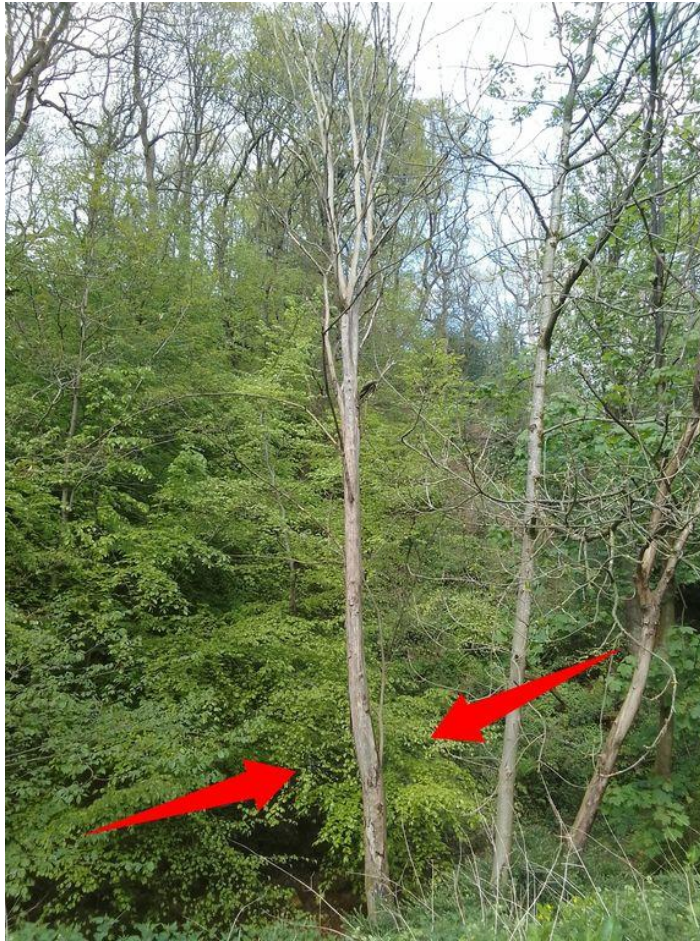
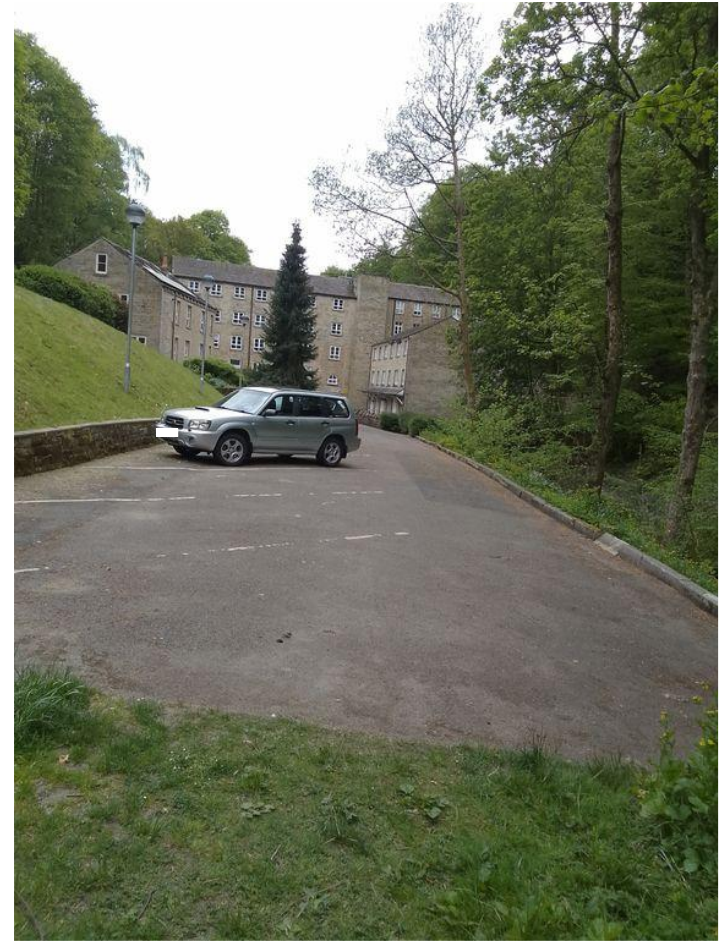
| T010 | Elm<br>( <i>Ulmus sp.</i> ) | Target # - car park.<br>- Occupancy - Frequent(3). | Height (m): 13<br>Crown Radius (m): 1<br>DBH (cm): 40<br>Life Stage: Dead | Dead tree | Dead | Moderate | 18 Months | Tree risk mitigation: remove the tree.<br>Timescale: 06-May-2027 (1 Year) | |

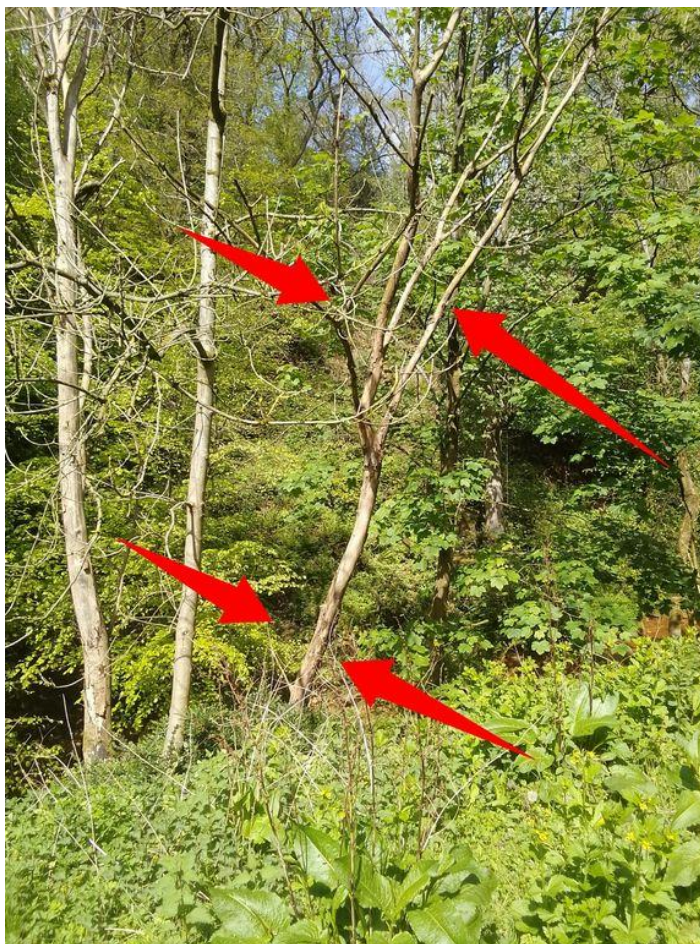
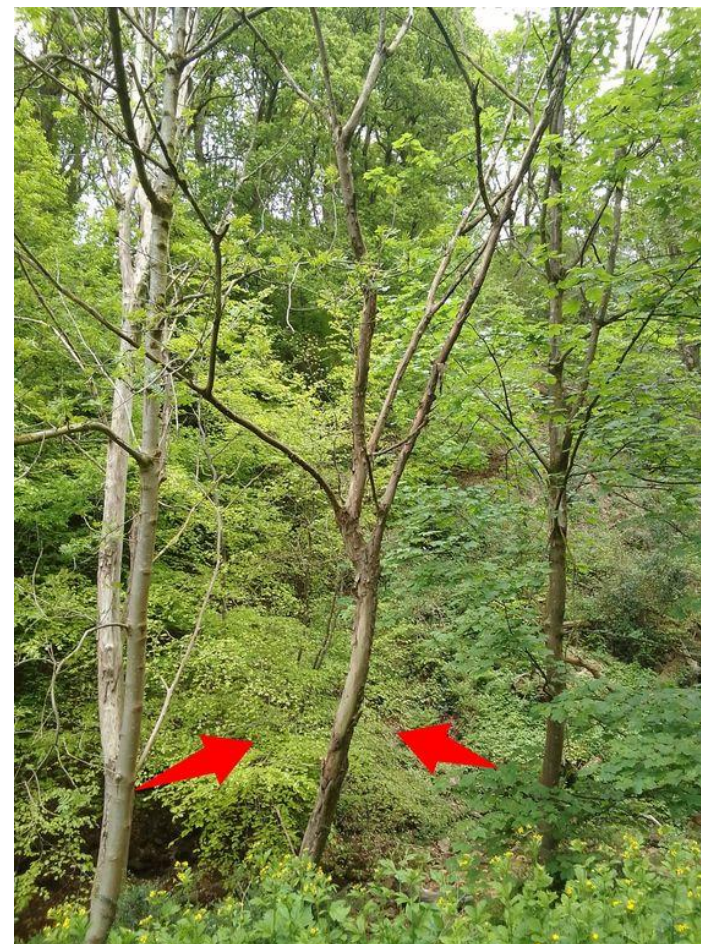
| T011 | Sycamore<br>( <i>Acer pseudoplatanus</i> ) | Target # - footpath.<br>- Occupancy - Rare(1). | Height (m): 7<br>Crown Radius (m): 2<br>DBH (cm): 20<br>Life Stage: Dead | Dead tree | Dead | Low | 18 Months | Tree risk mitigation: remove the tree.<br>Timescale: 06-May-2027 (1 Year)<br>Work Done: No works completed. | |

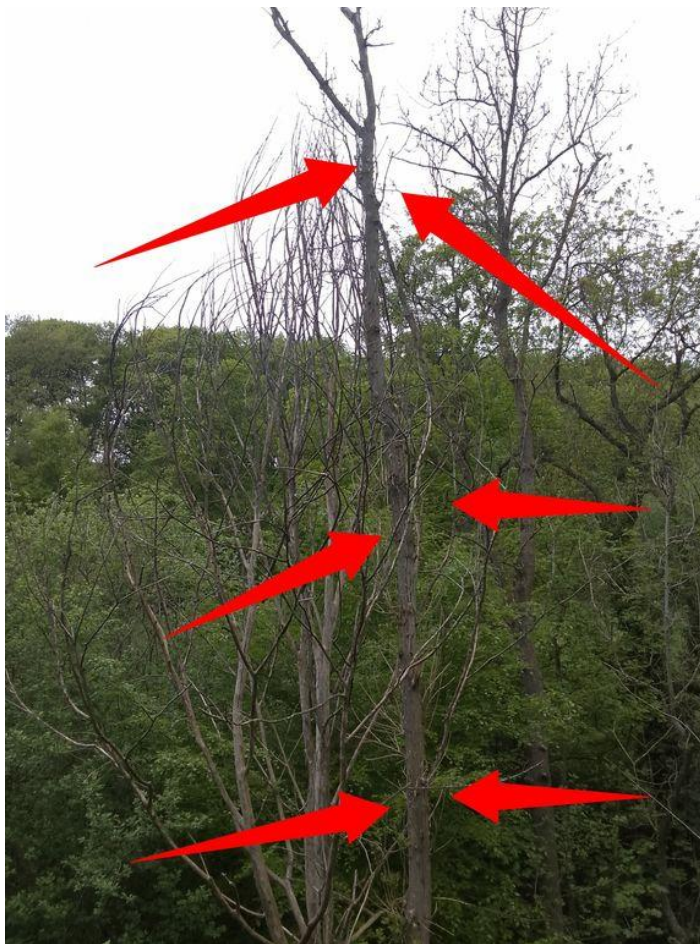
| T014 | Ash<br>( <i>Fraxinus sp.</i> ) | Target # - car park.<br>- Occupancy - Constant(4). | Height (m): 14<br>Crown Radius (m): 1<br>DBH (cm): 35<br>Life Stage: Dead | Dead tree | Dead | High | 18 Months | Tree risk mitigation: remove the tree.<br>Timescale: 06-Aug-2026 (3 Months)<br>Work Done: No works completed. | |

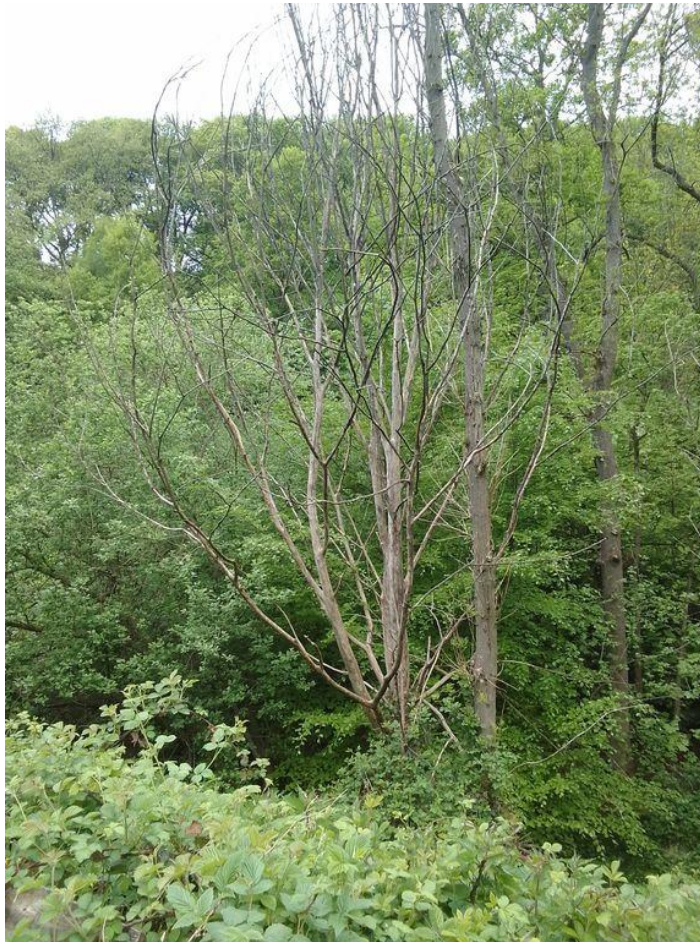
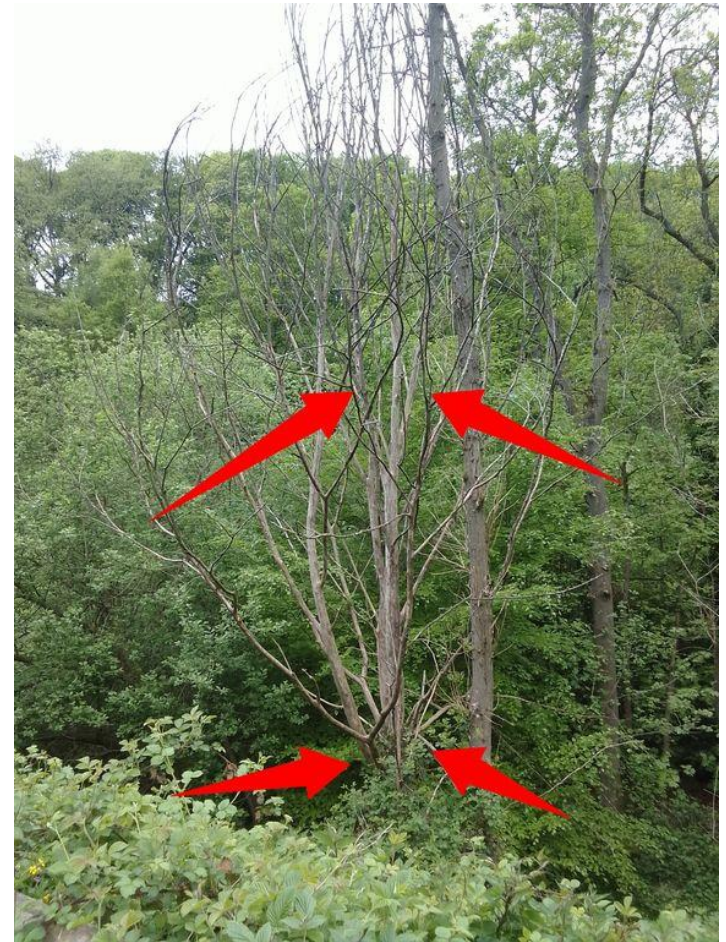
| T015 | Elm<br>( <i>Ulmus sp.</i> ) | Target # - car park.<br>- Occupancy - Constant(4). | Height (m): 11<br>Crown Radius (m): 3<br>DBH (cm): 40<br>Life Stage: Dead | Dead tree | Dead | High | 18 Months | Tree risk mitigation: remove the tree.<br>Timescale: 06-Aug-2026 (3 Months)<br>Work Done: No works completed. | |

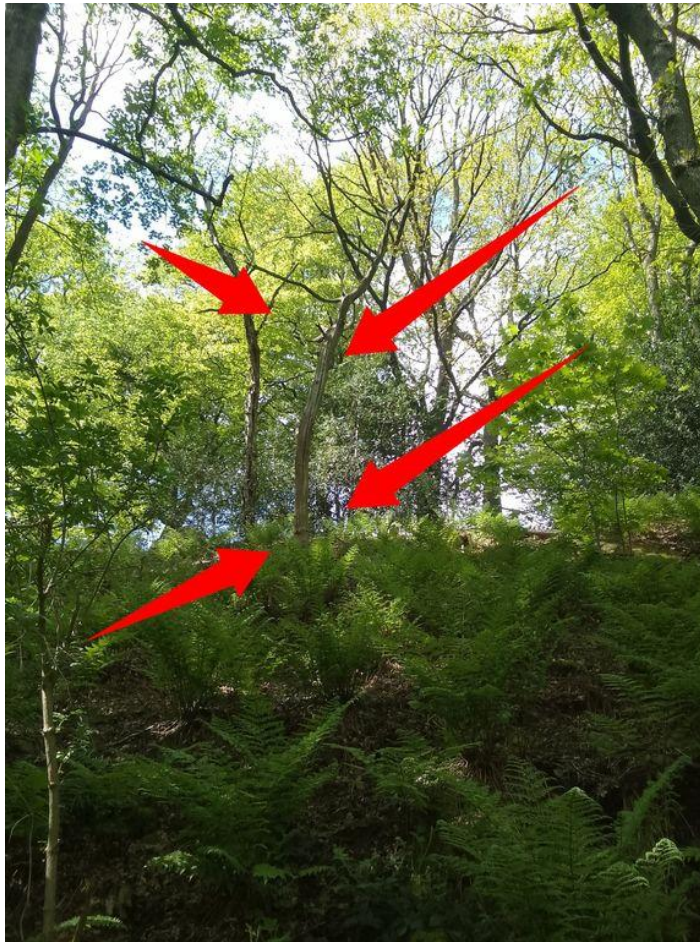
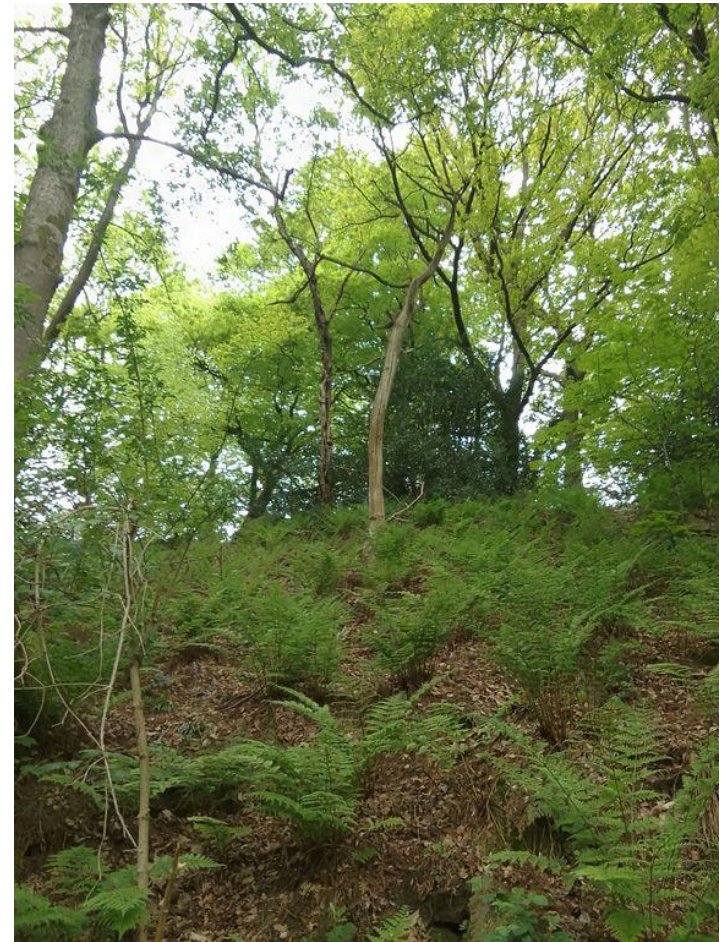
| T016 | Oak<br>( <i>Quercus sp.</i> ) | Target # - footpath.<br>- Occupancy - Rare(1). | Height (m): 10<br>Crown Radius (m): 3<br>DBH (cm): 30<br>Life Stage: Dead | Dead tree | Dead | Low | 18 Months | Tree risk mitigation: remove the tree.<br>Timescale: 06-May-2027 (1 Year)<br>Work Done: No works completed. | |

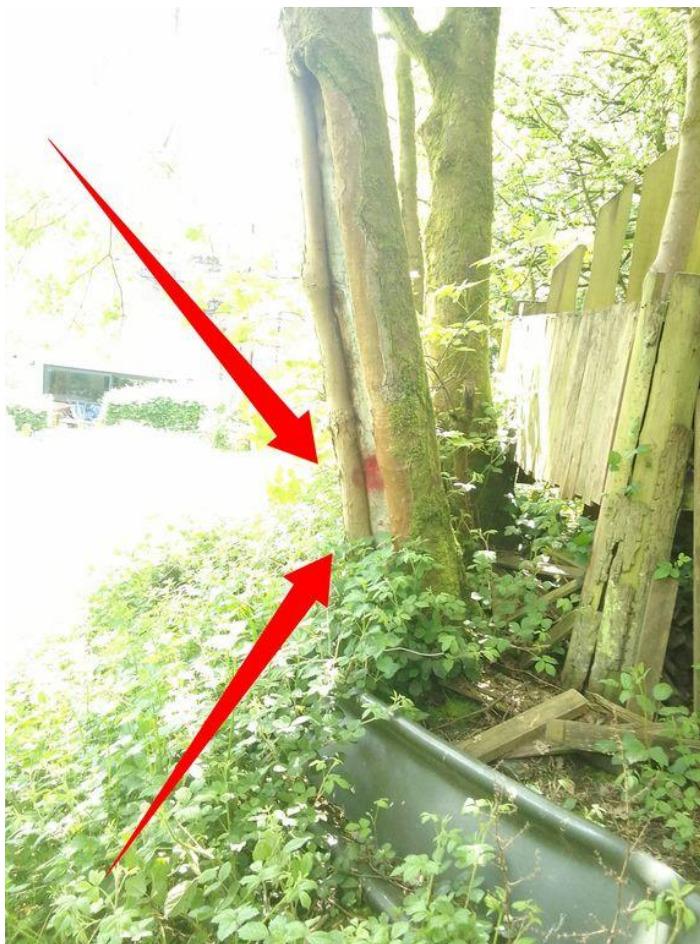
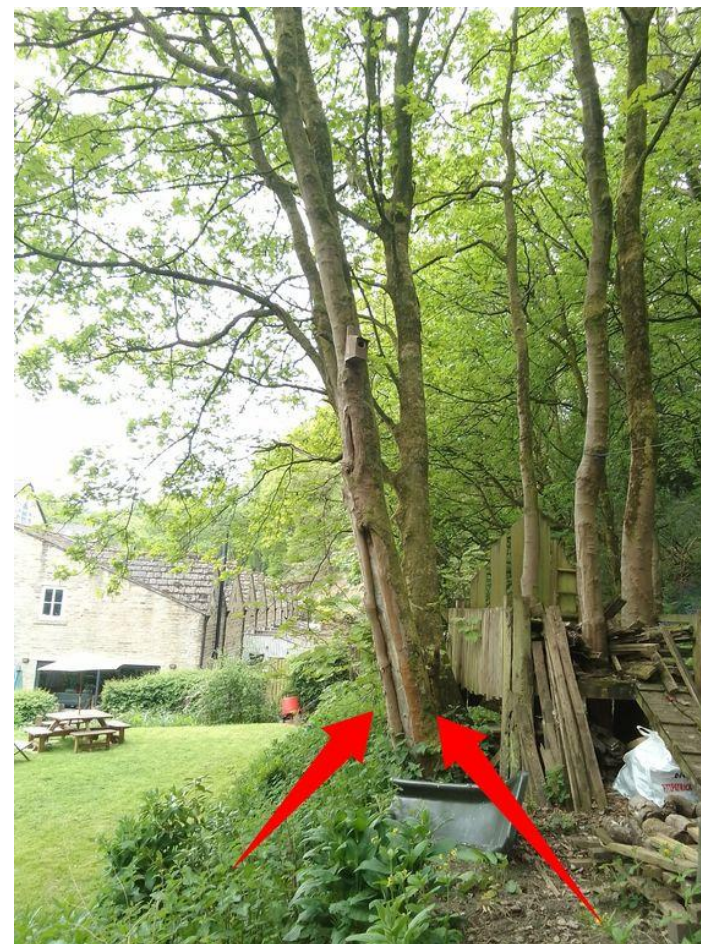
| T017 | Sycamore<br>( <i>Acer pseudoplatanus</i> ) | Target # - dwelling.<br>Target # - playground.<br>- Occupancy - Constant(4). | Height (m): 15<br>Crown Radius (m): 4<br>DBH (cm): 50<br>Life Stage: Early Mature | There is a large wound at the base of the tree.<br>The tree is healing over.<br>The probe test found hardwood in the wound | Poor | Moderate | 18 Months | Tree risk mitigation: remove the tree.<br>Timescale: 06-Nov-2026 (6 Months)<br>Work Done: No works completed. | |

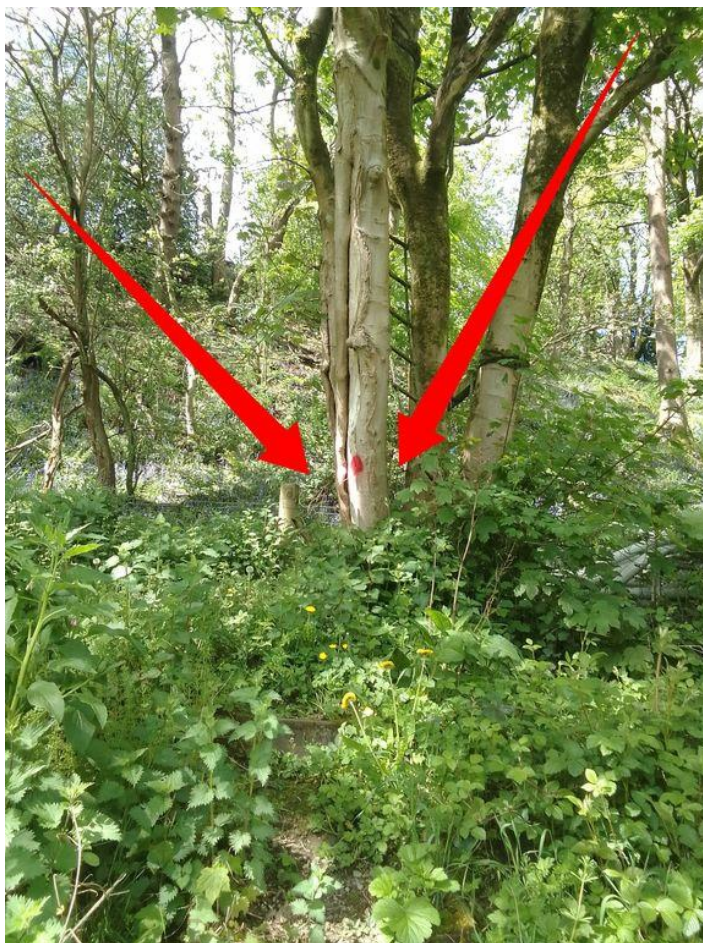
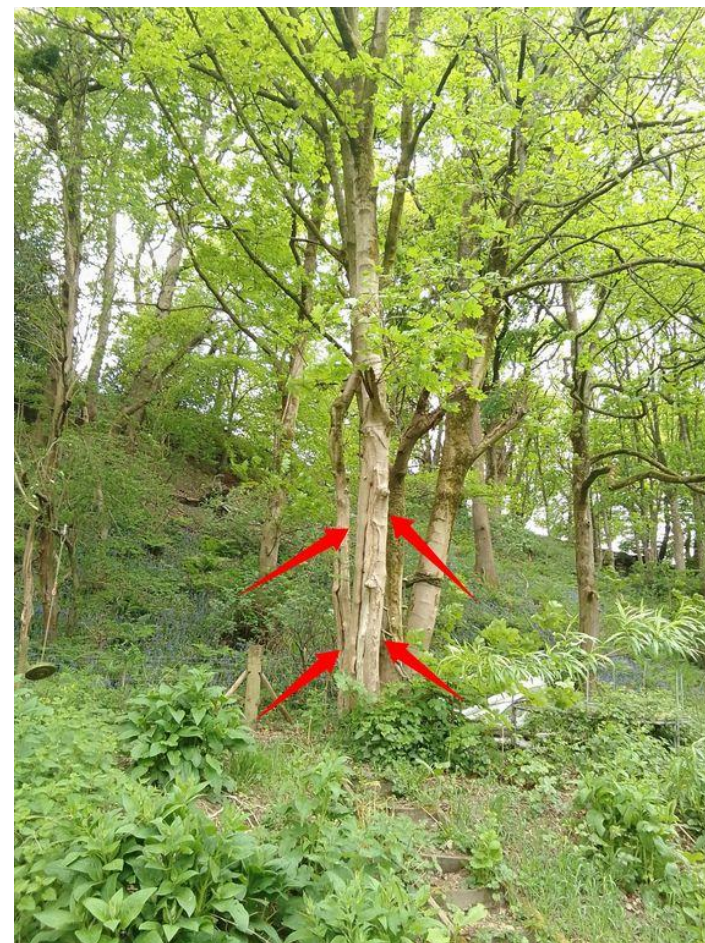
| T018 | Sycamore<br>( <i>Acer pseudoplatanus</i> ) | Target # - dwelling.<br>Target # - playground.<br>- Occupancy - Constant(4). | Height (m): 14<br>Crown Radius (m): 4<br>DBH (cm): 40<br>Life Stage: Semi Mature | There is a large wound at the base of the tree.<br>The tree is healing over.<br>The probe test found hardwood in the wound<br>Acoustic test revealed a hollow resonance | Poor | Moderate | 18 Months | Tree risk mitigation: remove the tree.<br>Timescale: 06-Nov-2026 (6 Months)<br>Work Done: No works completed. | |

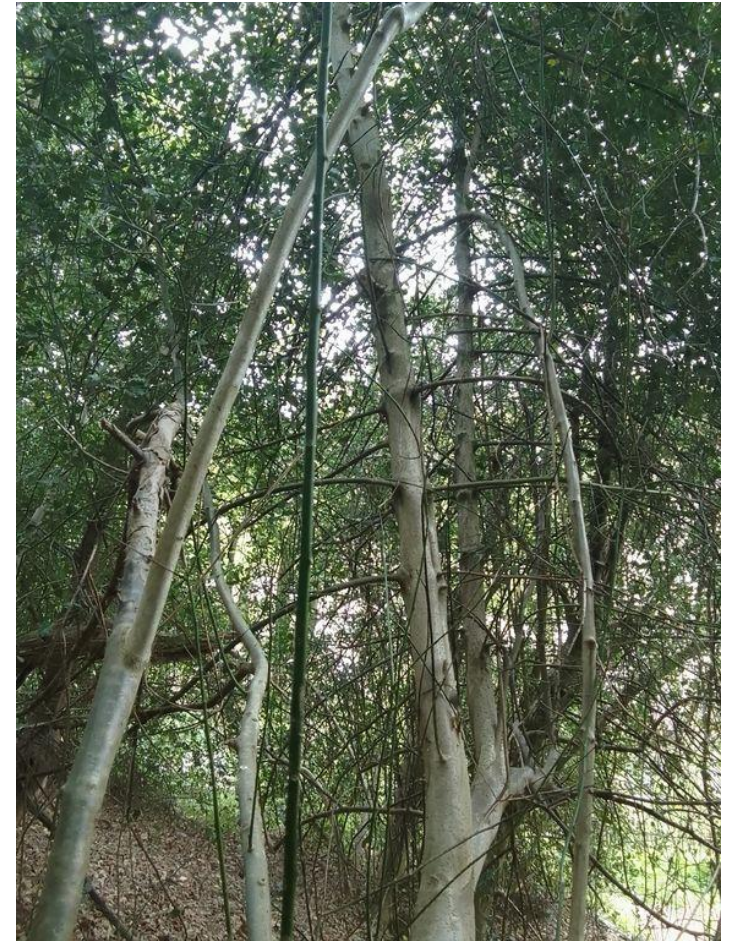
| T019 | Holly<br>( <i>Ilex sp.</i> ) | Target # - footpath.<br>- Occupancy - Occasionally(2). | Height (m): 9<br>Crown Radius (m): 4<br>DBH (cm): 20<br>Life Stage: Semi Mature | The tree is rotting at the base of the trunk | Poor | Low | 18 Months | Tree risk mitigation: remove the tree.<br>Timescale: 06-May-2027 (1 Year)<br>Work Done: No works completed. | |

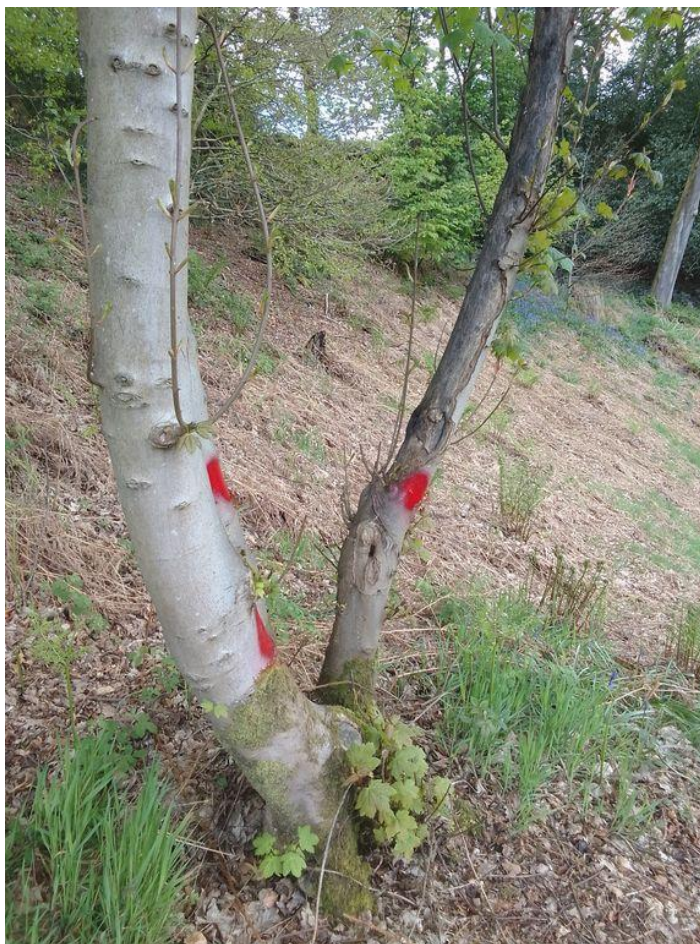
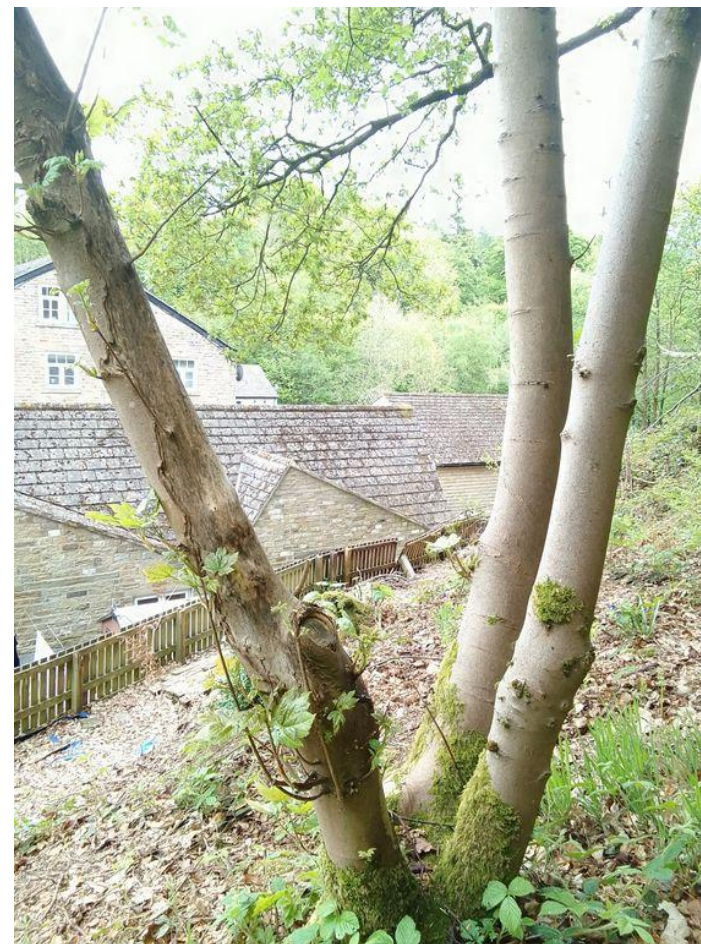
| T020 | Sycamore<br>( <i>Acer pseudoplatanus</i> ) | Target # - dwelling.<br>- Occupancy - Constant(4). | Height (m): 9<br>Crown Radius (m): 3<br>DBH (cm): 20<br>Life Stage: Semi Mature | There is a significant amount of missing bark from the trunk of the tree. | Poor | Moderate | 18 Months | Tree risk mitigation: remove the tree.<br>Timescale: 06-Nov-2026 (6 Months)<br>Work Done: No works completed. | |

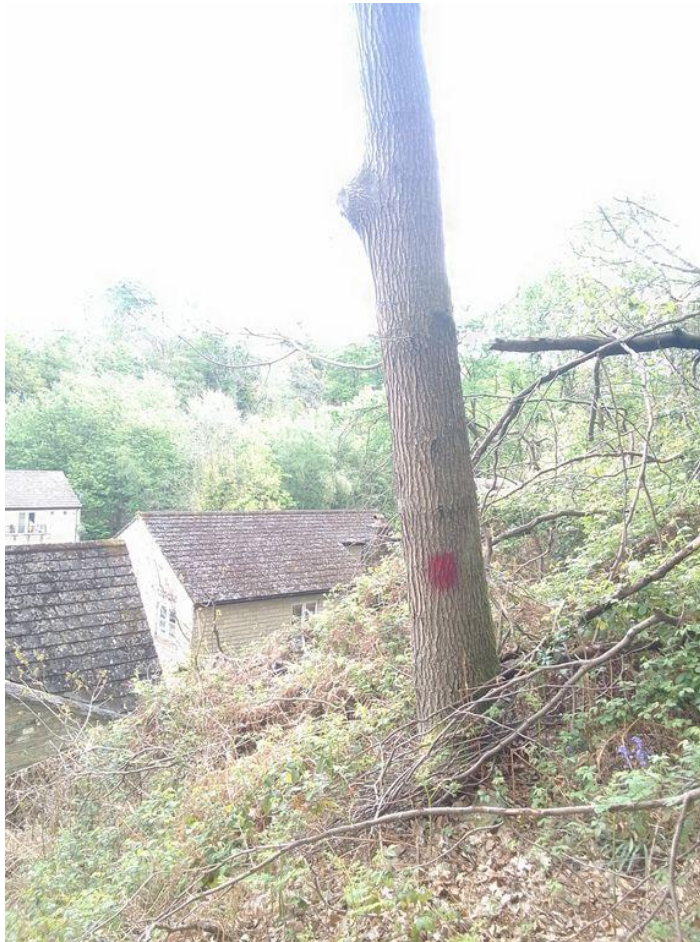
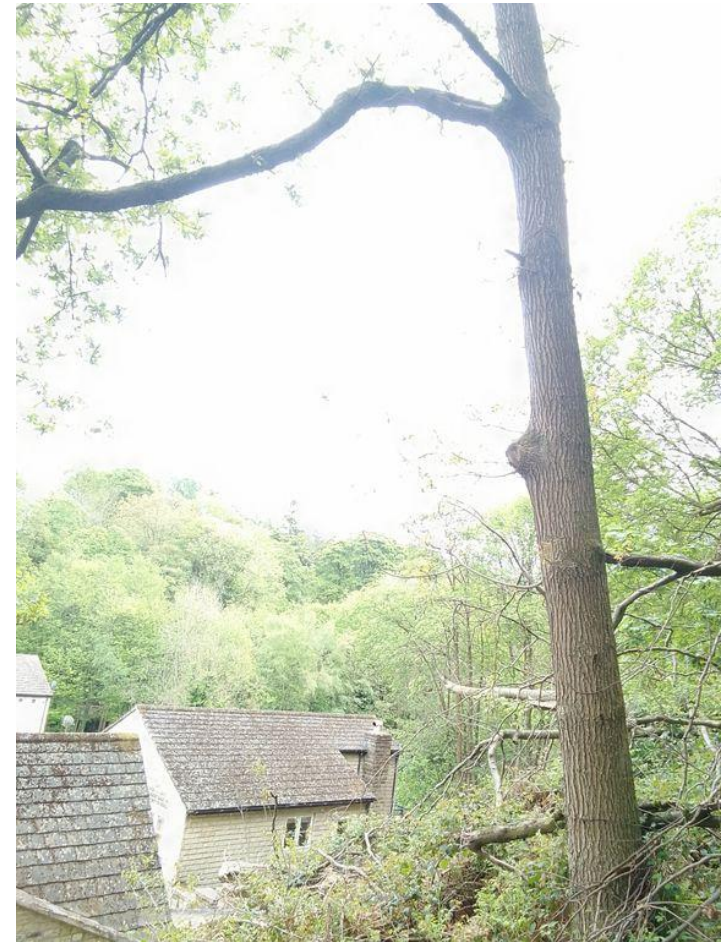
| T021 | Oak<br>( <i>Quercus sp.</i> ) | Target # - dwelling.<br>- Occupancy - Constant(4). | Height (m): 13<br>Crown Radius (m): 5<br>DBH (cm): 50<br>Life Stage: Semi Mature | Asymmetrical crown weighted to the north overhanging the dwelling house.<br>Dead wood present in the crown of the tree | Fair | Moderate | 18 Months | Tree risk mitigation: remove the tree.<br>Timescale: 06-Nov-2026 (6 Months)<br>Work Done: No works completed. | |

| | | | | Rotting wood at the base of the tree | | | | | |

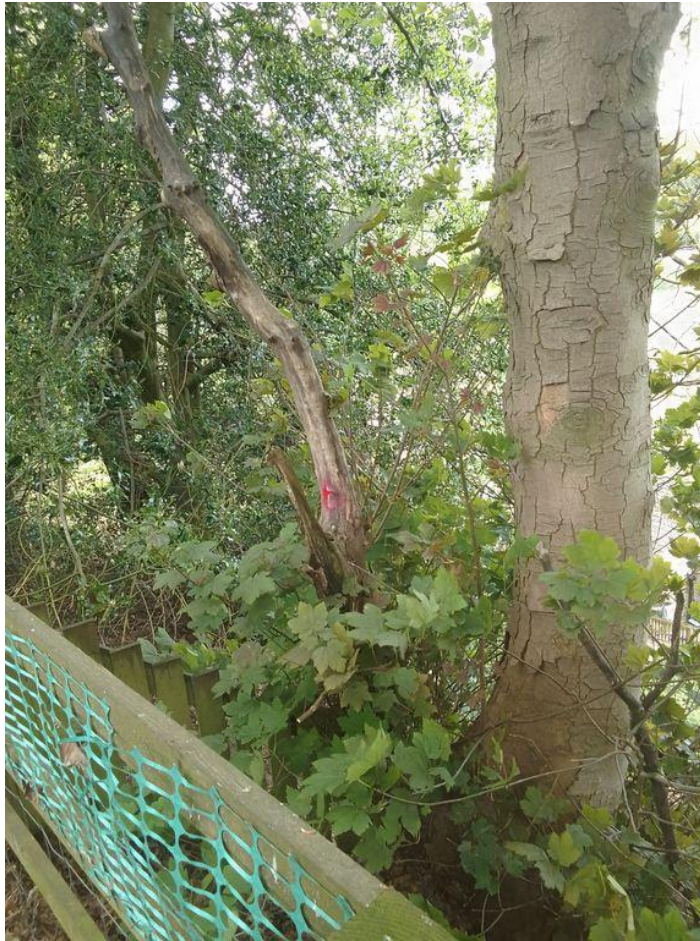
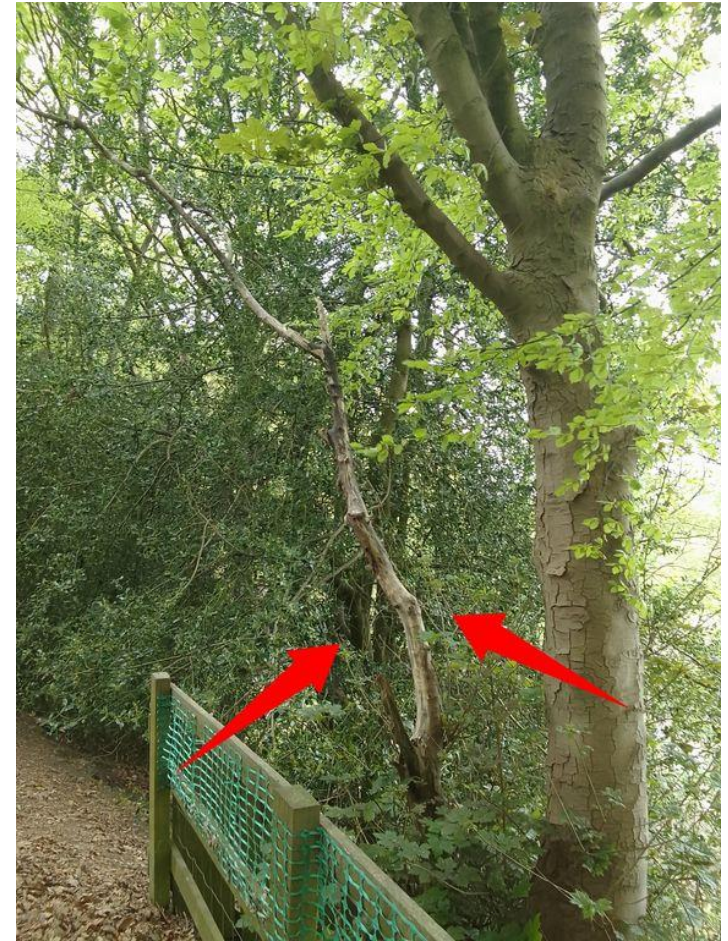
| T022 | Beech<br>( <i>Fagus sp.</i> ) | Target # - footpath.<br>- Occupancy - Occasionally(2). | Height (m): 6<br>Crown Radius (m): 3<br>DBH (cm): 20<br>Life Stage: Dead | Dead tree | Dead | Low | 18 Months | Tree risk mitigation: remove the tree.<br>Timescale: 06-May-2027 (1 Year)<br>Work Done: No works completed. | |
