### Appendix 3 - Tree Images

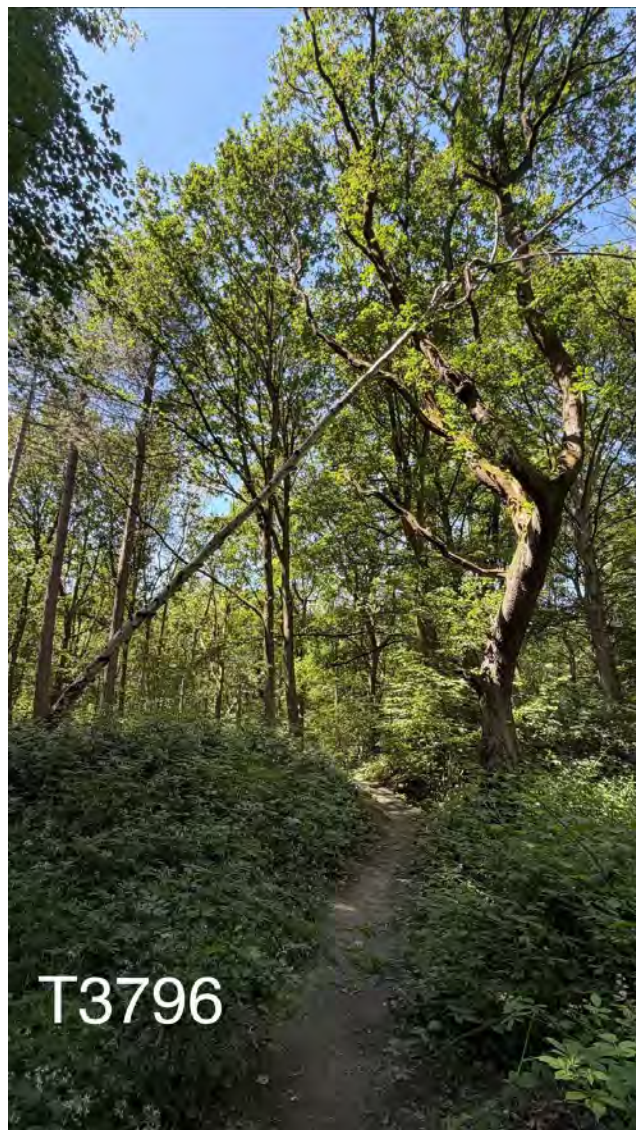
T3796 - above - a 3-stemmed birch that has failed at the base, with one stem hung up in a neighbouring oak, over the PROW.

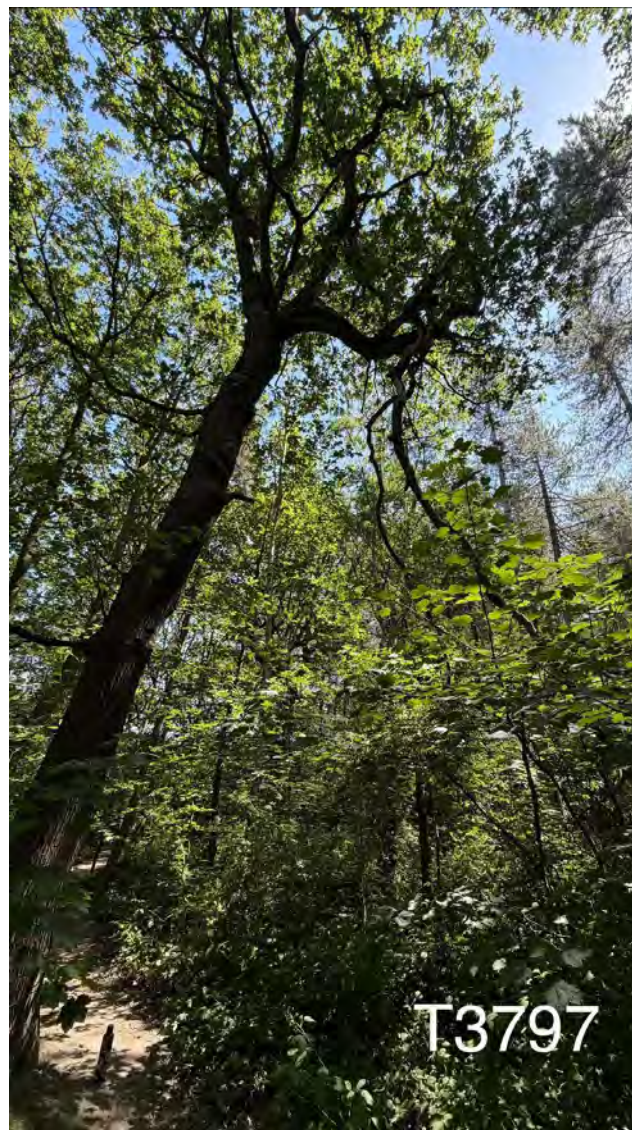
T3797 - above - this oak, in otherwise good condition, has a deadwood hanger over the footpath. This is recommended for removal

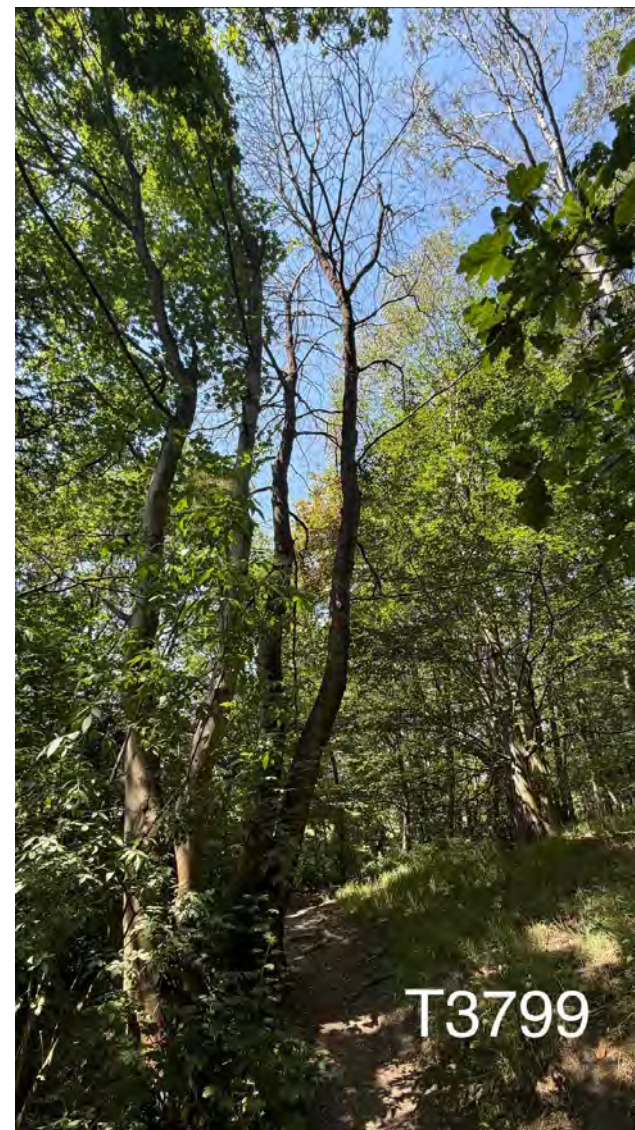
T3799 - above - a standing dead sycamore directly next to the footpath. The tree is recommended for removal.

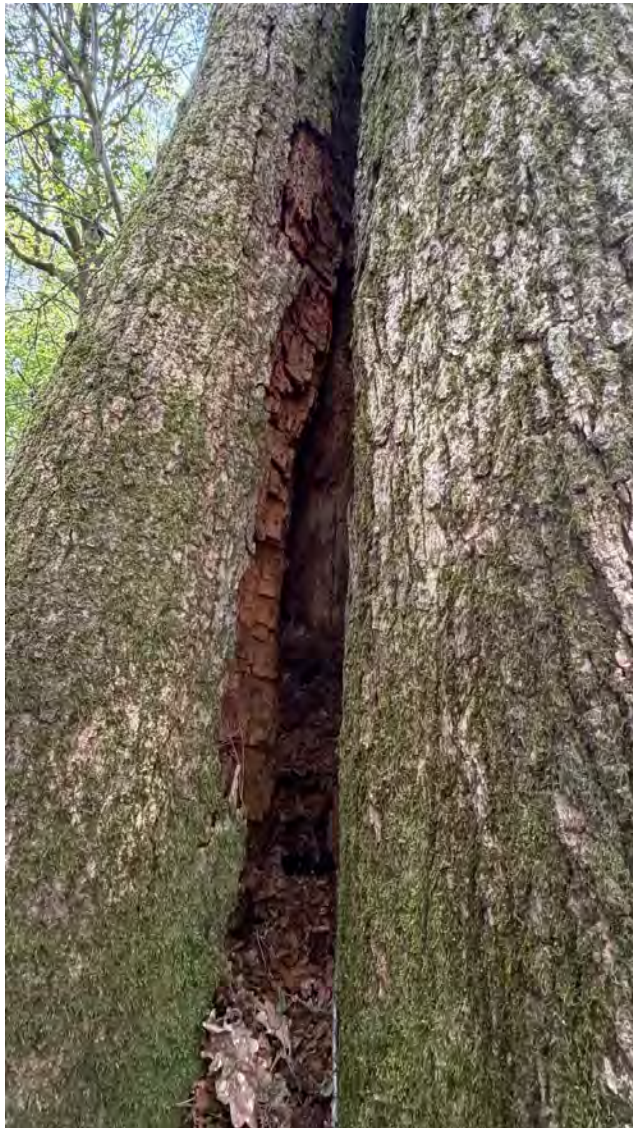
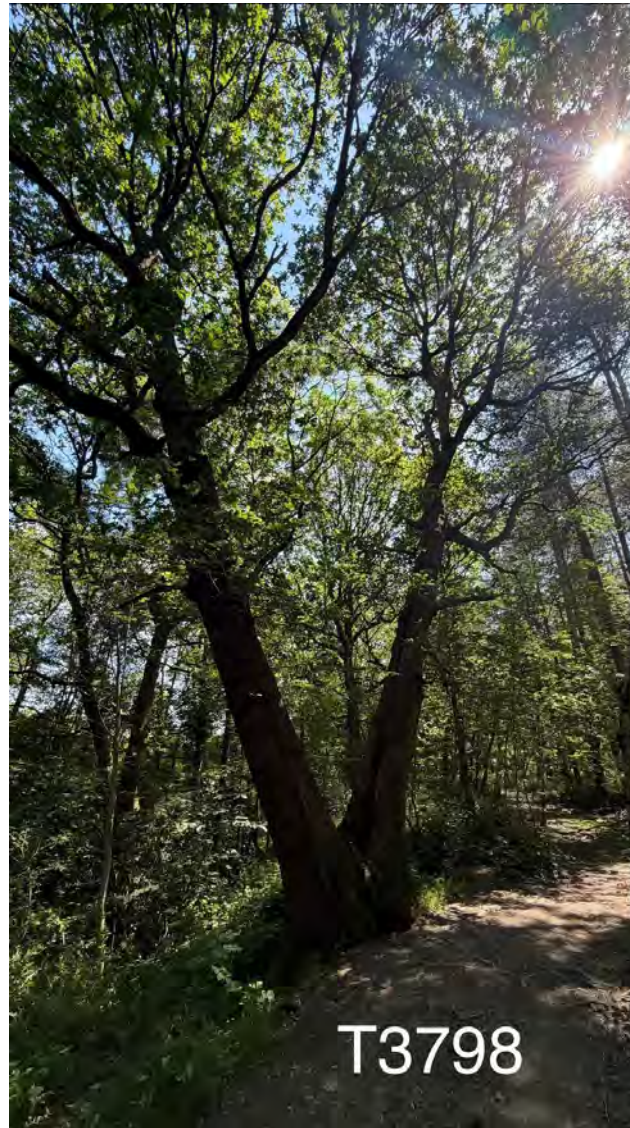
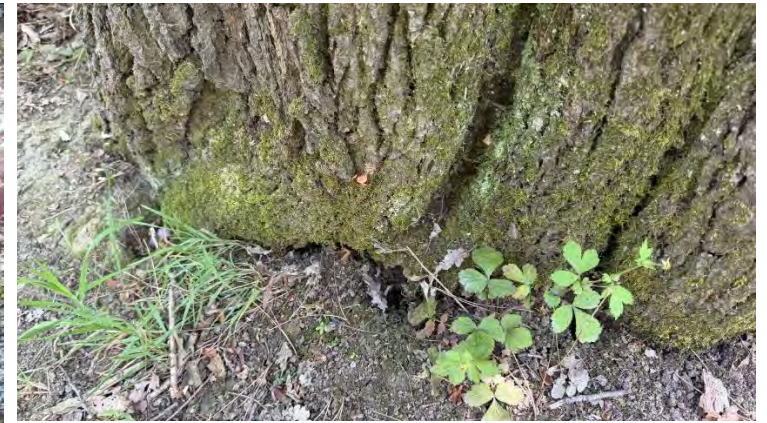
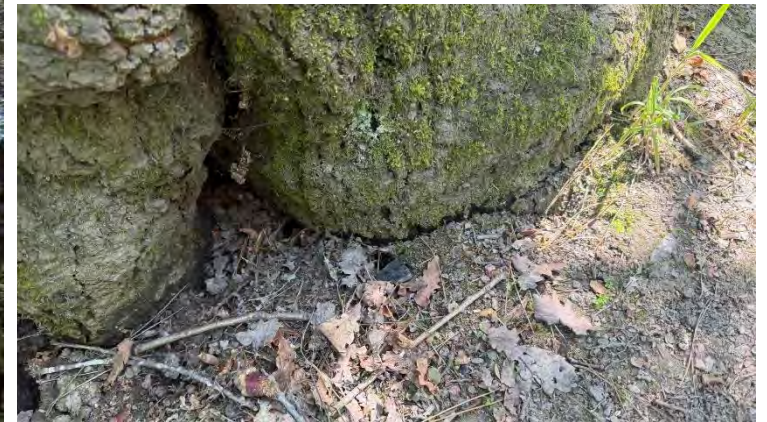
T3798 - above (all) - a mature oak within the woodland compartment. The leftmost image shows the brown cubical rot to the south east stem (the right stem in the centre image). The two right-hand images show the soil gap around the base.

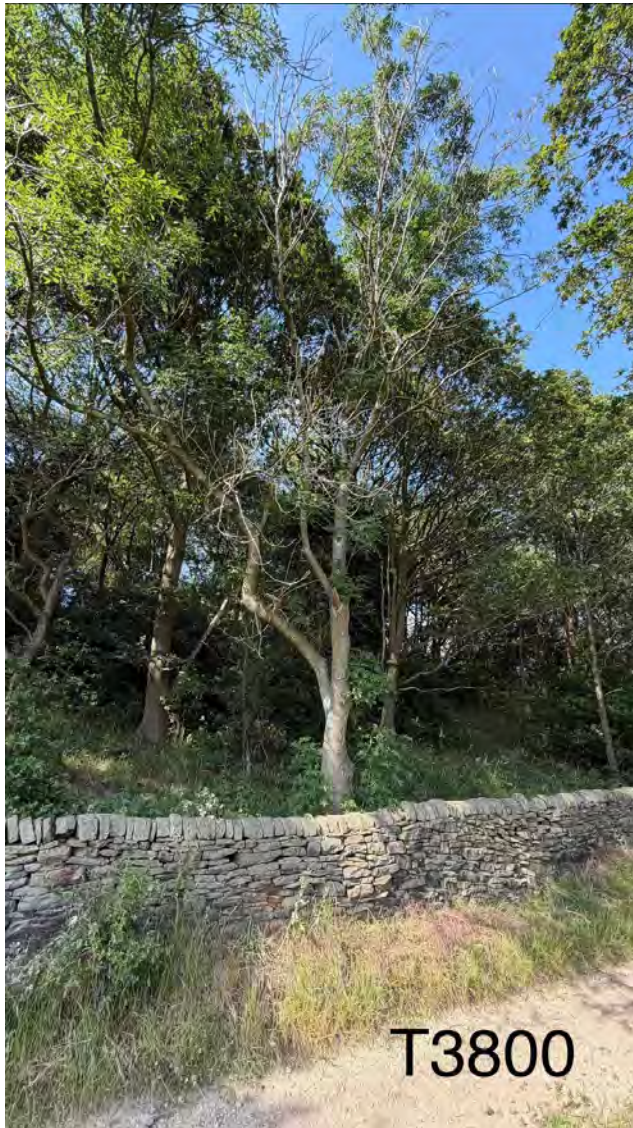
T3800 – above – a semi mature ash in decline from ADB, over a footpath.

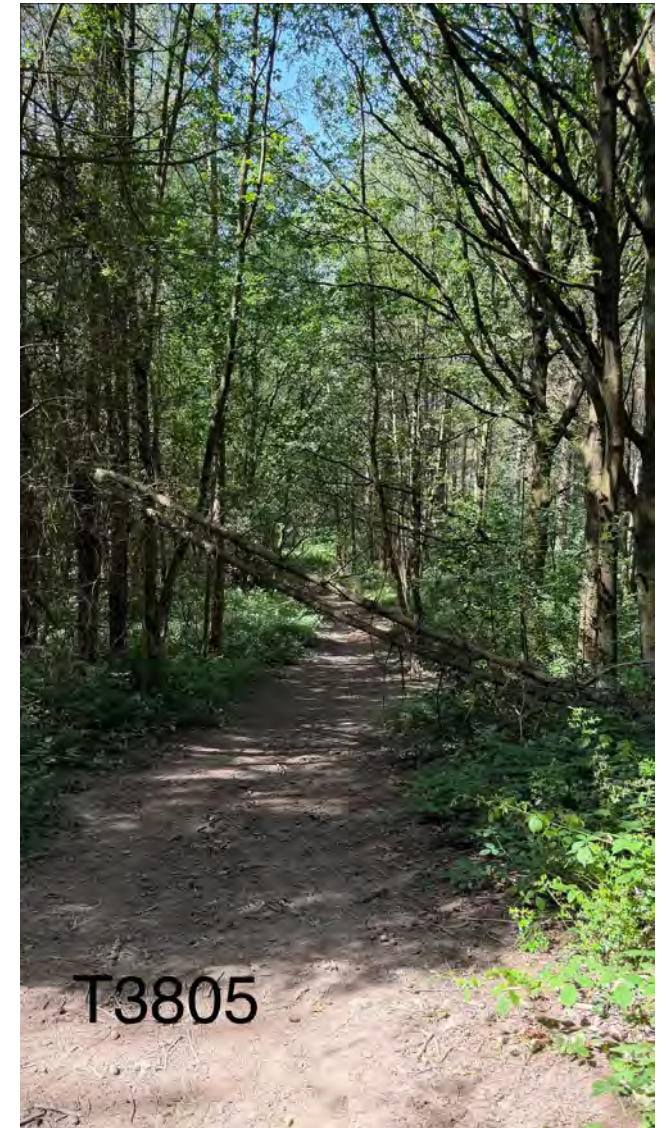
T3805 – above – a young Corsican pine, where two stems have collapsed over the footpath.

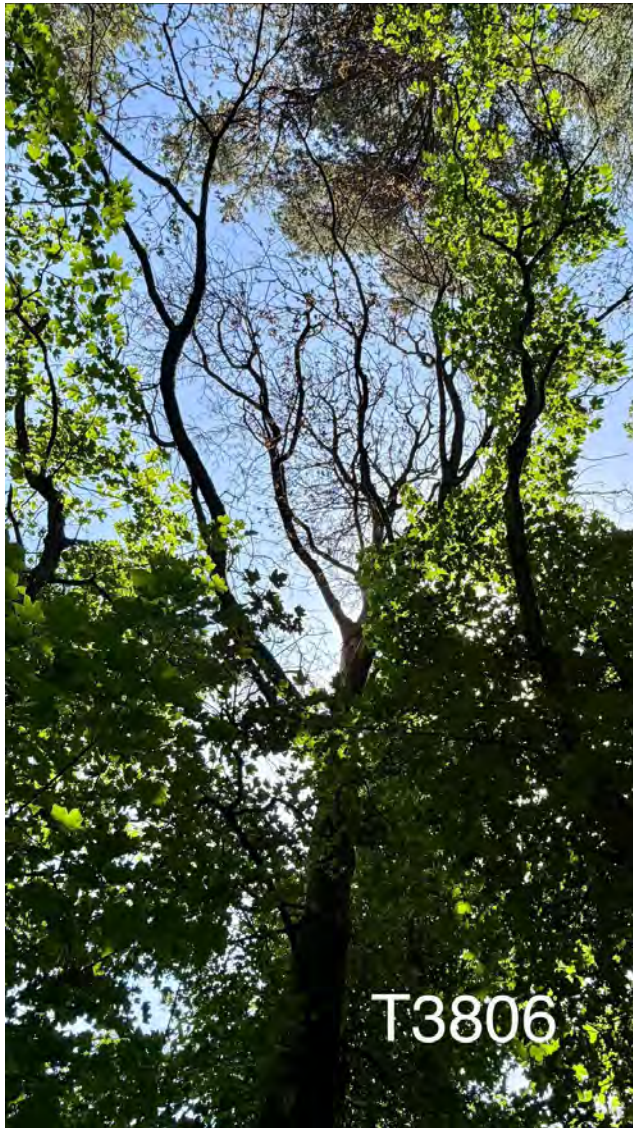
T3806 - above - a mature sycamore, which is in decline, over a footpath.

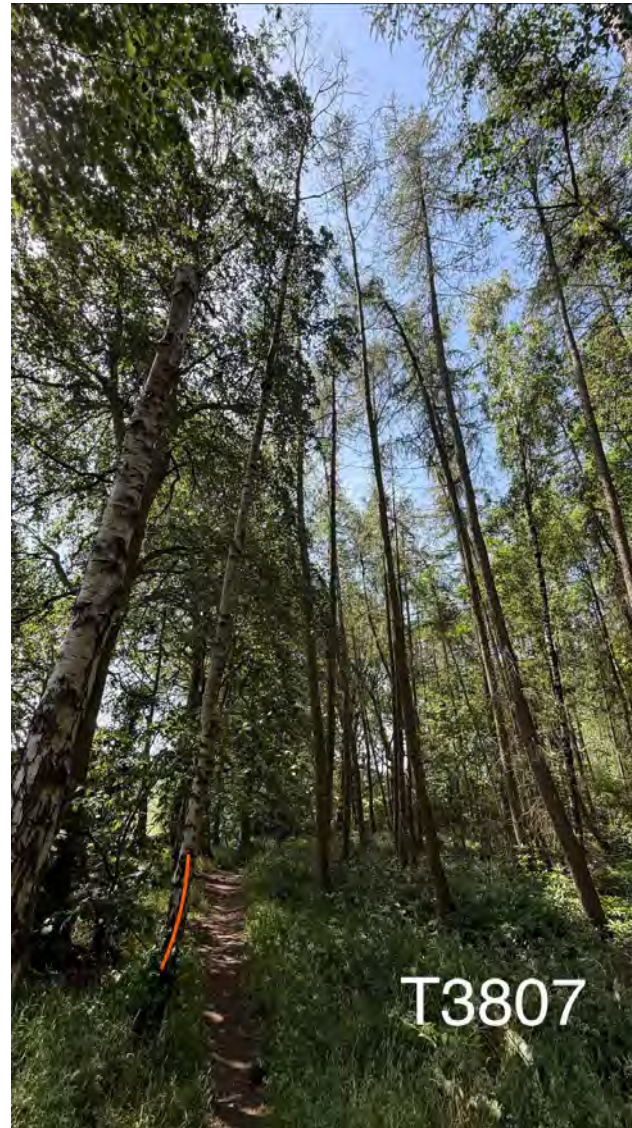
T3807 - above - a standing dead birch, over the footpath.

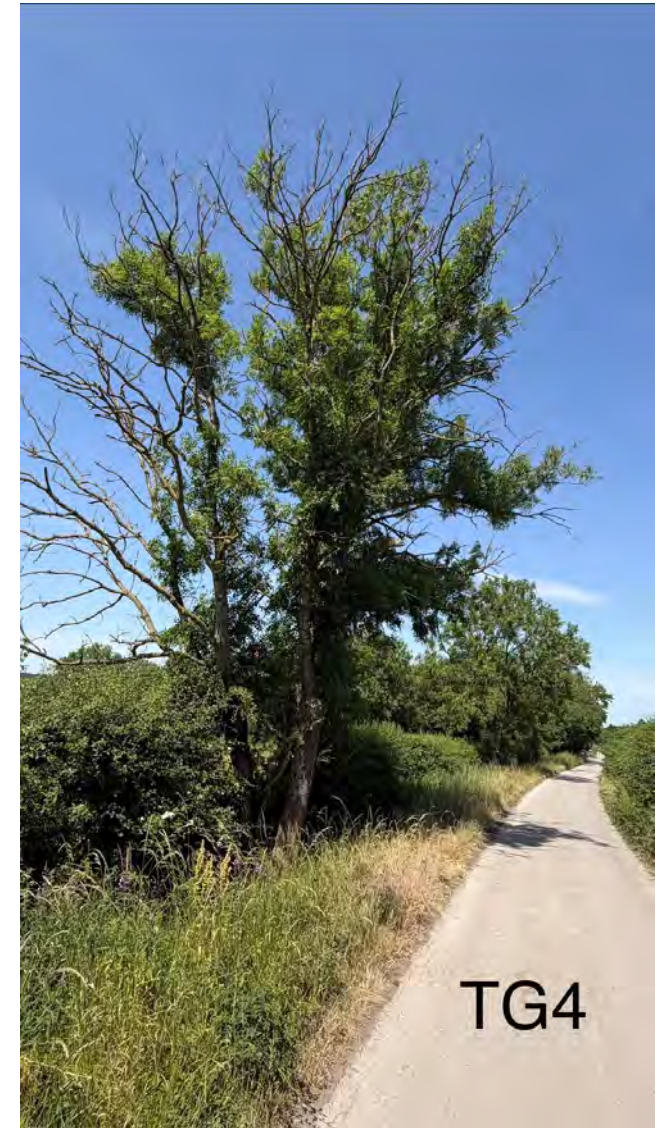
TG4 - above - a row of ash in decline from ADB over a road, which is also a farm access track and PROW.

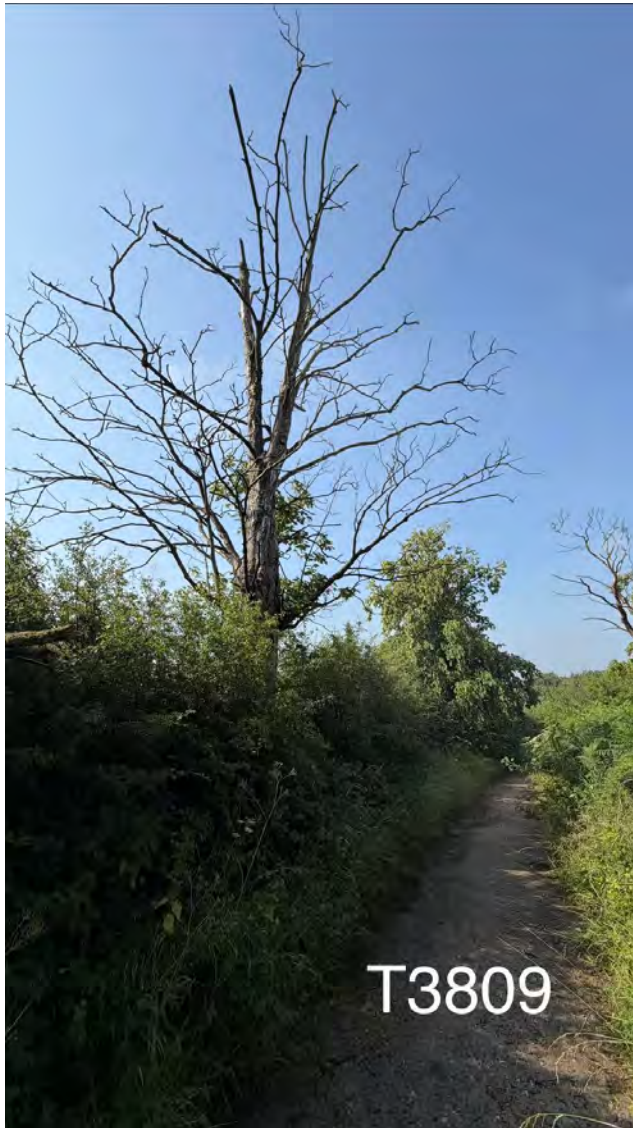
T3809 - above - a standing dead sycamore, within a hedgerow over a PROW

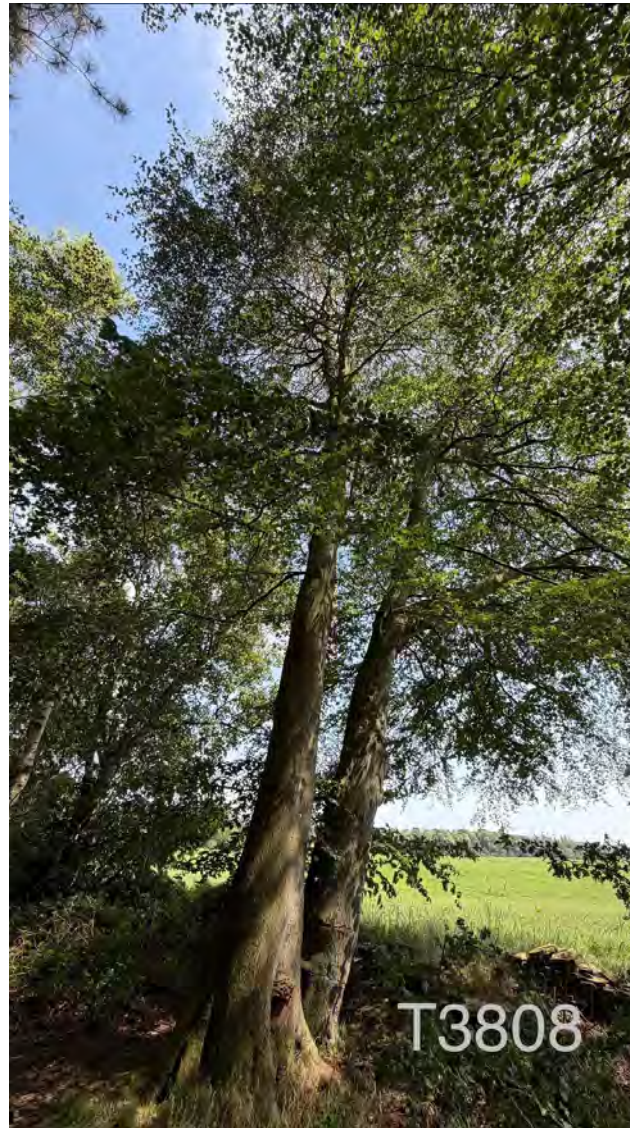
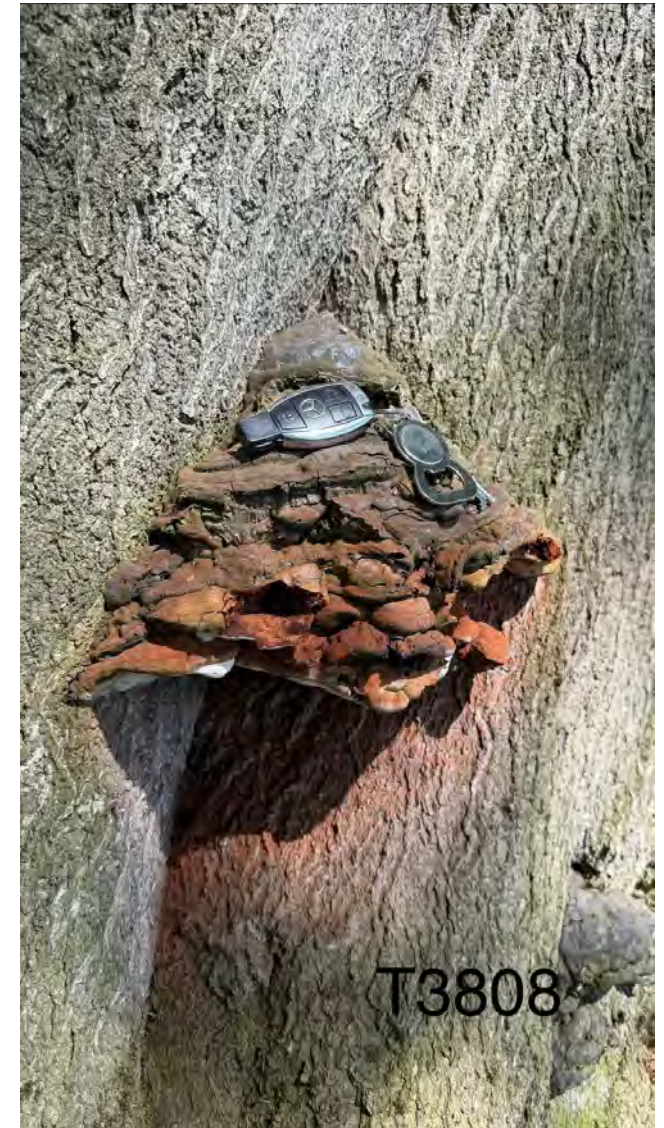
T3808 - above L&R - a mature beech to edge of the woodland. Image taken from the PROW. The right image shows a close up of the *Ganoderma* bracket, with car key for scale.
