# Tree Risk Assessment Report

Millbridge Playing Field  
Vernon Rd, Liversedge WF15 6HU

**Date of Survey:** 14<sup>th</sup> April 2026

Leonie Kapadia

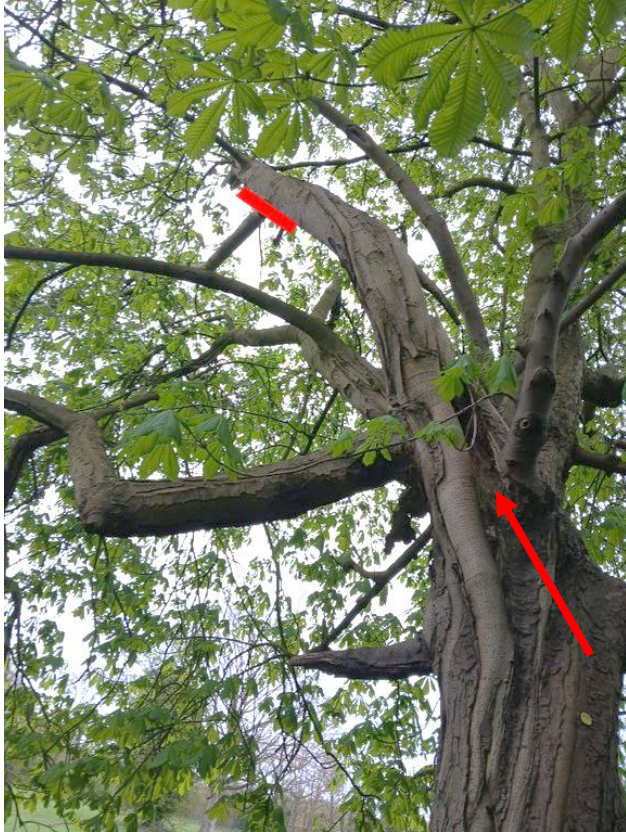
| Ref. | Species | Description & Targets | Measurements | Survey Notes | Overall Condition | Recommendation | Work Timescale |
|---|---|---|---|---|---|---|---|
| G05 | Mixed species<br>( <i>Mixed species</i> ) | Mixed group in centre of field. Horse chestnut, sycamore, lime. | Height (m): 16<br>Life Stage: Mature | <p>Trees growing closely as a group canopy resulting in leggy extended end weighted branches. Ash now removed. Lime has strip wound to 0.5m occluding well</p> <p>Large horse chestnut to East of group (tagged 0942) has one very decayed and extended limb which is starting to collapse, leaving a gap in canopy. Tree is gradually declining, and has extended lateral branches that will be vulnerable.</p> <p>Sycamore to SE of group (tagged 0943) is in serious decline with bark necrosis and bark delamination. Possible sooty bark disease. Half canopy in leaf, half not.</p> | Mixed | <p>Horse chestnut: Large limb with cavity at base to be shortened back to decayed area, retaining woodpecker habitat but removing weight from base of stem. Crown reduce remainder of tree by 30% canopy volume as per BS3998, shortening end weighted branches.</p> <p>Sycamore: fell to 3m stem and leave for habitat.</p> | 14-Jul-2026<br>(3 Months) |

G05 – Horse chestnut with decaying limb to be shortened back and tree crown reduced.

| Ref. | Species | Description & Targets | Measurements | Survey notes | Overall Condition | Recommendation | Work Timescale |
|---|---|---|---|---|---|---|---|
| G05 | Mixed species<br>(Mixed species) | Mixed group in centre of field. Horse chestnut, sycamore, lime. | Height (m): 16<br>Life Stage: Mature | <p>Trees growing closely as a group canopy resulting in leggy extended end weighted branches. Ash now removed. Lime has strip wound to 0.5m occluding well</p> <p>Large horse chestnut to East of group (tagged 0942) has one very decayed and extended limb which is starting to collapse, leaving a gap in canopy. Tree is gradually declining, and has extended lateral branches that will be vulnerable.</p> <p>Sycamore to SE of group (tagged 0943) is in serious decline with bark necrosis and bark delamination. Possible sooty bark disease. Half canopy in leaf, half not.</p> | Mixed | <p>Horse chestnut: Large limb with cavity at base to be shortened back to decayed area, retaining woodpecker habitat but removing weight from base of stem. Crown reduce remainder of tree by 30% canopy volume as per BS3998, shortening end weighted branches.</p> <p>Sycamore: fell to 3m stem and leave for habitat.</p> | 14-Jul-2026<br>(3 Months) |

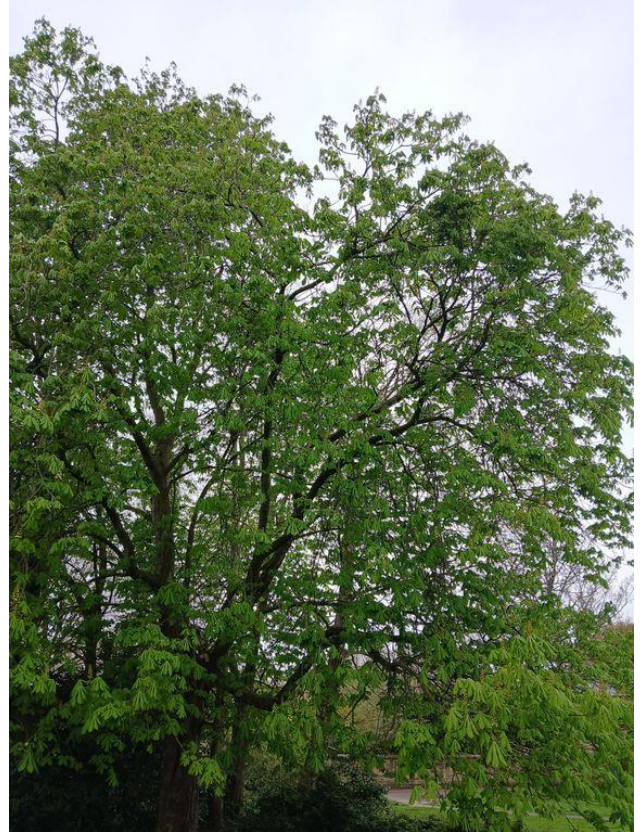
- G05 – Horse chestnut - (tagged 0942) has one very decayed and extended limb which is starting to collapse, leaving a gap in the canopy. This limb should be shortened back to decayed area, retaining woodpecker habitat but removing weight from base of stem. The remainder of the tree should be crown reduced by 30% canopy volume as per BS3998, shortening end weighted branches.
- G05 - Sycamore to SE of group (tagged 0943) is in serious decline with bark necrosis and bark delamination. Possible sooty bark disease. Half canopy in leaf, half not. This tree should be felled to a 3m stem and left for wildlife habitat.
- T03 - Sycamore with previous fire damage. Exposed heartwood is now decaying and the tree is 90% dead and collapsing. This tree should be felled to a 3m stem and left for wildlife habitat.

G05 - Horse chestnut with decaying/collapsing limb showing gap in canopy as branch is collapsing. Limb to be shortened back and tree to be crown reduced.

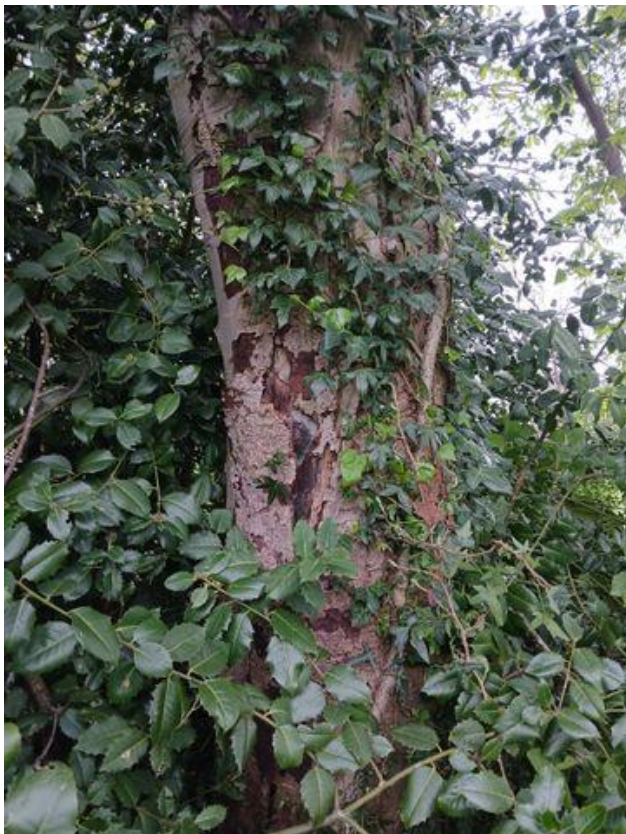
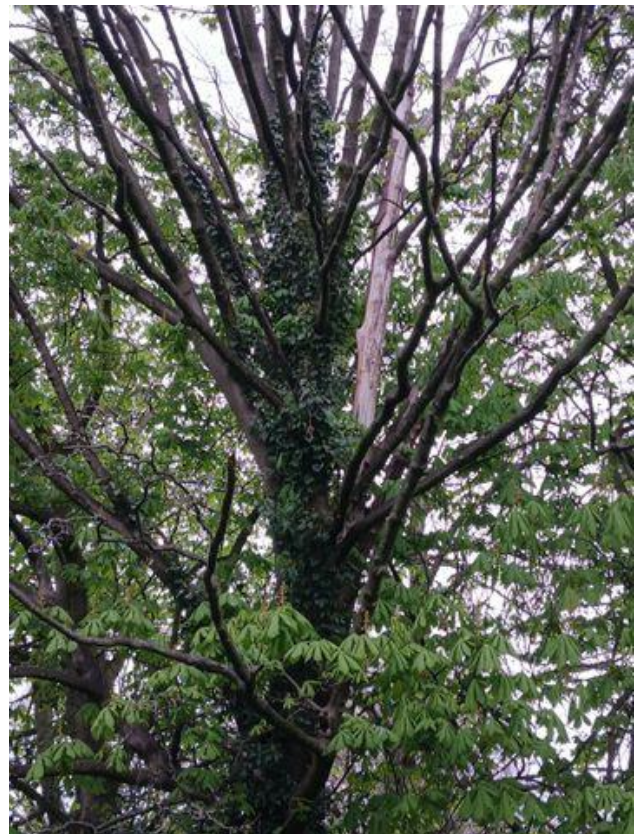
G05 - Sycamore to SE of group (tagged 0943) in serious decline with bark necrosis and bark delamination. Fell to 3m stem.

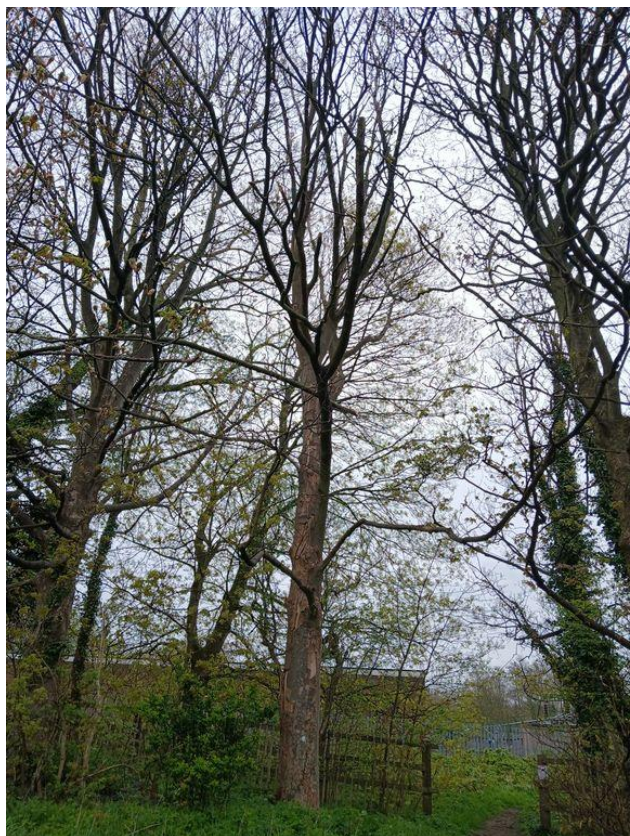
| Ref. | Species | Description & Targets | Measurements | Survey Notes | Overall Condition | Recommendation | Work Timescale |
|---|---|---|---|---|---|---|---|
| T03 | Sycamore<br>( <i>Acer pseudoplatanus</i> ) | Within grassed area.<br>Target - footpath. | Height (m): 15<br>DBH (cm): 40<br>Life Stage: Mature | Sycamore with previous fire damage. Exposed heartwood now decaying. Bark delamination throughout and dead wood throughout. Tree is 90% dead and collapsing. | Poor | Fell to 3m stump and retain for wildlife. Marked with white spot. | 14-Jul-2026<br>(3 Months) |

T03 – Sycamore with previous fire damage. Exposed heartwood now decaying. Tree 90% dead and collapsing. Fell to a 3m stem for wildlife habitat.

| Ref. | Species | Description & Targets | Measurements | Survey notes | Overall Condition | Recommendation | Work Timescale |
|---|---|---|---|---|---|---|---|
| T03 | Sycamore<br>( <i>Acer pseudoplatanus</i> ) | Within grassed area.<br><br>Target - footpath. | Height (m): 15<br>DBH (cm): 40<br>Life Stage: Mature | Sycamore with previous fire damage. Exposed heartwood now decaying. Bark delamination throughout and dead wood throughout. Tree is 90% dead and collapsing. | Poor | Fell to 3m stump and retain for wildlife. Marked with white spot. | 14-Jul-2026<br>(3 Months) |

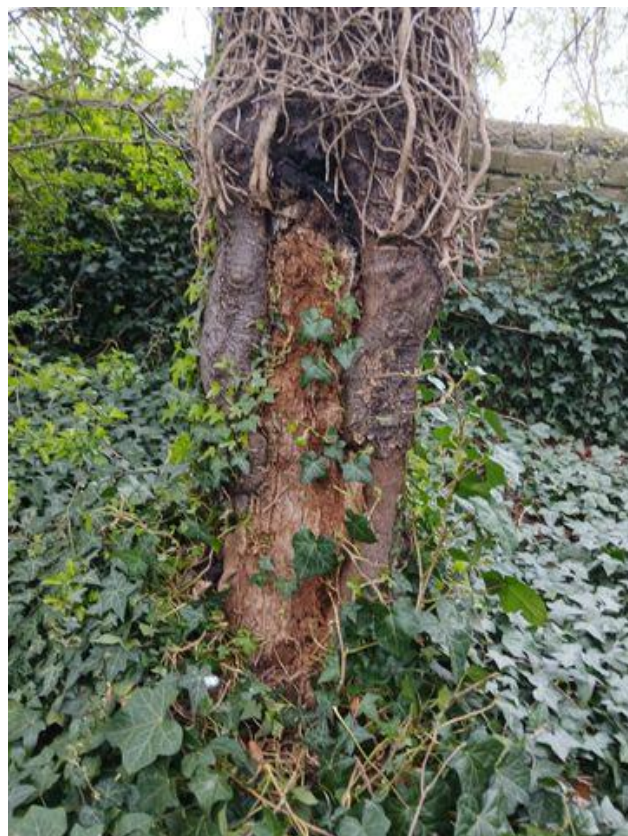
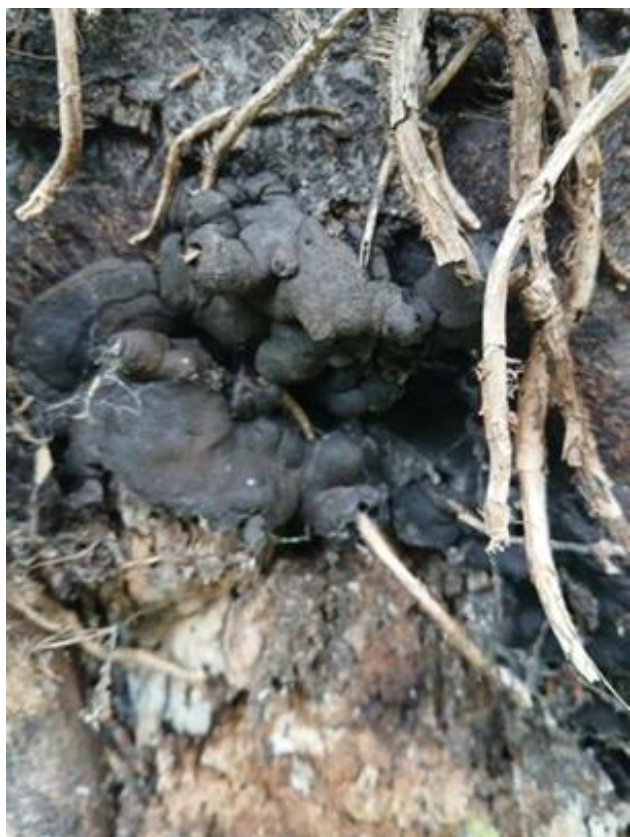
- T10 - Beech - suppressed beech tree under the canopy of a larger beech. It has a very large area of heartwood decay plus *kretzschmaria deusta* on dead wood. It is recommended this tree is felled to a 1m stump and left for wildlife habitat.
- T11 – Ash - Has moderate dead wood throughout over road and close to footpath. This tree should be crown-cleaned removing dead wood over 25mm. The remaining ivy should be removed around the base of tree to enable a fuller future inspection.

| Ref. | Species | Description & Targets | Measurements | Survey Notes | Overall Condition | Recommendation | Work Timescale |
|---|---|---|---|---|---|---|---|
| T10 | Common beech<br>( <i>Fagus sylvatica</i> ) | Alongside road. Target: footpath | Height (m): 8<br>DBH (cm): 30<br>Life Stage: Mature | Suppressed tree under canopy of larger beech. Ivy severed revealing very large area of heartwood decay plus <i>kretzschmaria deusta</i> on dead wood.<br>Fungus: <i>Kretzschmaria deusta</i> (Brittle Cinder) | Poor | Fell tree to a 1m stump for wildlife habitat. Caution that canopy branches are entwined in larger tree. | 14-Jul-2026<br>(3 Months) |

T10 – Suppressed beech with decaying heartwood and Kretschmaria on decay. Fell to 1m for wildlife.

| Ref. | Species | Description & Targets | Measurements | Survey notes | Overall Condition | Recommendation | Work Timescale |
|---|---|---|---|---|---|---|---|
| T10 | Common beech<br>( <i>Fagus sylvatica</i> ) | Alongside road.<br>Target: footpath | Height (m): 8<br>DBH (cm): 30<br>Life Stage: Mature | <p>Suppressed tree under canopy of larger beech. Ivy severed revealing very large area of heartwood decay plus <i>kretzschmaria deusta</i> on dead wood.</p> <p>Fungus: <i>Kretzschmaria deusta</i> (Brittle Cinder)</p> | Poor | Fell tree to a 1m stump for wildlife habitat. Caution that canopy branches are entwined in larger tree | 14-Jul-2026<br>(3 Months) |

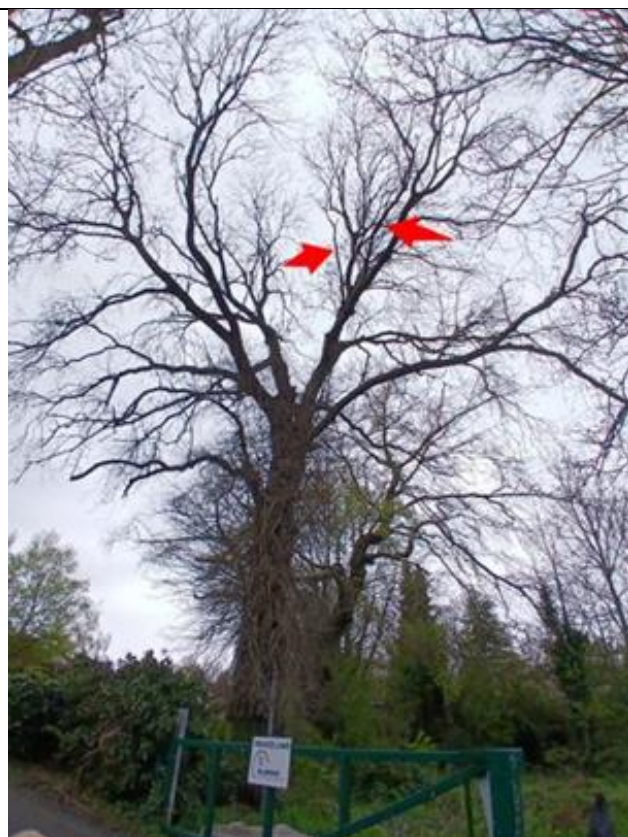
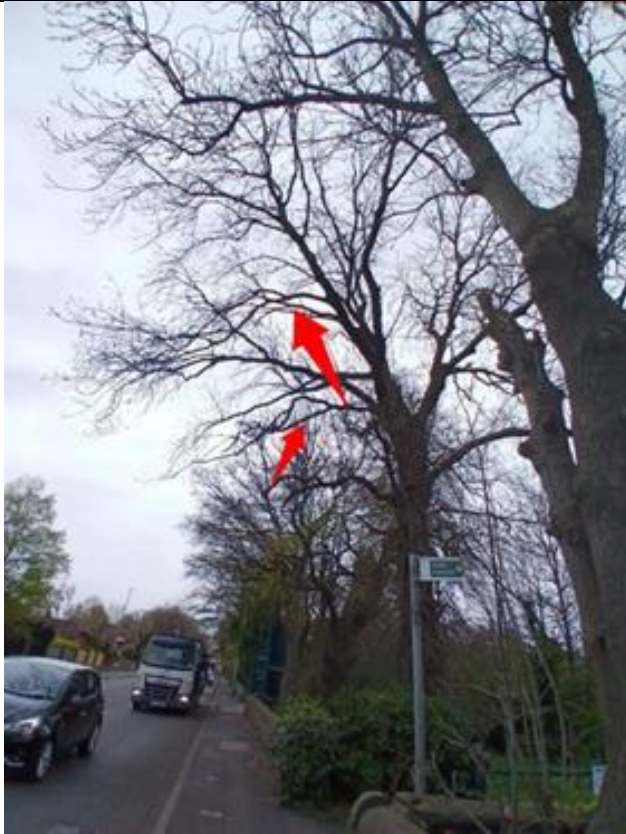
T11 – Ash with moderate deadwood over the A62 Leeds road. Crown clean removing deadwood over 25mm.

| Ref. | Species | Description & Targets | Measurements | Survey notes | Overall Condition | Recommendation | Work Timescale |
|---|---|---|---|---|---|---|---|
| T11 | Common ash<br>( <i>Fraxinus excelsior</i> ) | Northern boundary, adjacent to footpath and A62 | Height (m): 20<br>DBH (cm): 60<br>Life Stage: Over Mature | Ivy severed but base still obscured. Open grown canopy with straggly end weighted branches typical of species. Moderate dead wood throughout over road and close to footpath. Only partial basal inspection possible due to ivy. 2024: Ash Dieback Infection Level 1: 0% to 25% | Fair | Crown clean removing dead wood over 25mm. Remove ivy around base of tree. | 14-Jul-2026<br>(3 Months) |

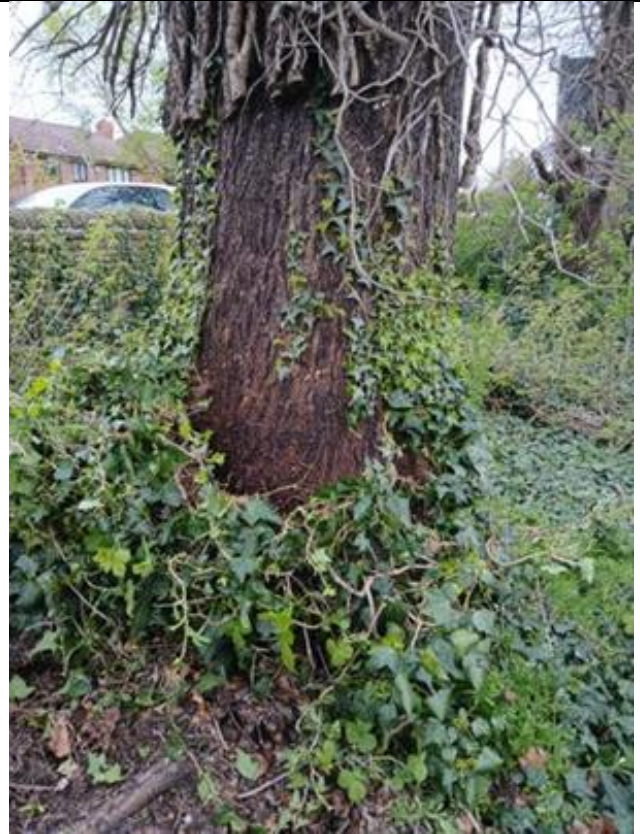
T11 – Ash with moderate deadwood - also sever ivy at base to enable fuller future inspection.
