# Arboricultural Assessment

**WC-541.1a**

Land adjacent to Huddersfield Road,  
Thongsbridge HD9 3TX

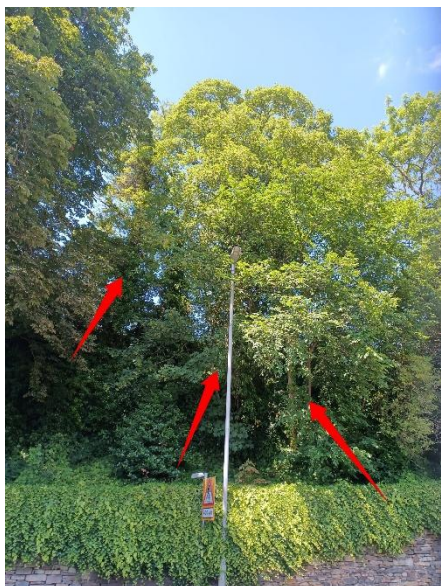
**Plate 1:** T001, T002, & T003 (right to left)

| Tree Ref: | Species | Age | SULE | Ht. | DBH | CS | | | | CC | Comments | RPA Radius | PC | SC | BS 5837: 2012 Category | Recommendations |
|---|---|---|---|---|---|---|---|---|---|---|---|---|---|---|---|---|
| T001 | Wych elm<br><i>Ulmus glabra</i> | SM | 10-20 | 11 | 230<br>250 | 3 | 6 | 4 | 1 | 0.5 | Bifurcates at ground level into two co-dominant stems. Asymmetrical form due to proximity with adjacent trees. Branches extending south encroach onto adjacent streetlamp. | 4.1 | G | F | C1 | No works recommended |
| T002 | Sycamore<br><i>Acer pseudoplatanus</i> | M | 40-80 | 19# | 600# | 5# | 7.5 | 6 | 5# | 3.5 | Positioned on steep embankment and unable to access the base of the main stem. Dense ivy <i>Hedera helix</i> established on the main stem and first order branches, which obscures tree features and potential defects. | 7.2 | G | F | B1 | No works recommended |

| Tree Ref: | Species | Age | SULE | Ht. | DBH | CS | | | | CC | Comments | RPA Radius | PC | SC | BS 5837: 2012 Category | Recommendations |
|---|---|---|---|---|---|---|---|---|---|---|---|---|---|---|---|---|
| T003 | Common ash<br><i>Fraxinus excelsior</i> | M | 10-20 | 16# | 500# | 5# | 6 | 5# | 5# | 3.5 | Positioned on steep embankment and unable to access the base of the main stem. Dense ivy <i>Hedera helix</i> established on the main stem and first order branches, which obscures tree features and potential defects. Extensive deadwood < 100 mm in diameter around the extremities of the crown, which may indicate infection by ash dieback <i>Hymenoscyphus fraxineus</i> . | 6 | P | F | C1 | No works recommended |

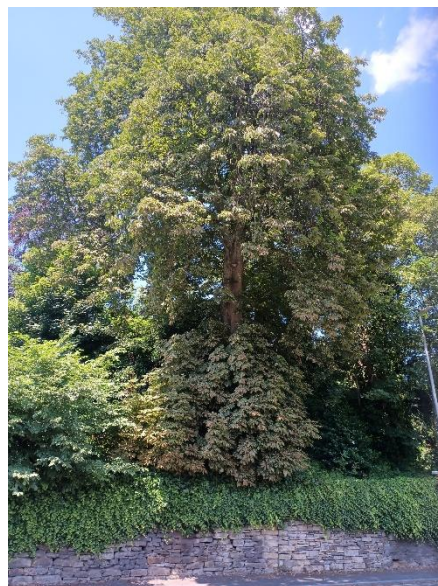
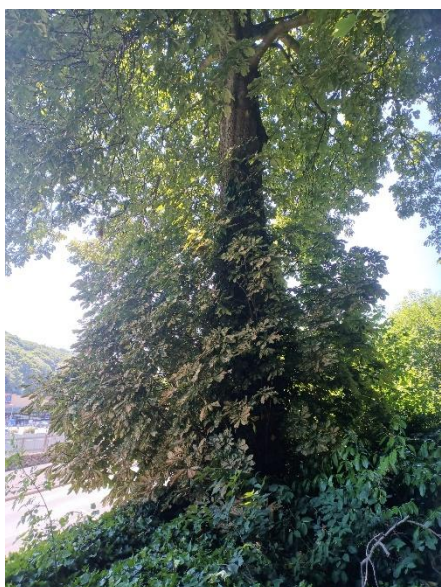
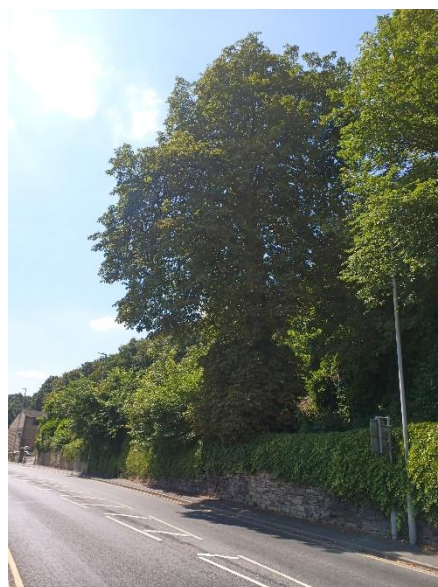
**Plate 2:** T004

- The significant defect and out of plane movement is centred about the position of a mature tree and has almost certainly occurred through physical damage from the close proximity of the tree.

- Given the close proximity of the existing mature tree to the subject wall, it will not be possible to carry out the safe removal of the existing wall and excavation whilst the tree remains in place.

| Tree Ref: | Species | Age | SULE | Ht. | DBH | CS | | | | CC | Comments | RPA Radius | PC | SC | BS 5837: 2012 Category | Recommendations |
|---|---|---|---|---|---|---|---|---|---|---|---|---|---|---|---|---|
| T004 | Horse chestnut<br><i>Aesculus hippocastanum</i> | M | 40-80 | 23 | 1150 | 5 | 8 | 7.5 | 6 | 6.5 | Dense epicormic and ivy <i>Hedera helix</i> on the main stem up to 4 m, which obscures tree features and potential defects. Positioned immediately to the rear of retaining structure, with asymmetrical rooting pattern therefore likely. Damage to foliage by horse chestnut leaf miner apparent throughout the crown. Minor deadwood < 100 mm in diameter scattered throughout the crown. | 13.8 | F | G | A2 | Remove the tree |

- 3.1.1.** The rebuilding of the defective section of wall will require removal of the existing (defective) masonry and excavation into the high-level ground. The extent of these excavations is shown in the Calculation Sheet (Ref: SK001 Rev A) and in the **Tree Plan** in **Appendix 3**. Since T004 is situated within the excavation zone required to rebuild the wall, retention of the tree throughout the repairs will unfortunately not be feasible.
- 3.1.2.** G001 also extends into the excavation zone and will therefore require partial removal and/or facilitation pruning.

- 3.2.1.** According to information which is available of the Kirklees Council Website, T004 is subject to a TPO (ID: 14/18/t1). Removal of T004 should therefore only be completed following the submission and approval of an application for works to protected trees by Kirklees Council. It is an offence to carry out works to a protected tree without consent, and such actions may result in enforcement action and prosecution.

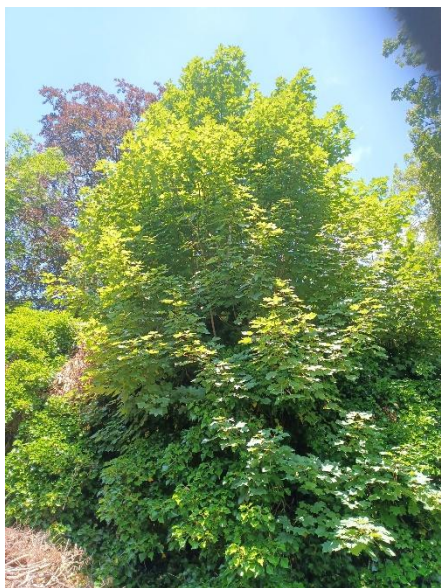
***Plate 5: T005***

| Tree Ref: | Species | Age | SULE | Ht. | DBH | CS | | | | CC | Comments | RPA Radius | PC | SC | BS 5837: 2012 Category | Recommendations |
|---|---|---|---|---|---|---|---|---|---|---|---|---|---|---|---|---|
| T005 | Sycamore<br><i>Acer pseudoplatanus</i> | SM | 40-80 | 10# | 300# | 3# | 3# | 3# | 3# | 5 | Positioned on steep embankment and unable to access the base of the main stem. | 3.6 | G | F | C1 | No works recommended |

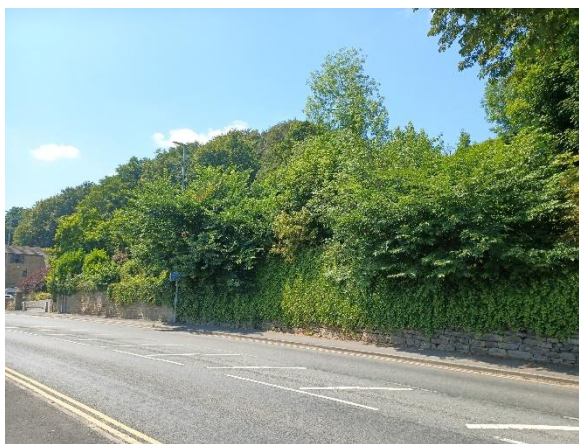
***Plate 6: G001***

| Group Ref: | Species Composition | Age | SULE | Mx. Ht. | Mx. DBH | CC | Comments | PC | SC | BS 5837:2012 Category | Recommendations |
|---|---|---|---|---|---|---|---|---|---|---|---|
| G001 | Sycamore<br><i>Acer pseudoplatanus</i><br>Horse chestnut<br><i>Aesculus hippocastanum</i><br>Common dogwood<br><i>Cornus sanguinea</i><br>Common hawthorn<br><i>Crataegus monogyna</i><br>Common ash<br><i>Fraxinus excelsior</i><br>Common holly<br><i>Ilex aquifolium</i><br>Privet<br><i>Ligustrum vulgare</i><br>Laurel cherry<br><i>Prunus laurocerasus</i><br>Goat willow<br><i>Salix caprea</i><br>Wych elm<br><i>Ulmus glabra</i> | Y<br>SM | 20-40 | 5 | 200 | 0 | Dense group of self-seeded trees. No obvious significant defects, though of limited arboricultural merit and lacks the necessary qualities for higher BS 5837 categorisation. | F | F | C1 | Partial removal/facilitation pruning |

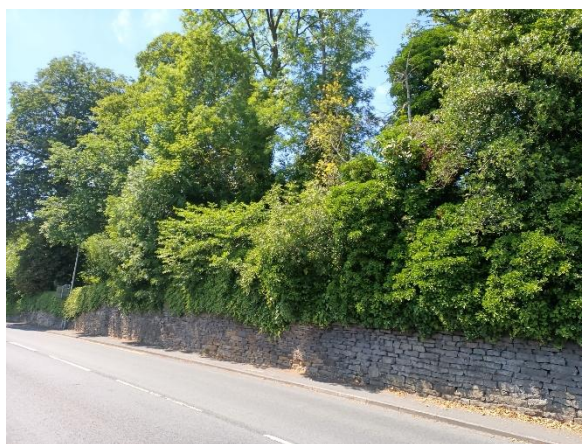
***Plate 7: G002***

| Group Ref: | Species Composition | Age | SULE | Mx. Ht. | Mx. DBH | CC | Comments | PC | SC | BS 5837:2012 Category | Recommendations |
|---|---|---|---|---|---|---|---|---|---|---|---|
| G002 | Sycamore<br><i>Acer pseudoplatanus</i><br>Common hawthorn<br><i>Crataegus monogyna</i><br>Common ash<br><i>Fraxinus excelsior</i><br>Common holly<br><i>Ilex aquifolium</i><br>Laurel cherry<br><i>Prunus laurocerasus</i> | Y<br>SM | 10-20 | 7 | 250 | 3 | Dense group of self-seeded trees. No obvious significant defects, though of limited arboricultural merit and lacks the necessary qualities for higher BS 5837 categorisation. | F | F | C1 | No works recommended |
