# **GOMERSAL ST MARYS PRIMARY SCHOOL**

## **Dilapidation Report (Shirley Road Roundabout)**

Hexa ref: SRP1134-HEX-XX-XX-T-C-0011

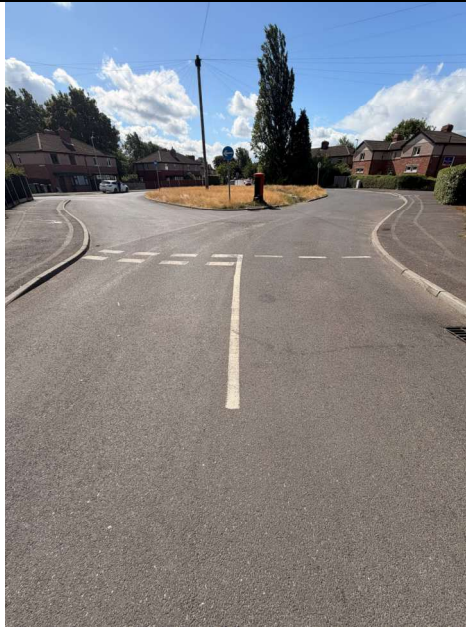
### 2.1

Comments: Junction general photo

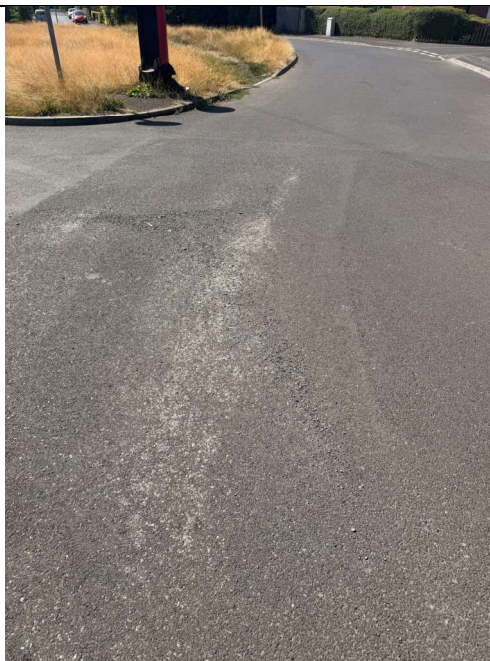
### 2.2

Comments: Road debris, Carriageway surface course polishing

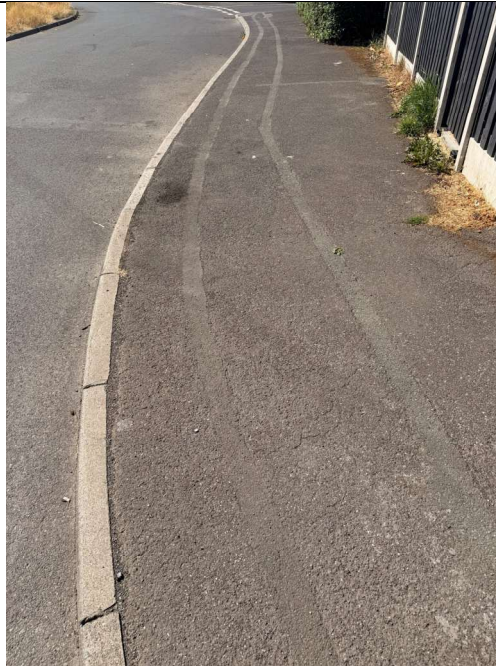
## 2.3

Comments: Damaged Kerbs, surface course cracking, scarring, vegetation growth

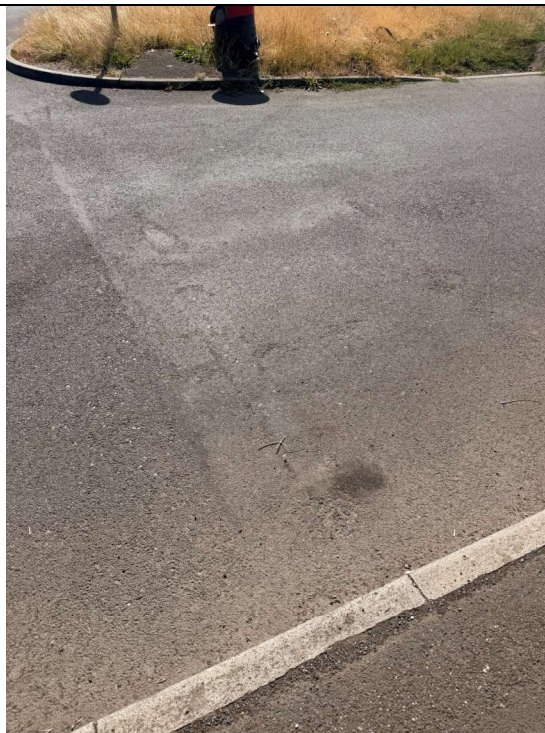
## 2.4

Comments: Carriageway surface course polishing, spillage

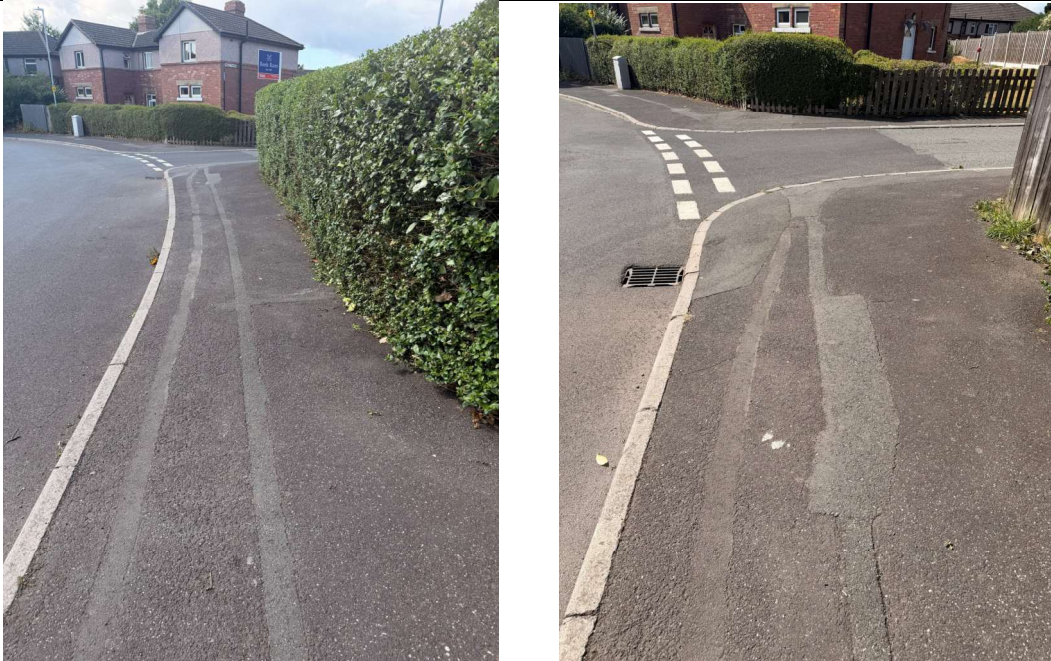
## 2.5

Comments: Damaged Kerbs, surface course cracking, scarring, vegetation growth

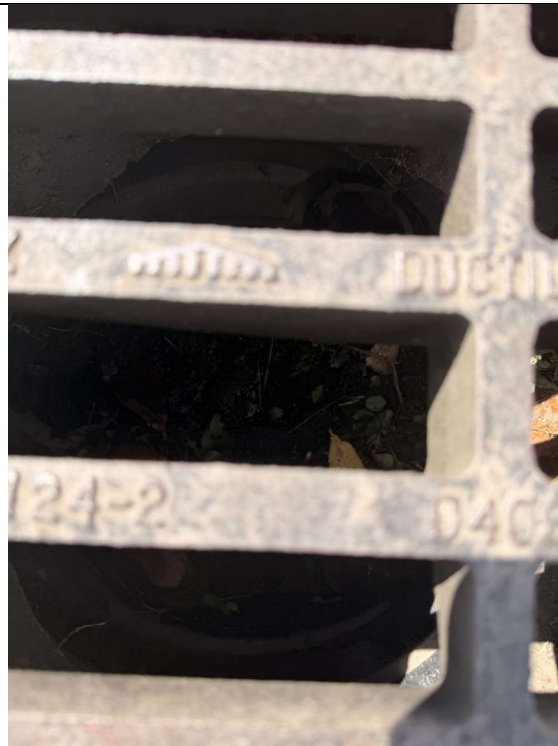
## 2.6

Comments: Gully full of silt – Gully from photo in 2.5

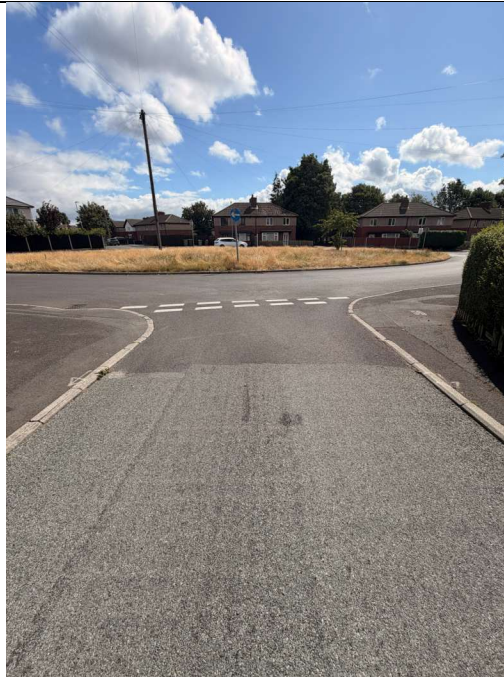
2.7

Comments: General photo – Carriageway material change

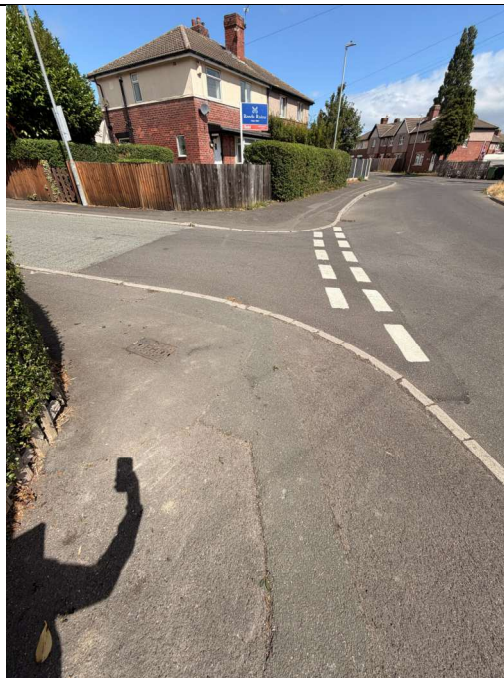
2.8

Comments: Damaged Kerbs, surface course cracking, scarring

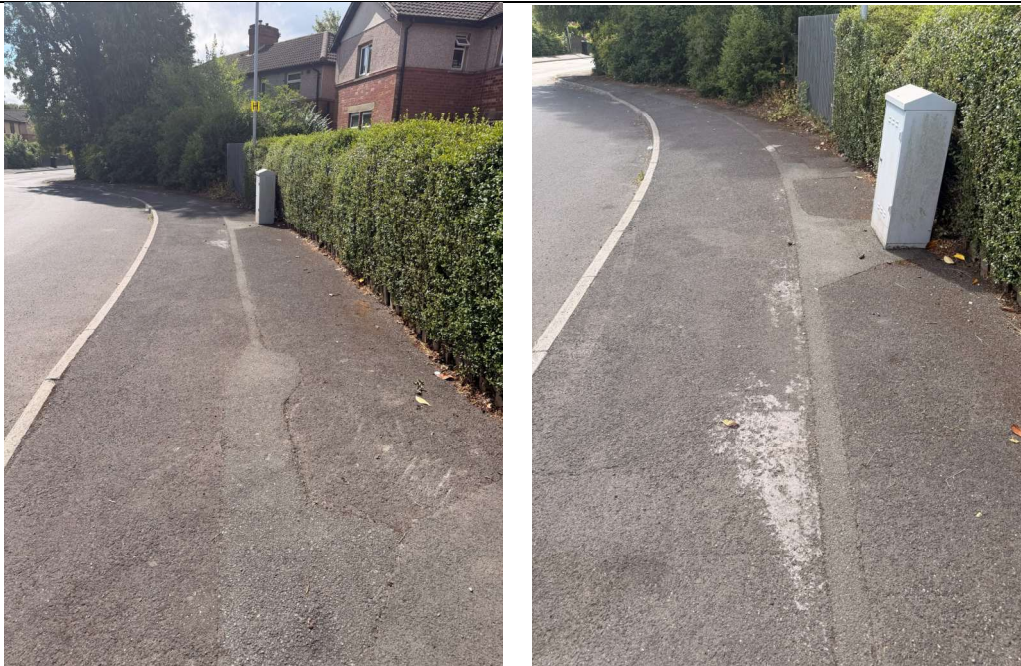
2.9

Comments: Damaged Kerbs, scarring, spillage, vegetation growth

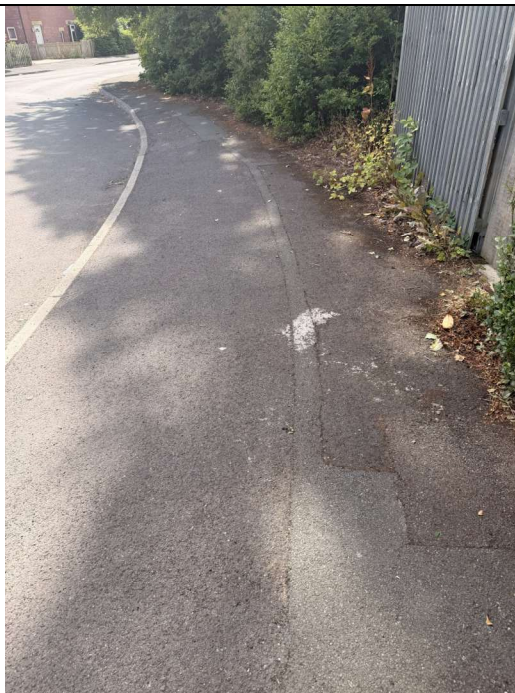
2.10

Comments: Scarring, spillage, vegetation growth

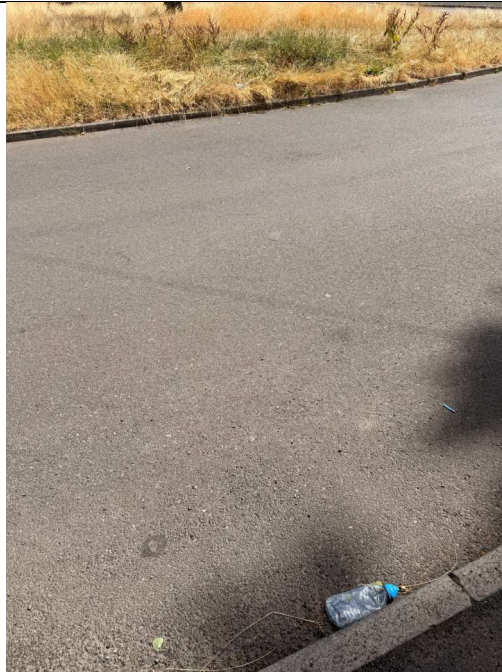
**2.11**

Comments: Spillage on the carriageway

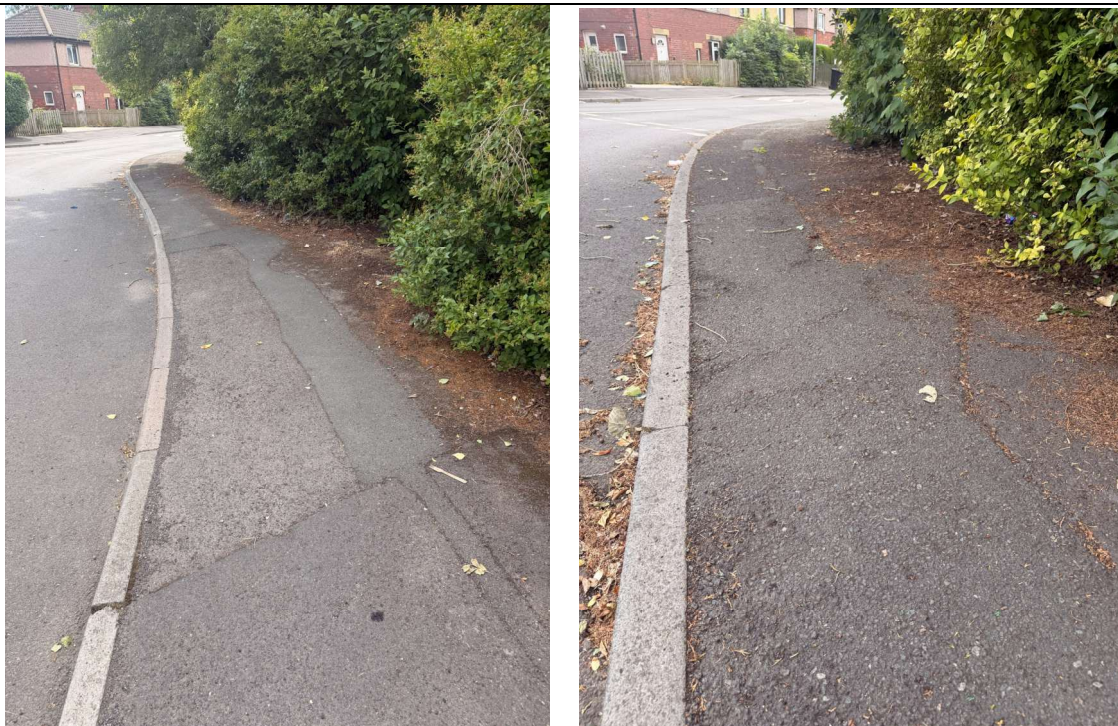
**2.12**

Comments: Damaged Kerbs, Surface course cracking, scarring, spillage, vegetation growth

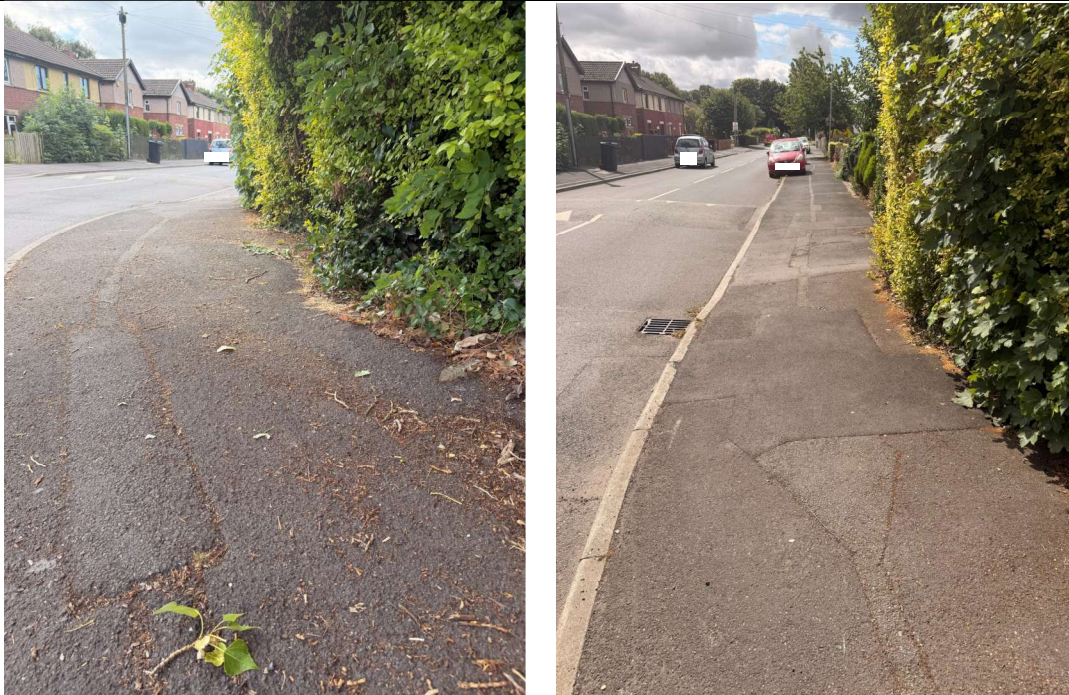
2.13

Comments: Damaged Kerbs, uneven footway, scarring, spillage, vegetation growth

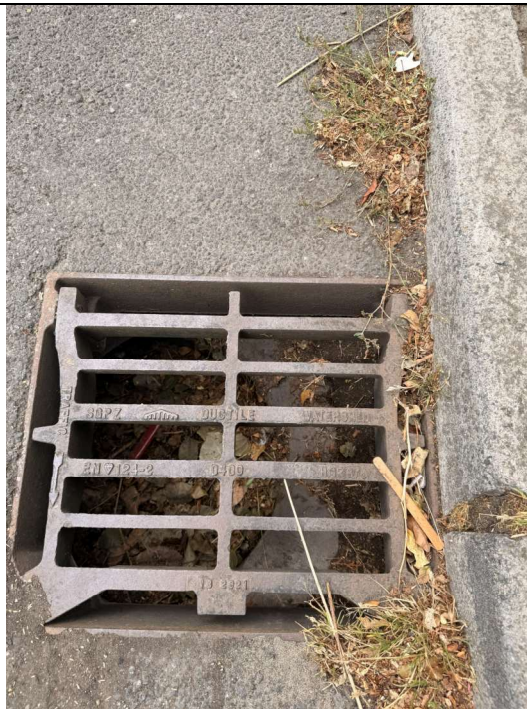
2.14

Comments: Gully full of silt

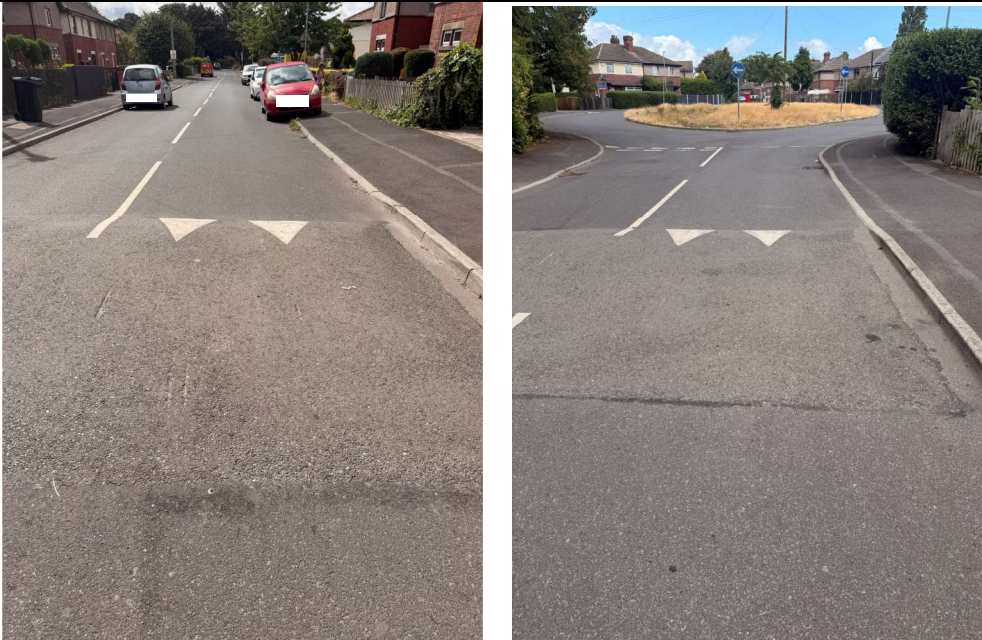
### 3.1

Comments: Damage to speed table surface, spillages

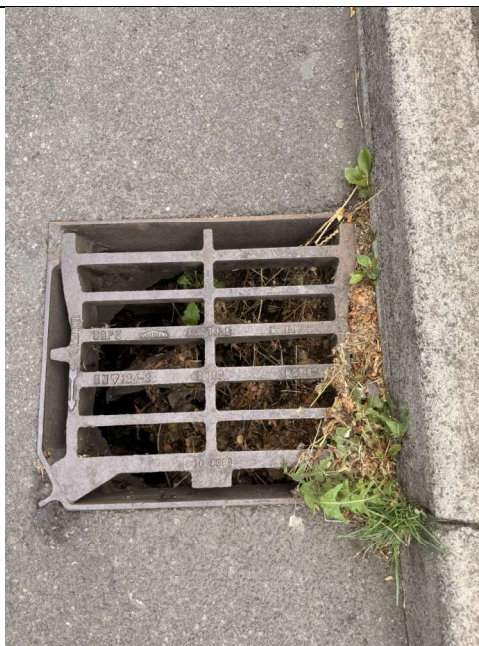
### 3.2

Comments: Gully full of silt

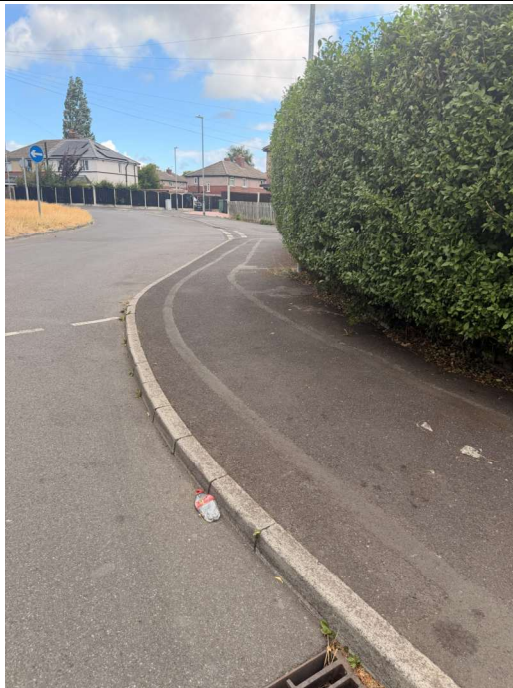
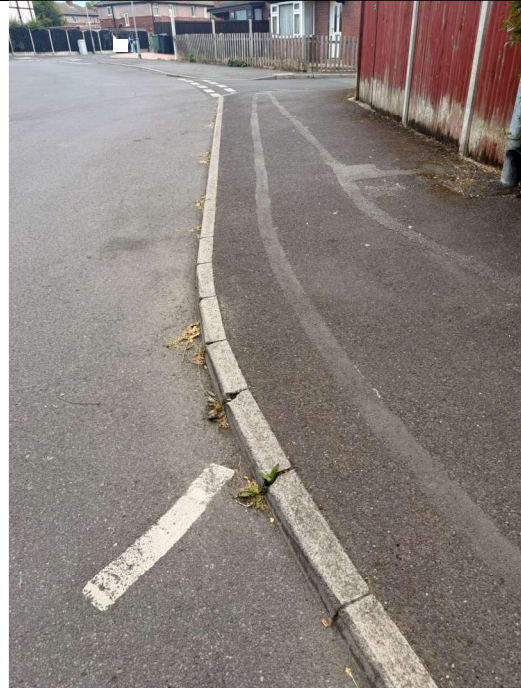
### 3.3

Comments: Damaged Kerbs, scarring, spillage, vegetation growth

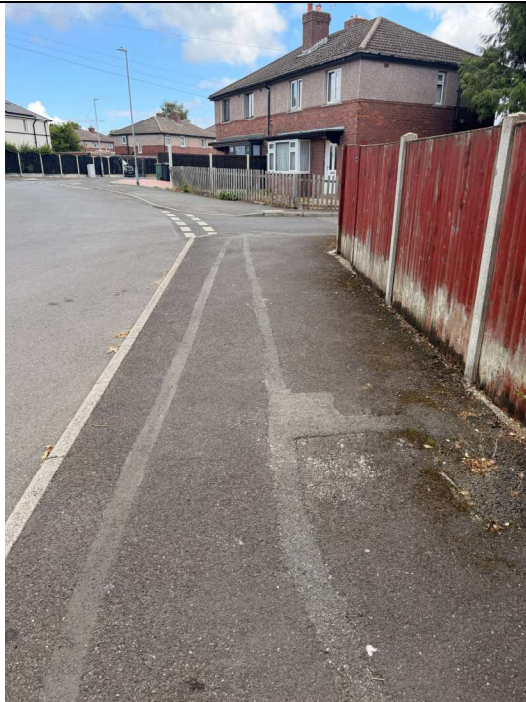
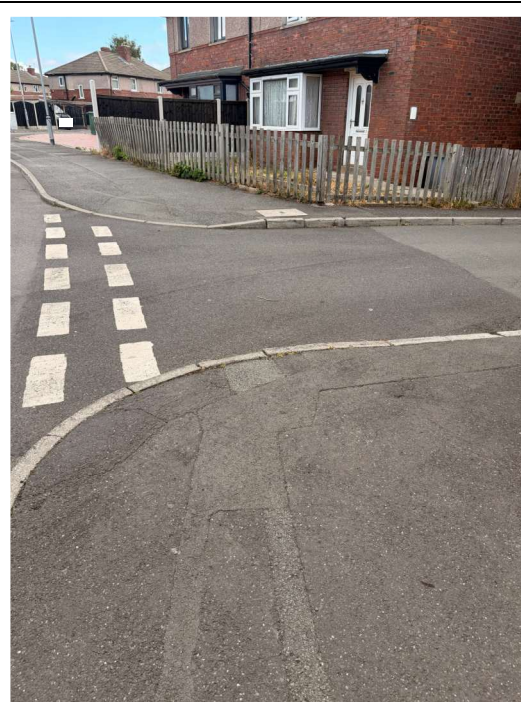
### 3.4

Comments: Damaged Kerbs, scarring, spillage, vegetation growth

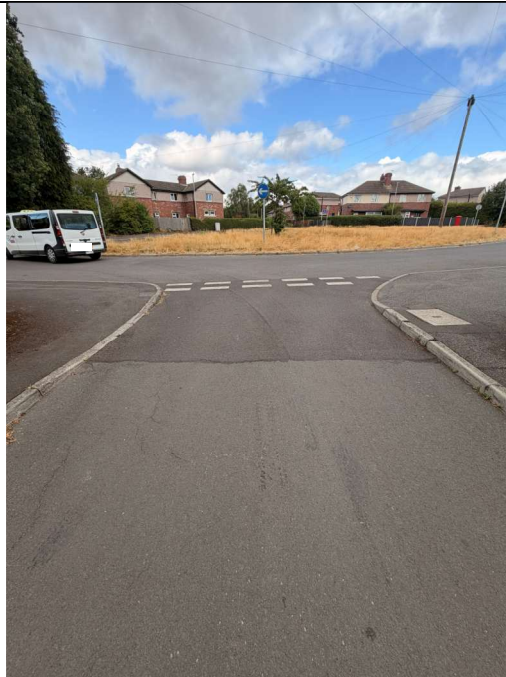
## 3.5

Comments: Carriageway material change, damaged Kerbs

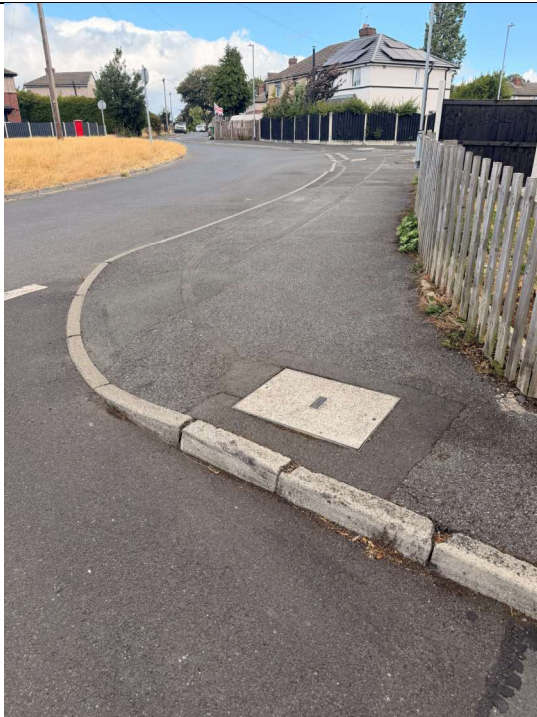
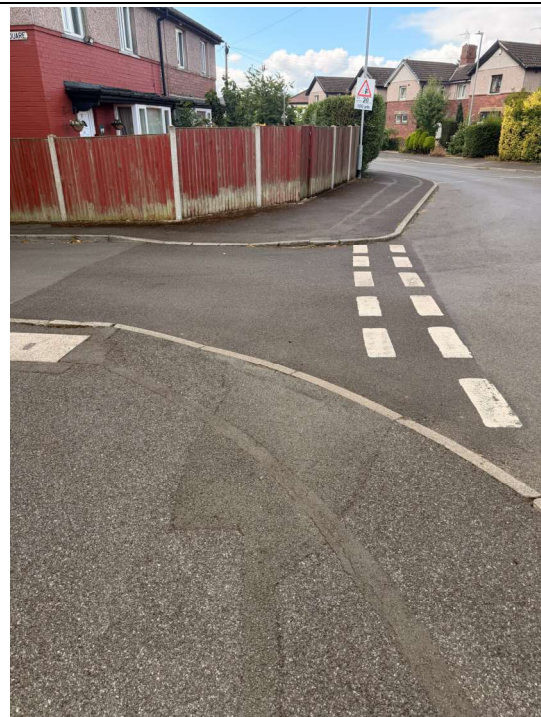
## 3.6

Comments: Damaged Kerbs, scarring, spillage, vegetation growth

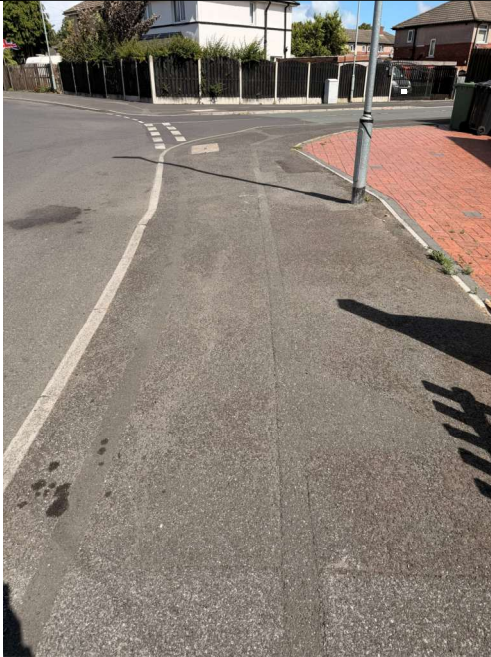
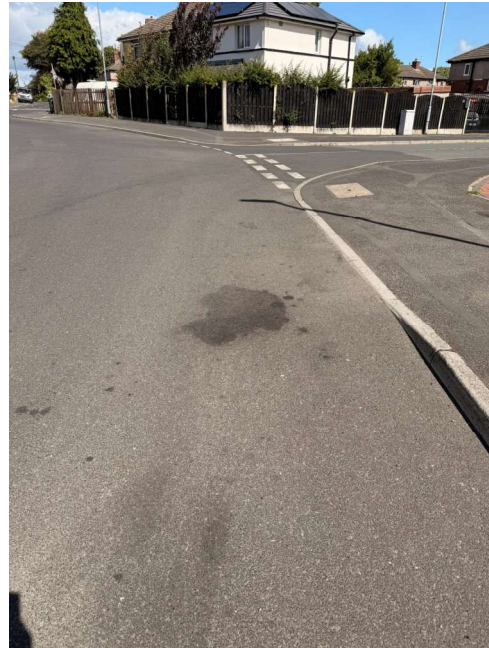
## 3.7

Comments: Damaged Kerbs, scarring, spillage, vegetation growth

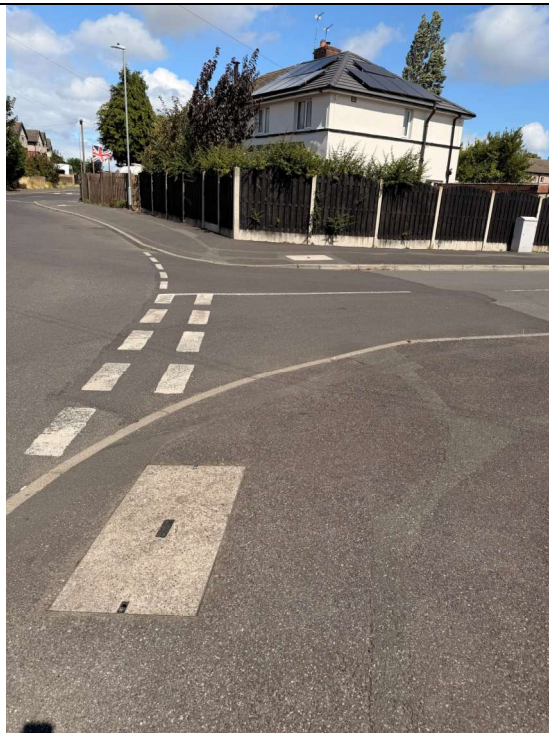
## 3.8

Comments: Damaged Kerbs, scarring, road markings worn

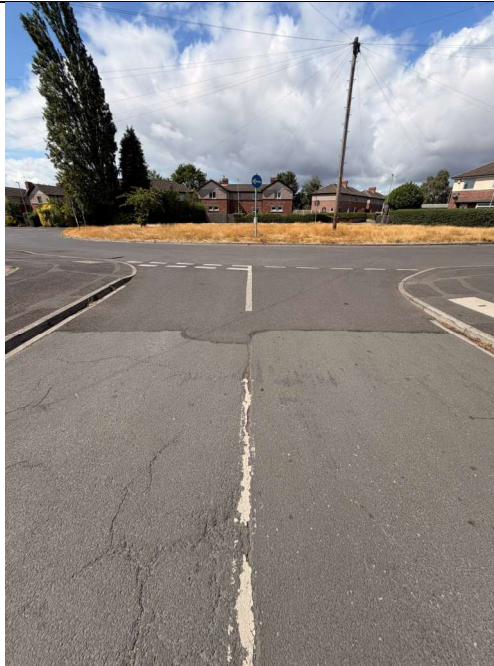
## 3.9

Comments: Damaged Kerbs, scarring, spillage, cracks in the carriageway, vegetation growth

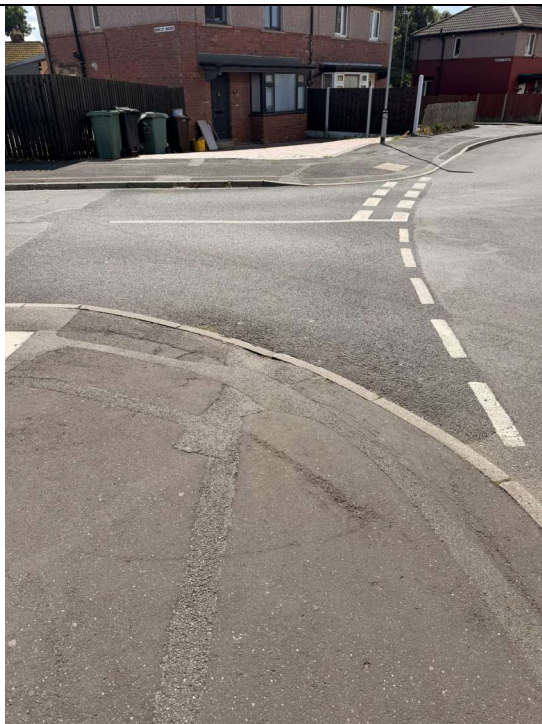
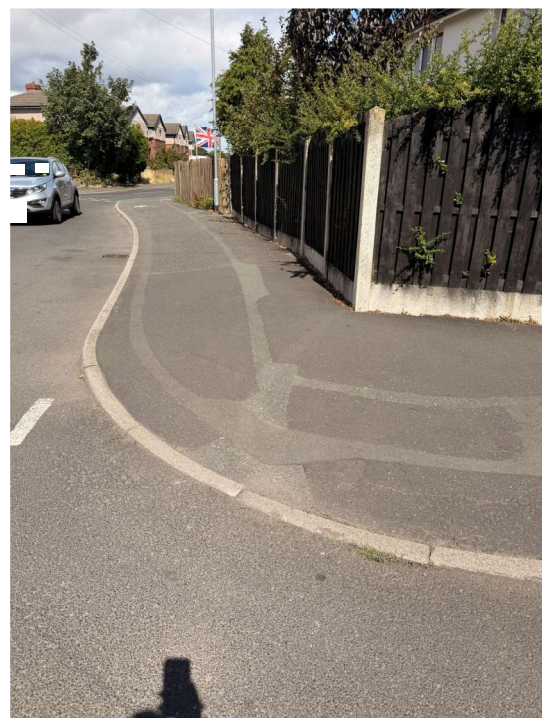
## 3.10

Comments: Damaged and misaligned Kerbs, scarring, spillage, vegetation growth

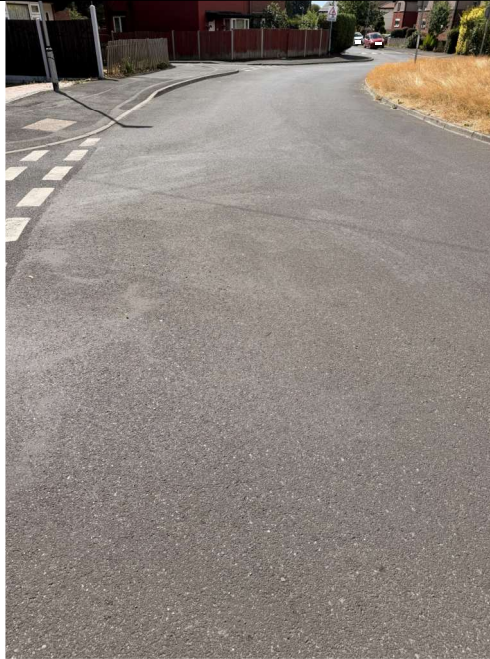
3.11

Comments: Carriageway surface course polishing

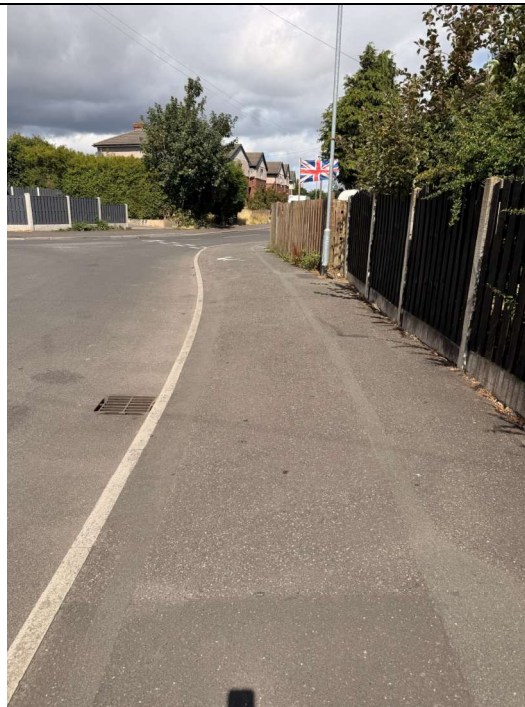
3.12

Comments: Spillage, vegetation growth

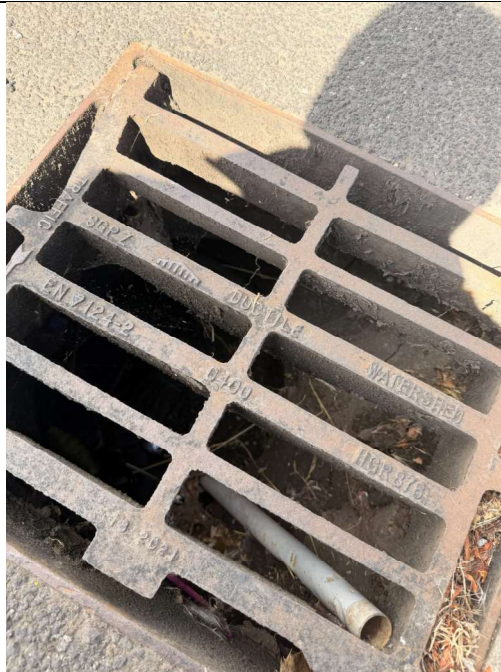
3.13

Comments: Gully full of silt and litter

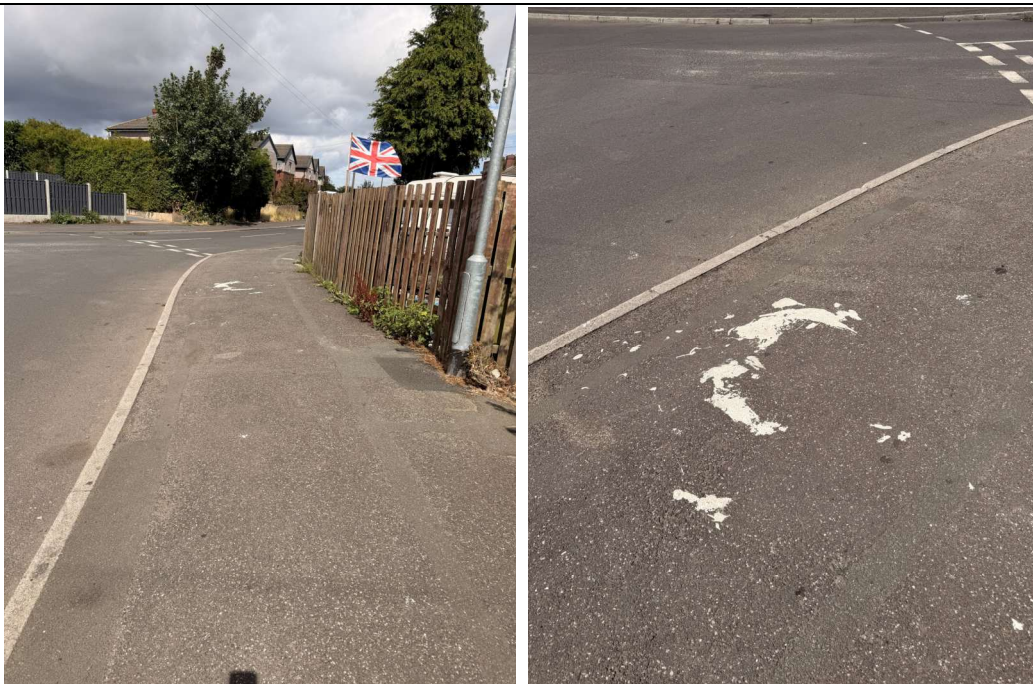
3.14

Comments: Damaged Kerbs, scarring, spillage, vegetation growth

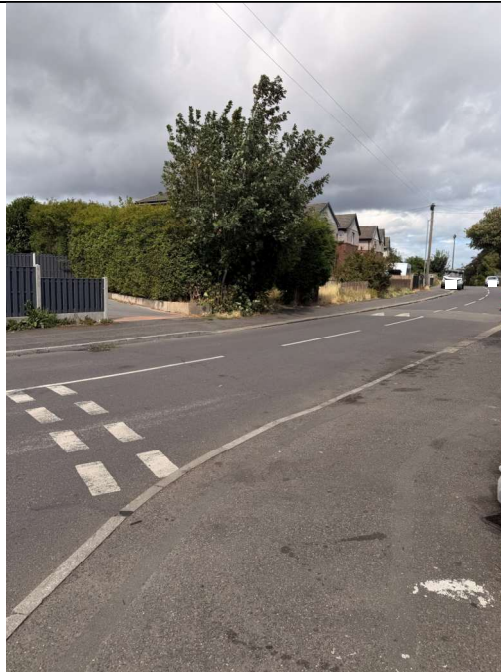
3.15

Comments: Damaged Kerbs, scarring, spillage

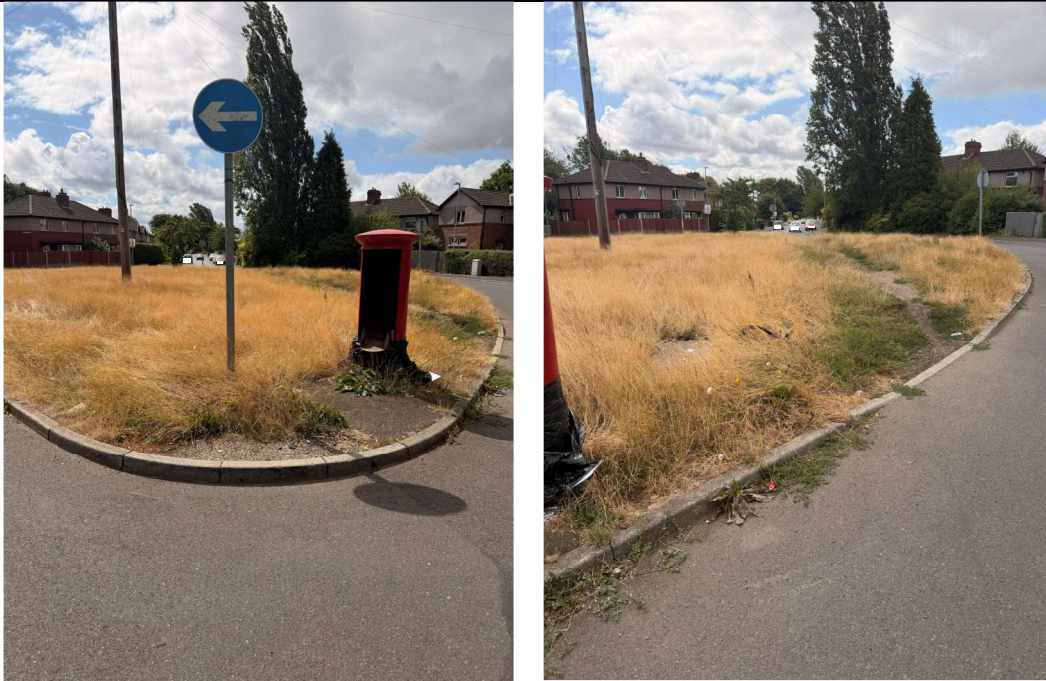
### 4.1

Comments: Damaged Kerbs, spillage, vegetation growth – damage to post box missing door

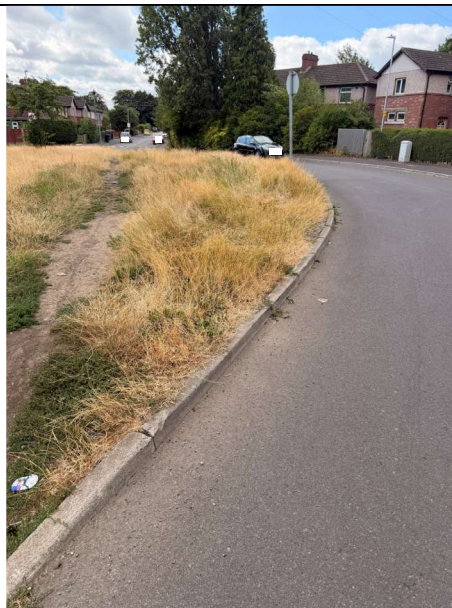
### 4.2

Comments: Damaged Kerbs, vegetation growth

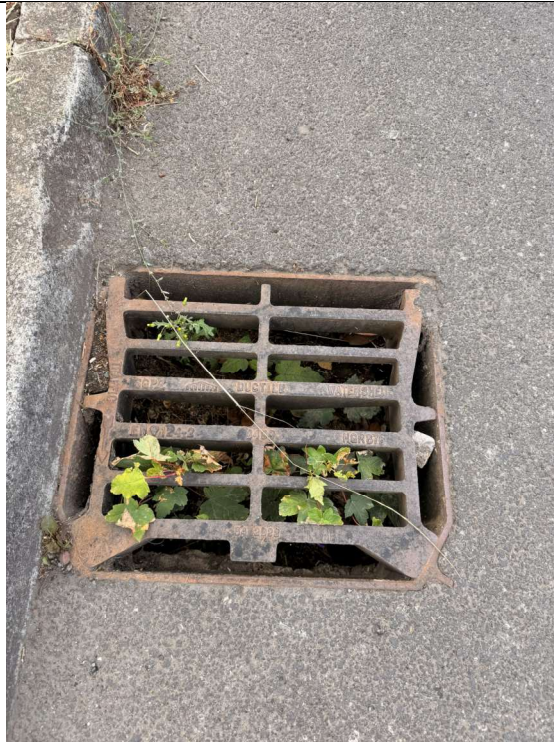
## 4.3

Comments: Gully full of silt and vegetation

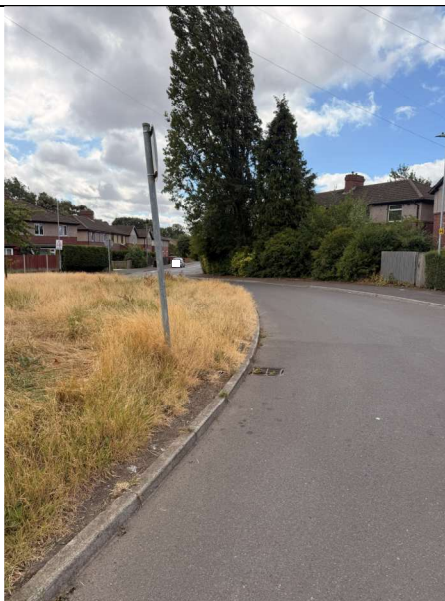
## 4.4

Comments: Road sign is leaning

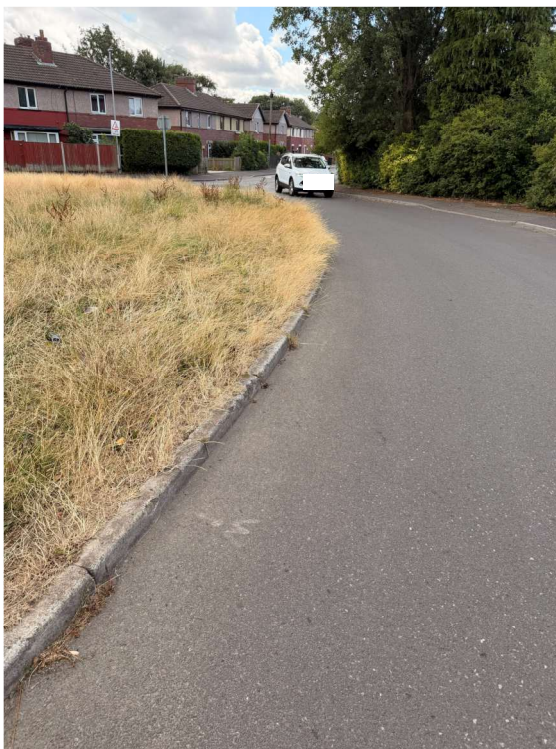
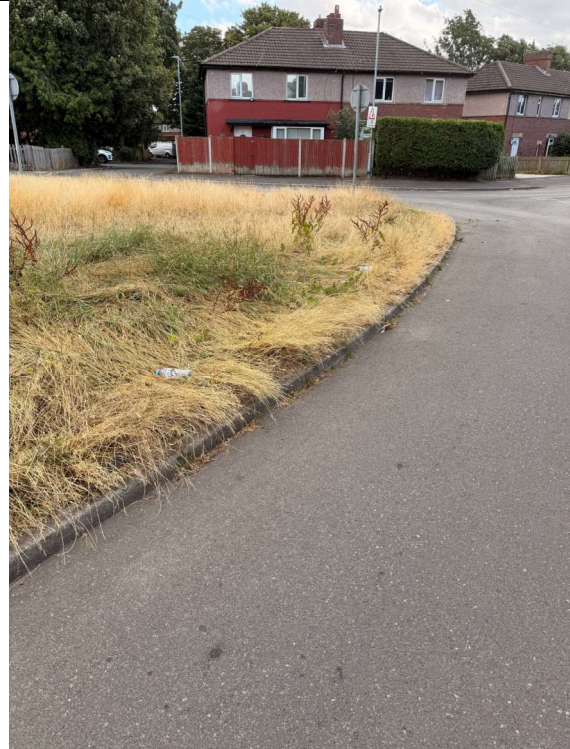
## 4.5

Comments: Damaged Kerbs, spillages, vegetation growth

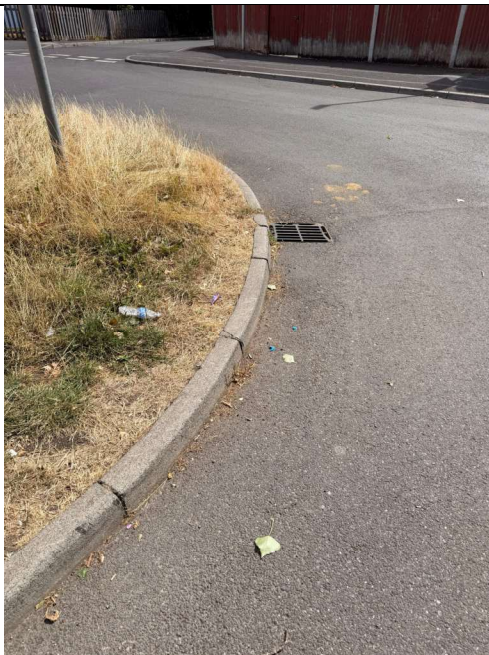
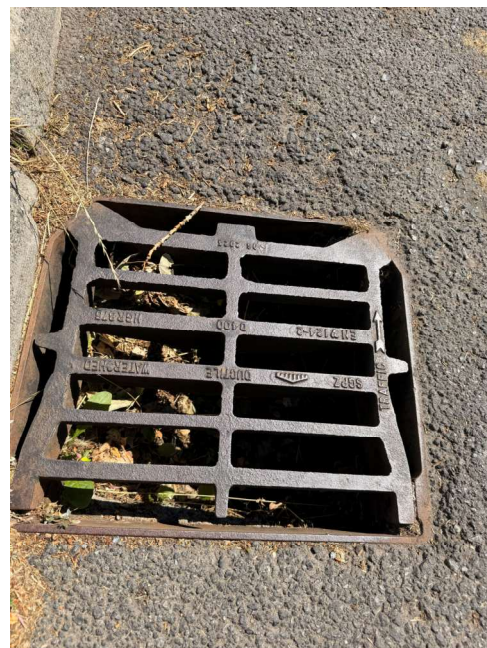
## 4.6

Comments: Damaged Kerbs, vegetation growth – Gully full of silt

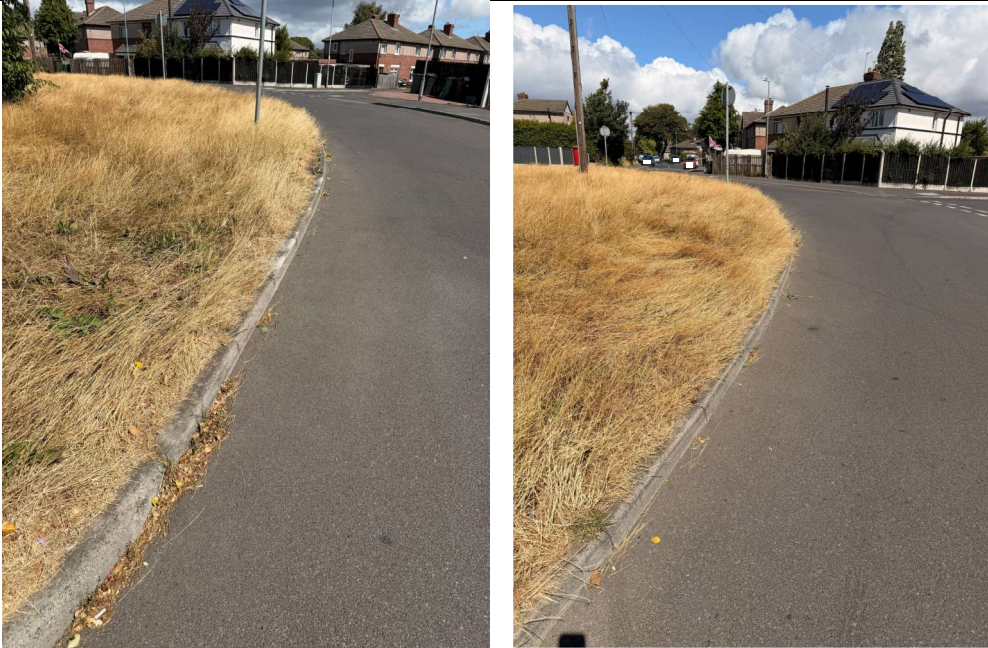
4.7

Comments: Damaged Kerbs, spillages

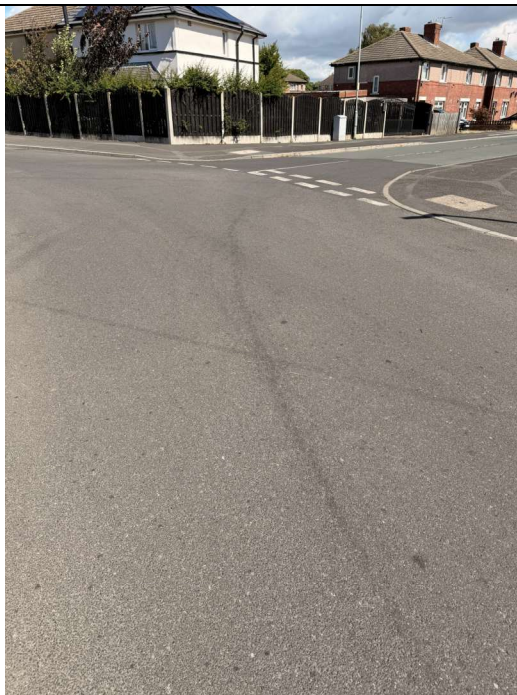
4.8

Comments: Spillages

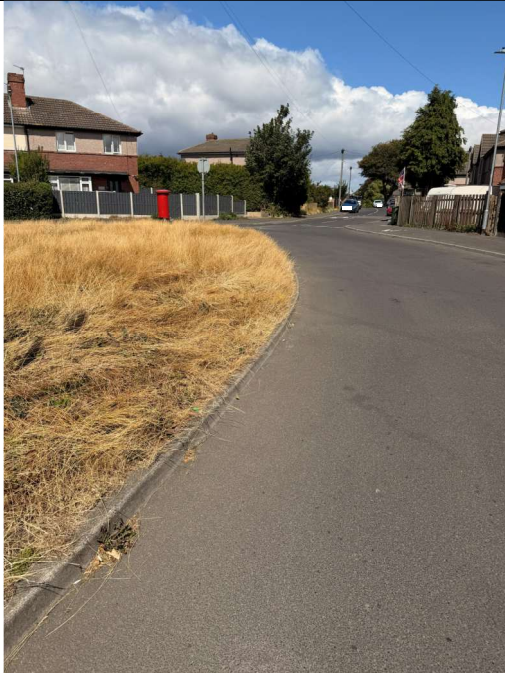
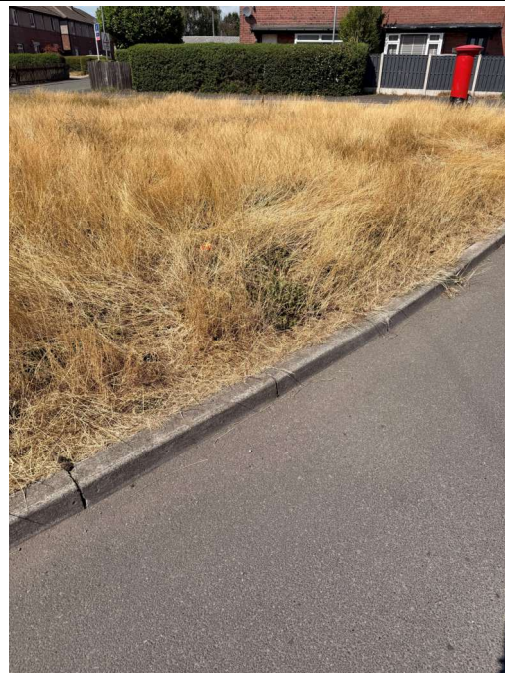
4.9

Comments: Damaged Kerbs, spillages

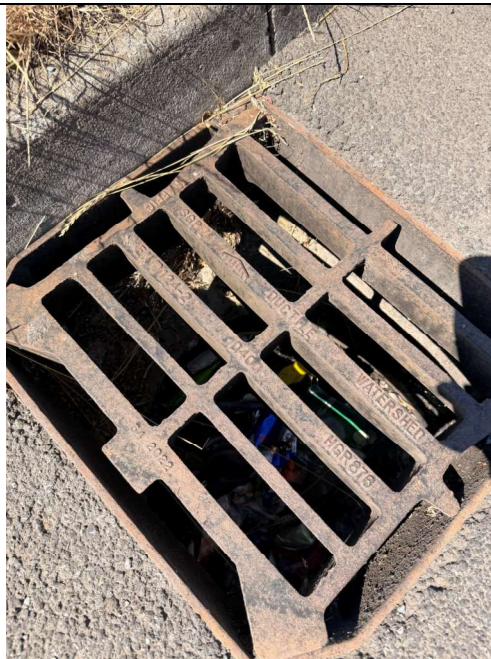
4.10

Comments: Gully full of silt

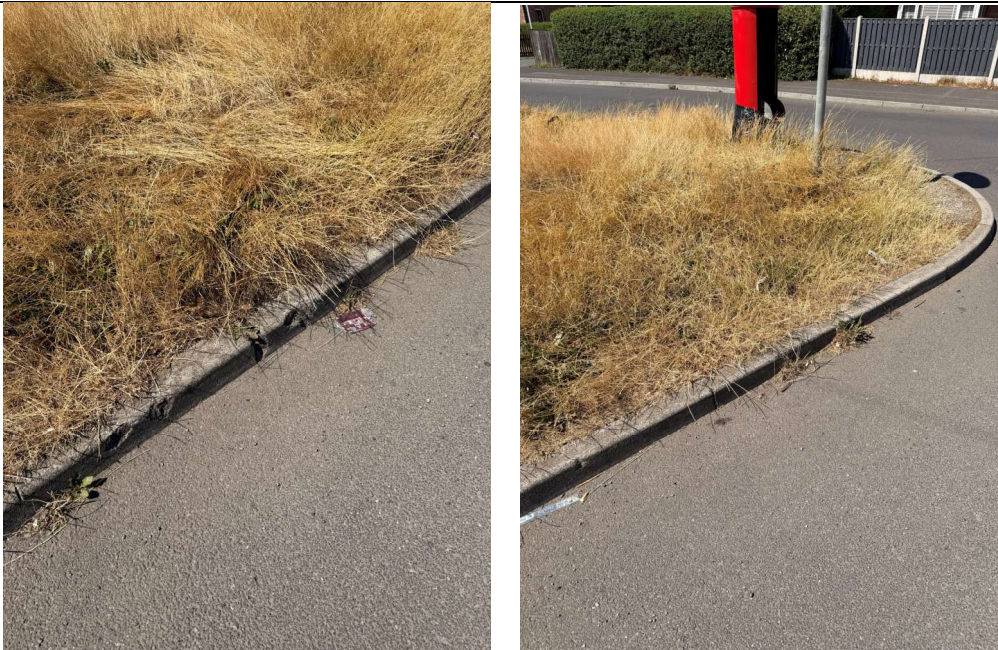
4.11

Comments: Damaged Kerbs
