**Project**

**Project Name:** P26-00188 ST MARYS PS\_ GOMERSAL  
**Project Description:** ST. MARY'S P.S. GOMERSAL  
**Project Number:** P26-00188  
**Project Status:** Complete  
**Project Date:** 20/03/2026  
**Inspection Standard:** MSCC5 Sewers & Drainage GB (SRM5 Scoring)

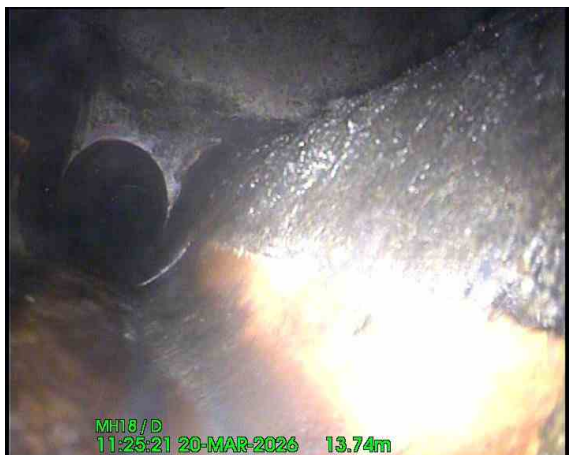
1, 00:01:06, 13.74 m  
Finish node, manhole, reference: OS8X

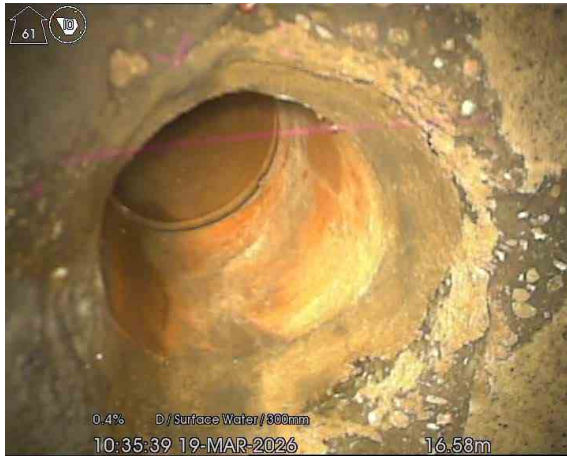
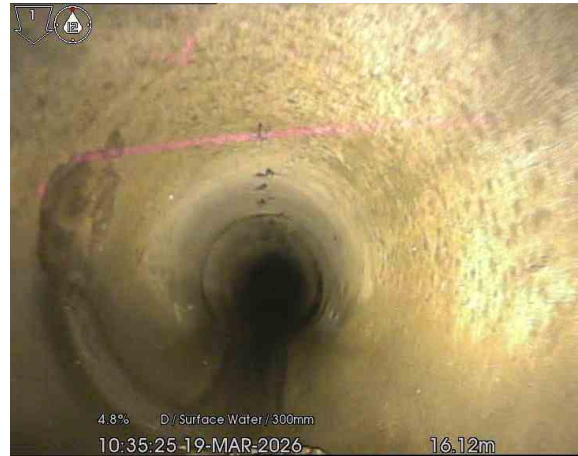
1, 00:01:15, 16.12 m  
Junction at 9 o'clock, 100mm dia

2, 00:01:15, 16.12 m  
Junction at 9 o'clock, 100mm dia

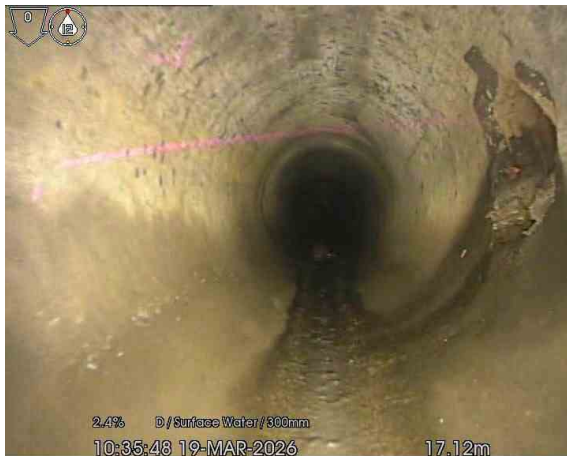
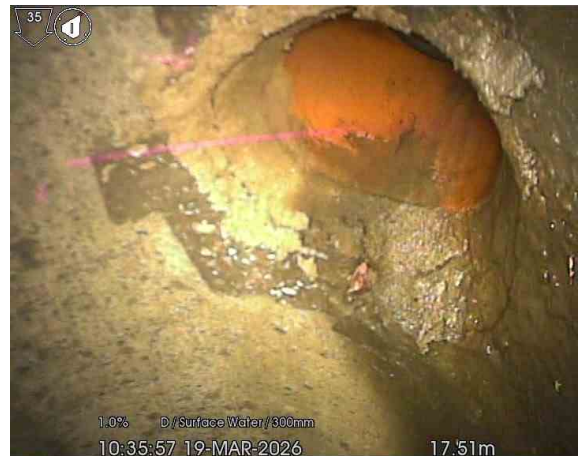
3, 00:01:38, 17.12 m  
Junction at 3 o'clock, 100mm dia

4, 00:01:38, 17.12 m  
Junction at 3 o'clock, 100mm dia

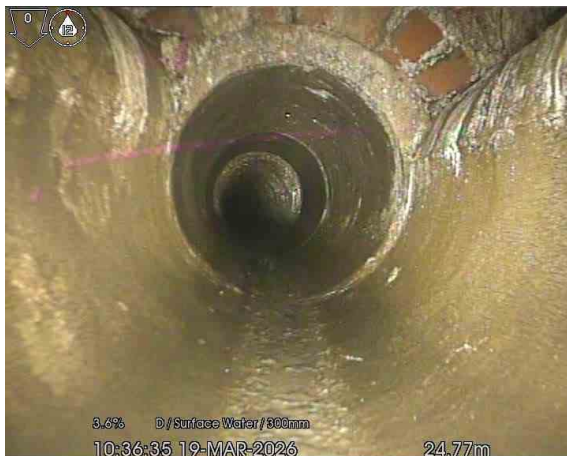
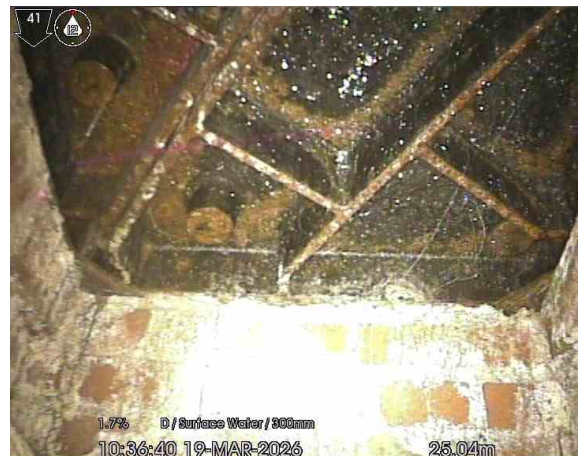
| <b>Comments:</b> | PIPE X. UNABLE TO MEASURE / SURVEY MH3 - COVER BURIED | | | | |

5, 00:02:25, 24.77 m  
Finish node, manhole, reference: MH3, COVER BURIED

6, 00:02:25, 24.77 m  
Finish node, manhole, reference: MH3, COVER BURIED

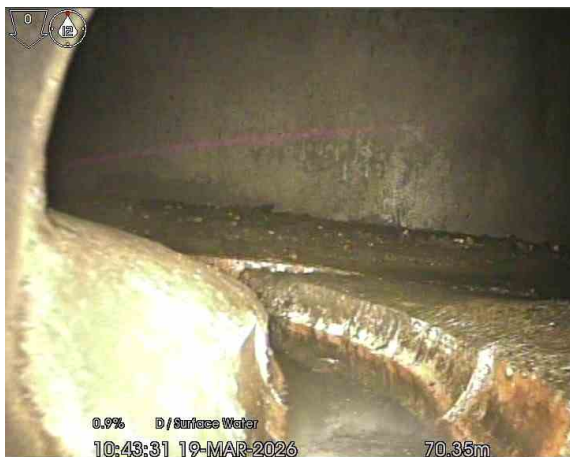
| Scale: 1:610 | Position [m] | Code | Observation | MPEG | Photo | Grade |
|---|---|---|---|---|---|---|
| | 70.35 | F02 | DER Settled deposits, coarse, 10% cross-sectional area loss, finish | 00:05:24 | | 3 |

1, 00:05:24, 70.35 m  
General photograph taken at this point, PIPE ENTERING  
CHAMBER

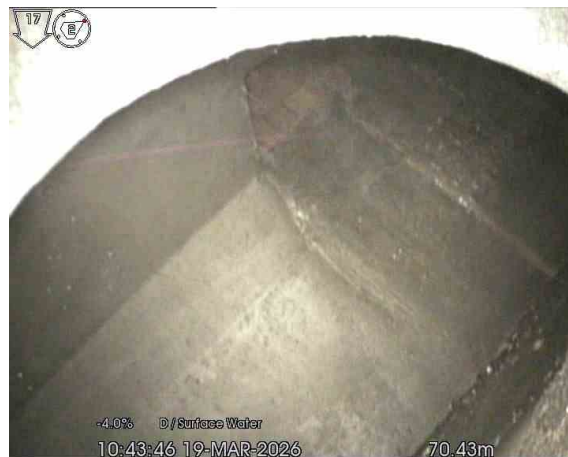
2, 00:05:25, 70.43 m  
Finish node, manhole, reference: SW7J, ATTENUATION  
TANK

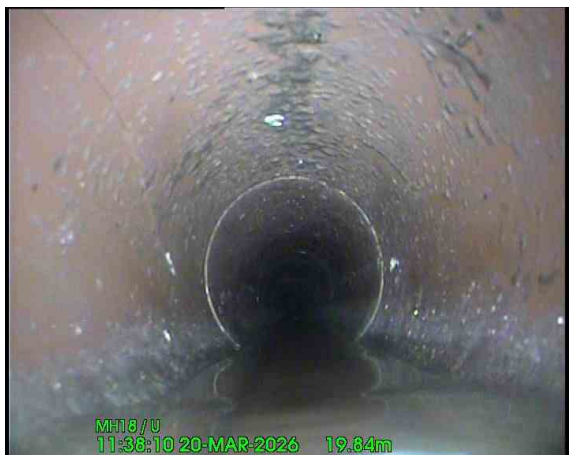
| Item No. | PLR | Grade | Description |
|---|---|---|---|
| 4 | FW7X | 4 | Fracture, spiral from 7 o'clock to 10 o'clock |

| Scale: | 1:248 | Position [m] | Code | Observation | MPEG | Photo | Grade |
|---|---|---|---|---|---|---|---|
| | 19.78 | FS | | Fracture, spiral from 7 o'clock to 10 o'clock | 00:02:04 | | 4 / 2 |

1, 00:02:04, 19.78 m  
Fracture, spiral from 7 o'clock to 10 o'clock

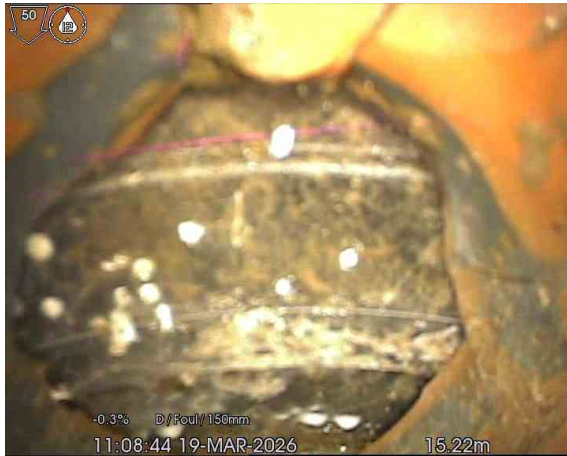
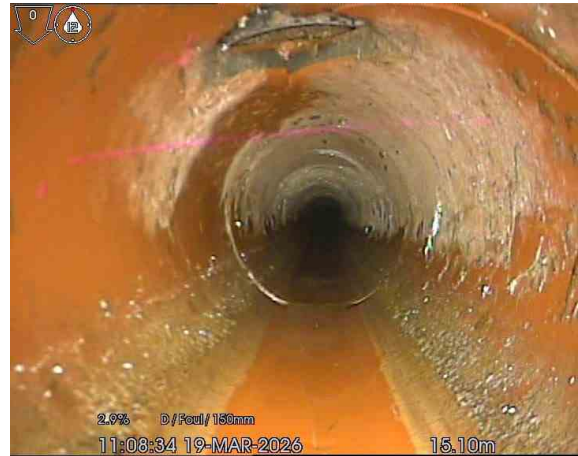
| Item No. | PLR | Grade | Description |
|---|---|---|---|
| 5 | MH2X | 4 | Hole in drain or sewer from 11 o'clock to 1 o'clock |

1, 00:01:51, 15.10 m  
Hole in drain or sewer from 11 o'clock to 1 o'clock

2, 00:01:51, 15.10 m  
Hole in drain or sewer from 11 o'clock to 1 o'clock

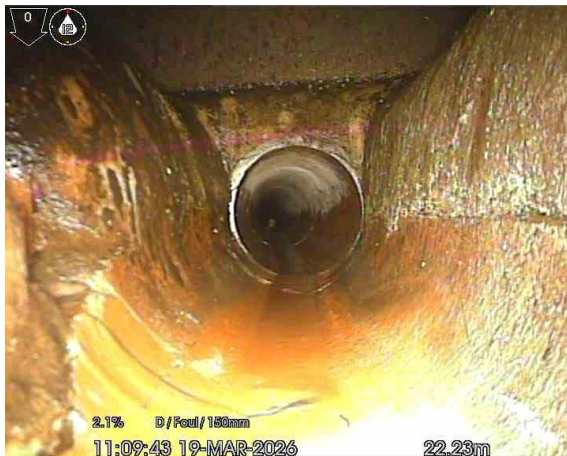
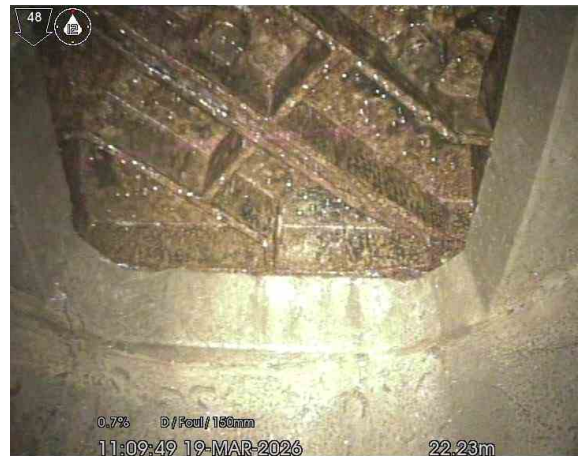
3, 00:03:15, 22.23 m  
Finish node, manhole, reference: MH4, UTM - COVER BURIED

4, 00:03:15, 22.23 m  
Finish node, manhole, reference: MH4, UTM - COVER BURIED

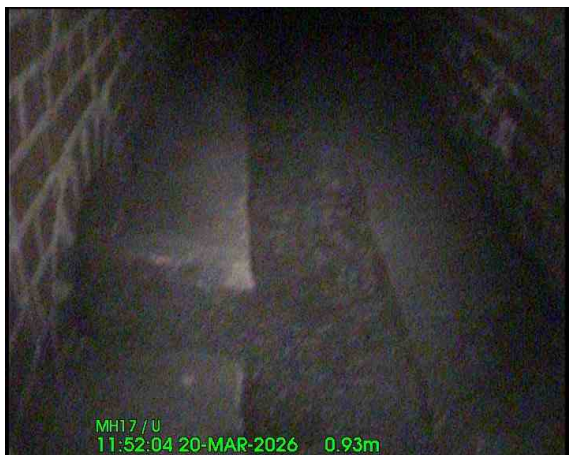
| Item No. | PLR | Grade | Description |
|---|---|---|---|
| 6 | SW7X | 5 | Settled deposits, fine, 95% cross-sectional area loss |

| <b>Comments:</b> | PIPE X. SMALLER U-SHAPED CHANNEL 300w X 150h - UNABLE TO SURVEY DUE TO SILT | | | | |

1, 00:00:25, 0.00 m  
Survey abandoned, SMALL CHANNEL FULLLY SILTED -  
UNABLE TO SURVEY

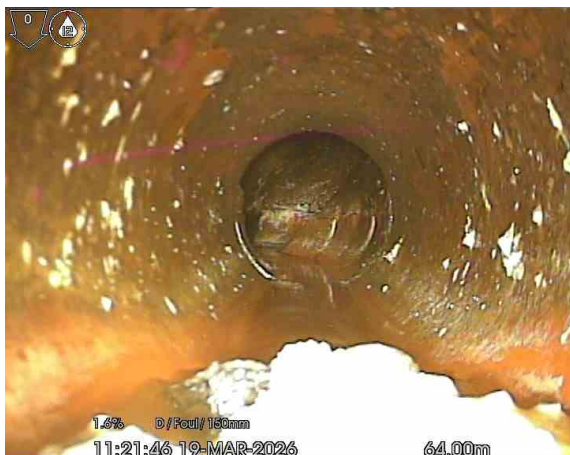
1, 00:09:38, 64.00 m

General remark, CHAMBER VISIBLE IN DISTANCE

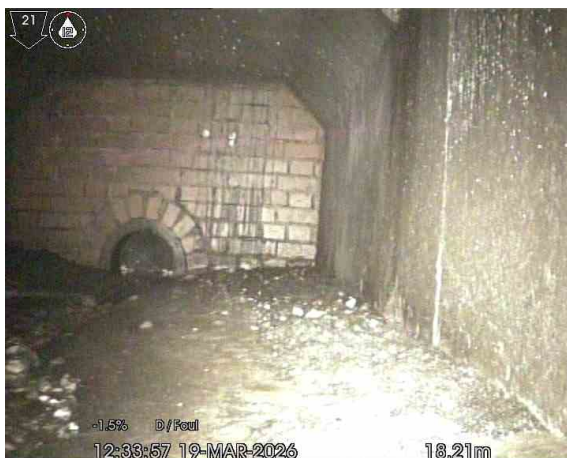
5, 00:04:40, 18.21 m

General photograph taken at this point, SMALL CHANNEL FULLY SILTED - UNABLE TO SURVEY

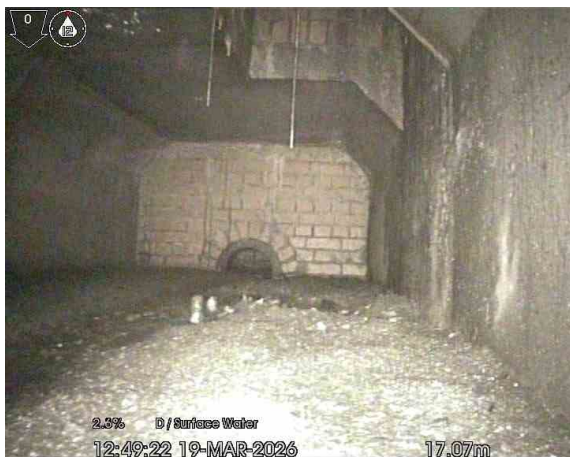
7, 00:03:00, 17.07 m

General photograph taken at this point, SHAFT OF SW7I AT  
 TOP OF PICTURE. PIPE SW7IX VISIBLE AHEAD

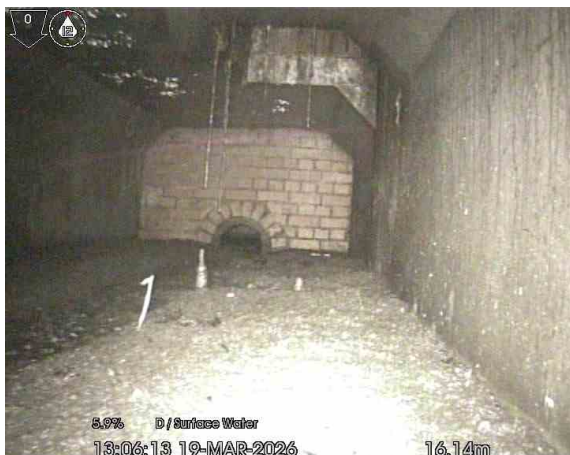
7, 00:02:15, 16.14 m

General photograph taken at this point, SW7H SHAFT AT TOP  
OF PICTURE, SW7H PIPE X AHEAD

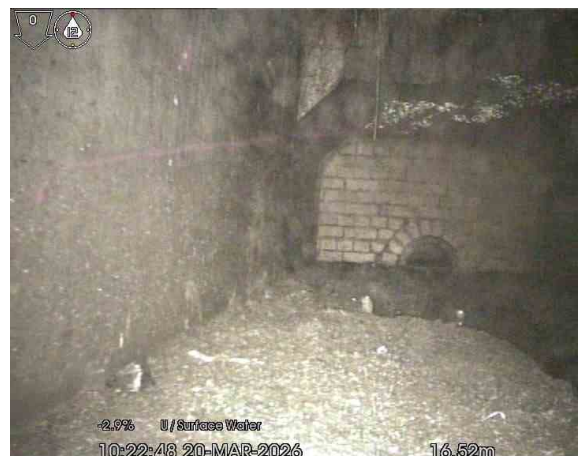
6, 00:02:47, 17.52 m

General photograph taken at this point, SHAFT OF SW7G  
 TOP OF PICTURE, PIPE SW7GX AHEAD
