Report No: 20574/NB

December 2016

**20574 COMPLETION REPORT**  
**for the**  
**REMEDIATION & PREPERATORY WORKS**  
**of land at**  
**Batley Fire Station**

**prepared for**  
**Riva Homes**

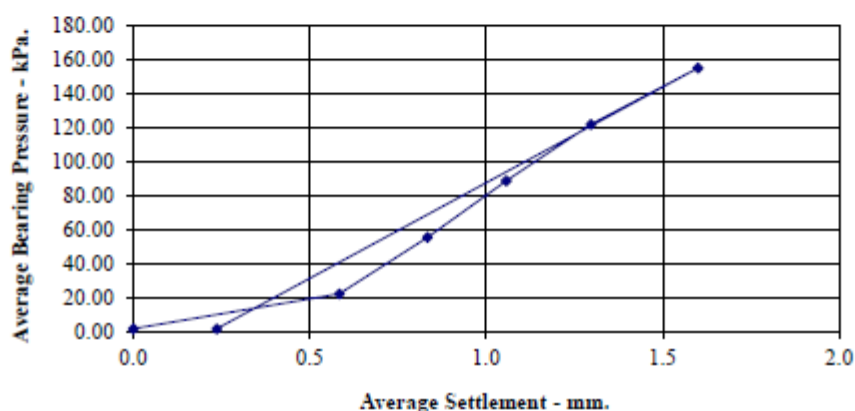
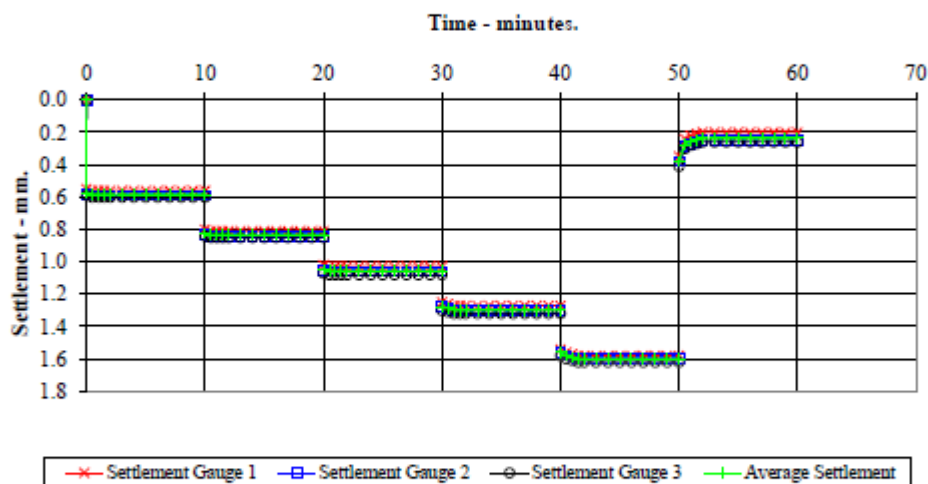
Test Position: Access Road 1

| CBR Value | 17.2 | % |

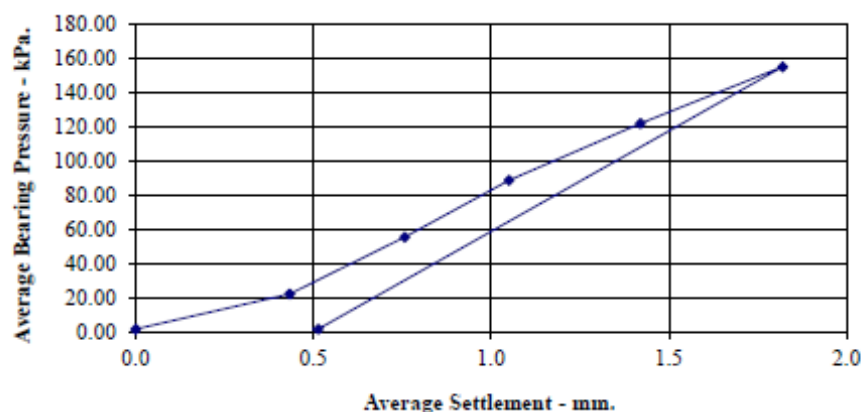
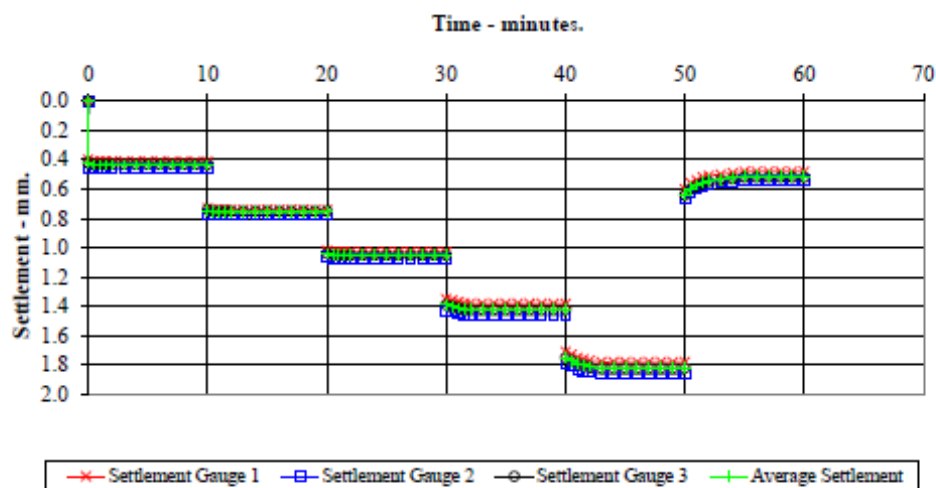
Test Position: Access Road 2

| CBR Value | 14.9 % |

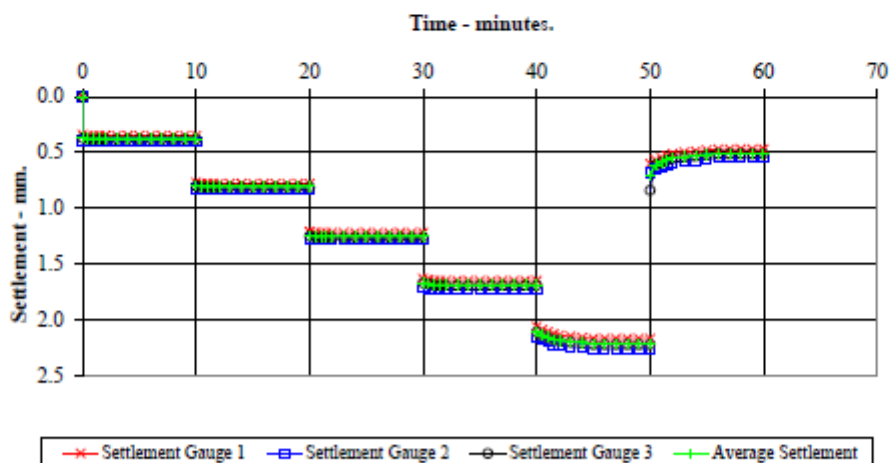
Test Position: Access Road 3

| CBR Value | 10.8 % |

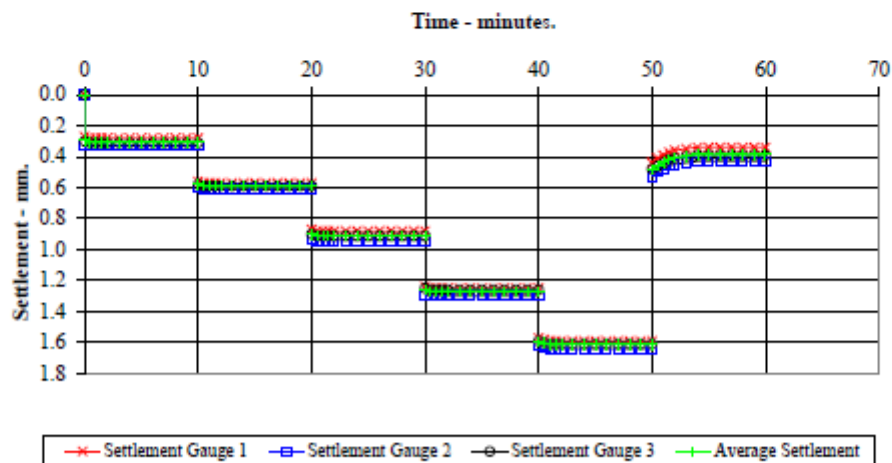
Test Position: Access Road 4

| Test ID | CBR % |
|---|---|
| Access Road 4 | 18.2 |
