**Phase 1, Phase 2 and Phase 3 Report (combined) &  
Revised Coal Mining Risk Assessment**

43 Bridle Street, Batley

| Project Number | 20615 |
| Report Number | 001 |

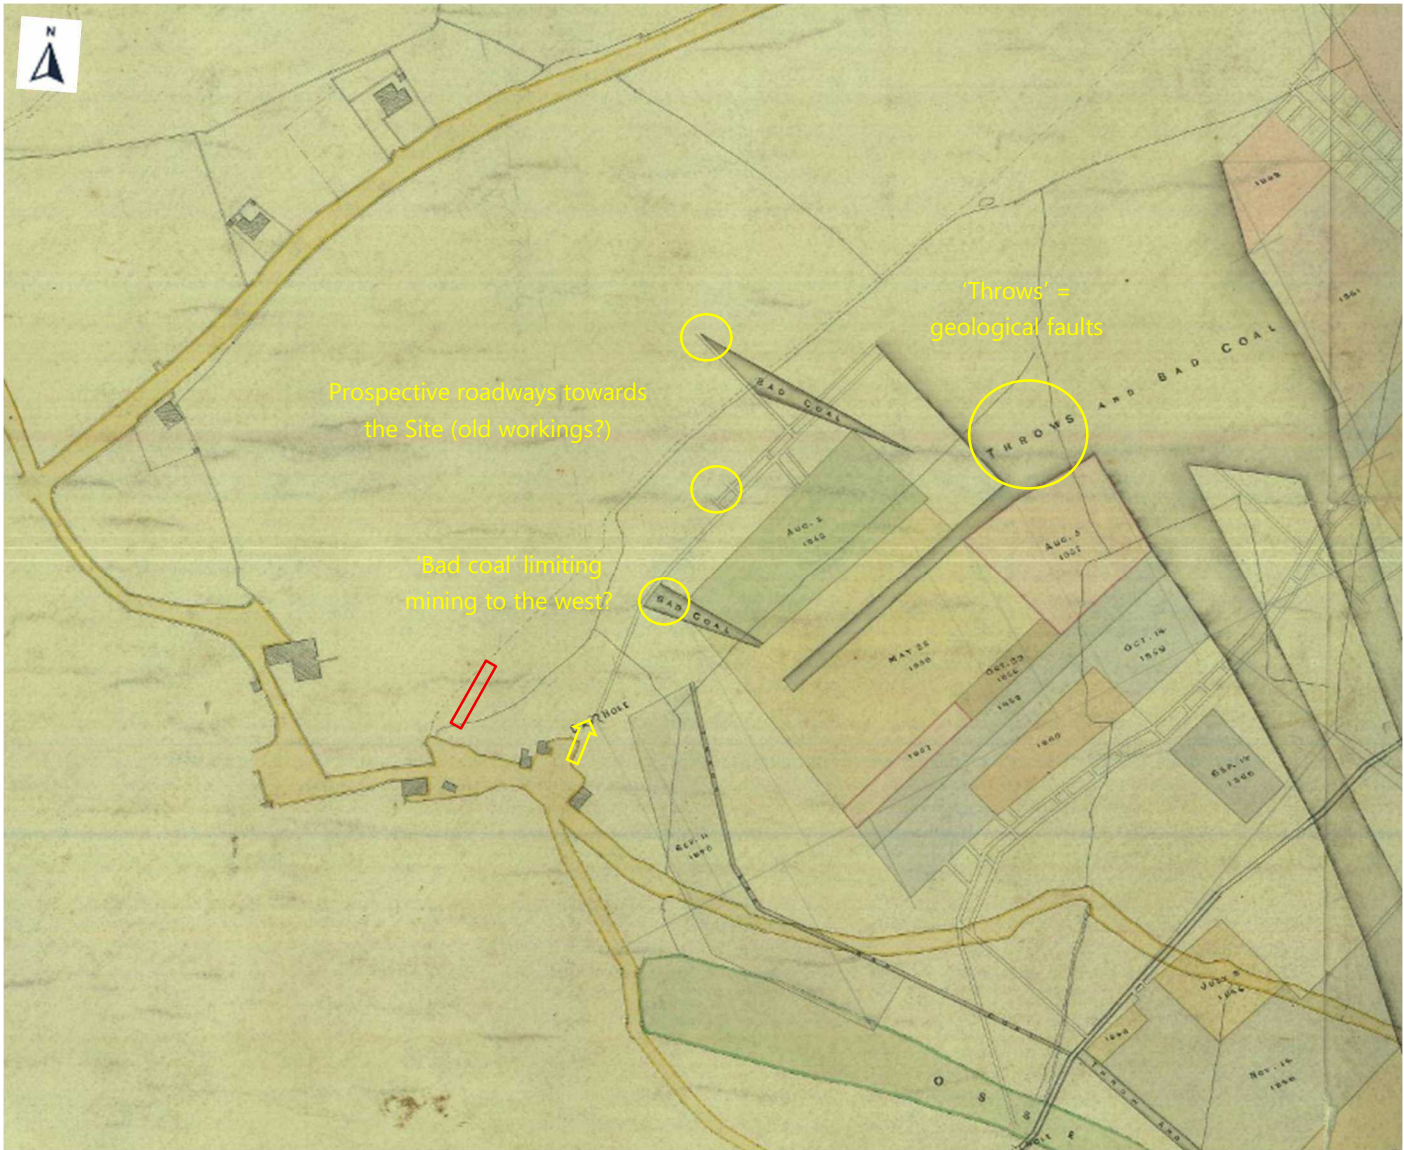
Figure 4: Extract from Soothills, Babes and Chideswell mine abandonment plan (21891161)

- > Reproduced under Open Government License (v 3.0)
- > Red line = approximate Site boundary
- > Yellow arrow = local adit (horizontal tunnel into mine workings) with bearing indicated – as illustrated on Figure 4
- > Yellow circles = key features

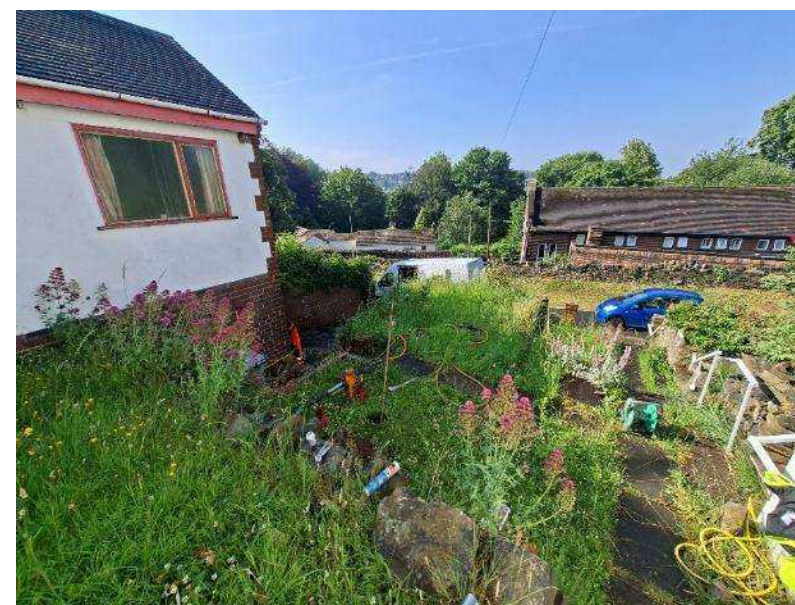
**Photograph 1:** General presentation of the Site looking south towards Bridle Street – RO101 in foreground

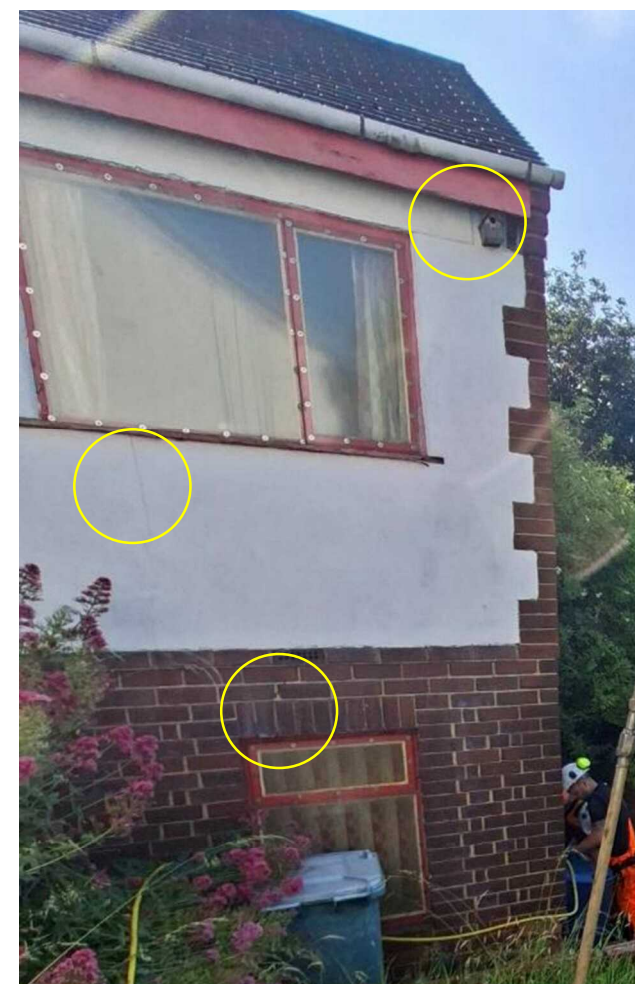
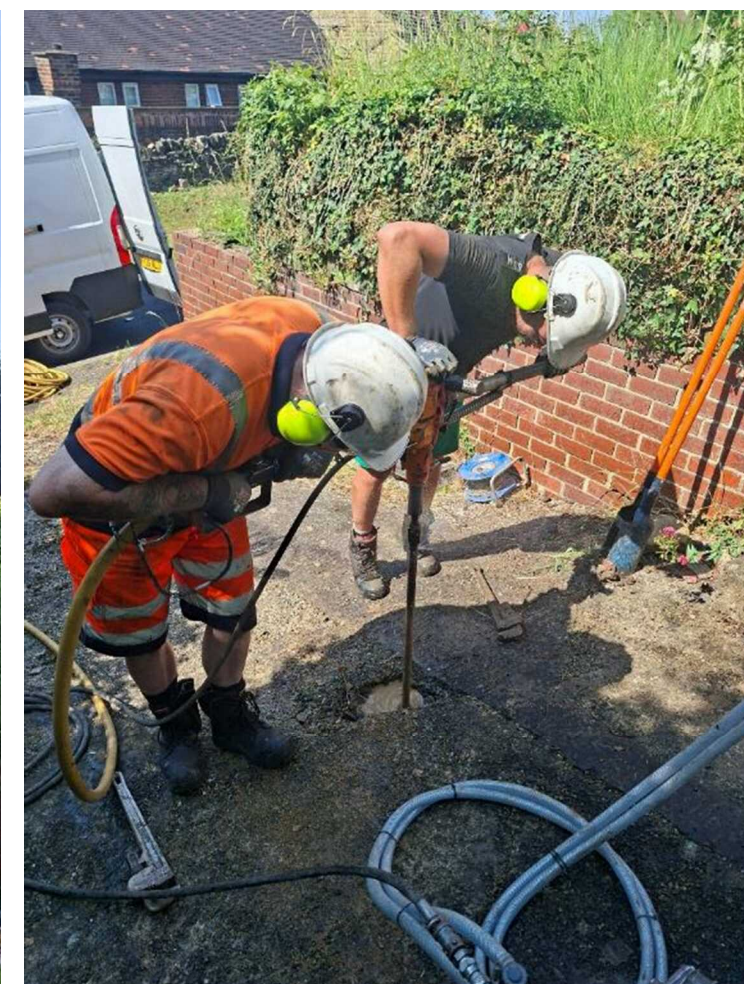
- No evidence of potentially harmful or polluting material on Site, e.g. chemical stores, suspected asbestos containing material or former fire pits.
- The existing structure (two storey) was inspected (by the Author of this Report) with evidence of minor cracking on the western elevation – Photograph 2 – that might be associated with ground movement (subsidence), N.B. this observation does not constitute a structural survey and should be treated only as a potential indicator that ground movement has occurred historically.
- No evidence of uneven ground surfaces on Site, or locally to the Site, that might otherwise suggest shallow voiding is present.

**Photograph 2:** General presentation of existing structure with minor cracking circled in yellow + drilling RO102

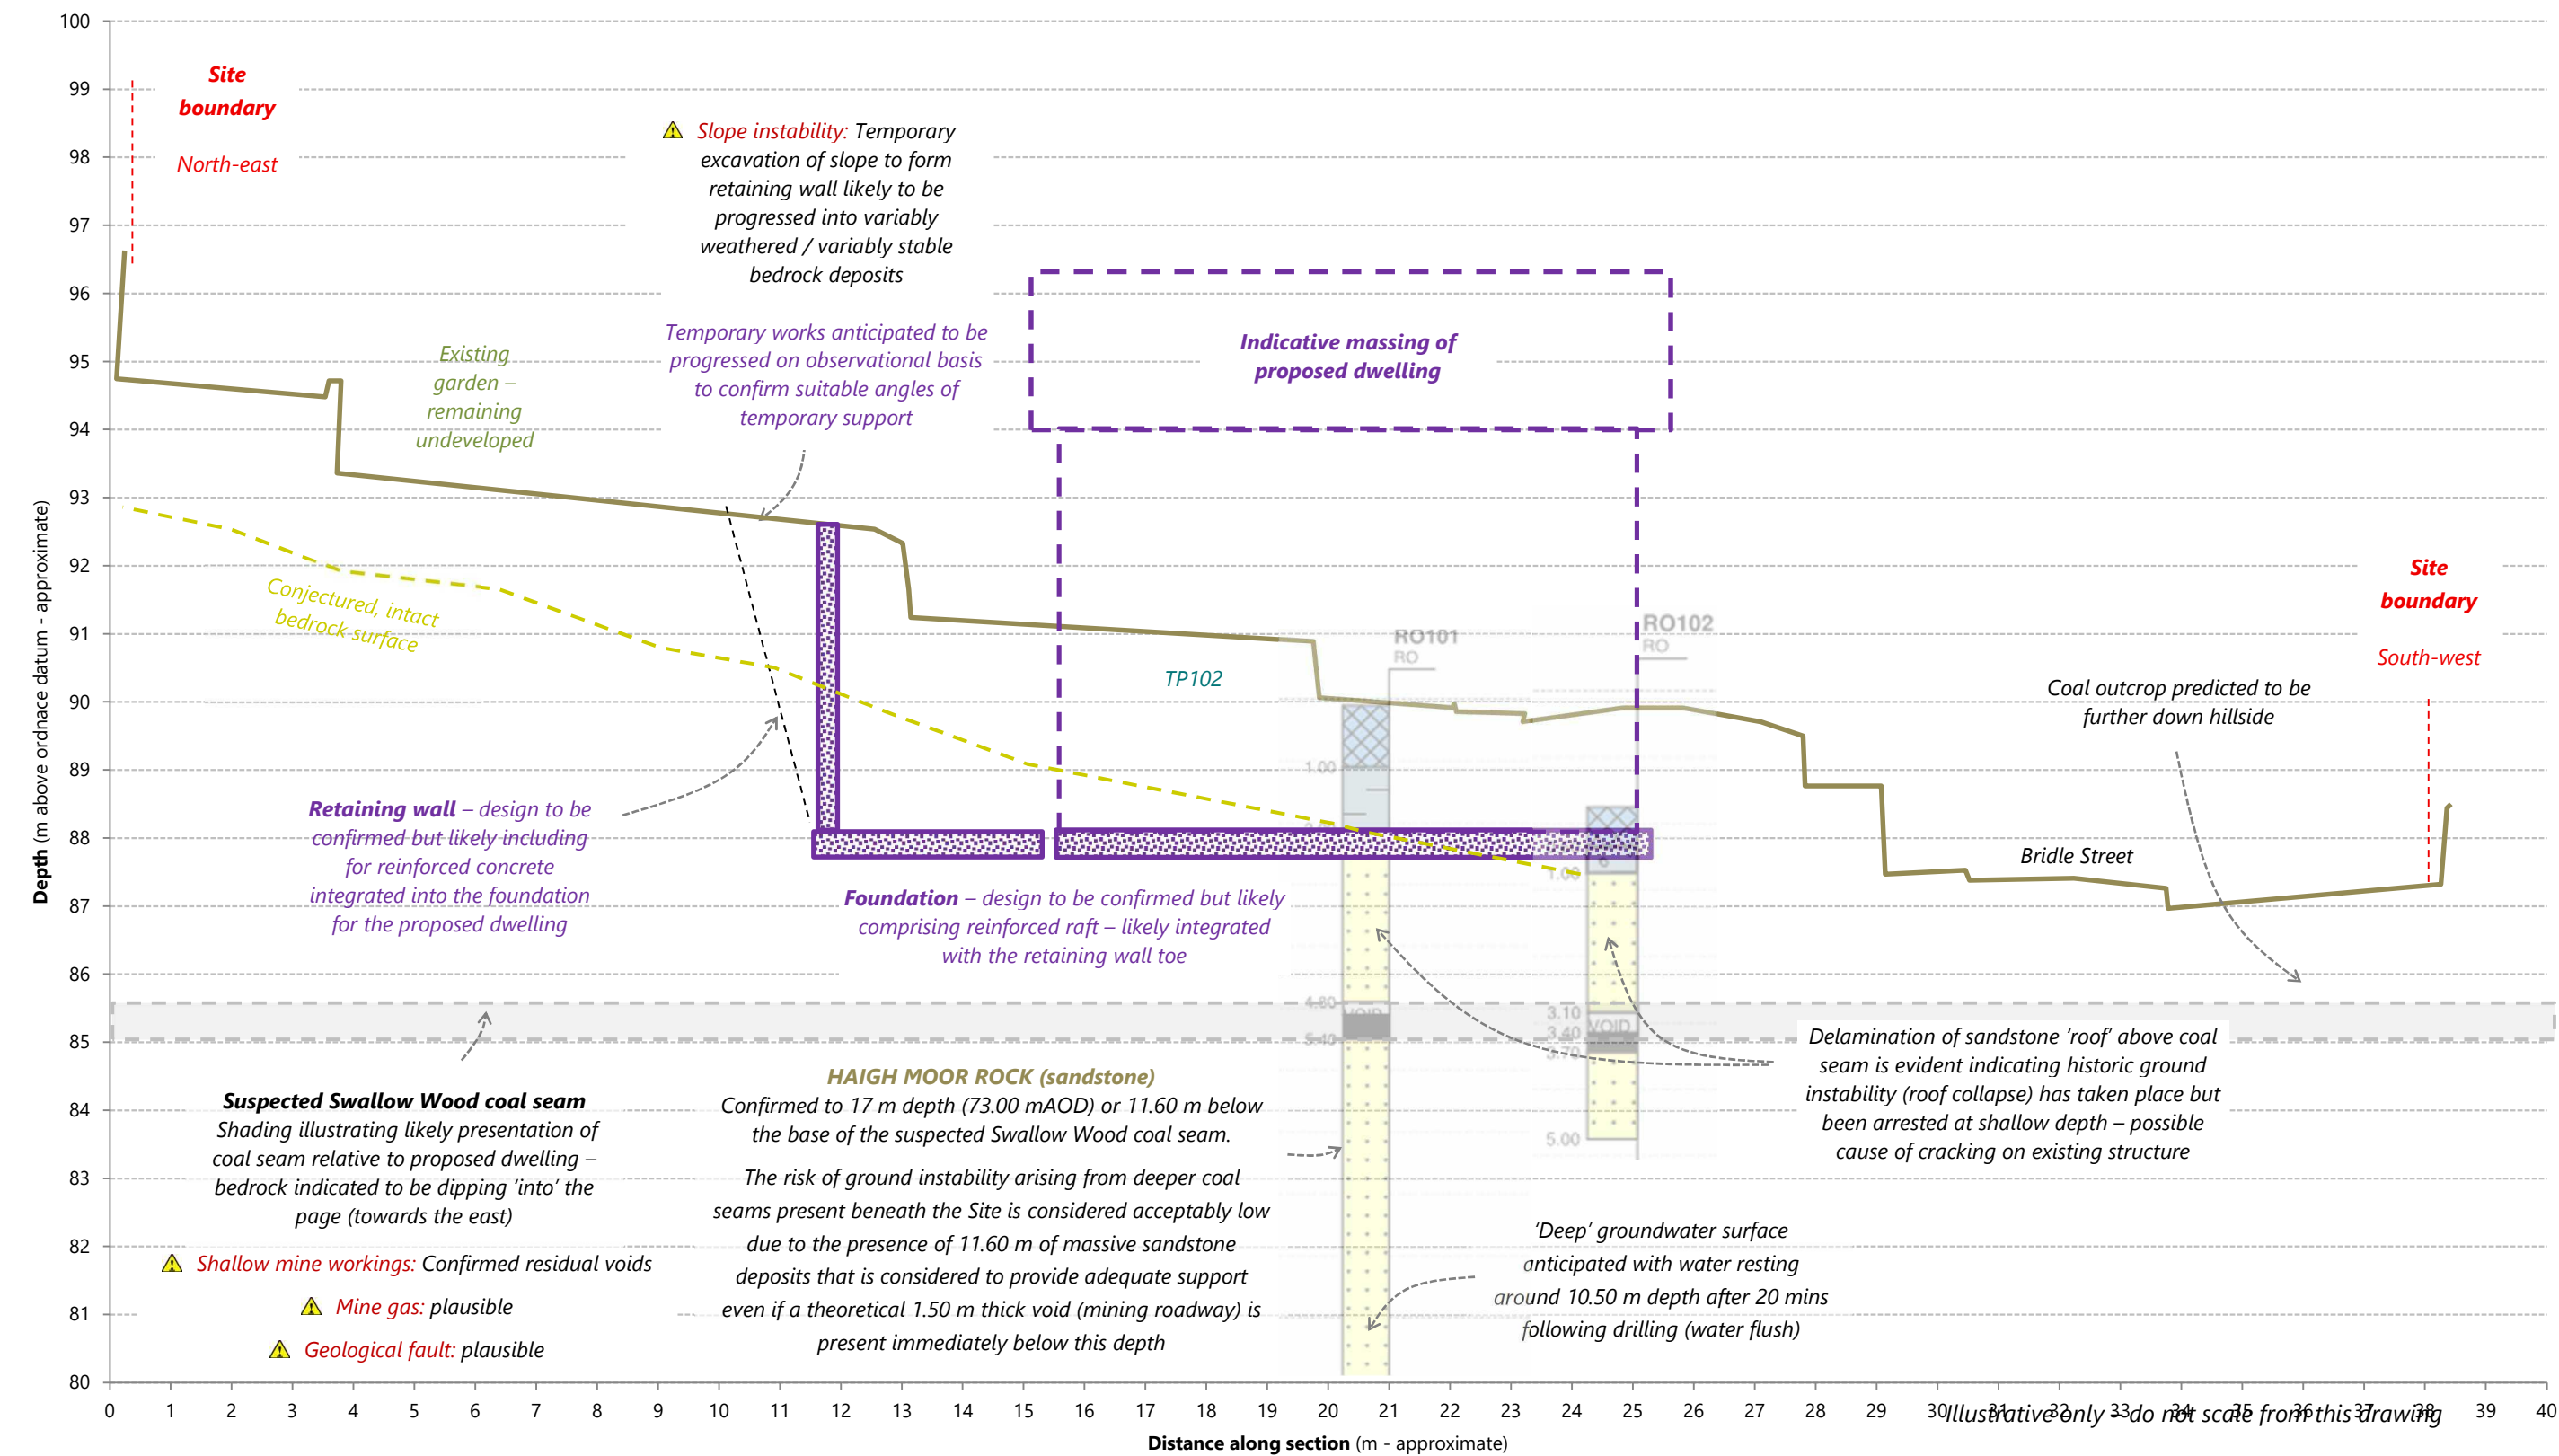
5.0 Ground Model – Profile

- RO101 was advanced with no obvious indication of mine workings with the void encountered at 4.80 m depth initially considered to be a fissure within the sandstone and not coal or mine working related. The continuous nature of the drilling beneath the void was another indication of this.

- > **Observation 1:** Evidence of coal and mine workings was noted at a depth of 84.00 mAOD within the two boreholes.
- > **Observation 2:** Possible groundwater (resting water level) was encountered at a depth of 79.4 mAOD (10.50 m below ground level) within RO101 after having been left to equalise 20 minutes following drilling (with water flush).
- > **Observation 3:** No evidence of potentially harmful or polluting material, e.g. stained, odorous or suspected asbestos containing material, was observed within the soils in the hand pits.

- Without risk reduction, ground instability may occur resulting in loss of support to the underside of foundations and potential foundation failure.
- Stabilisation of the mining voids (grouting) in advance of groundworks being completed is recommended. This will likely necessitate the demolition of the existing structure to have been completed however; this should be confirmed as part of the Scope of Works for Ground Stabilisation.

As noted above, in advance of foundations being formed a programme of ground stabilisation will be required to fill the residual mining voids present beneath the structure.
