**ARBORICULTURAL  
CONDITION REPORT  
at  
97a Penistone Road  
Huddersfield  
West Yorkshire  
HD8 0LF**

**JCA Ref:**  
24078/DK

- 1.1.1 This report details the findings of an expert arboricultural condition survey and risk assessment of the trees at:

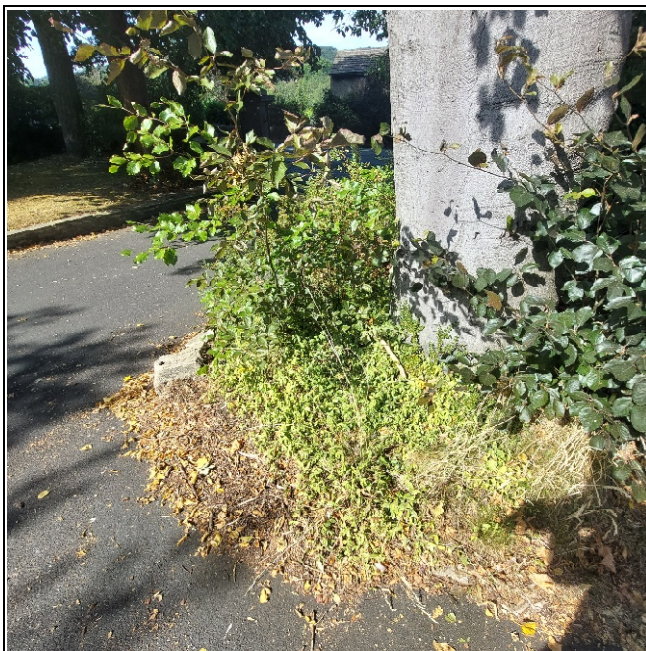
| Tree Ref. | Age<br><br>Common Name<br><br><i>Botanical Name</i> | Height (m) | Crown Height (m) | Crown Spread (m) | Diameter (cm) | Observations | Physiological Condition | Structural Condition | Life Expectancy (yrs) | Target Value | Recommendations | Priority | Safety Category | Re-Inspection Timing | Estimated Tree Age (yrs) |
|---|---|---|---|---|---|---|---|---|---|---|---|---|---|---|---|
| T 1 | Mature<br><br>Copper Beech<br><br><i>Fagus sylvatica</i><br><br>f.atropurpurea | 20+ # | 6+ # | 15+ # | 81 | Vertical main stem, high spreading crown. A fairly thin crown, poor crown symmetry. Historically lost crown growth/extensively pruned. Main stem divides into 2 at 4m #. A branch cavity (hole into main stem) to the east side at 3 to 4 metres with good surrounding wound wood, indicates the main stem may be hollowing. Epicormic growth at base, one with green leaves disassociated with the tree's main stem but possibly a reverted root sucker or growth from the type. Epicormic growth, from the base of a wound, slightly over the drive. At least two dead branches noted in the crown, ~2 metres and 4 metres long and up to ~ 10cm diameter at points of attachment. Matted Vinca and Cotoneaster growth around south side at base of tree limited a detailed inspection of this area. | Fair | Fair | 40+ | High | Remove deadwood.<br><br>Remove epicormic growth and root suckers to 3 metres.<br><br>Internal decay detection to ascertain radial/longitudinal decay present, residual wall thickness. Requires a ladder where tests are to be carried out above 2 metres. Hollowing may be anywhere from ground level up to the crown break at 3 to 4 metres. | MOD | B | 4 months. | 80 to 90 # |

**Photo 1: T1 Beech.** Epicormic growth and a potential root sucker. Various plants growth up to the tree's main stem. We advise these are all removed to prevent growth over the drive and to allow for clear tree inspections in future.

3.1.4 Further investigation in the form of a decay detection analysis, using an ultrasound or similar technology, is recommended for **T1** to assess its internal condition.

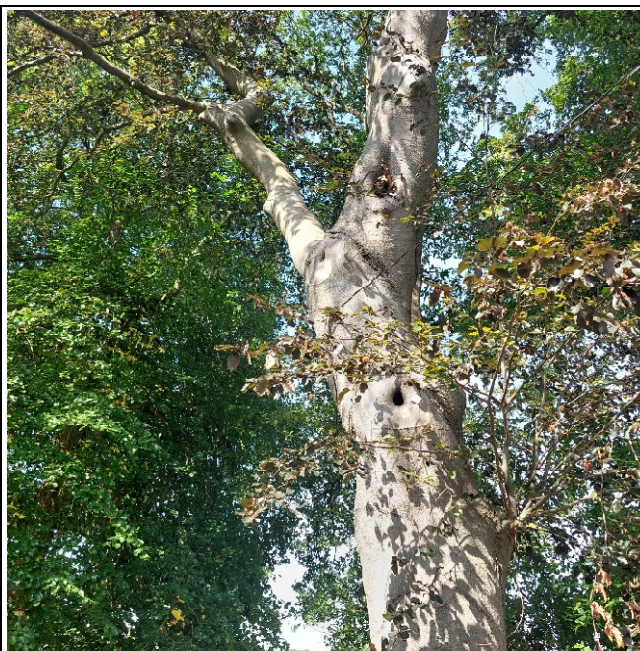
**Photo 2: T1 Beech.** Some additional epicormic growth, which has been recommended for removal, extends from 2 to 3 metres slightly into the driveway. Hollow into main stem, possible stem hollowing.

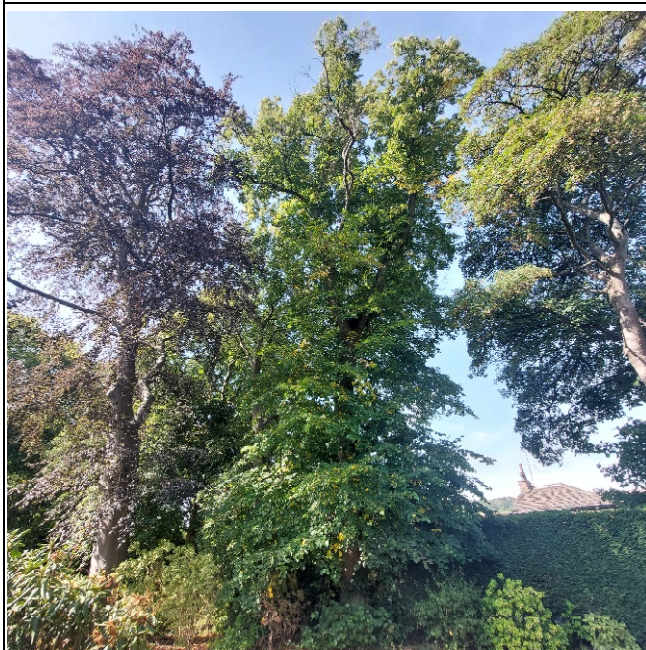
| Tree Ref. | Age<br><br>Common Name<br><br><i>Botanical Name</i> | Height (m) | Crown Height (m) | Crown Spread (m) | Diameter (cm) | Observations | Physiological Condition | Structural Condition | Life Expectancy (yrs) | Target Value | Recommendations | Priority | Safety Category | Re-Inspection Timing | Estimated Tree Age (yrs) |
|---|---|---|---|---|---|---|---|---|---|---|---|---|---|---|---|
| T 2 | Mature<br><br>Lime<br><br><i>Tilia species</i> | 20+ # | 5+ # | 15+ # | 86 | Vertical main stem, high spreading crown. Deadwood, to 6 metres long, to 15cm diameter at points of attachment, at least one large branch over drive and one smaller branch on west (road) side. Epicormic growth at base and on main stem. | Fair | Fair | 40+ | High | Remove deadwood. | HIGH | B | 2 years. | 80 to 90 # |

**Photo 3: T2 Lime.** Some fairly large deadwood was noted in the tree's crown over the driveway.

- The recommended works to **T2** should be undertaken as a matter of **high priority**.
- The recommended works to **T1** and **T5** are of **moderate** and **low priority** respectively.

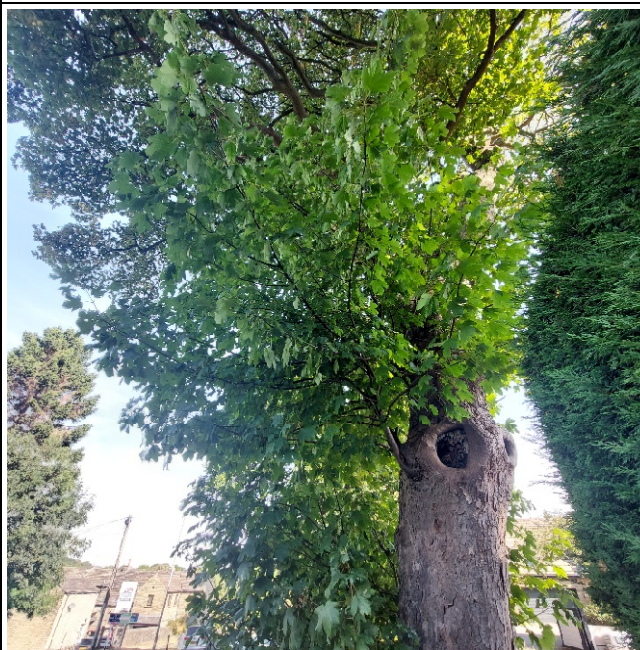
| Tree Ref. | Age<br><br>Common Name<br><br><i>Botanical Name</i> | Height (m) | Crown Height (m) | Crown Spread (m) | Diameter (cm) | Observations | Physiological Condition | Structural Condition | Life Expectancy (yrs) | Target Value | Recommendations | Priority | Safety Category | Re-Inspection Timing | Estimated Tree Age (yrs) |
|---|---|---|---|---|---|---|---|---|---|---|---|---|---|---|---|
| T 4 | Mature<br><br>Sycamore<br><br><i>Acer pseudoplatanus</i> | 15+ # | 5+ # | 15+ # | 70 | Vertical main stem. High spreading crown. Multiple branch wounds, notably two on east side on main stem occluding well. Cavity on stem to the southwest at about 2m with decay and occluding around wound. Epicormic growth at base and on main stem. | Fair | Fair | 40+ | High | Remove epicormic growth to 2 metres. Maintain basal area clear for future inspections. | LOW | B | 2 years. | 80 to 90 # |

**Photo 4: T4 Sycamore.** Two branch wounds with cavities forming looked acceptable at present.

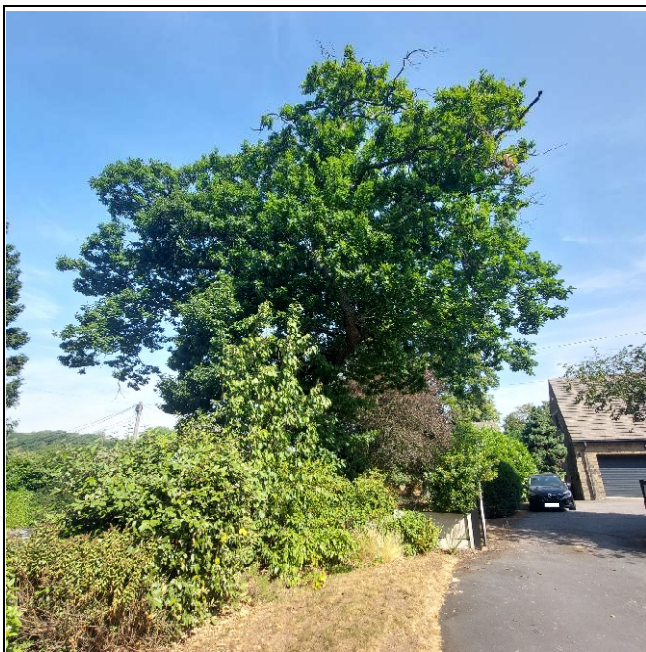
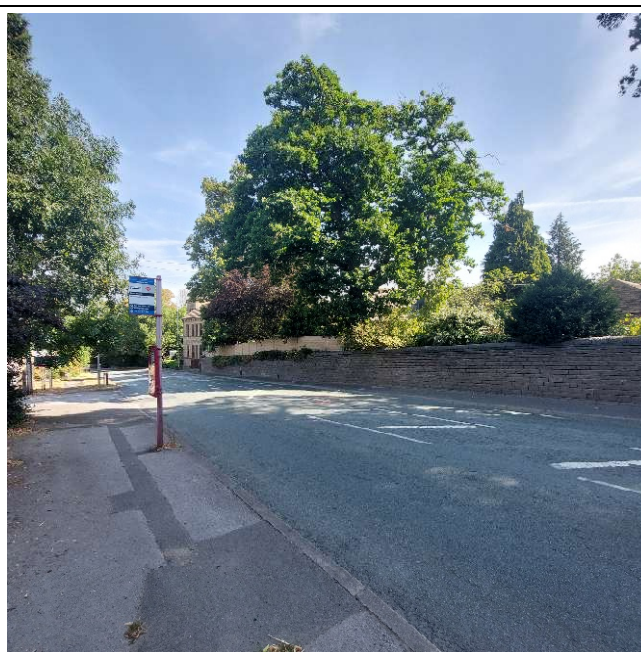
| Tree Ref. | Age<br><br>Common Name<br><br><i>Botanical Name</i> | Height (m) | Crown Height (m) | Crown Spread (m) | Diameter (cm) | Observations | Physiological Condition | Structural Condition | Life Expectancy (yrs) | Target Value | Recommendations | Priority | Safety Category | Re-Inspection Timing | Estimated Tree Age (yrs) |
|---|---|---|---|---|---|---|---|---|---|---|---|---|---|---|---|
| T 5 | Mature<br><br>Pedunculate Oak<br><br><i>Quercus robur</i> | 15+ # | 5+ # | 15+ # | 83 | Vertical main stem and high spreading crown. Branch end dieback on the east side of the crown, two minor dead branches to west (road) side, deadwood ~ to 2 to 3 metres long, to 5cm diameter at points of attachment. Retaining wall to the west is bowing due to root and basal growth. | Fair | Fair | 40+ | High | Remove deadwood.<br><br>Maintain access to main stem, minimal pruning of woody plants.<br><br>Monitor biennially. | LOW | B | 2 years. | 80 to 90 # |

**Photo 5 and 6: T5 Pedunculate Oak.** The left image shows part of the tree's crown with dieback, minor dead branch ends were also noted over the highway, all recommended for removal. It is not clear what has caused the dieback. A sound barrier/screen type of fence has been erected in the neighbouring property up to the main stem of the tree.

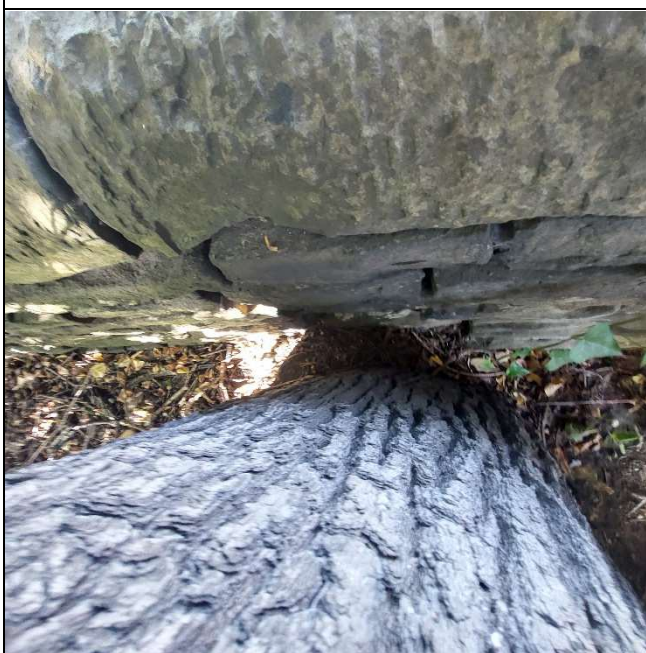
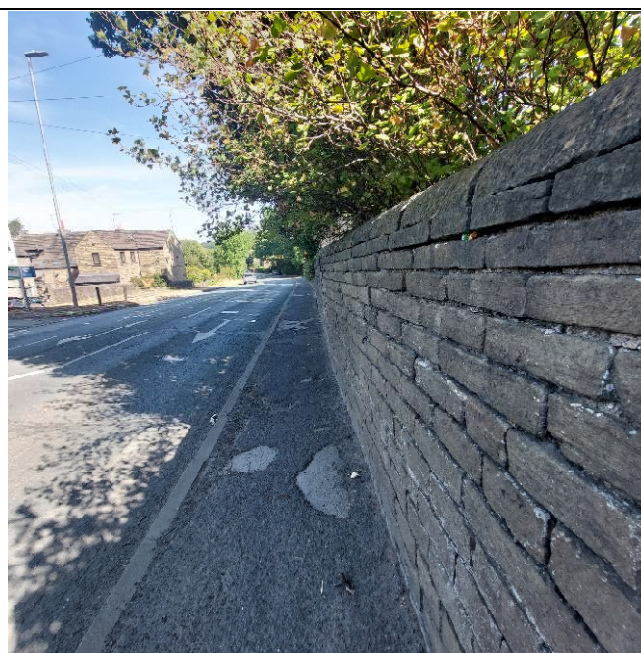
**Photo 7 and 8: T5 Pedunculate Oak.** The west side of the tree's buttress is against the boundary wall and when viewed outside the wall was seen to bowing slightly.
