## Introduction

## Details of damage

Damage to the main building of the property.

« 56 Lower Lane, Gomersal, Cleckheaton, BD19 4HZ »  
135319

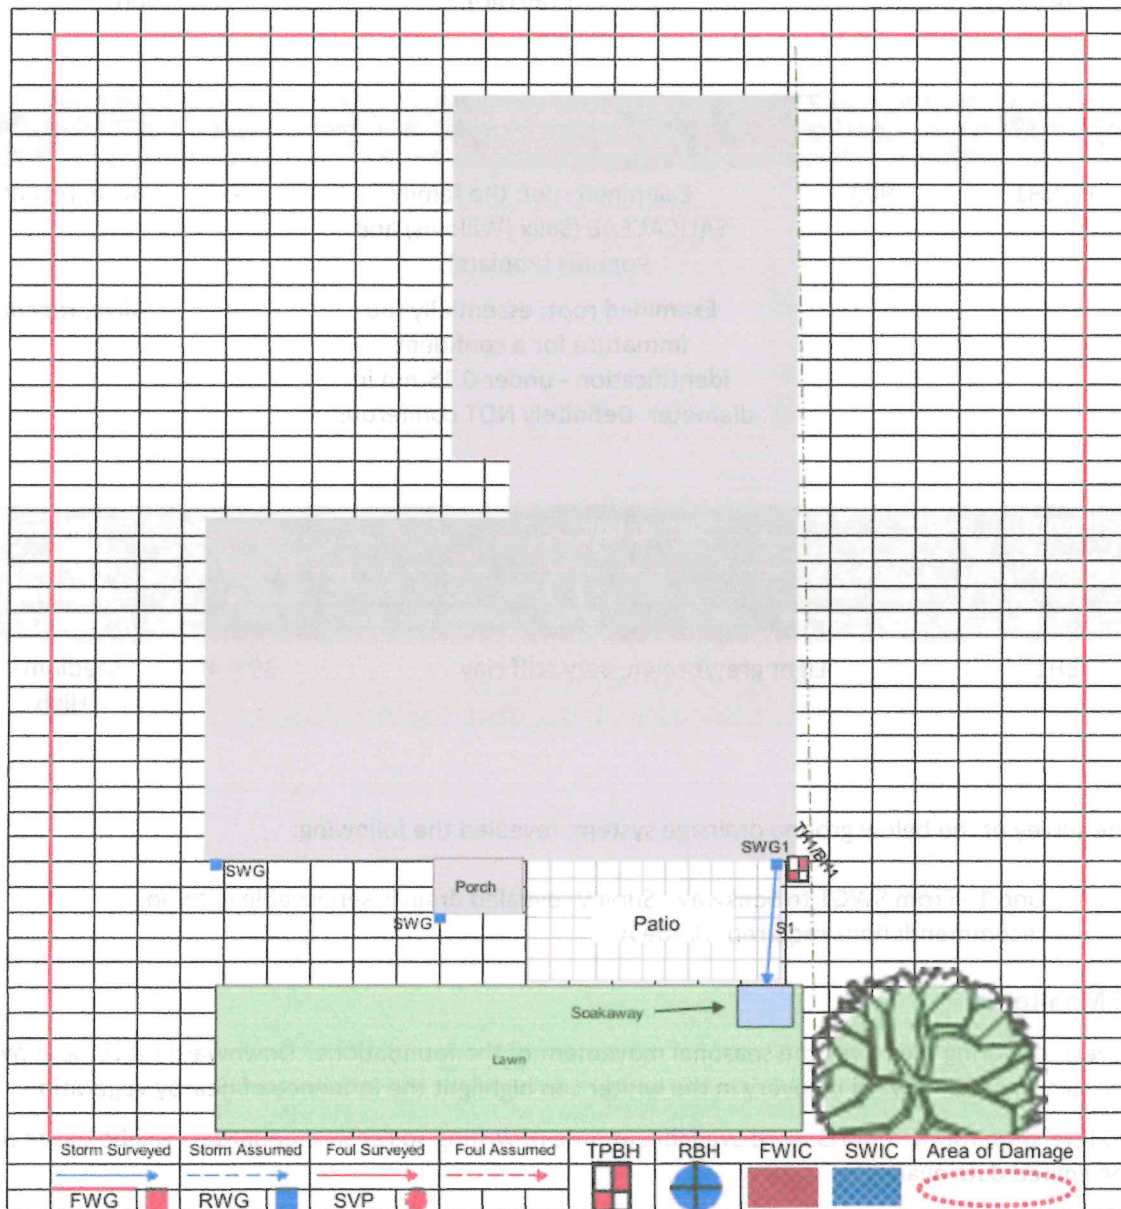
### Site Plan Not to Scale

| Ref. | Species | Height (m) | Canopy radius (m) | DBH (cm)<br>No. of stems | Estimated age and Life stage | Distance to area of damage (m) | Tree owner/ location | Vitality, previous works, comments | TPO/ CA |
|---|---|---|---|---|---|---|---|---|---|
| T1 | Willow | 11 | 3 | 60 #<br>1 | 50<br>Mature | 9 | Neighbour<br>54 Lower Lane | Good.<br>High-water demand. | CA |
| T2 | Beech | 10 | 2 | 30 #<br>1 | 60<br>Early-mature | 14 | Neighbour<br>68 Lower Lane | Poor.<br>Moderate-water demand. | Unknown |

- Willow (T1) has a high-water demand and is within the 75% distance for damage in the C&R study. Laboratory analysis of the roots found below foundation depth during the site investigation identified them as *Salix* spp.
- Beech (T2) is toward the maximum distance for damage in the C&R study.
- At time of writing, no level monitoring reports were available to confirm seasonal movement therefore any recommendations to mitigate current or future risk are based on the limited data available.

| Ref. | Species & estimated age | Height DBH (m) | Dist. to area of damage (m) | Vitality & previous works | Tree owner/ location | Recommendation | TPO CA |
|---|---|---|---|---|---|---|---|
| T1 | Willow 50 Mature | 11 (0.60) | 9 | Good | Neighbour 54 Lower Lane | Remove close to ground level and treat stumps with herbicide to inhibit regrowth. | CA |
