## Supporting Statement – Proposed Replacement of Existing Windows and Doors

3 Bankfoot lane  
Armitage Bridge  
HD4 7NW

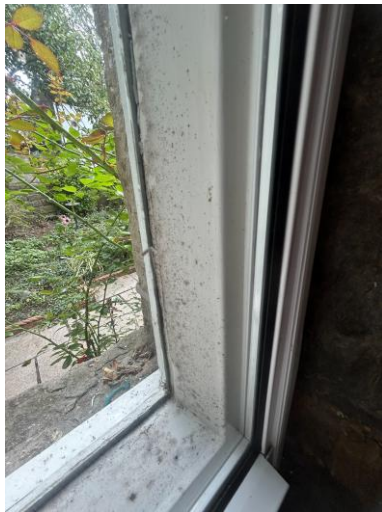
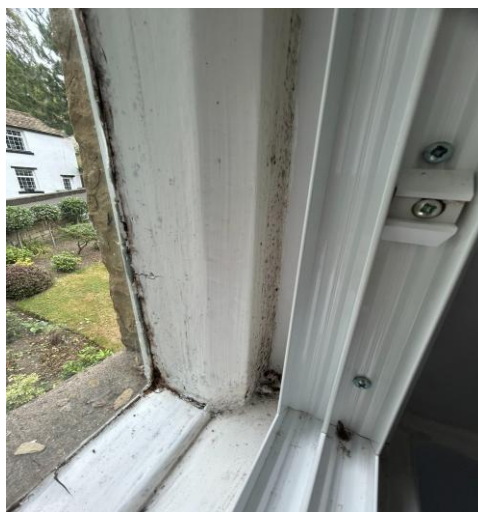
Mould growth, Occurring on every window.

The enclosed space between the original windows and the secondary glazing has created a relatively stagnant environment in which condensation and mould growth have become particularly problematic. Julia regularly has to clean mould from the windows and surrounding areas, particularly during colder periods.

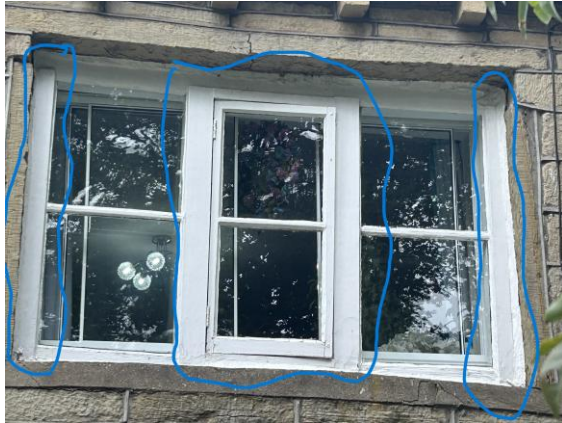
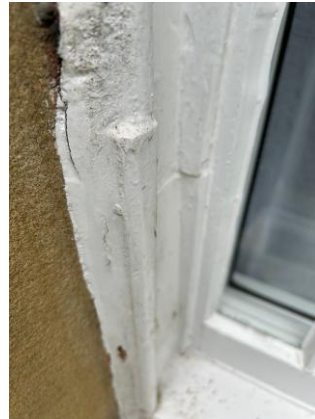
Past repairs.

Some areas have previously been repaired by others. Unfortunately, a number of these repairs are visually unsatisfactory and have themselves affected the appearance of the historic joinery.

The difficulty is no longer simply one of cutting out an isolated area of decay and introducing a small timber splice or resin repair. To properly address some of the existing repairs, it would first be necessary to remove previous repair material and then cut back further into the surrounding timber until sound and suitable material was reached. Probability of this is low.

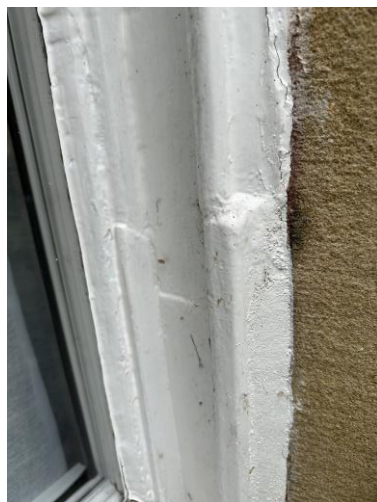
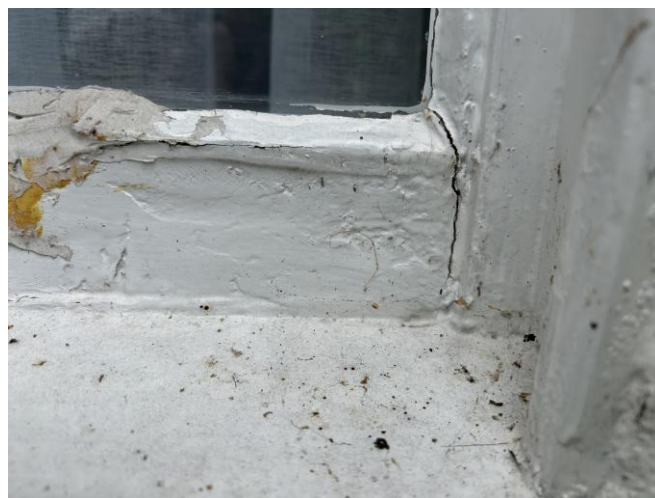
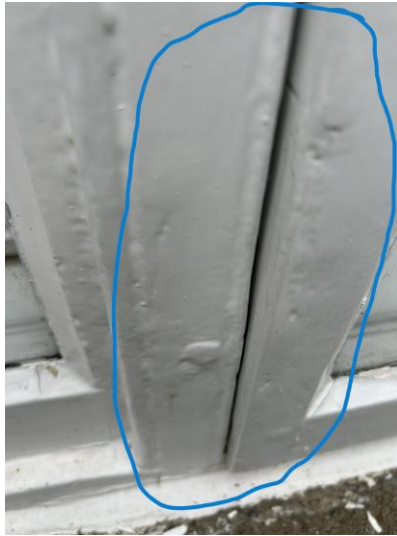
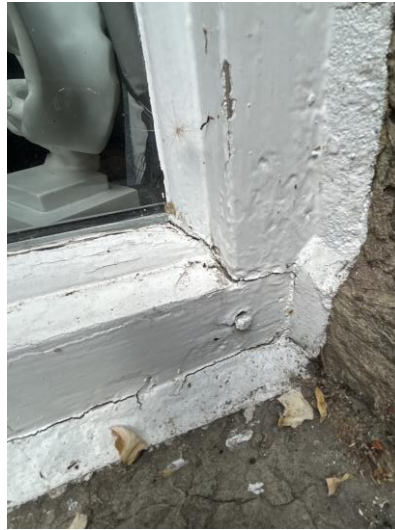
Timbers have been planted on the face, probably covering decay.

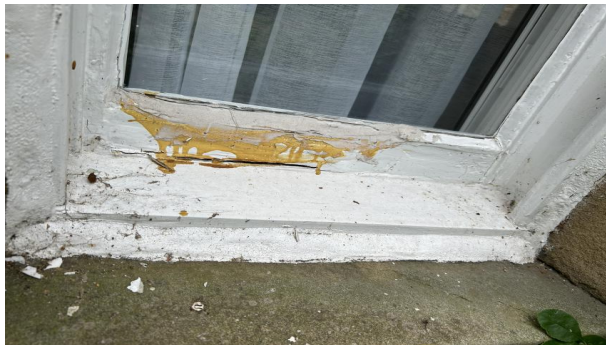
More filler than wood.

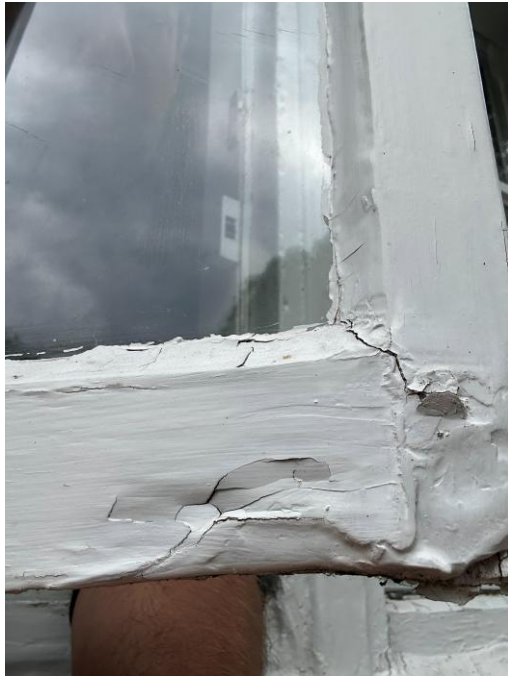
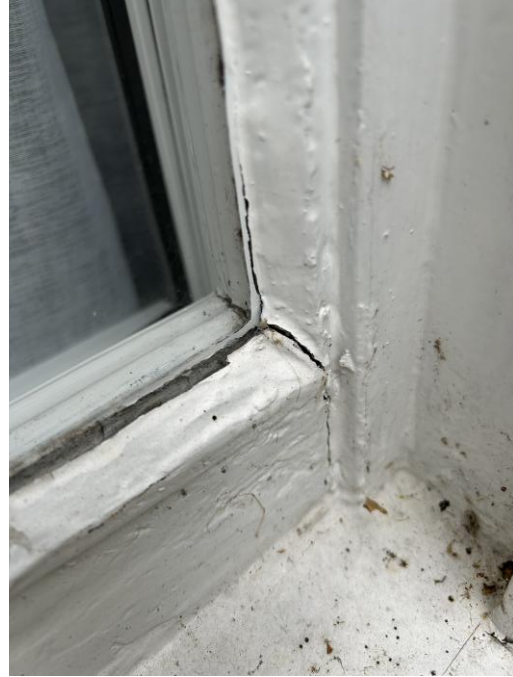
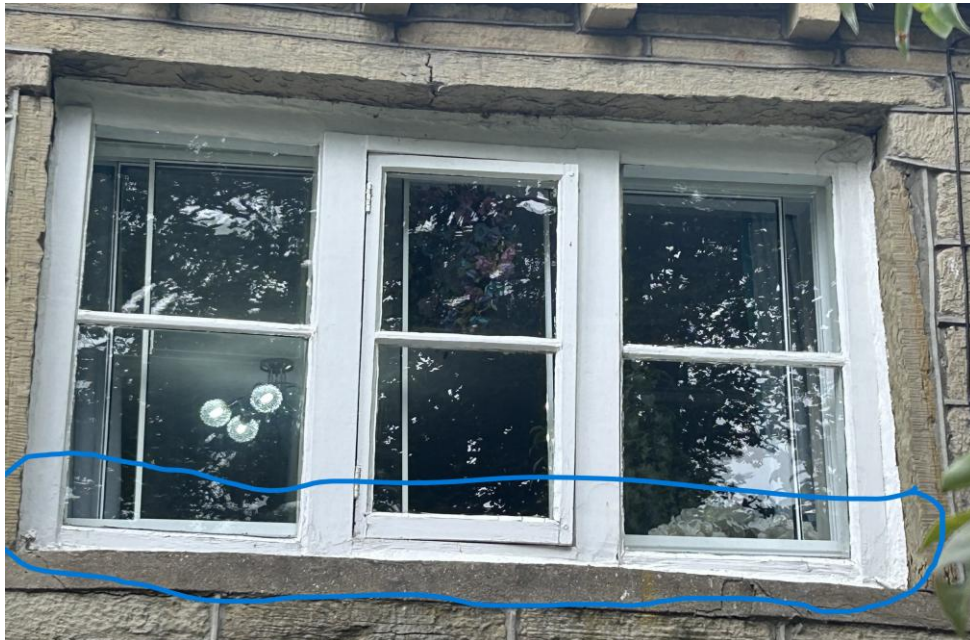
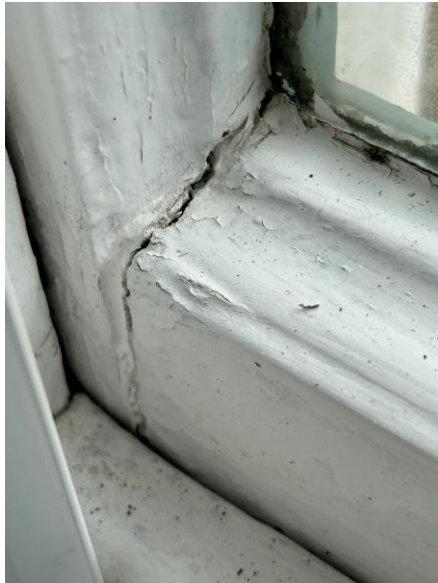
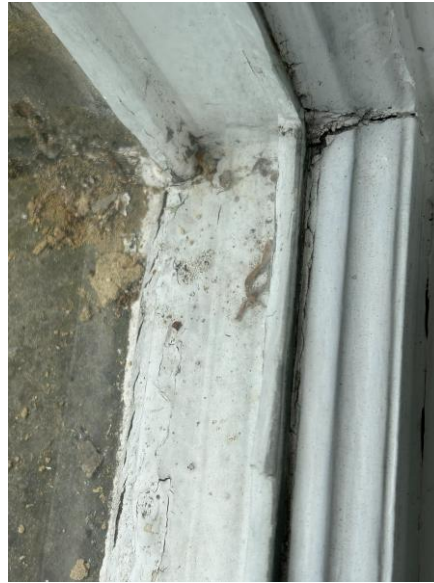
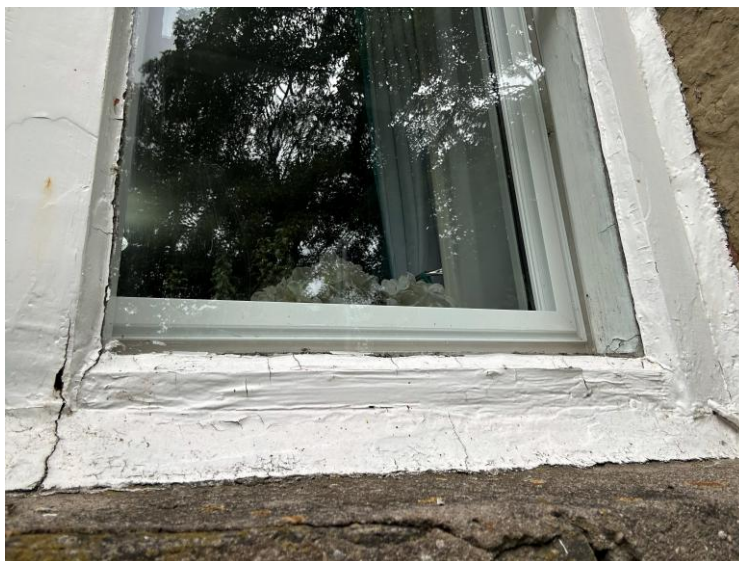
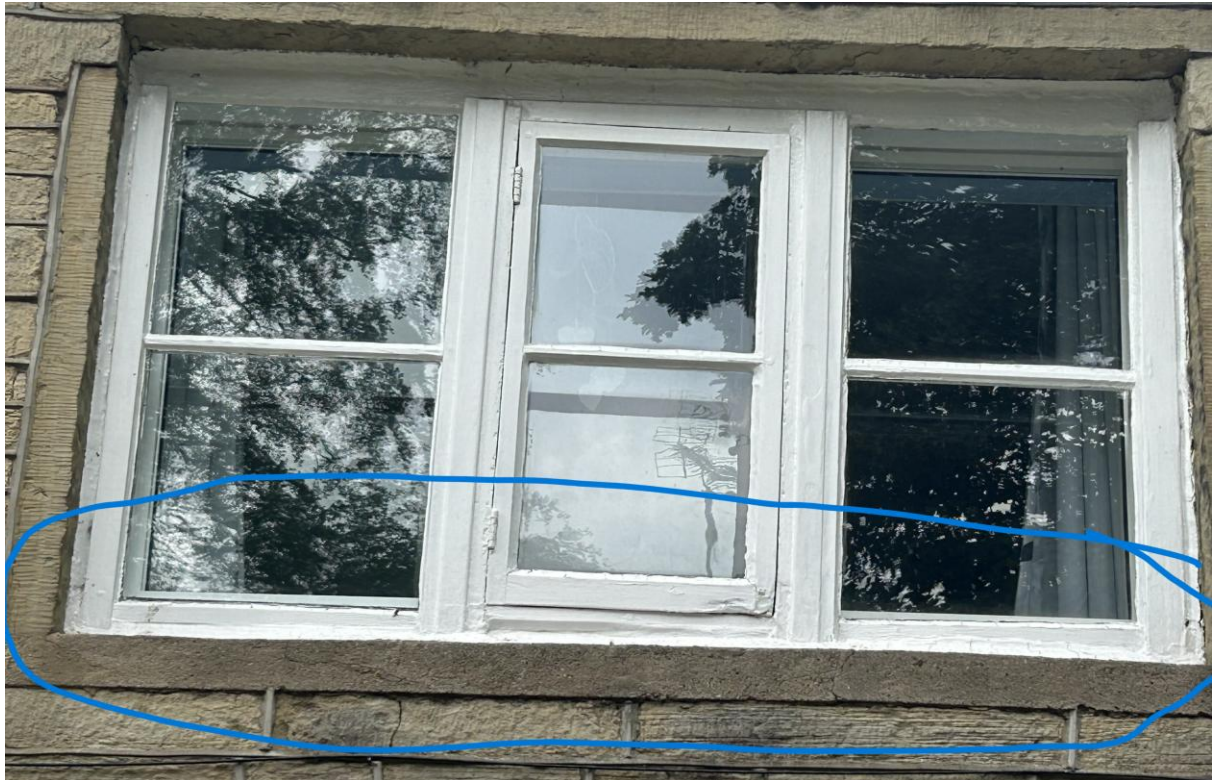
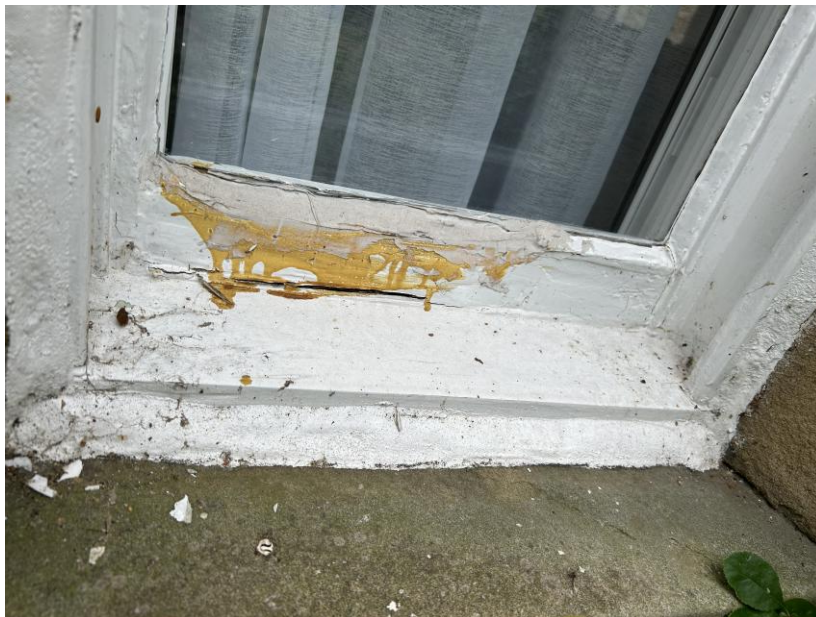
Timber decay.
