# Structural Dilapidation Report for the Retaining Wall

Woodman Inn, Thunder Bridge Lane, Kirkburton, Huddersfield  
HD8 0PX

## **Survey Report**

MDL - 11682

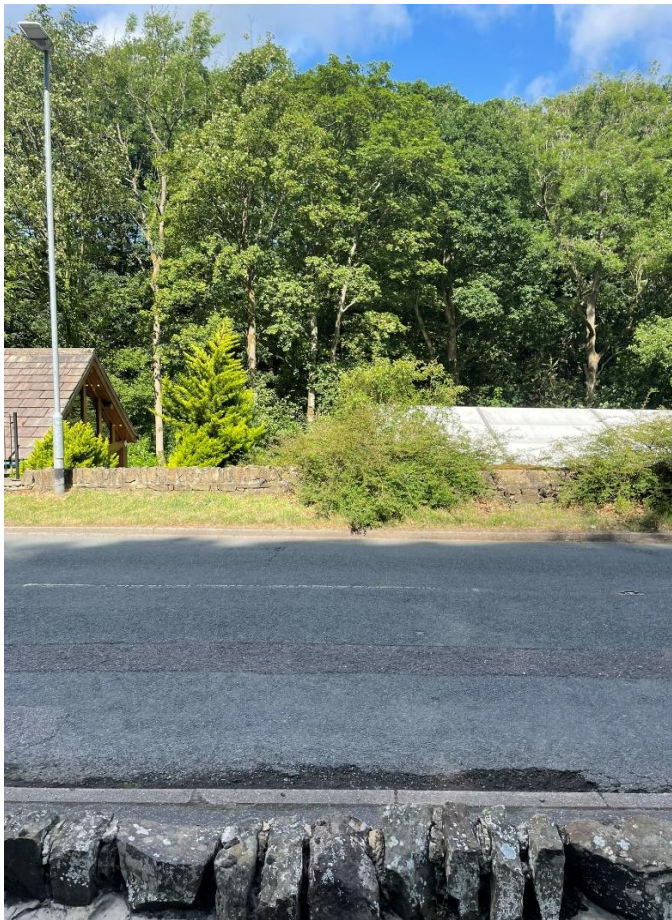
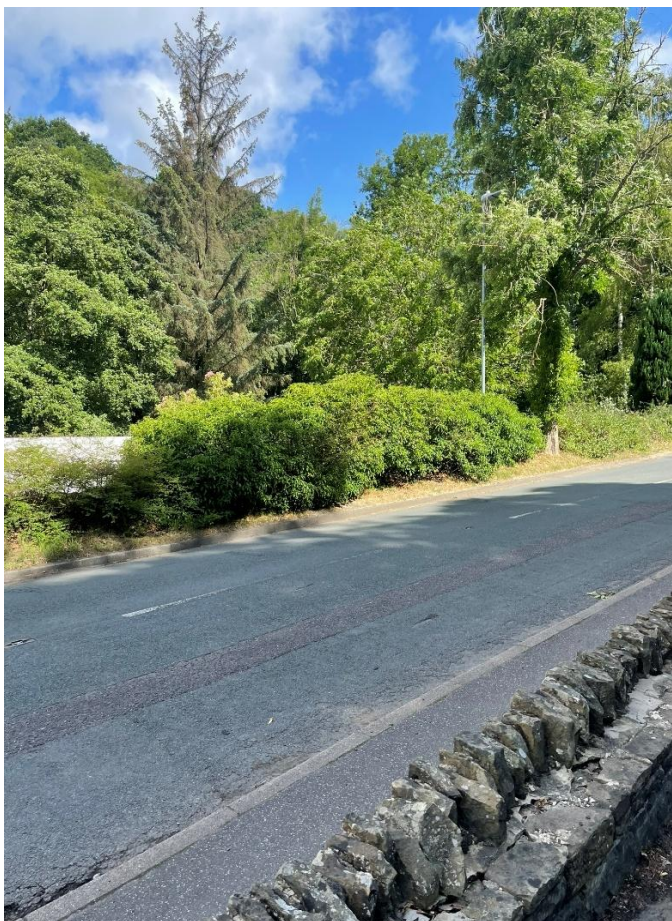
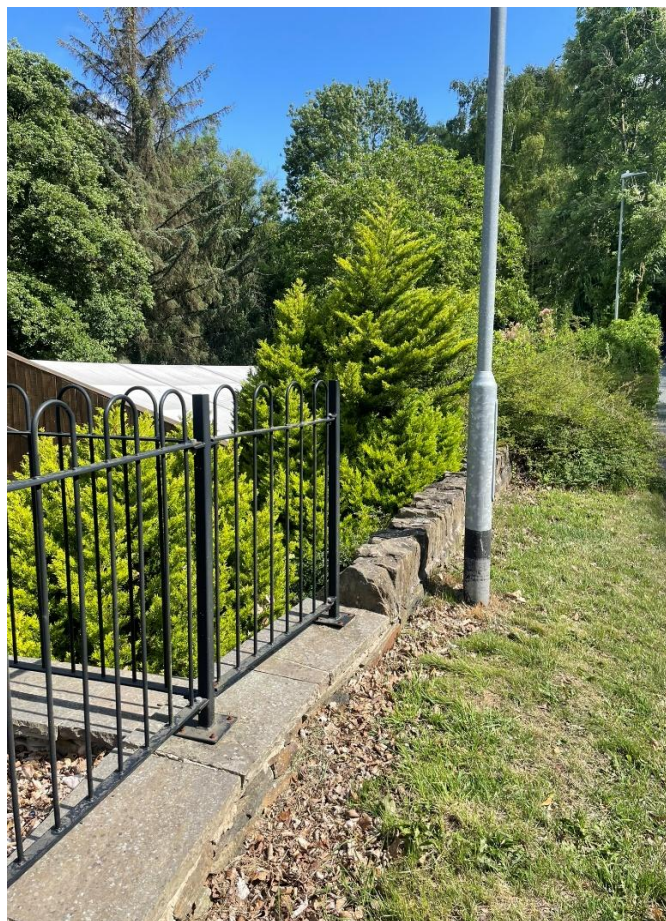
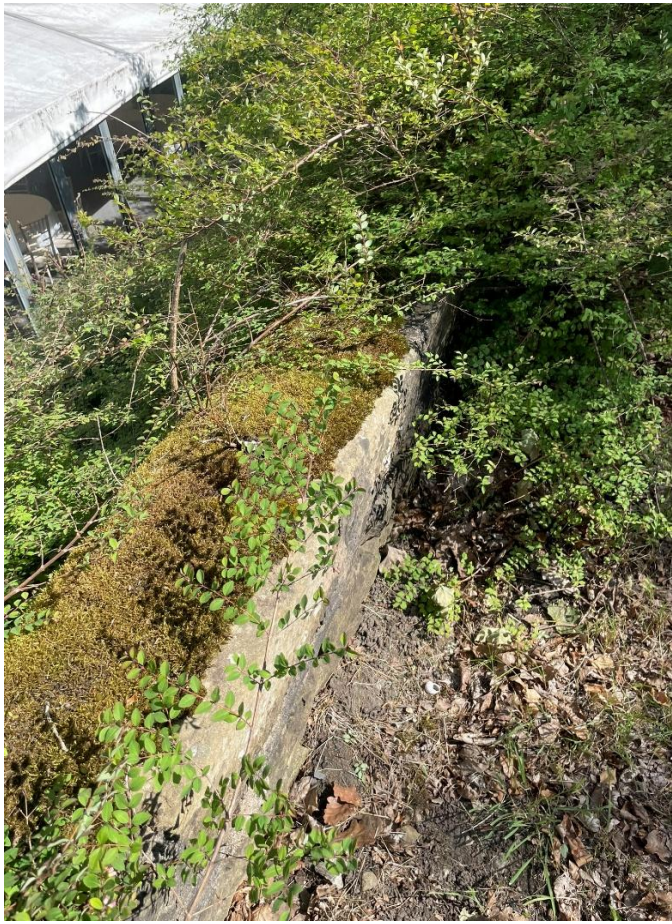
There were no major signs of subgrade settlement noted to the retained strata to the road side parallel to the parapet wall. **Pic Ref: 1-5**

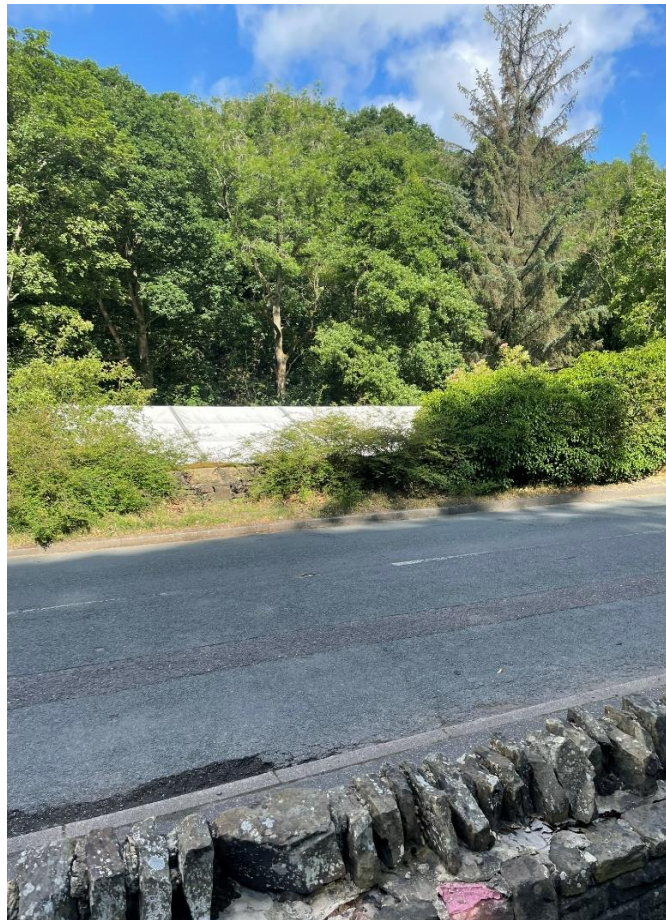
2

There is a mature tree to the right side of the road (viewed from front) which may have overgrown its original intended area. However there were no clear signs of damage noted to the retaining wall in this area. **Pic Ref: 2**

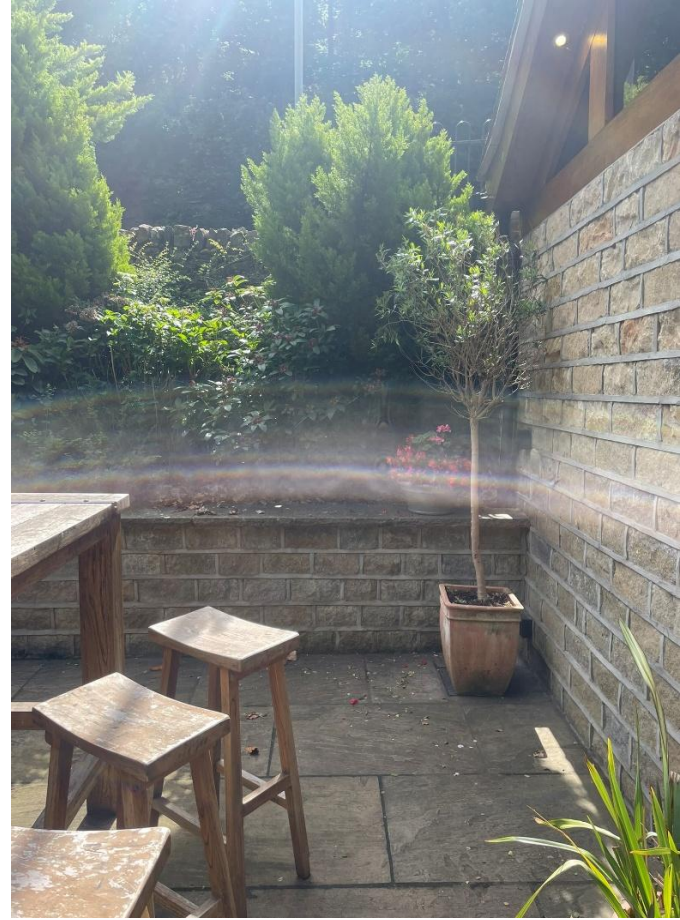
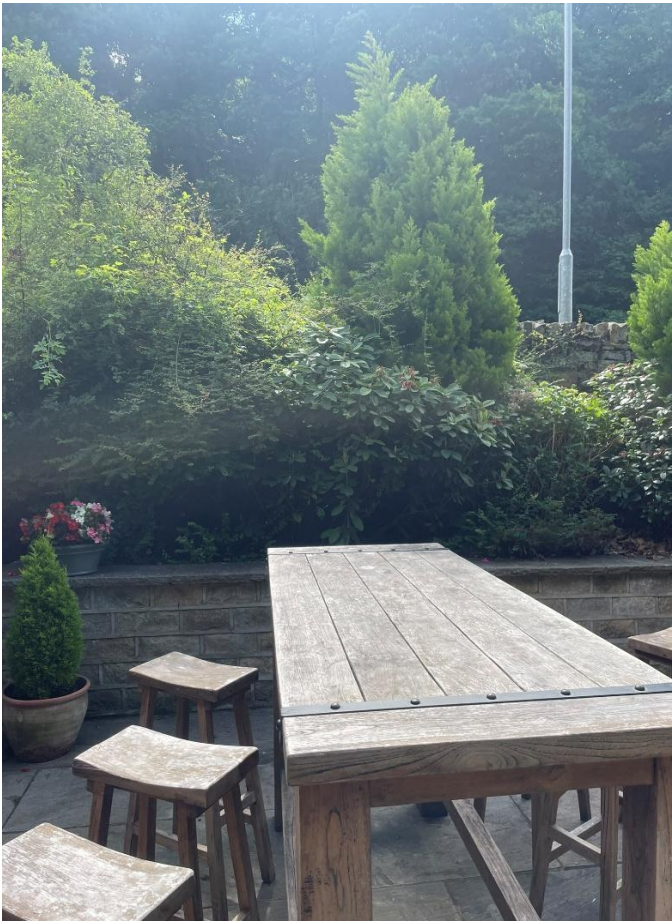
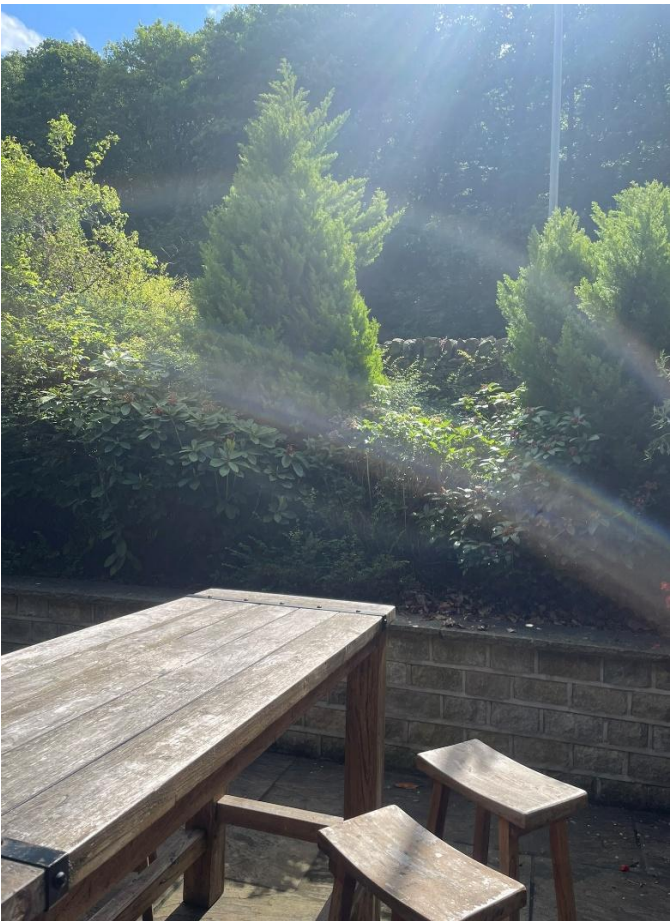
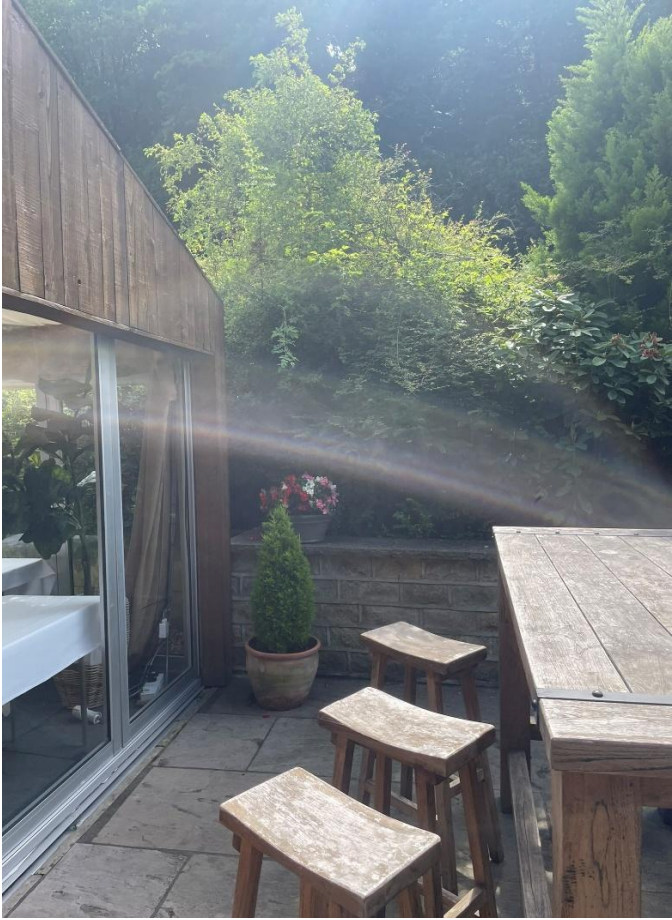
There is an additional lower retaining wall positioned 2.50m to the front to accommodate the raised bed. Approximate length of 6.50m @ 800mm high x 350mm wide. There are no signs of cracking and movement noted. Performing as intended. **Pic Ref: 8-11**

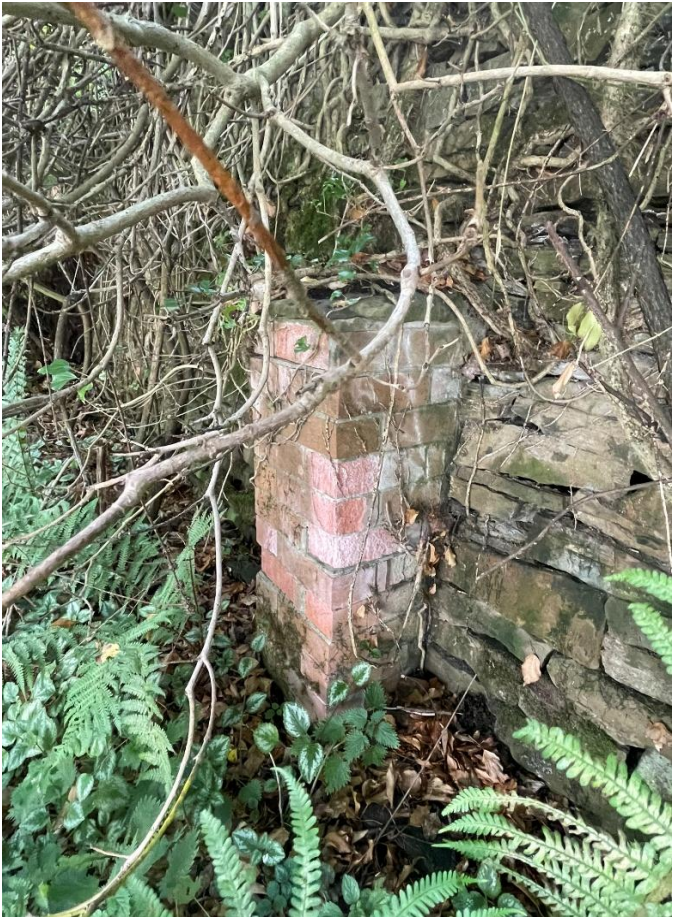
19

No movement and cracking noted to the additional brick pillar to the front of the dry-stone wall situated within the raised planter areas. **Pic Ref: 19**

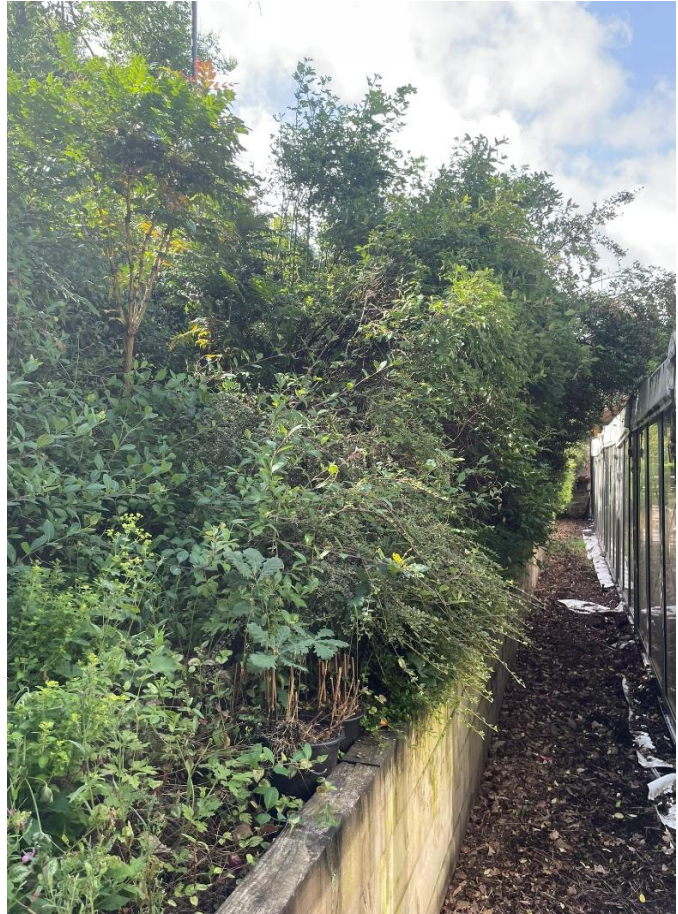
24

Further raised planter constructed in sleeper timbers positioned 1.50m to the front. Approximate length of 23.50m @ 800mm high. Slight lateral movement noted. Performing as intended. **Pic Ref: 24**
