## Outline Arboricultural Impact Assessment

Paddock Lane and Moor Lane,  
Kirkburton

JBA 25/203 AR01 – REV B

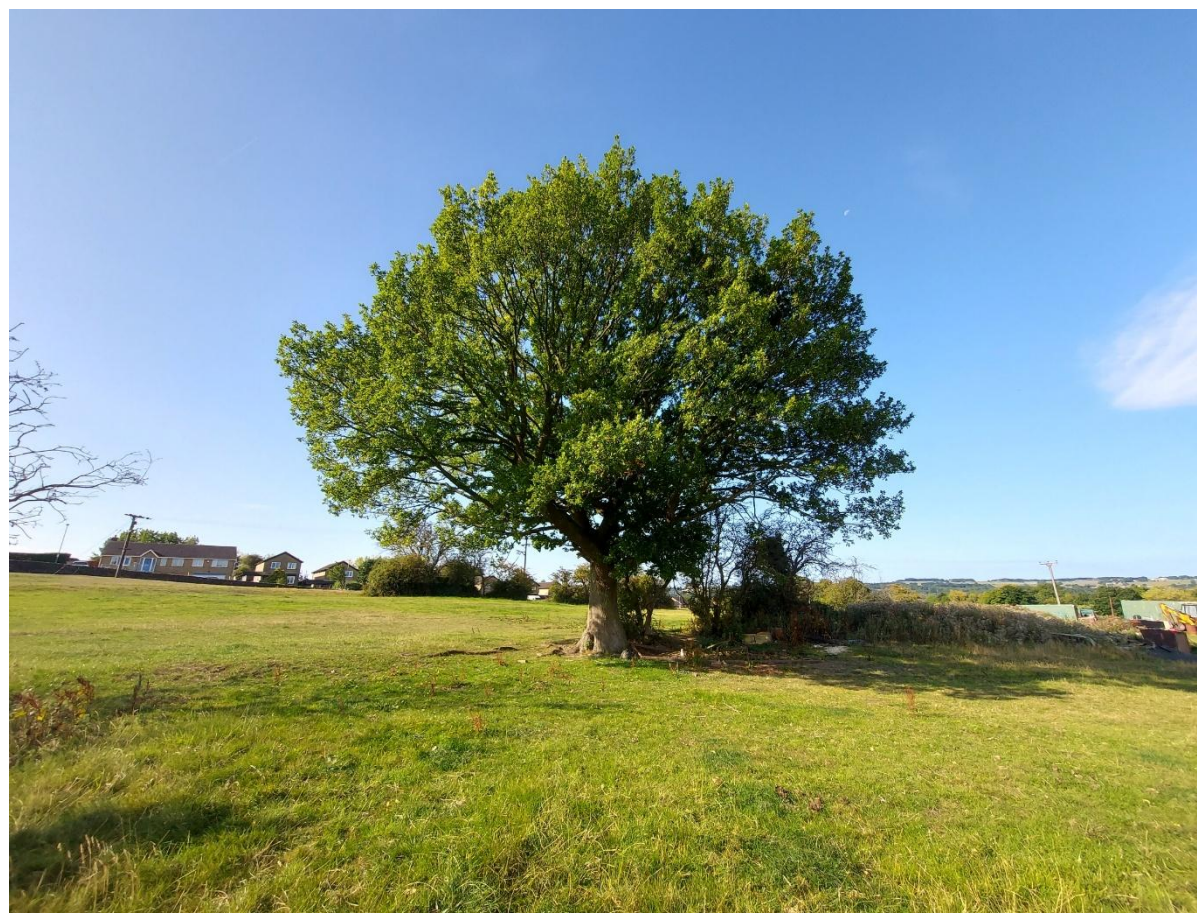
**Photograph 1** (above). T014, Oak, located centrally to the site, Viewed looking towards the east.

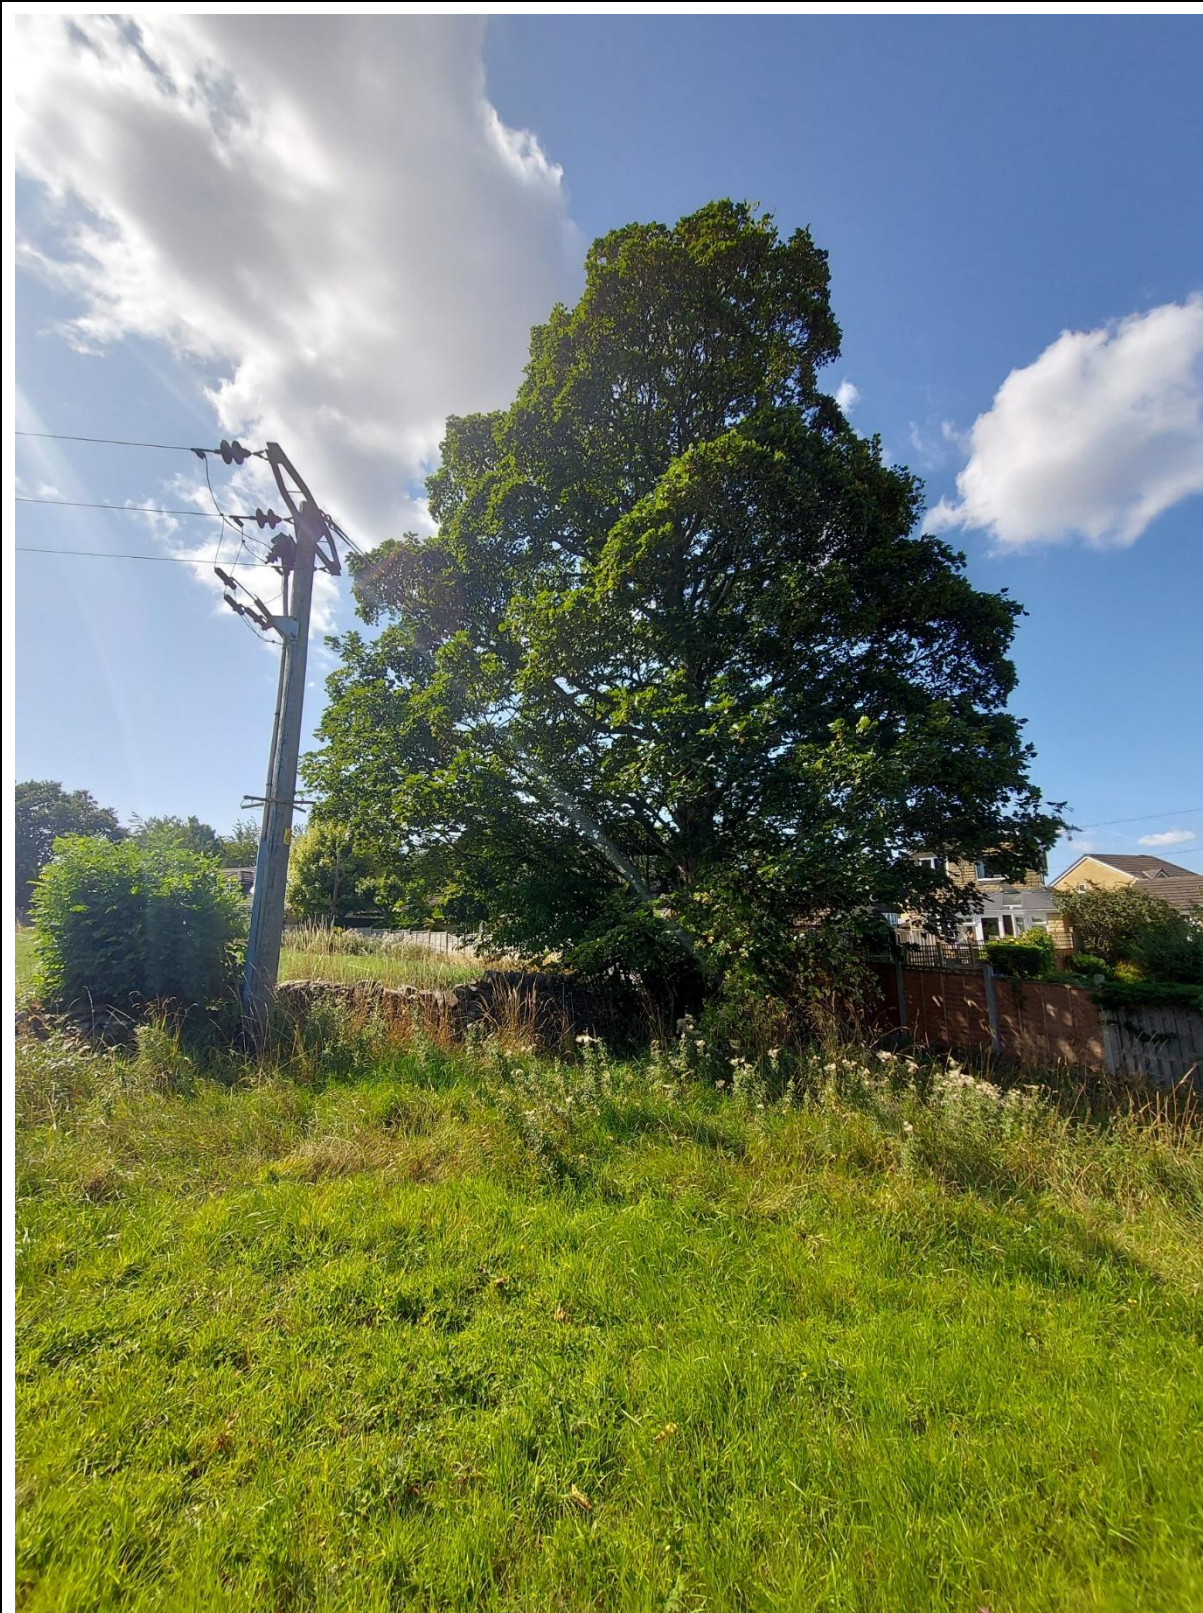
**Photograph 2** (above). T051, Sycamore, located on the western boundary, Viewed looking towards the south.

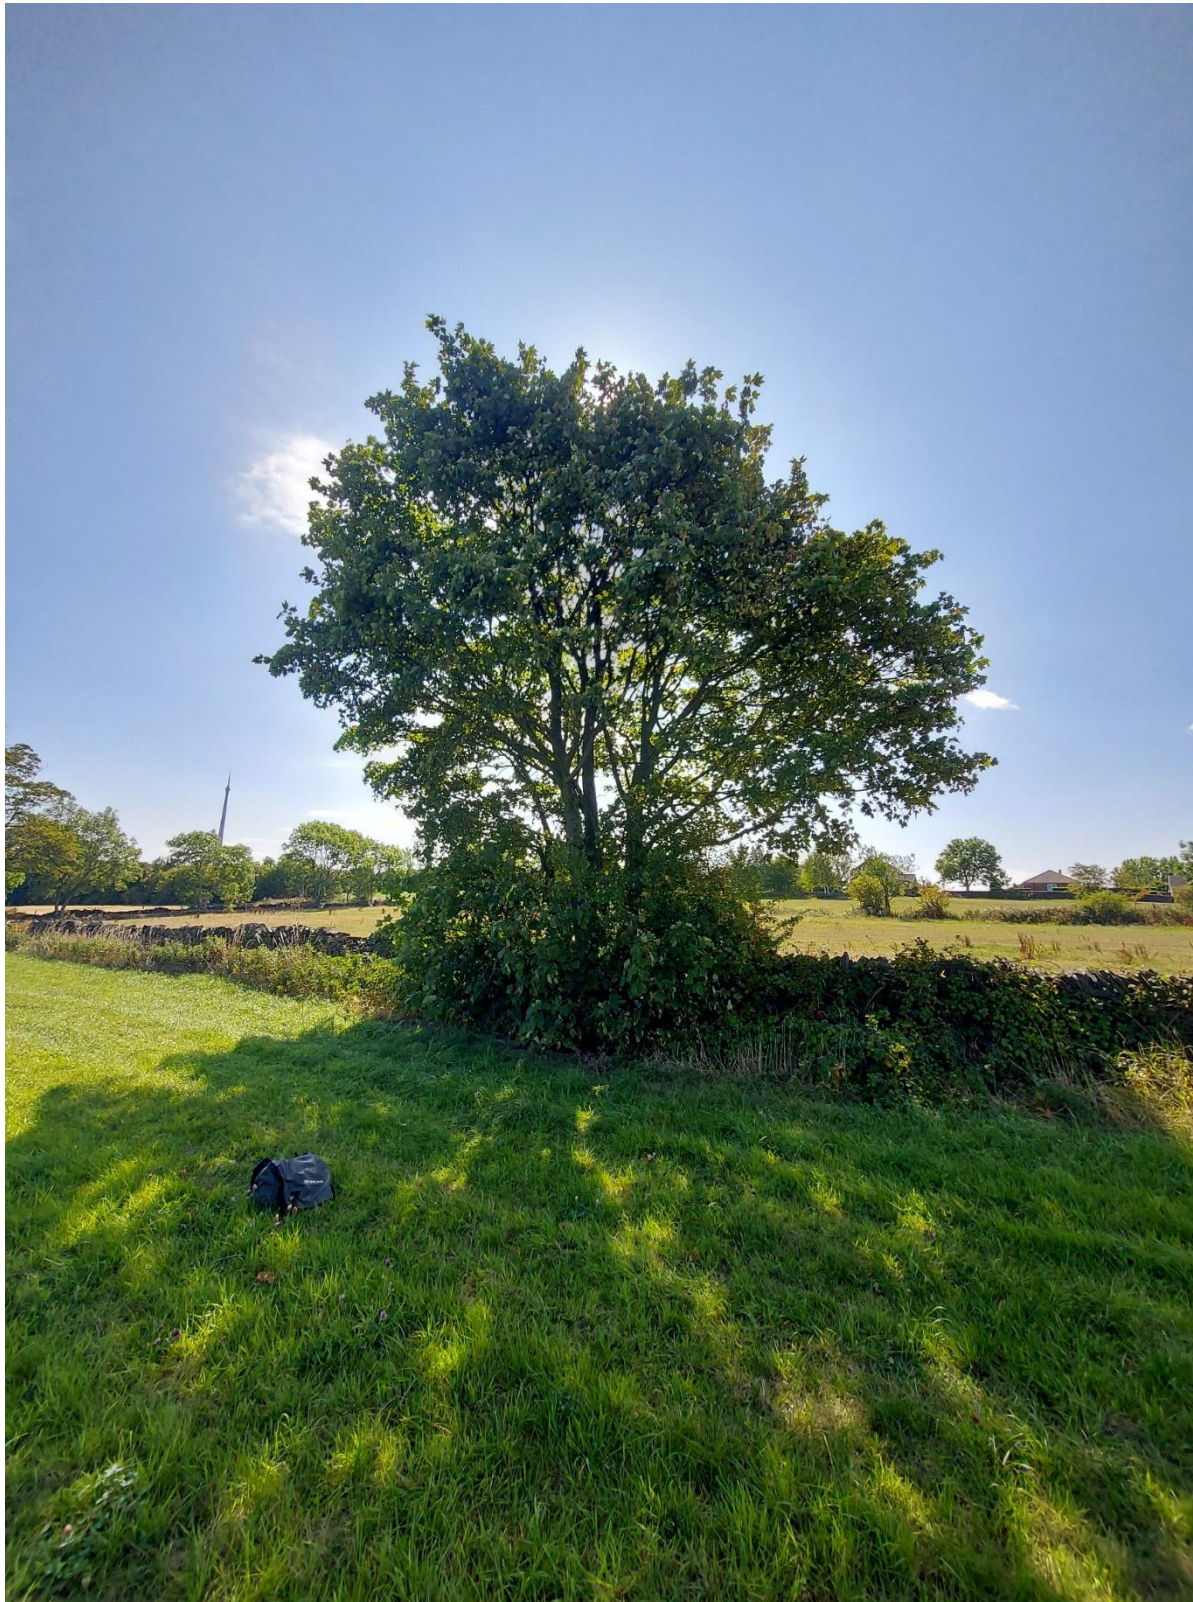
**Photograph 3** (above). T045, Sycamore, located midway between the north and south of the site towards the eastern boundary, Viewed looking towards the north west.

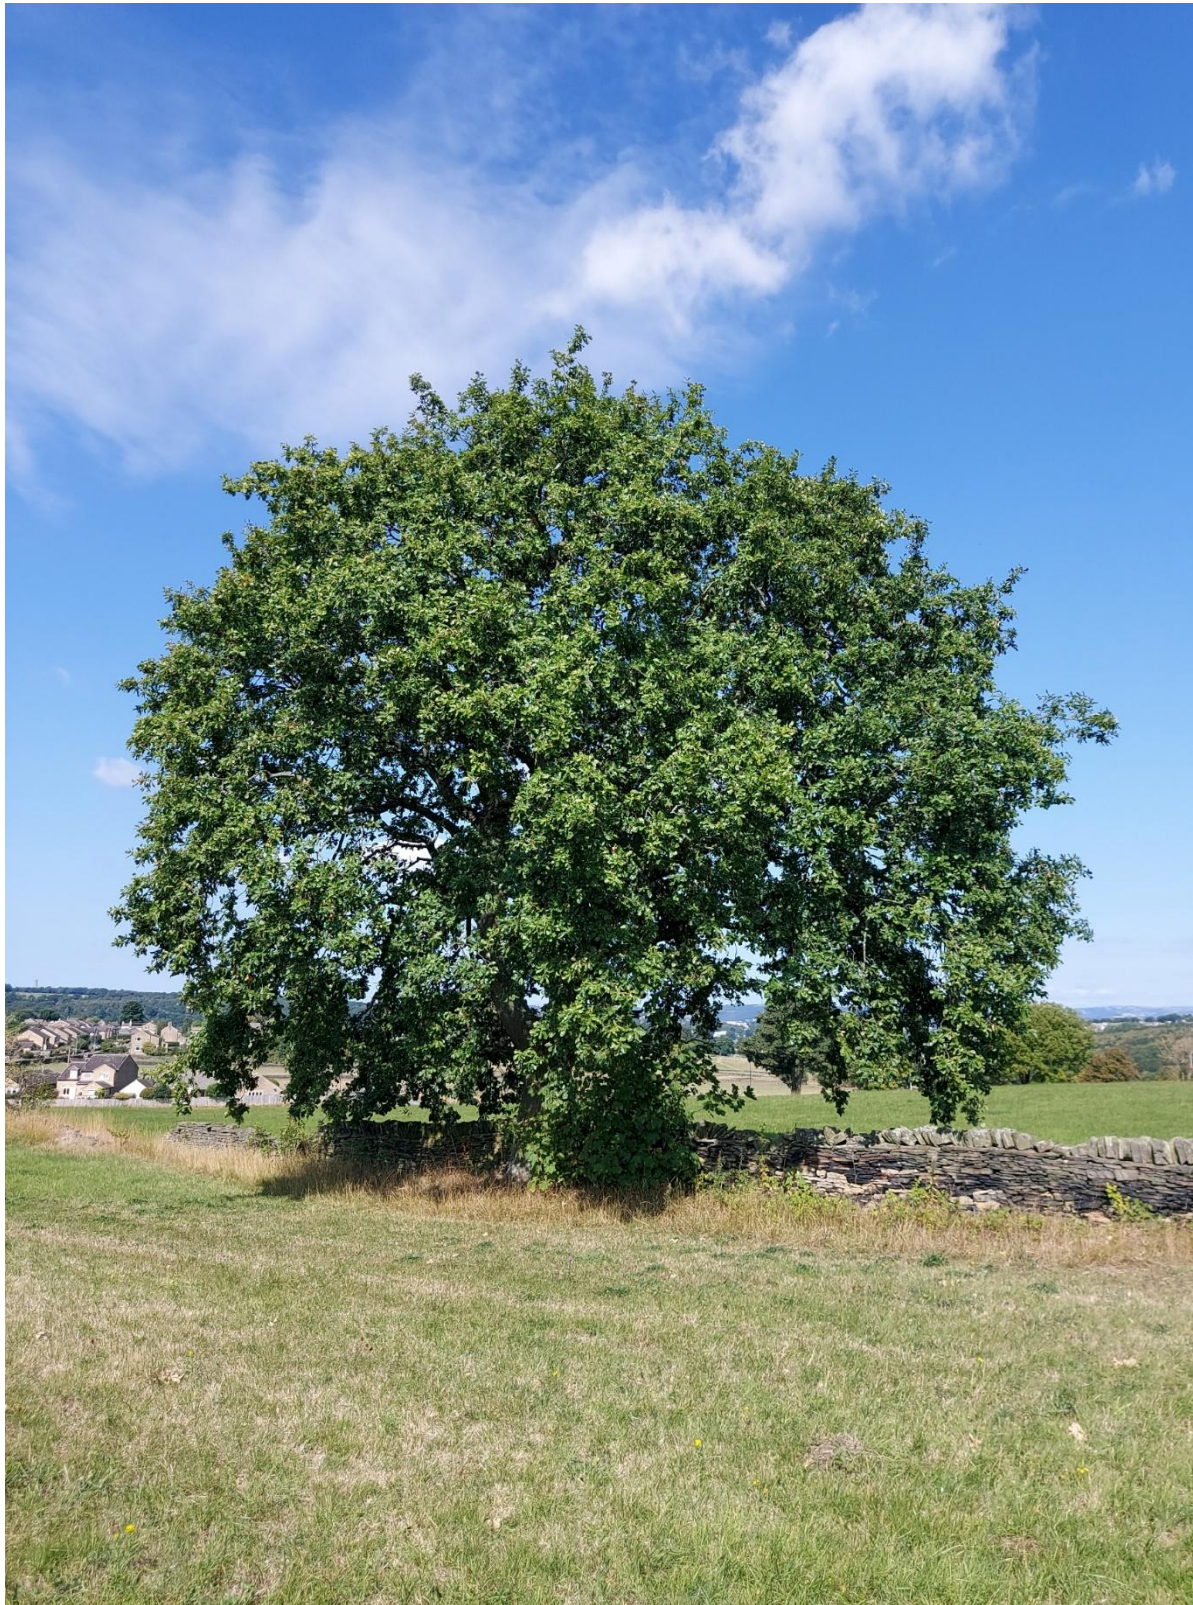
**Photograph 4** (above). T047, Oak, located in the northern half of the site near the middle, Viewed looking towards the south east.

| Tree Number | Species | Work Requirements | Reason(s) for works |
|---|---|---|---|
| T047 | Oak | Fell to ground level and remove stump | Conflict with proposed properties. |

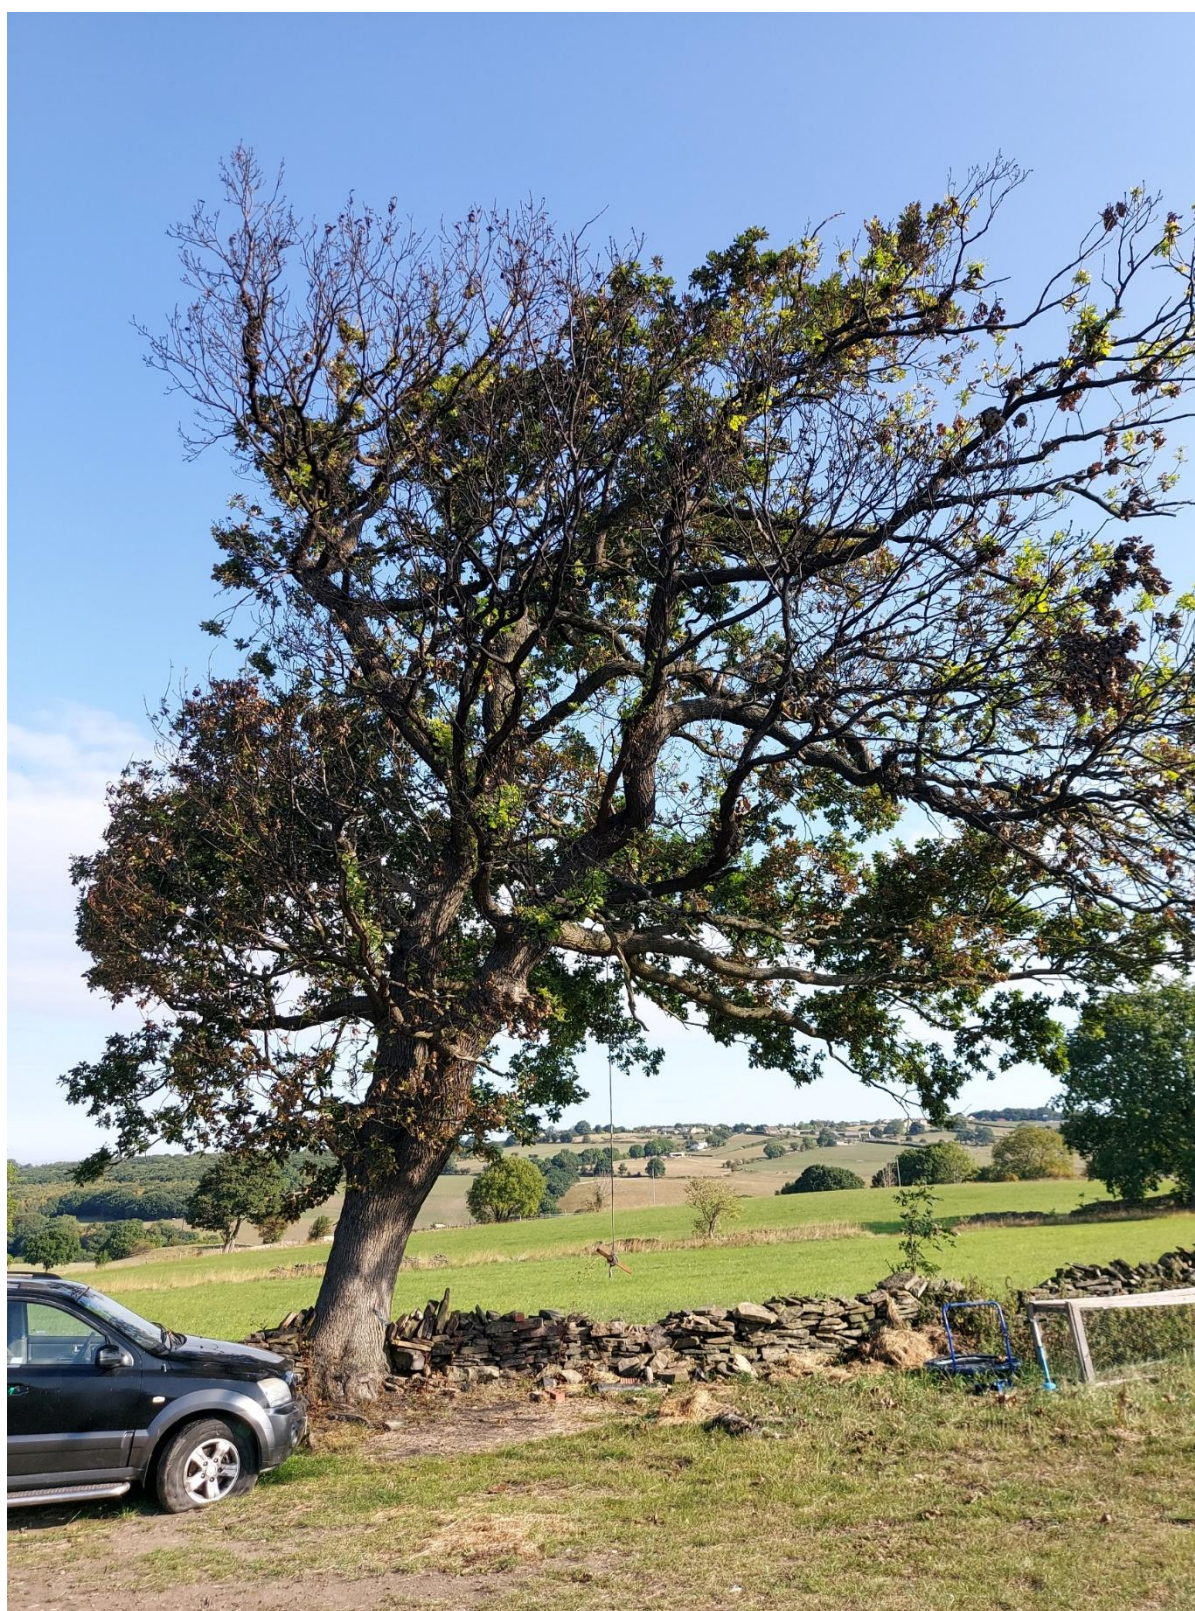
**Photograph 5** (above). T011, Oak, located centrally in the site, Viewed looking towards the north.

| Reference | Species | life Stage | Stem Diameters | Height | Crown Spread | | | | Physiological Condition | Structural Condition | General Observations | Recommendations | life Expectancy | Retention Category | RPA |
|---|---|---|---|---|---|---|---|---|---|---|---|---|---|---|---|
| T011 | Pedunculate oak<br>( <i>Quercus robur</i> ) | Mature | 830 | 11.0 | 5.0 | 7.0 | 6.0 | 4.0 | Fair | Fair | Root plate not showing signs of disturbance.<br>Stem has historical pruning wounds with good occlusion. Stem is in the line of a dry stone wall.<br>Crown breaks at 2m above ground level and has good form and vitality. Crown has dieback on the southeast and west, which appears to have been caused by fire, there are signs of regrowth with bright green leaves growing from the damaged areas. | Pre construction:<br>No action required.<br><br>During construction:<br>Protect trees with protective barriers - as shown on plans.<br><br>Post construction:<br>No action required. | 20+ Years | B1,2 | Radius:<br>10.0m.<br>Area: 314 sq m. |

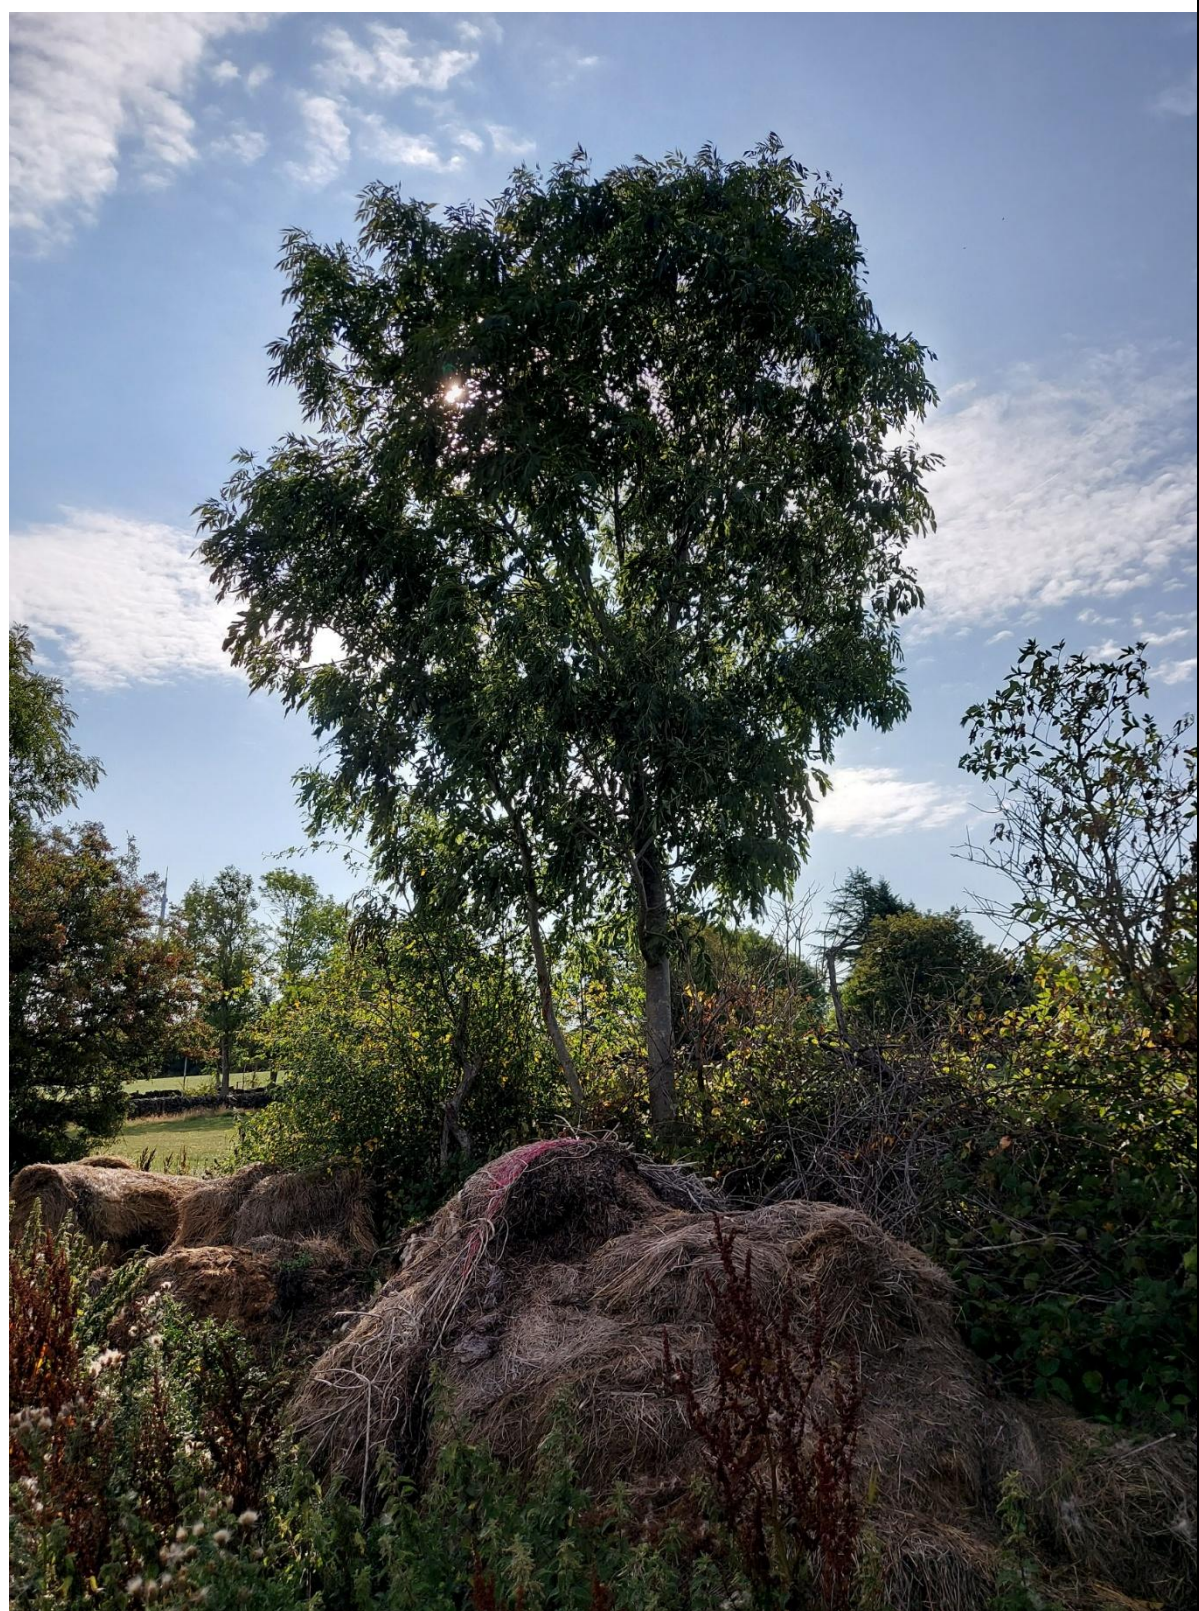
**Photograph 6** (above). T019, Ash, located in the southern half towards the eastern boundary, Viewed looking towards the east.

| Tree Number | Species | Work Requirements | Reason(s) for works |
|---|---|---|---|
| T019 | Ash | Fell to ground level and remove stump | Conflict with proposed properties. |

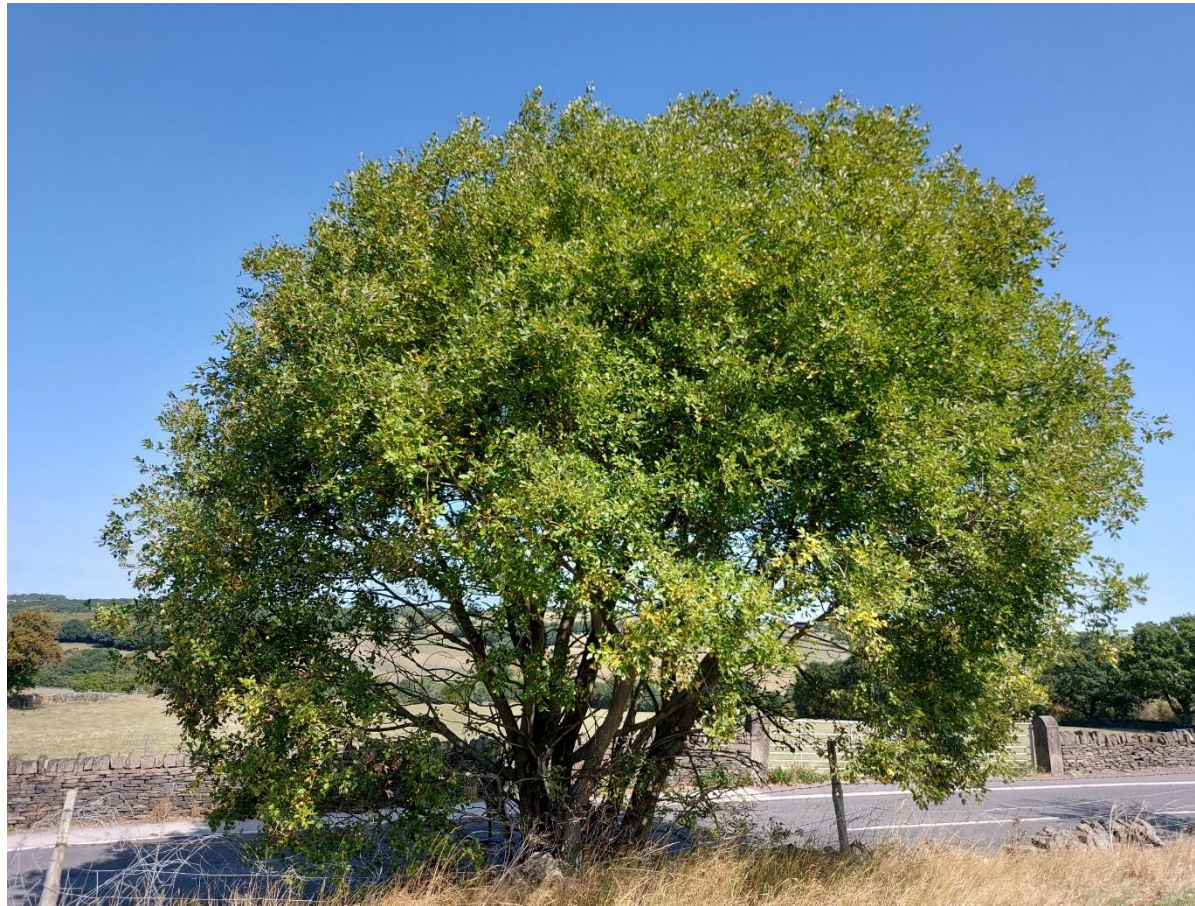
**Photograph 7** (above). T055, Goat willow, located on the northern boundary, Viewed looking towards the north.
