### Demolition Asbestos Survey

### Ground Floor, Holme Park Court, Berry Brow, Huddersfield, HD4 7NH

Issue number:	2
Survey number:	7923.HPC. Ground
Survey date:	Jan 2026
Client:	Metropolitan Demolition
Survey carried out by:	Phil Cox & Graham Brown
Survey compiled by:	Phil Cox & Graham Brown
Survey checked by:	Phil Cox & Graham Brown
Survey Issued	05/02/2026

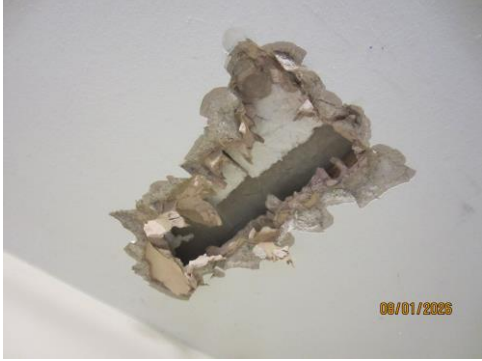
<b>Level of ID:</b>	Visually inspected	<b>Ref:</b>	
	<b>Building / Floor:</b> HPC / Ground <b>Area:</b> R01 Entrance Lobby <b>Location:</b> Ceiling <b>Description:</b> Plasterboard on polystyrene on concrete <b>Asbestos Type:</b> No suspect material <b>Amount:</b>

No action required

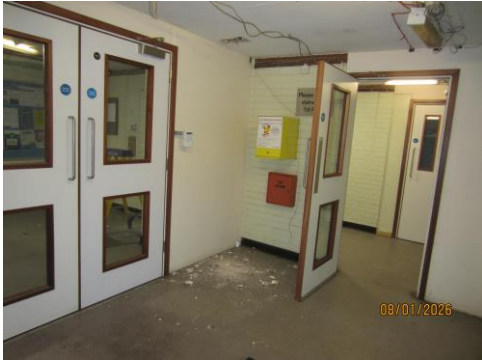
<b>Level of ID:</b>	Visually inspected	<b>Ref:</b>	As S01
	<b>Building / Floor:</b> HPC / Ground <b>Area:</b> R01 Entrance Lobby <b>Location:</b> Wall <b>Description:</b> Concrete, masonry, stud wall <b>Asbestos Type:</b> No asbestos detected <b>Amount:</b>

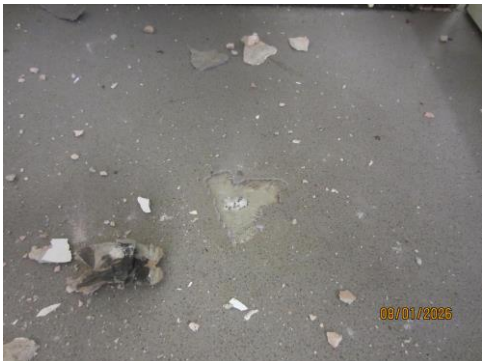
<b>Level of ID:</b>	Visually inspected	<b>Ref:</b>	As S05
	<b>Building / Floor:</b> HPC / Ground <b>Area:</b> R01 Entrance Lobby <b>Location:</b> Floor <b>Description:</b> Bitumen residue to slab below floor covering <b>Asbestos Type:</b> <b>Chrysotile</b> <b>Amount:</b>

Remove in accordance with the Control of Asbestos Regulations 2012 and dispose of as hazardous waste.

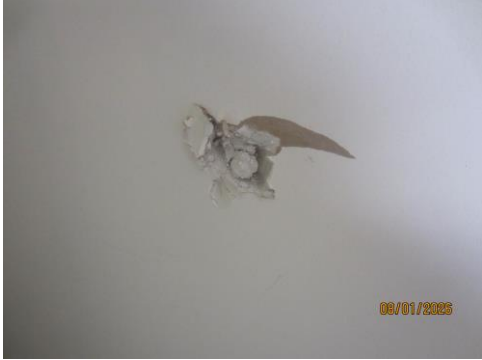
<b>Level of ID:</b>	Sampled	<b>Ref:</b>	S01
	<b>Building / Floor:</b> HPC / Ground <b>Area:</b> R02 Communal Hallway <b>Location:</b> Wall <b>Description:</b> Partition wall <b>Asbestos Type:</b> No asbestos detected <b>Amount:</b>			
<b>Recommendations:</b>				
No action required

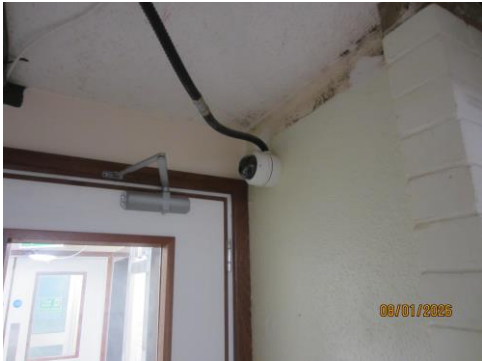
<b>Level of ID:</b>	Sampled	<b>Ref:</b>	S03
	<b>Building / Floor:</b> HPC / Ground <b>Area:</b> R02 Communal Hallway <b>Location:</b> Wall <b>Description:</b> Further samples indicate chrysotile in the wall artex <b>Asbestos Type:</b> Chrysotile <b>Amount:</b> 8m2			
<b>Recommendations:</b>				
Remove in accordance with the Control of Asbestos Regulations 2012 and dispose of as hazardous waste.

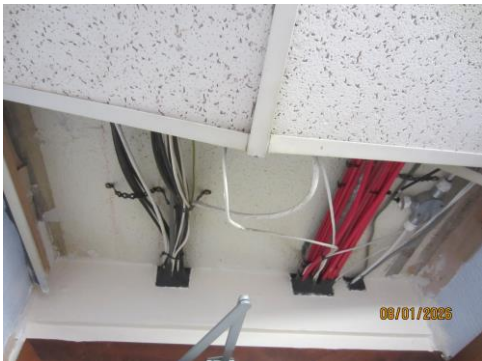
<b>Level of ID:</b>	Visually inspected	<b>Ref:</b>	AS S02
	<b>Building / Floor:</b> HPC / Ground <b>Area:</b> R03 Lobby <b>Location:</b> Ceiling <b>Description:</b> Suspended ceiling below Artex on concrete <b>Asbestos Type:</b> Chrysotile <b>Amount:</b> 4 m2			
<b>Recommendations:</b>				
Remove in accordance with the Control of Asbestos Regulations 2012 and dispose of as hazardous waste.

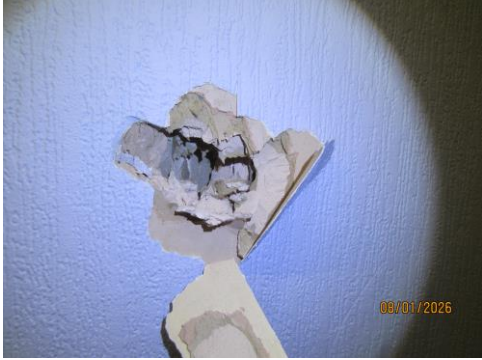
<table border="1"> <tr> <td><b>Level of ID:</b></td> <td>Visually inspected</td> <td><b>Ref:</b></td> <td></td> </tr> </table>	<b>Level of ID:</b>	Visually inspected	<b>Ref:</b>	
	<b>Level of ID:</b>	Visually inspected	<b>Ref:</b>		
<p><b>Building / Floor:</b> HPC / Ground</p> <p><b>Area:</b> R03 Lobby</p> <p><b>Location:</b> Wall</p> <p><b>Description:</b> Masonry/concrete, plasterboard lined</p> <p><b>Asbestos Type:</b> No suspect material</p> <p><b>Amount:</b></p>					
<b>Recommendations:</b>					
No action required

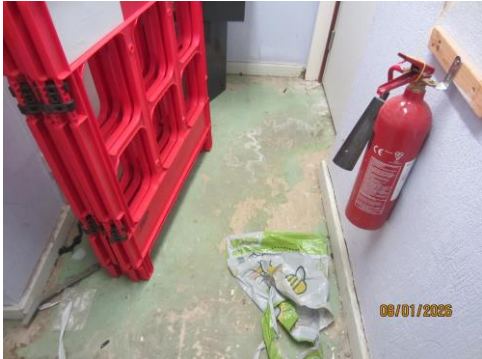
<table border="1"> <tr> <td><b>Level of ID:</b></td> <td>Visually inspected</td> <td><b>Ref:</b></td> <td></td> </tr> </table>	<b>Level of ID:</b>	Visually inspected	<b>Ref:</b>	
	<b>Level of ID:</b>	Visually inspected	<b>Ref:</b>		
<p><b>Building / Floor:</b> HPC / Ground</p> <p><b>Area:</b> R03 Lobby</p> <p><b>Location:</b> Floor</p> <p><b>Description:</b> Bitumen residue to slab below floor covering</p> <p><b>Asbestos Type:</b> No suspect material</p> <p><b>Amount:</b></p>					
<b>Recommendations:</b>					
No action required

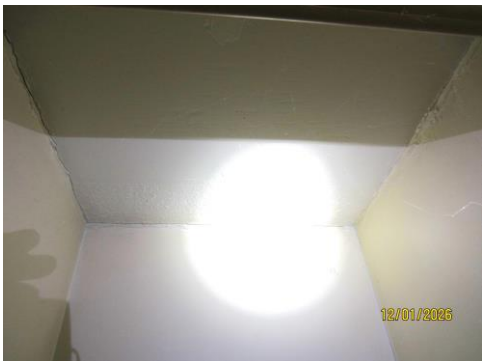
<table border="1"> <tr> <td><b>Level of ID:</b></td> <td>Visually inspected</td> <td><b>Ref:</b></td> <td></td> </tr> </table>	<b>Level of ID:</b>	Visually inspected	<b>Ref:</b>	
	<b>Level of ID:</b>	Visually inspected	<b>Ref:</b>		
<p><b>Building / Floor:</b> HPC / Ground</p> <p><b>Area:</b> R04 Store cupboard</p> <p><b>Location:</b> Ceiling</p> <p><b>Description:</b> Concrete</p> <p><b>Asbestos Type:</b> No suspect material</p> <p><b>Amount:</b></p>					
<b>Recommendations:</b>					
No action required

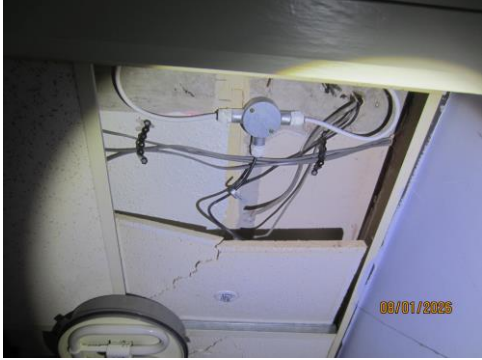
<b>Level of ID:</b>	Visually inspected	<b>Ref:</b>	AS S02
	<b>Building / Floor:</b> HPC / Ground <b>Area:</b> R05 Store cupboard <b>Location:</b> Ceiling <b>Description:</b> Concrete with part artex coating <b>Asbestos Type:</b> Chrysotile <b>Amount:</b> 0.5 m2			
<b>Recommendations:</b>				
Remove in accordance with the Control of Asbestos Regulations 2012 and dispose of as hazardous waste.

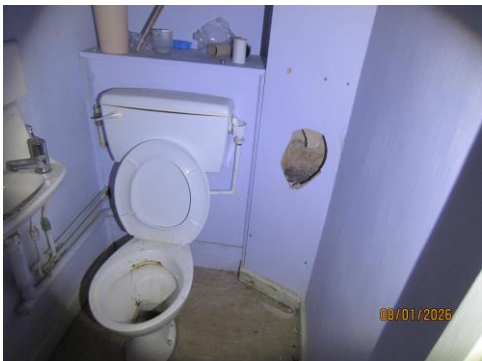
<b>Level of ID:</b>	Visually inspected	<b>Ref:</b>	
	<b>Building / Floor:</b> HPC / Ground <b>Area:</b> R06 Toilet <b>Location:</b> Wall <b>Description:</b> Masonry/concrete, plasterboard lined, Supalux back panel to WC <b>Asbestos Type:</b> No suspect material <b>Amount:</b>			
<b>Recommendations:</b>				
No action required

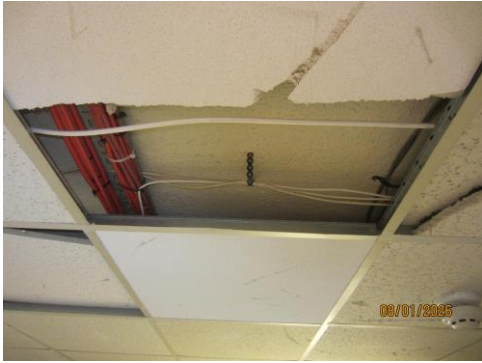
<b>Level of ID:</b>	Sampled	<b>Ref:</b>	S04
	<b>Building / Floor:</b> HPC / Ground <b>Area:</b> R07 Office 5 <b>Location:</b> Ceiling <b>Description:</b> Suspended ceiling below Artex on concrete <b>Asbestos Type:</b> Chrysotile <b>Amount:</b> 19 m2			
<b>Recommendations:</b>				
Remove in accordance with the Control of Asbestos Regulations 2012 and dispose of as hazardous waste.

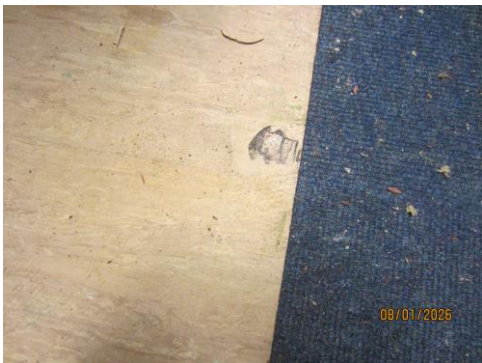
<b>Level of ID:</b>	Sampled	<b>Ref:</b>	S05
	<b>Building / Floor:</b> HPC / Ground <b>Area:</b> R07 Office 5 <b>Location:</b> Floor <b>Description:</b> Bitumen residue to slab below floor covering <b>Asbestos Type:</b> Chrysotile <b>Amount:</b> 19 m2			
<b>Recommendations:</b>				
Remove in accordance with the Control of Asbestos Regulations 2012 and dispose of as hazardous waste.

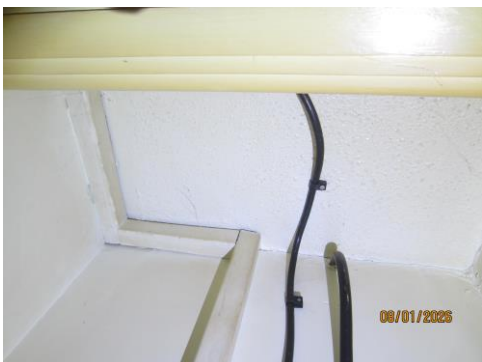
<b>Level of ID:</b>	Visually inspected	<b>Ref:</b>	As S04
	<b>Building / Floor:</b> HPC / Ground <b>Area:</b> R08 Store cupboard <b>Location:</b> Ceiling <b>Description:</b> Artex on concrete <b>Asbestos Type:</b> Chrysotile <b>Amount:</b> 0.5 m2			
<b>Recommendations:</b>				
Remove in accordance with the Control of Asbestos Regulations 2012 and dispose of as hazardous waste.

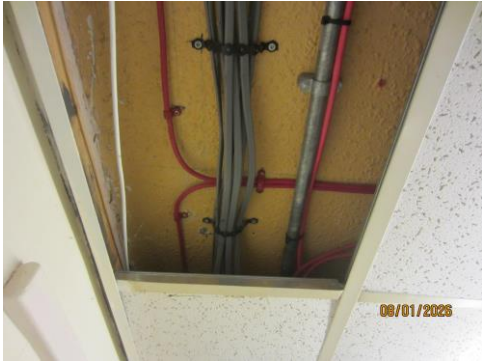
<b>Level of ID:</b>	Visually inspected	<b>Ref:</b>	As S04
	<b>Building / Floor:</b> HPC / Ground <b>Area:</b> R09 Kitchen <b>Location:</b> Ceiling <b>Description:</b> Suspended ceiling below Artex on concrete <b>Asbestos Type:</b> Chrysotile <b>Amount:</b> 3.5 m2			
<b>Recommendations:</b>				
Remove in accordance with the Control of Asbestos Regulations 2012 and dispose of as hazardous waste.

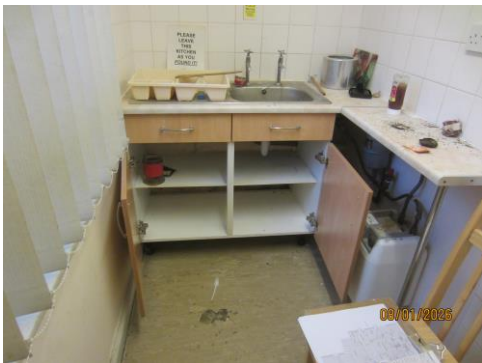
<b>Level of ID:</b>	Visually inspected	<b>Ref:</b>	As S05
	<b>Building / Floor:</b> HPC / Ground <b>Area:</b> R09 Kitchen <b>Location:</b> Floor <b>Description:</b> Bitumen residue to slab below floor covering, modern units <b>Asbestos Type:</b> Chrysotile <b>Amount:</b> 3.5m2			
<b>Recommendations:</b>				
Remove in accordance with the Control of Asbestos Regulations 2012 and dispose of as hazardous waste.

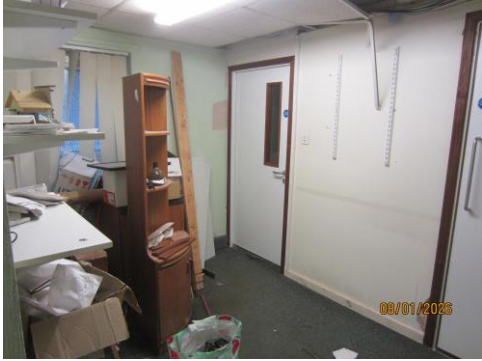
<b>Level of ID:</b>	Visually inspected	<b>Ref:</b>	As S05
	<b>Building / Floor:</b> HPC / Ground <b>Area:</b> R10 Office 4 <b>Location:</b> Floor <b>Description:</b> Bitumen residue to slab below floor covering <b>Asbestos Type:</b> Chrysotile <b>Amount:</b> 12m2			
<b>Recommendations:</b>				
Remove in accordance with the Control of Asbestos Regulations 2012 and dispose of as hazardous waste.

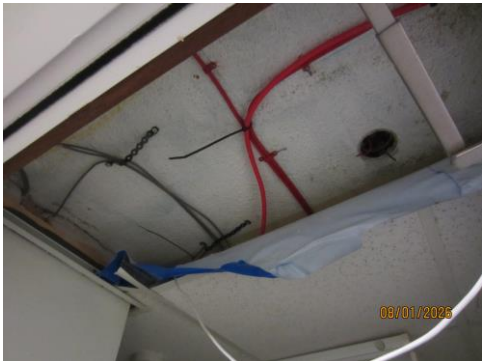
<b>Level of ID:</b>	Visually inspected	<b>Ref:</b>	As S06
	<b>Building / Floor:</b> HPC / Ground <b>Area:</b> R11 Store <b>Location:</b> Ceiling <b>Description:</b> Suspended grid below Artex <b>Asbestos Type:</b> Chrysotile <b>Amount:</b> 6m2			
<b>Recommendations:</b>				
Remove in accordance with the Control of Asbestos Regulations 2012 and dispose of as hazardous waste.

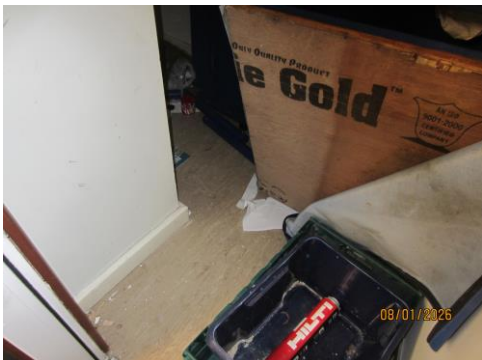
<b>Level of ID:</b>	Visually inspected	<b>Ref:</b>	As S05
	<b>Building / Floor:</b> HPC / Ground <b>Area:</b> R11 Store <b>Location:</b> Floor <b>Description:</b> Bitumen residue to slab below floor covering <b>Asbestos Type:</b> Chrysotile <b>Amount:</b> 6m2			
<b>Recommendations:</b>				
Remove in accordance with the Control of Asbestos Regulations 2012 and dispose of as hazardous waste.

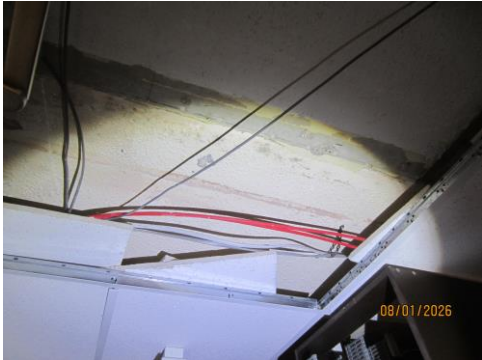
<b>Level of ID:</b>	Visually inspected	<b>Ref:</b>	As S06
	<b>Building / Floor:</b> HPC / Ground <b>Area:</b> R13 Office 3 <b>Location:</b> Ceiling <b>Description:</b> Suspended grid below Artex <b>Asbestos Type:</b> Chrysotile <b>Amount:</b> 10m2

Remove in accordance with the Control of Asbestos Regulations 2012 and dispose of as hazardous waste.

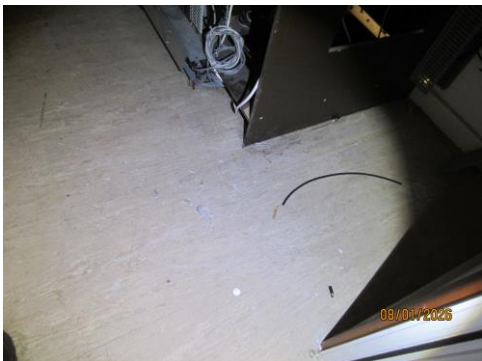
<b>Level of ID:</b>	Sampled	<b>Ref:</b>	S07
	<b>Building / Floor:</b> HPC / Ground <b>Area:</b> R13 Office 3 <b>Location:</b> Floor <b>Description:</b> Bitumen residue to slab below floor covering <b>Asbestos Type:</b> Chrysotile <b>Amount:</b> 10m2

Remove in accordance with the Control of Asbestos Regulations 2012 and dispose of as hazardous waste.

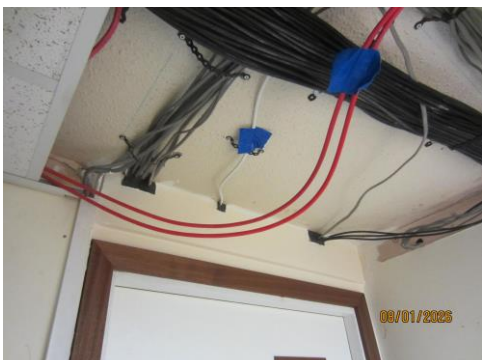
<b>Level of ID:</b>	Visually inspected	<b>Ref:</b>	As S06
	<b>Building / Floor:</b> HPC / Ground <b>Area:</b> R14 Office 2 <b>Location:</b> Ceiling <b>Description:</b> Suspended grid below Artex <b>Asbestos Type:</b> Chrysotile <b>Amount:</b> 9m2

Remove in accordance with the Control of Asbestos Regulations 2012 and dispose of as hazardous waste.

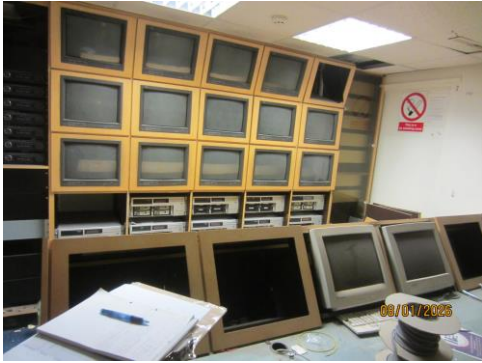
<b>Level of ID:</b>	Visually inspected	<b>Ref:</b>	
	<b>Building / Floor:</b> HPC / Ground <b>Area:</b> R14 Office 2 <b>Location:</b> Wall <b>Description:</b> Concrete, plasterboard lined, stud walls, modern screens & equipment <b>Asbestos Type:</b> No suspect material <b>Amount:</b>			
<b>Recommendations:</b>				
No action required

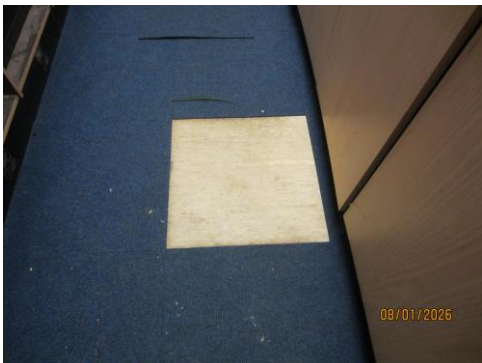
<b>Level of ID:</b>	Visually inspected	<b>Ref:</b>	As S05
	<b>Building / Floor:</b> HPC / Ground <b>Area:</b> R14 Office 2 <b>Location:</b> Floor <b>Description:</b> Bitumen residue to slab below floor covering <b>Asbestos Type:</b> Chrysotile <b>Amount:</b> 9m2			
<b>Recommendations:</b>				
Remove in accordance with the Control of Asbestos Regulations 2012 and dispose of as hazardous waste.

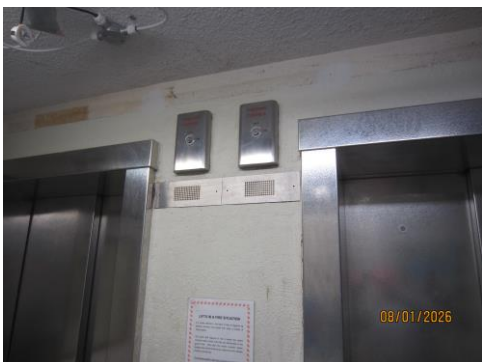
<b>Level of ID:</b>	Visually inspected	<b>Ref:</b>	As S06
	<b>Building / Floor:</b> HPC / Ground <b>Area:</b> R15 Lift Lobby <b>Location:</b> Ceiling <b>Description:</b> Artex on concrete <b>Asbestos Type:</b> Chrysotile <b>Amount:</b> 8m2			
<b>Recommendations:</b>				
Remove in accordance with the Control of Asbestos Regulations 2012 and dispose of as hazardous waste.

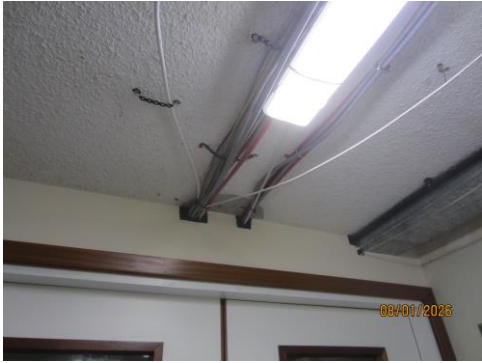
<b>Level of ID:</b>	Sampled	<b>Ref:</b>	S17
	<b>Building / Floor:</b> HPC / Ground <b>Area:</b> R15 Lift Lobby <b>Location:</b> Wall <b>Description:</b> Artex on concrete, modern fire break above the doors <b>Asbestos Type:</b> Chrysotile <b>Amount:</b> 10m2

Remove in accordance with the Control of Asbestos Regulations 2012 and dispose of as hazardous waste.

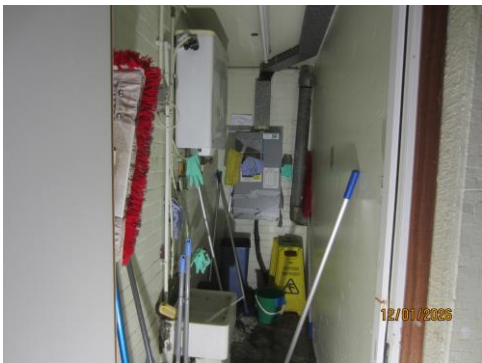
<b>Level of ID:</b>	Visually inspected	<b>Ref:</b>	
	<b>Building / Floor:</b> HPC / Ground <b>Area:</b> R16 Store Room <b>Location:</b> Wall <b>Description:</b> Masonry, modern boiler, electrics & cleaners sink <b>Asbestos Type:</b> No suspect material <b>Amount:</b>

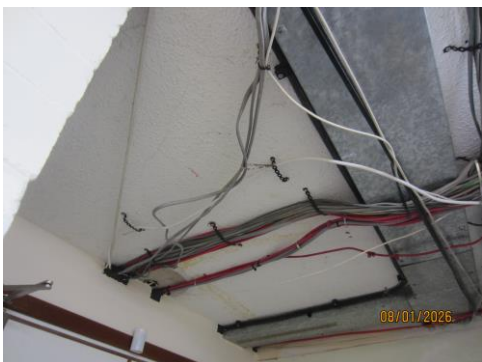
<b>Level of ID:</b>	Visually inspected	<b>Ref:</b>	As S06
	<b>Building / Floor:</b> HPC / Ground <b>Area:</b> R17 Rear Lobby/Corridor <b>Location:</b> Ceiling <b>Description:</b> Artex on concrete <b>Asbestos Type:</b> Chrysotile <b>Amount:</b> 14m2

Remove in accordance with the Control of Asbestos Regulations 2012 and dispose of as hazardous waste.

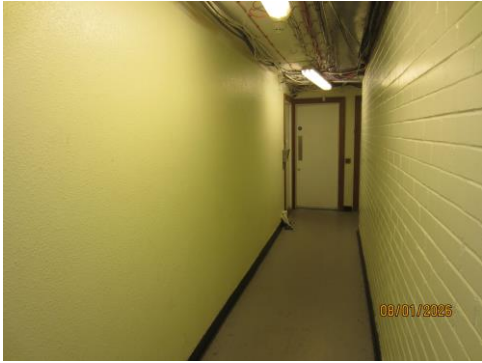
<b>Level of ID:</b>	Visually inspected	<b>Ref:</b>	S18
	<b>Building / Floor:</b> HPC / Ground <b>Area:</b> R17 Rear Lobby/Corridor <b>Location:</b> Wall <b>Description:</b> Artex on concrete <b>Asbestos Type:</b> Chrysotile <b>Amount:</b> 25m2

Remove in accordance with the Control of Asbestos Regulations 2012 and dispose of as hazardous waste.

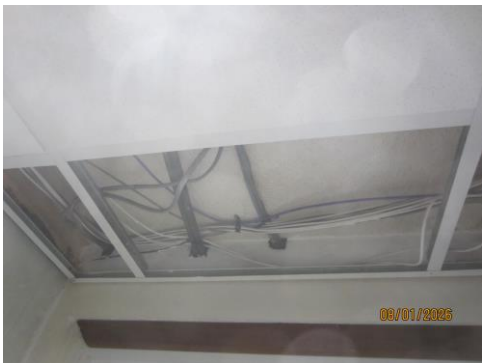
<b>Level of ID:</b>	Visually inspected	<b>Ref:</b>	As S06
	<b>Building / Floor:</b> HPC / Ground <b>Area:</b> R18 Lobby <b>Location:</b> Ceiling <b>Description:</b> Artex on concrete <b>Asbestos Type:</b> Chrysotile <b>Amount:</b> 5m2

Remove in accordance with the Control of Asbestos Regulations 2012 and dispose of as hazardous waste.

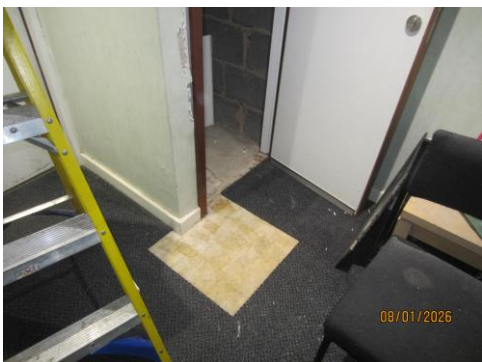
<b>Level of ID:</b>	Visually inspected	<b>Ref:</b>	As S05
	<b>Building / Floor:</b> HPC / Ground <b>Area:</b> R18 Lobby <b>Location:</b> Floor <b>Description:</b> Bitumen residue to slab below floor covering <b>Asbestos Type:</b> Chrysotile <b>Amount:</b> 5m2

Remove in accordance with the Control of Asbestos Regulations 2012 and dispose of as hazardous waste.

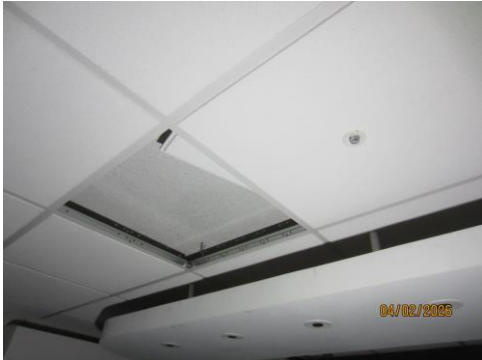
<b>Level of ID:</b>	Sampled	<b>Ref:</b>	S08
	<b>Building / Floor:</b> HPC / Ground <b>Area:</b> R20 Security camera room <b>Location:</b> Ceiling <b>Description:</b> Suspended grid below Artex <b>Asbestos Type:</b> Chrysotile <b>Amount:</b> 40m2

Remove in accordance with the Control of Asbestos Regulations 2012 and dispose of as hazardous waste.

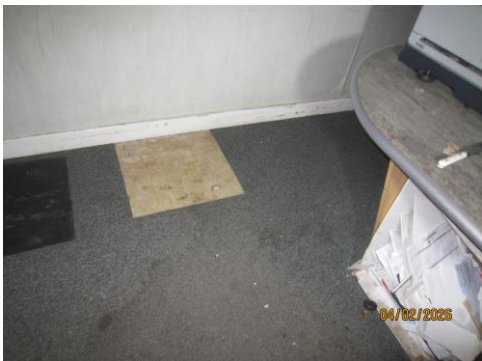
<b>Level of ID:</b>	Sampled	<b>Ref:</b>	S09
	<b>Building / Floor:</b> HPC / Ground <b>Area:</b> R20 Security camera room <b>Location:</b> Floor <b>Description:</b> Bitumen residue to slab below floor covering <b>Asbestos Type:</b> Chrysotile <b>Amount:</b> 40m2

Remove in accordance with the Control of Asbestos Regulations 2012 and dispose of as hazardous waste.

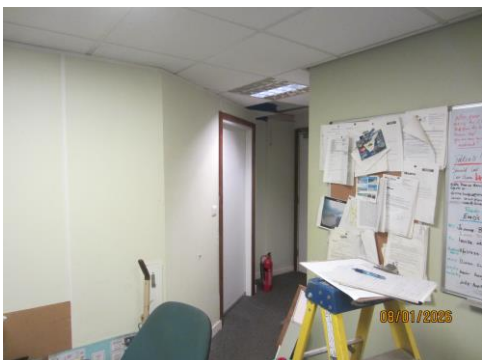
<b>Level of ID:</b>	Visually inspected	<b>Ref:</b>	
	<b>Building / Floor:</b> HPC / Ground <b>Area:</b> R21 Staffroom <b>Location:</b> Wall <b>Description:</b> Concrete, plasterboard lined, stud walls <b>Asbestos Type:</b> No suspect material <b>Amount:</b>

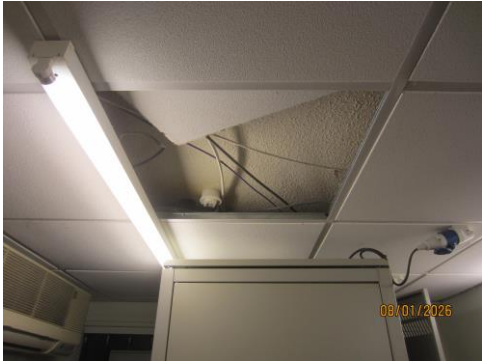
<b>Level of ID:</b>	Visually inspected	<b>Ref:</b>	As S08
	<b>Building / Floor:</b> HPC / Ground <b>Area:</b> R22 Locker Room <b>Location:</b> Ceiling <b>Description:</b> Suspended grid below Artex <b>Asbestos Type:</b> Chrysotile <b>Amount:</b> 12m2			
<b>Recommendations:</b>				
Remove in accordance with the Control of Asbestos Regulations 2012 and dispose of as hazardous waste.

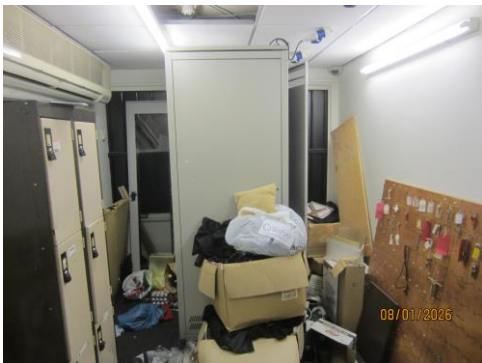
<b>Level of ID:</b>	Visually inspected	<b>Ref:</b>	
	<b>Building / Floor:</b> HPC / Ground <b>Area:</b> R22 Locker Room <b>Location:</b> Wall <b>Description:</b> Concrete, plasterboard lined, stud walls, metal lockers <b>Asbestos Type:</b> No suspect material <b>Amount:</b>			
<b>Recommendations:</b>				
No action required

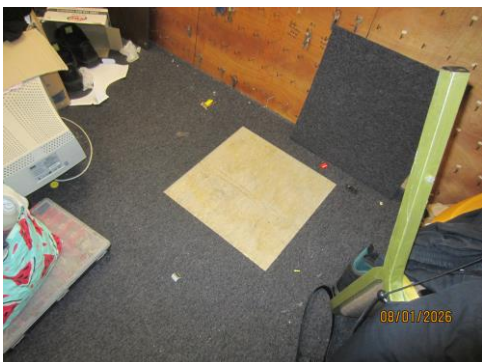
<b>Level of ID:</b>	Visually inspected	<b>Ref:</b>	As S09
	<b>Building / Floor:</b> HPC / Ground <b>Area:</b> R22 Locker Room <b>Location:</b> Floor <b>Description:</b> Bitumen residue to slab below floor covering <b>Asbestos Type:</b> Chrysotile <b>Amount:</b> 12m2			
<b>Recommendations:</b>				
Remove in accordance with the Control of Asbestos Regulations 2012 and dispose of as hazardous waste.

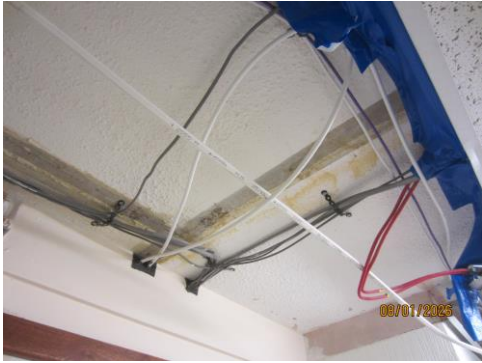
<b>Level of ID:</b>	Visually inspected	<b>Ref:</b>	As S08
	<b>Building / Floor:</b> HPC / Ground <b>Area:</b> R23 Kitchen <b>Location:</b> Ceiling <b>Description:</b> Suspended grid below Artex <b>Asbestos Type:</b> Chrysotile <b>Amount:</b> 6m2			
<b>Recommendations:</b>				
Remove in accordance with the Control of Asbestos Regulations 2012 and dispose of as hazardous waste.

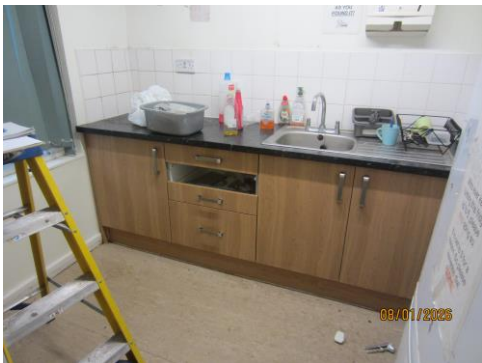
<b>Level of ID:</b>	Visually inspected	<b>Ref:</b>	As S09
	<b>Building / Floor:</b> HPC / Ground <b>Area:</b> R23 Kitchen <b>Location:</b> Floor <b>Description:</b> Bitumen residue to slab below floor covering, modern units <b>Asbestos Type:</b> Chrysotile <b>Amount:</b> 6m2			
<b>Recommendations:</b>				
Remove in accordance with the Control of Asbestos Regulations 2012 and dispose of as hazardous waste.

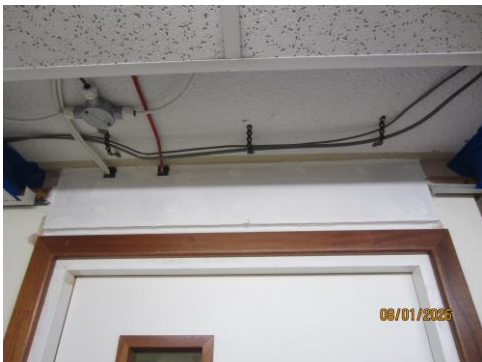
<b>Level of ID:</b>	Visually inspected	<b>Ref:</b>	As S08
	<b>Building / Floor:</b> HPC / Ground <b>Area:</b> R24 Rear Lobby <b>Location:</b> Ceiling <b>Description:</b> Suspended grid below Artex <b>Asbestos Type:</b> Chrysotile <b>Amount:</b> 8m2			
<b>Recommendations:</b>				
Remove in accordance with the Control of Asbestos Regulations 2012 and dispose of as hazardous waste.

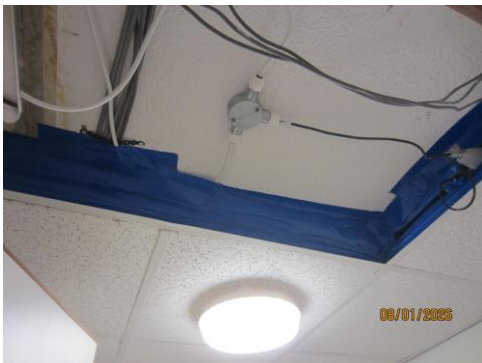
<b>Level of ID:</b>	Visually inspected	<b>Ref:</b>	As S08
	<b>Building / Floor:</b> HPC / Ground <b>Area:</b> R25 Bathroom <b>Location:</b> Ceiling <b>Description:</b> Suspended grid below Artex <b>Asbestos Type:</b> Chrysotile <b>Amount:</b> 5m2			
<b>Recommendations:</b>				
Remove in accordance with the Control of Asbestos Regulations 2012 and dispose of as hazardous waste.

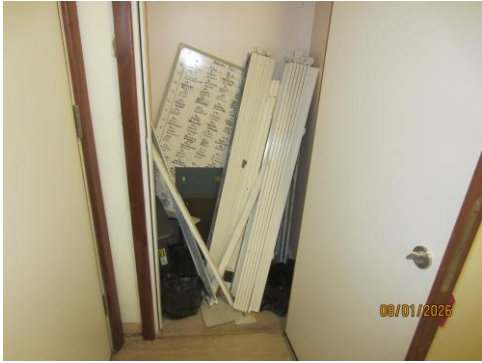
<b>Level of ID:</b>	Visually inspected	<b>Ref:</b>	As S09
	<b>Building / Floor:</b> HPC / Ground <b>Area:</b> R26 Store <b>Location:</b> Floor <b>Description:</b> Bitumen residue to slab below floor covering <b>Asbestos Type:</b> Chrysotile <b>Amount:</b> 5m2

Remove in accordance with the Control of Asbestos Regulations 2012 and dispose of as hazardous waste.

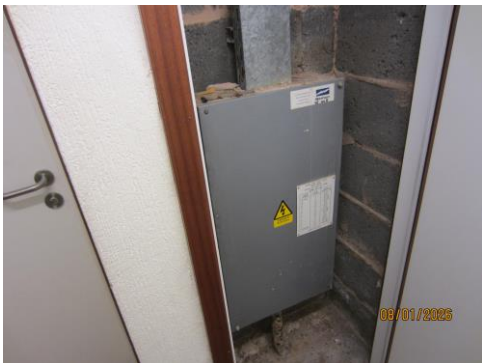
<b>Level of ID:</b>	Visually inspected	<b>Ref:</b>	
	<b>Building / Floor:</b> HPC / Ground <b>Area:</b> R27 Store <b>Location:</b> Wall <b>Description:</b> Masonry, modern electrics <b>Asbestos Type:</b> No suspect material <b>Amount:</b>

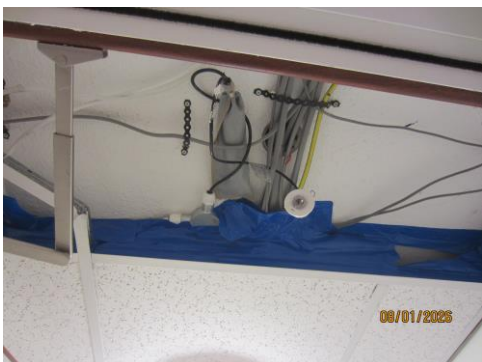
<b>Level of ID:</b>	Visually inspected	<b>Ref:</b>	As S08
	<b>Building / Floor:</b> HPC / Ground <b>Area:</b> R28 Bathroom <b>Location:</b> Ceiling <b>Description:</b> Suspended grid below Artex, artex in boxed area <b>Asbestos Type:</b> Chrysotile <b>Amount:</b> 5m2

Remove in accordance with the Control of Asbestos Regulations 2012 and dispose of as hazardous waste.

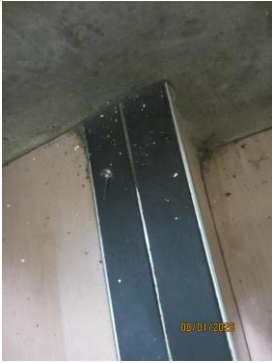
<b>Level of ID:</b>	Visually inspected	<b>Ref:</b>	
	<b>Building / Floor:</b> HPC / Ground <b>Area:</b> R28 Bathroom <b>Location:</b> Wall <b>Description:</b> Concrete, plasterboard lined, stud walls, supalux IPS panel <b>Asbestos Type:</b> No suspect material <b>Amount:</b>			
<b>Recommendations:</b>				
No action required

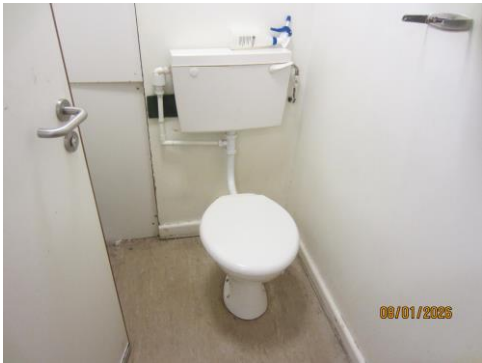
<b>Level of ID:</b>	Visually inspected	<b>Ref:</b>	As S09
	<b>Building / Floor:</b> HPC / Ground <b>Area:</b> R28 Bathroom <b>Location:</b> Floor <b>Description:</b> Bitumen residue to slab below floor covering, modern sanitaryware & fittings <b>Asbestos Type:</b> <b>Chrysotile</b> <b>Amount:</b> 5m2			
<b>Recommendations:</b>				
Remove in accordance with the Control of Asbestos Regulations 2012 and dispose of as hazardous waste.

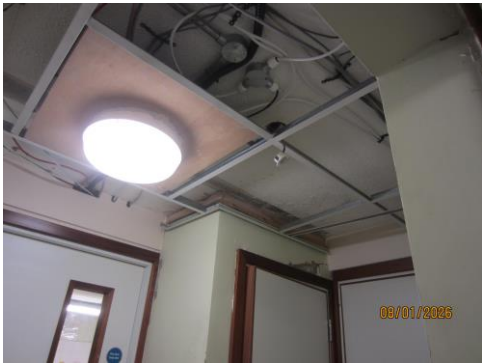
<b>Level of ID:</b>	Visually inspected	<b>Ref:</b>	As S08
	<b>Building / Floor:</b> HPC / Ground <b>Area:</b> R29 Hallway <b>Location:</b> Ceiling <b>Description:</b> Suspended grid below Artex <b>Asbestos Type:</b> <b>Chrysotile</b> <b>Amount:</b> 5m2			
<b>Recommendations:</b>				
Remove in accordance with the Control of Asbestos Regulations 2012 and dispose of as hazardous waste.

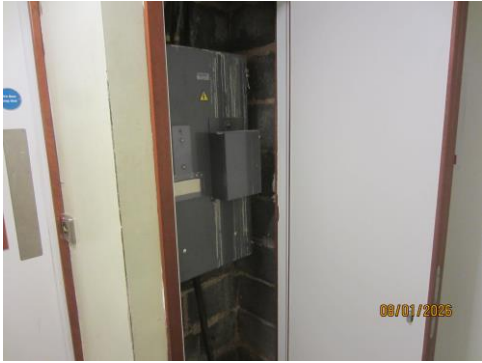
<b>Level of ID:</b>	Visually inspected	<b>Ref:</b>	
	<b>Building / Floor:</b> HPC / Ground <b>Area:</b> R30 Cupboard <b>Location:</b> Wall <b>Description:</b> Masonry, modern electrics <b>Asbestos Type:</b> No suspect material <b>Amount:</b>			
<b>Recommendations:</b>				
No action required

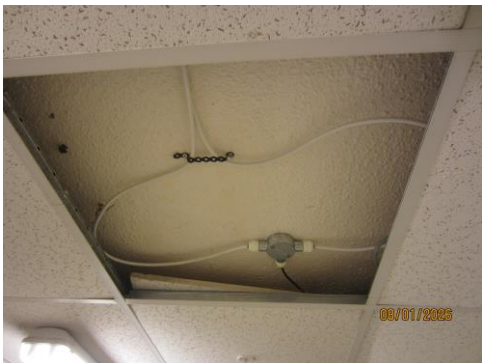
<b>Level of ID:</b>	Sampled	<b>Ref:</b>	S10
	<b>Building / Floor:</b> HPC / Ground <b>Area:</b> R31 Laundry room <b>Location:</b> Ceiling <b>Description:</b> Suspended grid below Artex <b>Asbestos Type:</b> Chrysotile <b>Amount:</b> 24m2			
<b>Recommendations:</b>				
Remove in accordance with the Control of Asbestos Regulations 2012 and dispose of as hazardous waste.
