Demolition Asbestos Survey

In accordance with HSG264 - Asbestos: The Survey Guide

Floors 13 to 17, Holme Park Court, Berry Brow, Huddersfield, HD4 7NH

Issue number:	1
Survey number:	7923 HPC 13 - 17
Survey date:	January 2026
Client:	Metropolitan Demolition
Survey carried out by:	Phil Cox & Graham Brown
Survey compiled by:	Phil Cox & Graham Brown
Survey checked by:	Phil Cox & Graham Brown
Survey Issued	09/02/2026

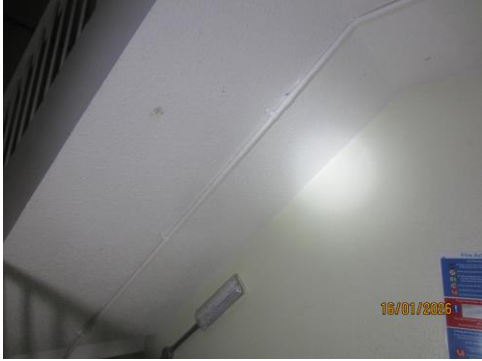
Level of ID:	Sampled	Ref:	S01
	Building / Floor: HPC / Thirteenth Area: Communal, R01 Stairs Location: Ceiling Description: Artex on concrete Asbestos Type: Chrysotile Amount: 10 m2

Remove artex in accordance with the Control of Asbestos Regulations 2012 and dispose of as hazardous waste.

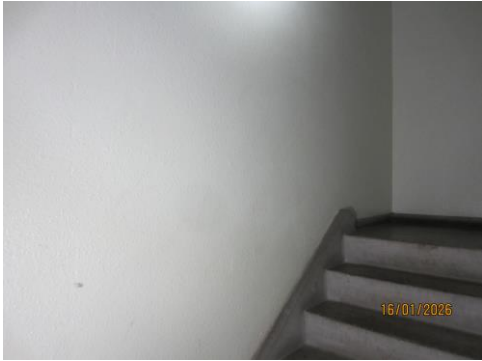
Level of ID:	Sampled	Ref:	S02
	Building / Floor: HPC / Thirteenth Area: Communal, R01 Stairs Location: Wall Description: Artex on concrete Asbestos Type: Chrysotile Amount: 25 m2

Remove artex in accordance with the Control of Asbestos Regulations 2012 and dispose of as hazardous waste.

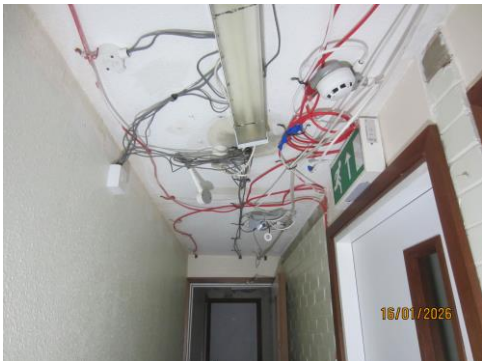
Level of ID:	Visually inspected	Ref:	As S01
	Building / Floor: HPC / Thirteenth Area: Communal, R02 Landing Location: Ceiling Description: Artex on concrete Asbestos Type: Chrysotile Amount: 4 m2

Remove artex in accordance with the Control of Asbestos Regulations 2012 and dispose of as hazardous waste.

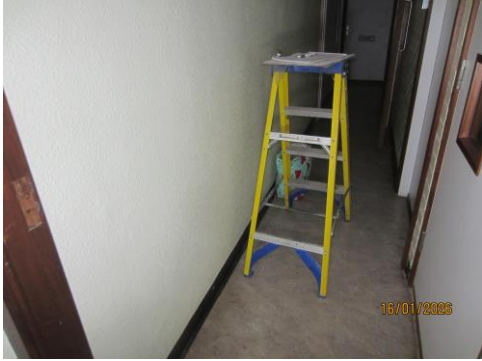
Level of ID:	Visually inspected	Ref:	As S04
	<p>Building / Floor: HPC / Thirteenth</p> <p>Area: Communal, R02 Landing</p> <p>Location: Floor</p> <p>Description: Bitumen on floor slab below floor covering</p> <p>Asbestos Type: Chrysotile</p> <p>Amount: 4 m2</p>

Remove bitumen in accordance with the Control of Asbestos Regulations 2012 and dispose of as hazardous waste.

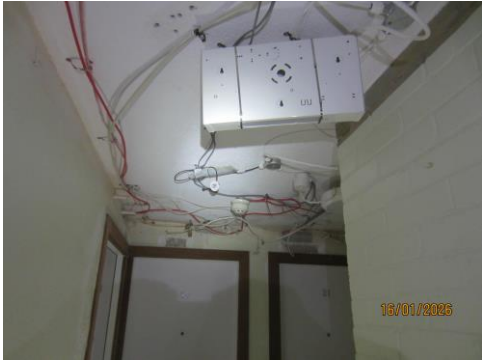
Level of ID:	Visually inspected	Ref:	As S01
	<p>Building / Floor: HPC / Thirteenth</p> <p>Area: Communal, R03 Corridor</p> <p>Location: Ceiling</p> <p>Description: Artex on concrete</p> <p>Asbestos Type: Chrysotile</p> <p>Amount: 6 m2</p>

Remove artex in accordance with the Control of Asbestos Regulations 2012 and dispose of as hazardous waste.

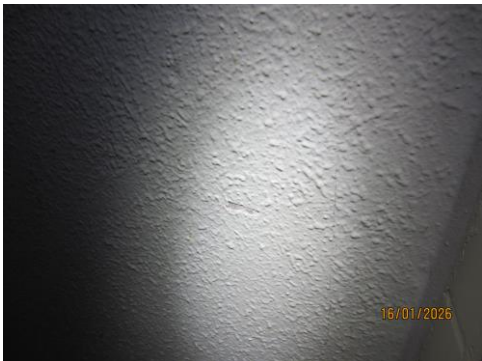
Level of ID:	Sampled	Ref:	S03
	<p>Building / Floor: HPC / Thirteenth</p> <p>Area: Communal, R03 Corridor</p> <p>Location: Wall</p> <p>Description: Artex on concrete, masonry, stud wall</p> <p>Asbestos Type: Chrysotile</p> <p>Amount: 12 m2</p>

Remove artex in accordance with the Control of Asbestos Regulations 2012 and dispose of as hazardous waste.

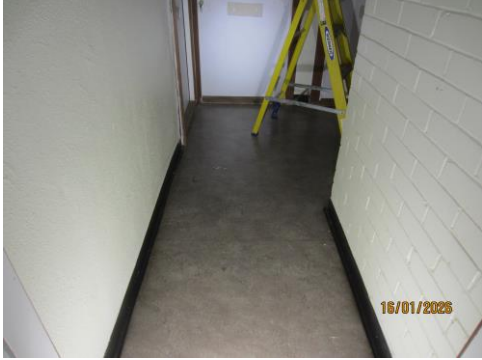
Level of ID: Visually inspected	Ref: As S04
	Building / Floor: HPC / Thirteenth Area: Communal, R03 Corridor Location: Floor Description: Bitumen on floor slab below floor covering Asbestos Type: Chrysotile Amount: 6 m2

Remove bitumen in accordance with the Control of Asbestos Regulations 2012 and dispose of as hazardous waste.

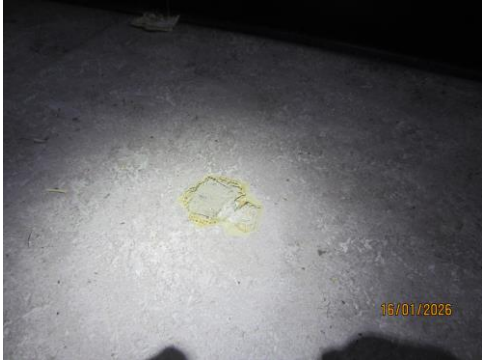
Level of ID: Sampled	Ref: S04
	Building / Floor: HPC / Thirteenth Area: Communal, R04 Corridor Location: Floor Description: Bitumen on floor slab below floor covering Asbestos Type: Chrysotile Amount: 7 m2

Remove bitumen in accordance with the Control of Asbestos Regulations 2012 and dispose of as hazardous waste.

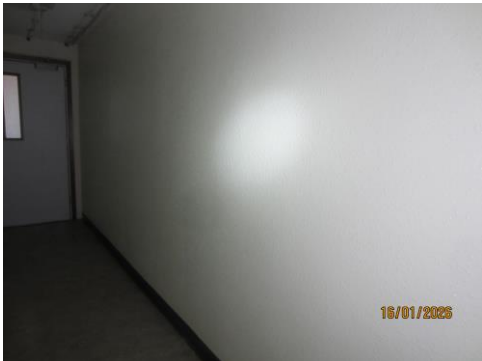
Level of ID: Sampled	Ref: S05
	Building / Floor: HPC / Thirteenth Area: Communal, R05 Corridor Location: Wall Description: Artex on concrete, masonry Asbestos Type: Chrysotile Amount: 20 m2

Remove artex in accordance with the Control of Asbestos Regulations 2012 and dispose of as hazardous waste.

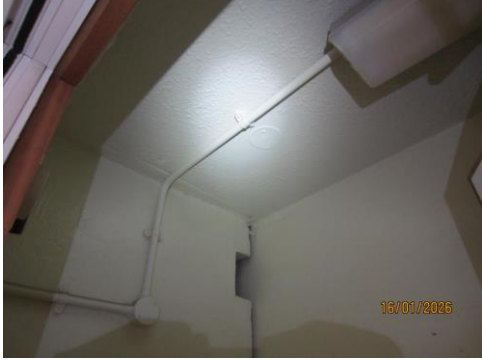
Level of ID:	Visually inspected	Ref:	As S05
	Building / Floor: HPC / Thirteenth Area: Communal, R07 Refuse chute room Location: Wall Description: Artex on concrete, masonry Asbestos Type: Chrysotile Amount: 8 m2

Remove artex in accordance with the Control of Asbestos Regulations 2012 and dispose of as hazardous waste.

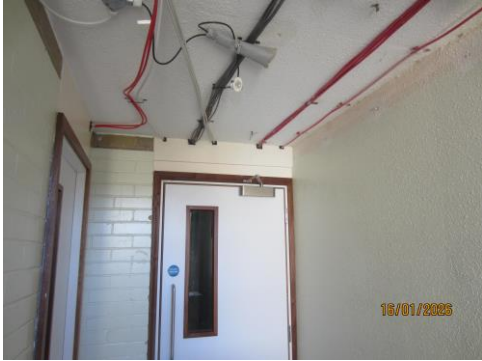
Level of ID:	Visually inspected	Ref:	As S01
	Building / Floor: HPC / Thirteenth Area: Communal, R08 Corridor Location: Ceiling Description: Artex on concrete Asbestos Type: Chrysotile Amount: 5 m2

Remove artex in accordance with the Control of Asbestos Regulations 2012 and dispose of as hazardous waste.

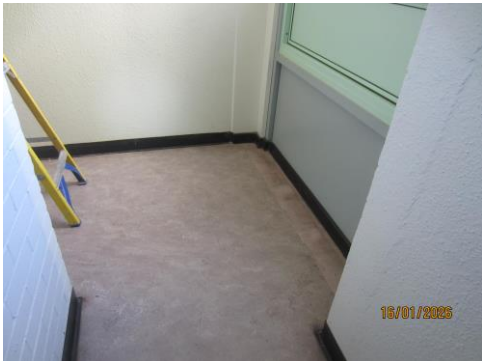
Level of ID:	Visually inspected	Ref:	As S04
	Building / Floor: HPC / Thirteenth Area: Communal, R08 Corridor Location: Floor Description: Bitumen on floor slab below floor covering Asbestos Type: Chrysotile Amount: 5 m2

Remove bitumen in accordance with the Control of Asbestos Regulations 2012 and dispose of as hazardous waste.

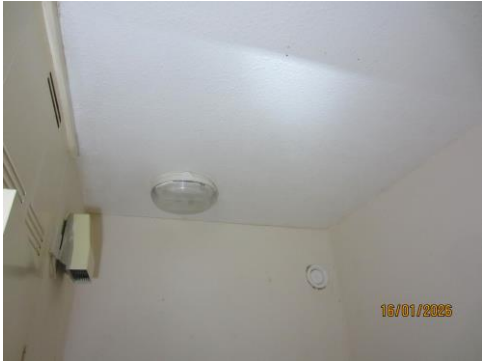
Level of ID:	Visually inspected	Ref:	As S01
	Building / Floor: HPC / Thirteenth Area: Flat 22, R01 Hallway Location: Ceiling Description: Artex on concrete Asbestos Type: Chrysotile Amount: 4 m2

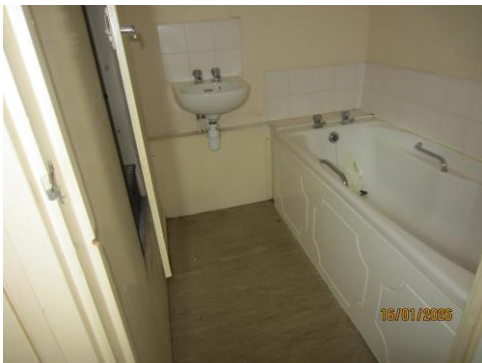
Level of ID:	Visually inspected	Ref:	As S04
	Building / Floor: HPC / Thirteenth Area: Flat 22, R02 Bathroom Location: Floor Description: Bitumen on floor slab below floor covering, modern sanitaryware & fittings Asbestos Type: Chrysotile Amount: 1 m2

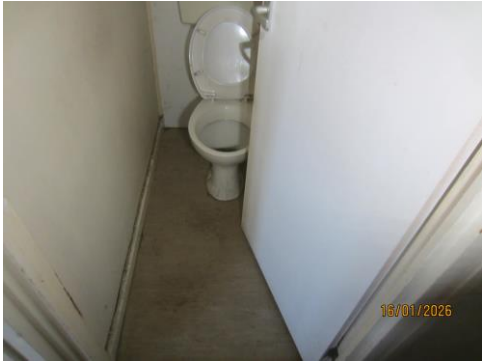
Level of ID:	Visually inspected	Ref:	As S04
	Building / Floor: HPC / Thirteenth Area: Flat 22 R06 Toilet Location: Floor Description: Bitumen on floor slab below floor covering Asbestos Type: Chrysotile Amount: 1.5 m2

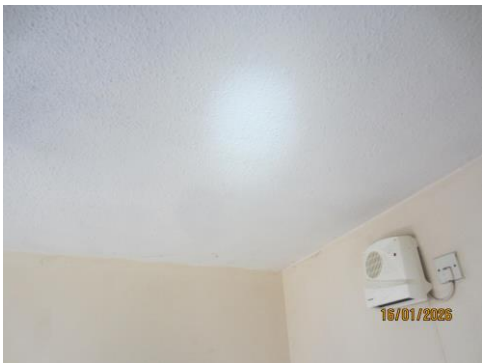
Level of ID:	Sampled	Ref:	S06
	Building / Floor: HPC / Thirteenth Area: Flat 22 R07 Kitchen Location: Ceiling Description: Artex on concrete Asbestos Type: Chrysotile Amount: 3.5 m2

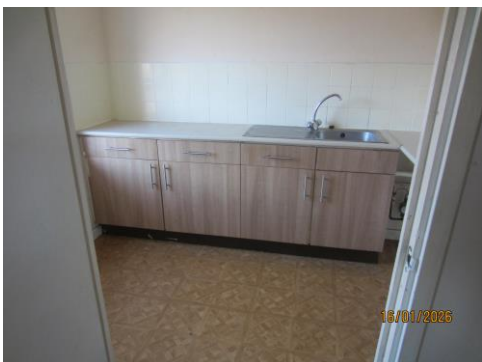
Level of ID:	Visually inspected	Ref:	As S04
	Building / Floor: HPC / Thirteenth Area: Flat 22 R07 Kitchen Location: Floor Description: Bitumen on floor slab below floor covering, modern units & fittings Asbestos Type: Chrysotile Amount: 3.5 m2

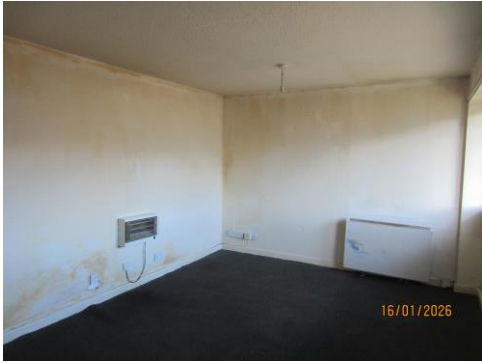
Level of ID:	Visually inspected	Ref:	As S06
	Building / Floor: HPC / Thirteenth Area: Flat 22 R08 Lounge Location: Ceiling Description: Artex on concrete Asbestos Type: Chrysotile Amount: 14 m2

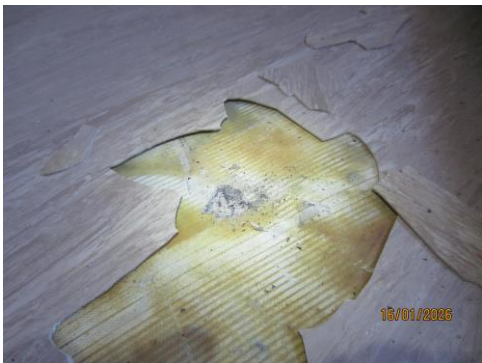
Level of ID:	Sampled	Ref:	S07
	Building / Floor: HPC / Thirteenth Area: Flat 22 R09 Bedroom Location: Floor Description: Bitumen on floor slab below floor covering Asbestos Type: Chrysotile Amount: 11 m2

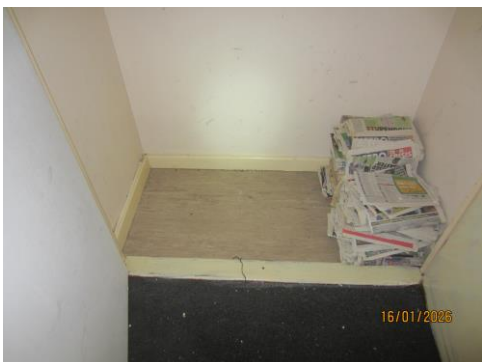
Level of ID:	Visually inspected	Ref:	As S07
	Building / Floor: HPC / Thirteenth Area: Flat 22 R10 Cupboard Location: Floor Description: Bitumen on floor slab below floor covering Asbestos Type: Chrysotile Amount: 1 m2

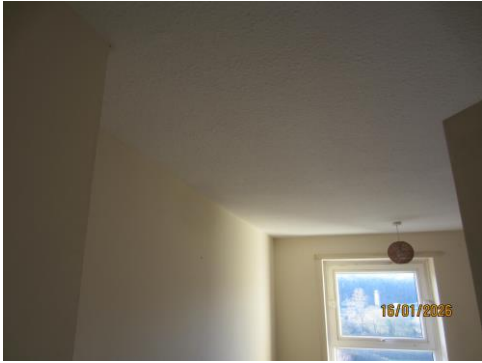
Level of ID:	Visually inspected	Ref:	As S06
	Building / Floor: HPC / Thirteenth Area: Flat 19 to 21 & 23 to 24 Location: Ceiling Description: Artex on concrete Asbestos Type: Chrysotile Amount: 168 m2

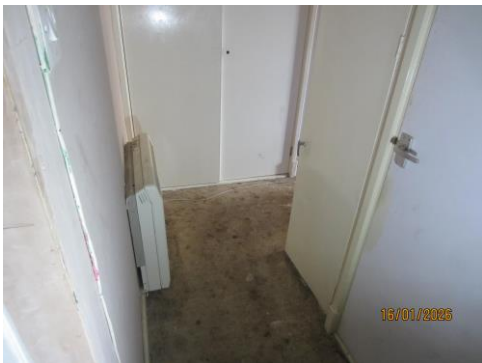
Level of ID:	Visually inspected	Ref:	As S07
	Building / Floor: HPC / Thirteenth Area: Flat 19 to 21 & 23 to 24 Location: Floor Description: Bitumen on floor slab below floor covering Asbestos Type: Chrysotile Amount: 163 m2

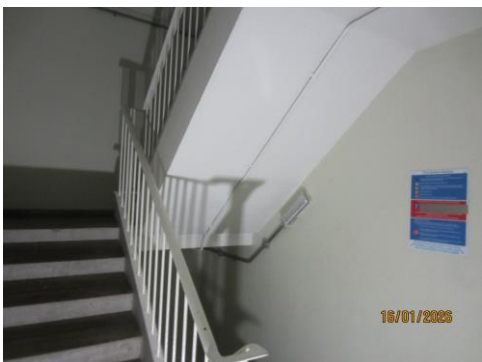
Level of ID:	Visually inspected	Ref:	As S06
	Building / Floor: HPC / Fourteenth Area: Communal areas Location: Ceiling Description: Artex on concrete Asbestos Type: Chrysotile Amount: 44 m2

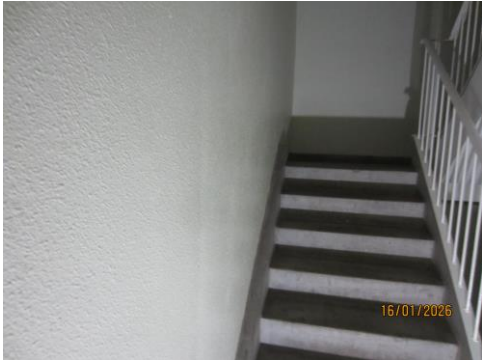
Level of ID:	Visually inspected	Ref:	As S05
	Building / Floor: HPC / Fourteenth Area: Communal areas Location: Wall Description: Artex on concrete Asbestos Type: Chrysotile Amount: 101 m2

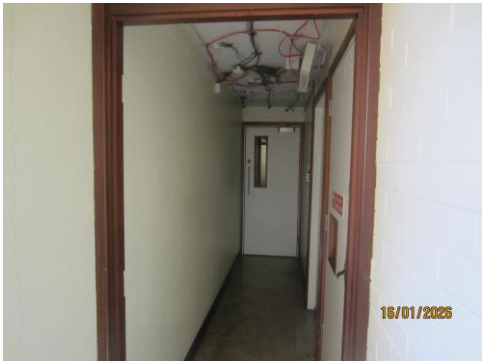
Level of ID:	Visually inspected	Ref:	As S07
	Building / Floor: HPC / Fourteenth Area: Communal areas Location: Floor Description: Bitumen on floor slab below floor covering Asbestos Type: Chrysotile Amount: 34 m2

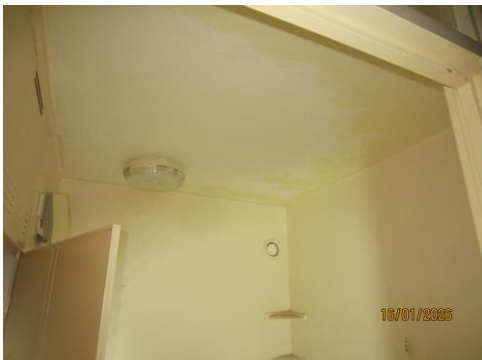
Level of ID:	Visually inspected	Ref:	As S06
	Building / Floor: HPC / Fourteenth Area: Flats 13 to 18 Location: Ceiling Description: Artex on concrete Asbestos Type: Chrysotile Amount: 205 m2

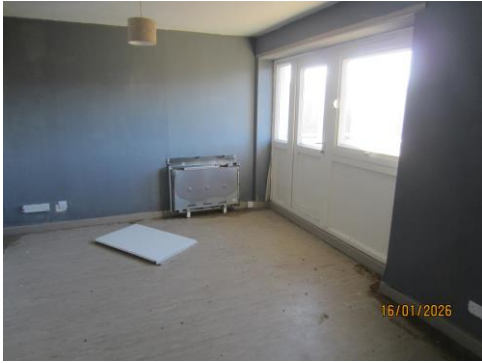
Level of ID:	Visually inspected	Ref:	As S07
	Building / Floor: HPC / Fourteenth Area: Flats 13 to 18 Location: Floor Description: Bitumen on floor slab below floor covering Asbestos Type: Chrysotile Amount: 199 m2

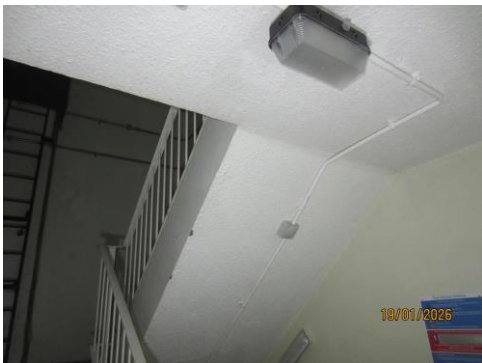
Level of ID:	Sampled	Ref:	S01
	Building / Floor: HPC / Fifteenth Area: Communal, R01 Stairs Location: Ceiling Description: Artex on concrete Asbestos Type: Chrysotile Amount: 10 m2

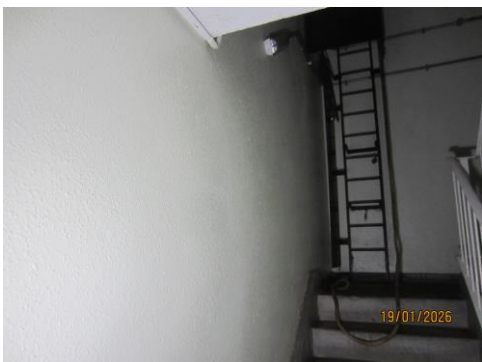
Level of ID:	Sampled	Ref:	S02
	Building / Floor: HPC / Fifteenth Area: Communal, R01 Stairs Location: Wall Description: Artex on concrete Asbestos Type: Chrysotile Amount: 25 m2

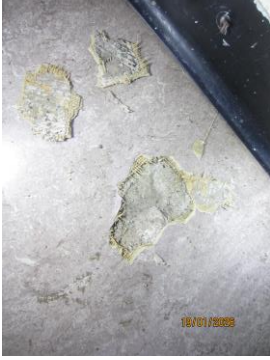
Level of ID:	Sampled	Ref:	S03
	Building / Floor: HPC / Fifteenth Area: Communal, R02 Landing Location: Floor Description: Bitumen on floor slab below floor covering Asbestos Type: Chrysotile Amount: 4 m2

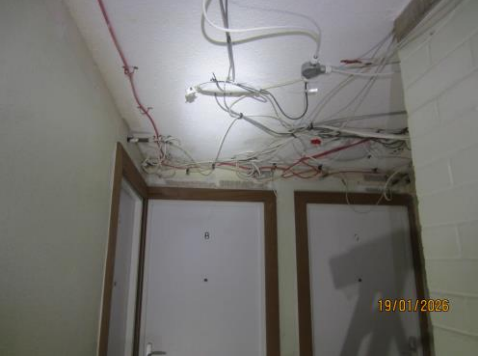
Level of ID:	Visually inspected	Ref:	As S02
	Building / Floor: HPC / Fifteenth Area: Communal, R03 Corridor Location: Wall Description: Artex on concrete, masonry, stud wall Asbestos Type: Chrysotile Amount: 12 m2

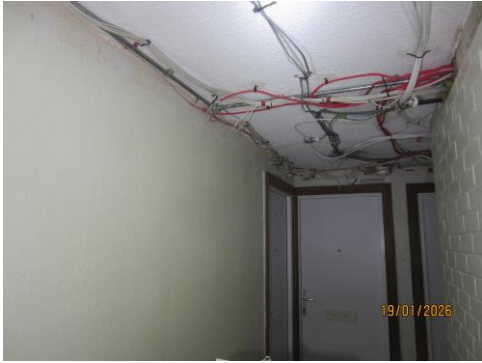
Level of ID:	Sampled	Ref:	S05
	Building / Floor: HPC / Fifteenth Area: Communal, R05 Corridor Location: Ceiling Description: Artex on concrete Asbestos Type: Chrysotile Amount: 10 m2

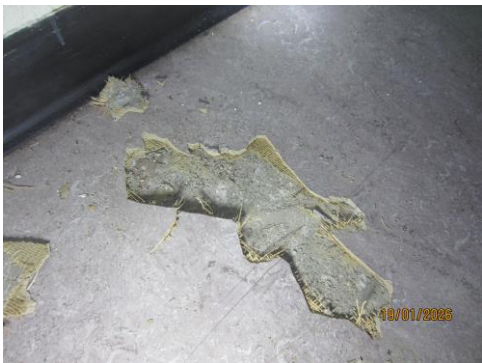
Level of ID:	Sampled	Ref:	S07
	Building / Floor: HPC / Fifteenth Area: Communal, R05 Corridor Location: Floor Description: Bitumen on floor slab below floor covering Asbestos Type: Chrysotile Amount: 10 m2

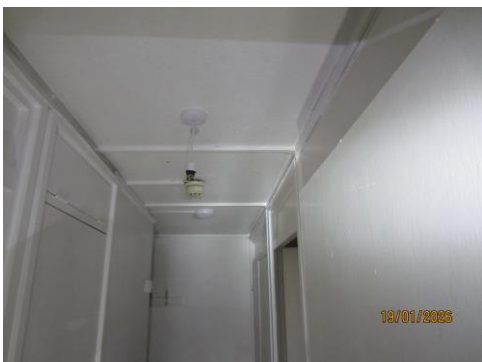
Level of ID:	Visually inspected	Ref:	As S05
	Building / Floor: HPC / Fifteenth Area: Flat 7, R01 Hallway Location: Ceiling Description: Artex on concrete Asbestos Type: Chrysotile Amount: 4 m2

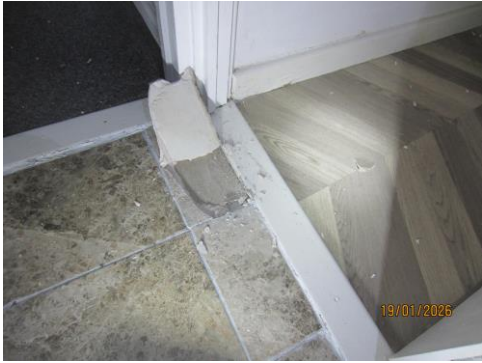
Level of ID:	Visually inspected	Ref:	As S07
	<p>Building / Floor: HPC / Fifteenth</p> <p>Area: Flat 7, R01 Hallway</p> <p>Location: Floor</p> <p>Description: Bitumen on floor slab below floor covering</p> <p>Asbestos Type: Chrysotile</p> <p>Amount: 4 m2</p>

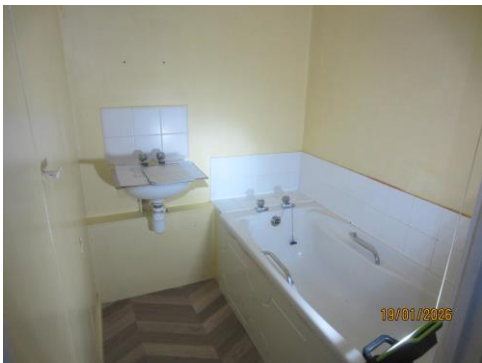
Level of ID:	Visually inspected	Ref:	As S07
	<p>Building / Floor: HPC / Fifteenth</p> <p>Area: Flat 7, R02 Bathroom</p> <p>Location: Floor</p> <p>Description: Bitumen on floor slab below floor covering, modern sanitaryware & fittings</p> <p>Asbestos Type: Chrysotile</p> <p>Amount: 1 m2</p>

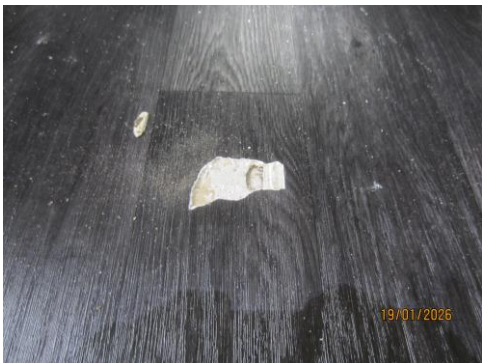
Level of ID:	Sampled	Ref:	S10
	Building / Floor: HPC / Fifteenth Area: Flat 7 R07 Kitchen Location: Floor Description: Bitumen on floor slab below floor covering, modern units & fittings Asbestos Type: Chrysotile Amount: 3.5 m2			
Recommendations:				
Remove bitumen in accordance with the Control of Asbestos Regulations 2012 and dispose of as hazardous waste.

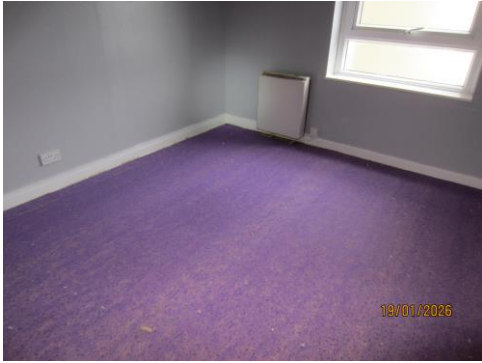
Level of ID:	Visually inspected	Ref:	As S10
	Building / Floor: HPC / Fifteenth Area: Flat 7 R09 Bedroom Location: Floor Description: Bitumen on floor slab below floor covering Asbestos Type: Chrysotile Amount: 11 m2

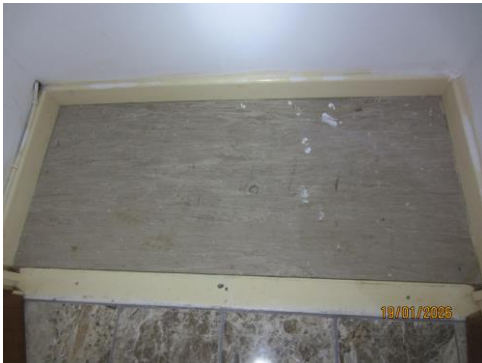
Level of ID:	Sampled	Ref:	S09
	Building / Floor: HPC / Fifteenth Area: Flat 7 R10 Cupboard Location: Floor Description: Bitumen on floor slab below floor covering Asbestos Type: Chrysotile Amount: 1 m2

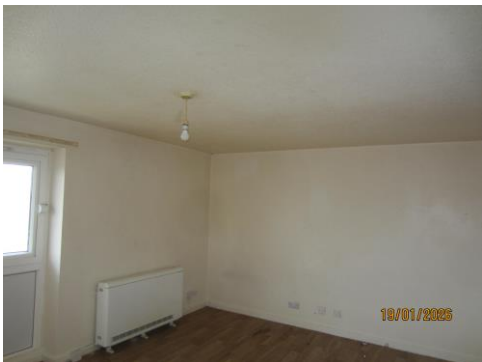
Level of ID:	Visually inspected	Ref:	As S08
	Building / Floor: HPC / Fifteenth Area: Flat 8 to 12 Location: Ceiling Description: Artex on concrete Asbestos Type: Chrysotile Amount: 168 m2

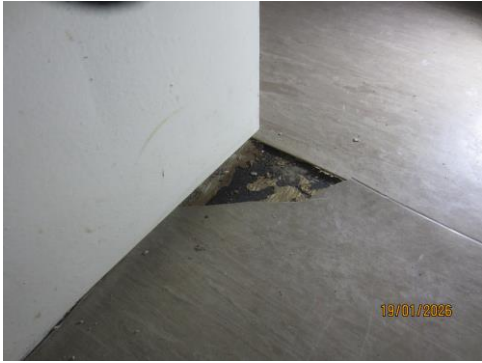
Level of ID:	Visually inspected	Ref:	As S10
	Building / Floor: HPC / Fifteenth Area: Flat 8 to 12 Location: Floor Description: Bitumen on floor slab below floor covering Asbestos Type: Chrysotile Amount: 163 m2			
Recommendations:				
Remove bitumen in accordance with the Control of Asbestos Regulations 2012 and dispose of as hazardous waste.

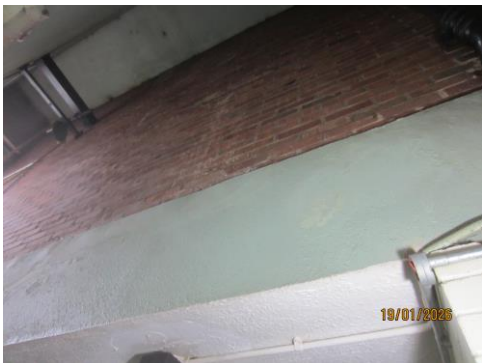
Level of ID:	Sampled	Ref:	As S02
	Building / Floor: HPC / Sixteenth Area: Communal, R01 Stairs void to lift motor room Location: Wall Description: Artex on concrete, cat ladder to lift motor room Asbestos Type: Chrysotile Amount: 12 m2			
Recommendations:				
Remove in accordance with the Control of Asbestos Regulations 2012 and dispose of as hazardous waste.

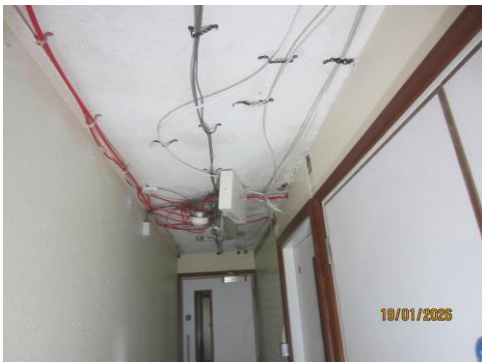
Level of ID:	Visually inspected	Ref:	As S08
	Building / Floor: HPC / Sixteenth Area: Communal areas Location: Ceiling Description: Artex on concrete Asbestos Type: Chrysotile Amount: 44 m2			
Recommendations:				
Remove artex in accordance with the Control of Asbestos Regulations 2012 and dispose of as hazardous waste.

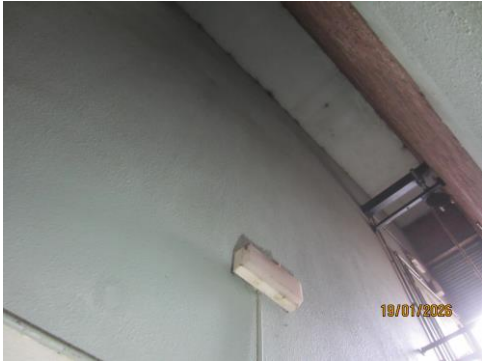
Level of ID:	Visually inspected	Ref:	As S06
	Building / Floor: HPC / Sixteenth Area: Communal areas Location: Wall Description: Artex on concrete Asbestos Type: Chrysotile Amount: 101 m2			
Recommendations:				
Remove artex in accordance with the Control of Asbestos Regulations 2012 and dispose of as hazardous waste.

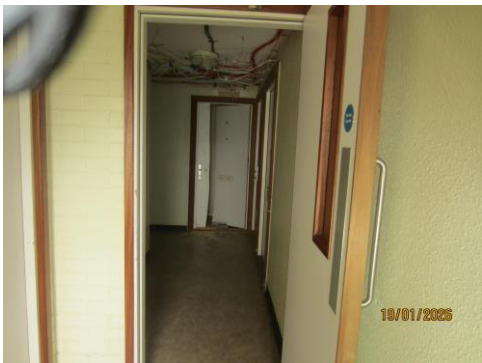
Level of ID:	Visually inspected	Ref:	As S07
	Building / Floor: HPC / Sixteenth Area: Communal areas Location: Floor Description: Bitumen on floor slab below floor covering Asbestos Type: Chrysotile Amount: 34 m2			
Recommendations:				
Remove bitumen in accordance with the Control of Asbestos Regulations 2012 and dispose of as hazardous waste.
