Demolition Asbestos Survey

Floors 5 - 8, Holme Park Court, Berry Brow, Huddersfield, HD4 7NH

Issue number:	1
Survey number:	7923. HP floors 5-8
Survey date:	January 2026
Client:	Metropolitan Demolition
Survey carried out by:	Phil Cox & Graham Brown
Survey compiled by:	Phil Cox & Graham Brown
Survey checked by:	Phil Cox & Graham Brown
Survey Issued	06/02/2026

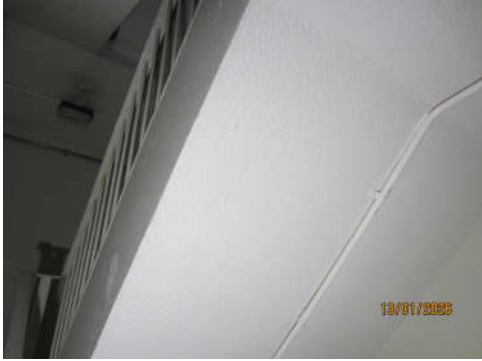
Level of ID:	Sampled	Ref:	S01
	<p>Building / Floor: HPC / Fifth Area: Communal, R01 Stairs Location: Ceiling Description: Artex on concrete Asbestos Type: Chrysotile Amount: 10 m2</p>

Remove artex in accordance with the Control of Asbestos Regulations 2012 and dispose of as hazardous waste.

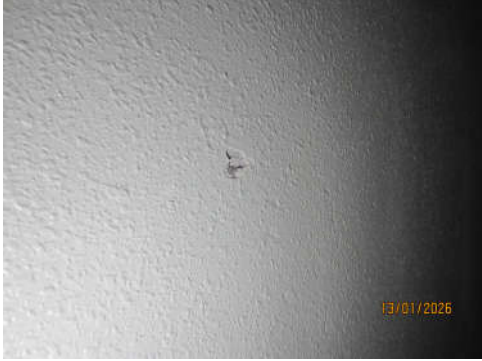
Level of ID:	Sampled	Ref:	S02
	<p>Building / Floor: HPC / Fifth Area: Communal, R01 Stairs Location: Wall Description: Artex on concrete Asbestos Type: Chrysotile Amount: 25 m2</p>

Remove artex in accordance with the Control of Asbestos Regulations 2012 and dispose of as hazardous waste.

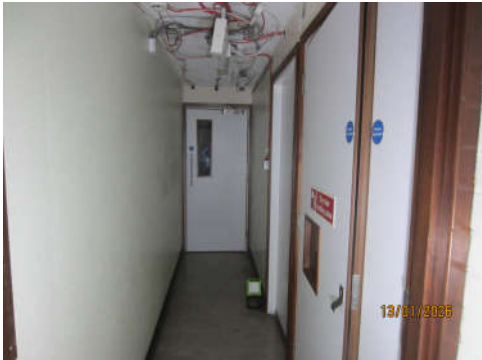
Level of ID:	Visually inspected	Ref:	As S02
	<p>Building / Floor: HPC / Fifth Area: Communal, R02 Landing Location: Wall Description: Artex on concrete, masonry Asbestos Type: Chrysotile Amount: 11 m2</p>

Remove artex in accordance with the Control of Asbestos Regulations 2012 and dispose of as hazardous waste.

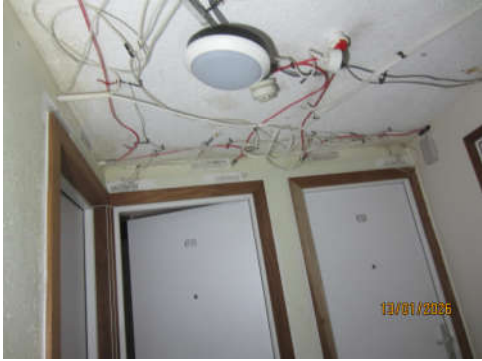
Level of ID:	Visually inspected	Ref:	As S01
	Building / Floor: HPC / Fifth Area: Communal, R03 Corridor Location: Ceiling Description: Artex on concrete Asbestos Type: Chrysotile Amount: 6 m2

Remove artex in accordance with the Control of Asbestos Regulations 2012 and dispose of as hazardous waste.

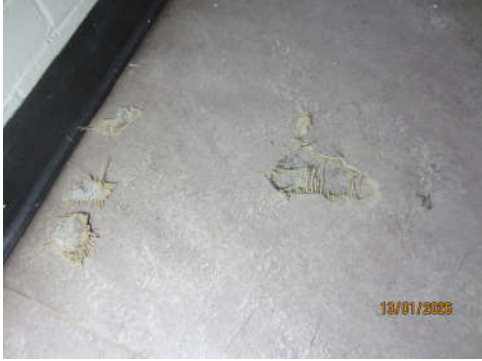
Level of ID:	Sampled	Ref:	S03
	Building / Floor: HPC / Fifth Area: Communal, R03 Corridor Location: Floor Description: Bitumen on floor slab below floor covering Asbestos Type: Chrysotile Amount: 6 m2

Remove bitumen in accordance with the Control of Asbestos Regulations 2012 and dispose of as hazardous waste.

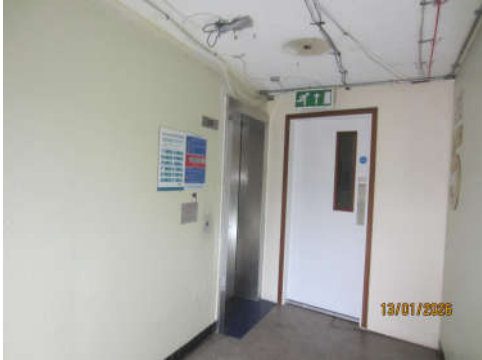
Level of ID:	Visually inspected	Ref:	As S02
	Building / Floor: HPC / Fifth Area: Communal, R04 Corridor Location: Wall Description: Artex on concrete, masonry, stud wall Asbestos Type: Chrysotile Amount: 15 m2

Remove artex in accordance with the Control of Asbestos Regulations 2012 and dispose of as hazardous waste.

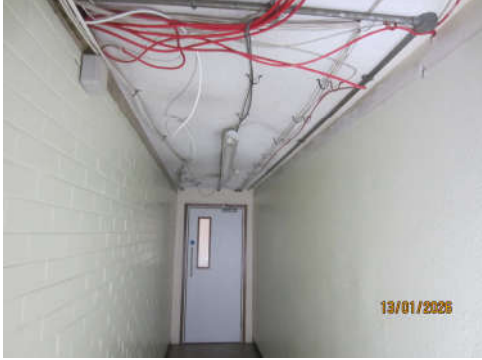
Level of ID:	Visually inspected	Ref:	As S01
	Building / Floor: HPC / Fifth Area: Communal, R05 Corridor Location: Ceiling Description: Artex on concrete Asbestos Type: Chrysotile Amount: 10 m2

Remove artex in accordance with the Control of Asbestos Regulations 2012 and dispose of as hazardous waste.

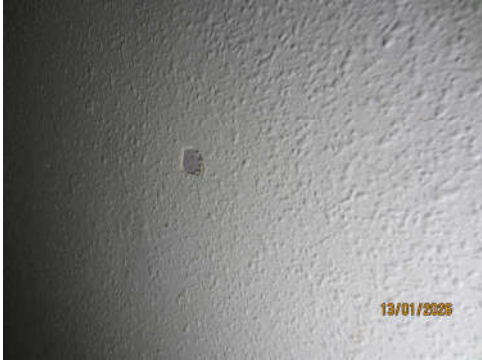
Level of ID:	Sampled	Ref:	S04
	Building / Floor: HPC / Fifth Area: Communal, R05 Corridor Location: Wall Description: Artex on concrete, masonry Asbestos Type: Chrysotile Amount: 20 m2

Remove artex in accordance with the Control of Asbestos Regulations 2012 and dispose of as hazardous waste.

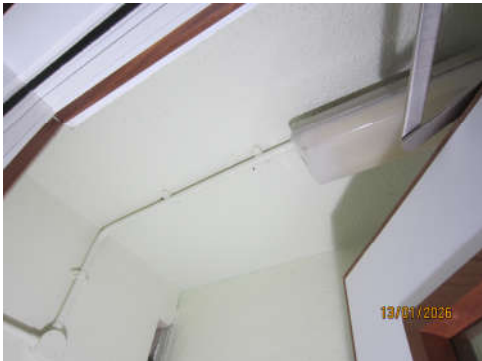
Level of ID:	Visually inspected	Ref:	As S01
	Building / Floor: HPC / Fifth Area: Communal, R07 Refuse chute room Location: Ceiling Description: Artex on concrete Asbestos Type: Chrysotile Amount: 2 m2

Remove artex in accordance with the Control of Asbestos Regulations 2012 and dispose of as hazardous waste.

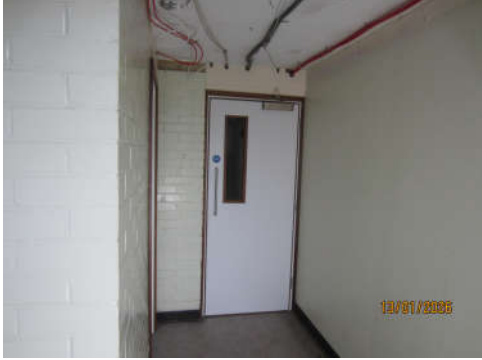
Level of ID:	Visually inspected	Ref:	As S03
	<p>Building / Floor: HPC / Fifth</p> <p>Area: Communal, R08 Corridor</p> <p>Location: Floor</p> <p>Description: Bitumen on floor slab below floor covering</p> <p>Asbestos Type: Chrysotile</p> <p>Amount: 5 m2</p>

Remove bitumen in accordance with the Control of Asbestos Regulations 2012 and dispose of as hazardous waste.

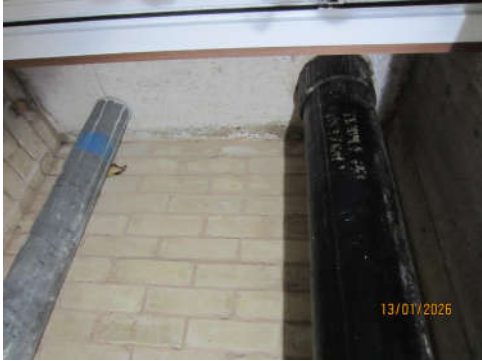
Level of ID:	Visually inspected	Ref:	As S01/6
	<p>Building / Floor: HPC / Fifth</p> <p>Area: Communal, R09 Riser</p> <p>Location: Pipework</p> <p>Description: Pitch fibre S&V pipe</p> <p>Asbestos Type: Chrysotile</p> <p>Amount: 2.5 lin m</p>

Remove Pitch fibre pipe in accordance with the Control of Asbestos Regulations 2012 and dispose of as hazardous waste.

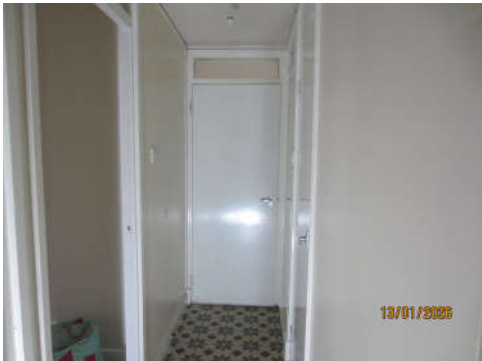
Level of ID:	Visually inspected	Ref:	As S05
	<p>Building / Floor: HPC / Fifth</p> <p>Area: Flat 71, R01 Hallway</p> <p>Location: Ceiling</p> <p>Description: Artex on concrete</p> <p>Asbestos Type: Chrysotile</p> <p>Amount: 4 m2</p>

Remove artex in accordance with the Control of Asbestos Regulations 2012 and dispose of as hazardous waste.

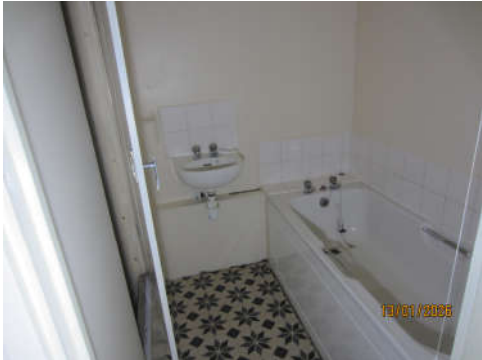
Level of ID:	Visually inspected	Ref:	As S06
	<p>Building / Floor: HPC / Fifth</p> <p>Area: Flat 71, R02 Bathroom</p> <p>Location: Floor</p> <p>Description: Bitumen on floor slab below floor covering, modern sanitaryware & fittings</p> <p>Asbestos Type: Chrysotile</p> <p>Amount: 1 m2</p>

Remove bitumen in accordance with the Control of Asbestos Regulations 2012 and dispose of as hazardous waste.

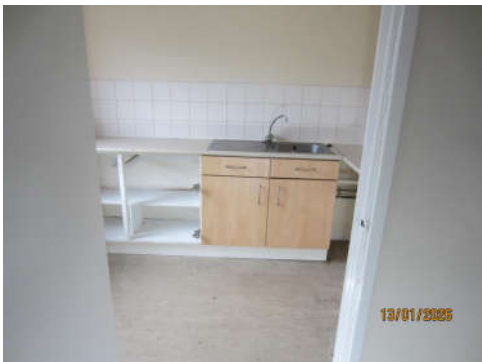
Level of ID:	Visually inspected	Ref:	As S06
	Building / Floor: HPC / Fifth Area: Flat 71 R07 Kitchen Location: Floor Description: Bitumen on floor slab below floor covering, modern units & fittings Asbestos Type: Chrysotile Amount: 3.5 m2			
Recommendations:				
Remove bitumen in accordance with the Control of Asbestos Regulations 2012 and dispose of as hazardous waste.

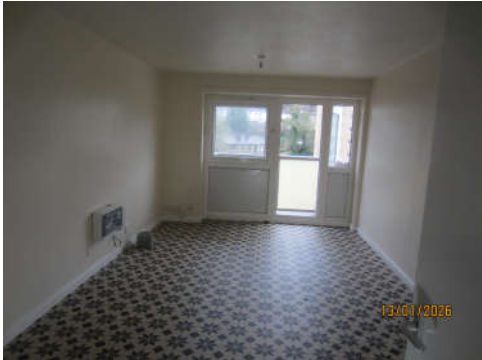
Level of ID:	Visually inspected	Ref:	As S05
	Building / Floor: HPC / Fifth Area: Flat 71 R08 Lounge Location: Ceiling Description: Artex on concrete Asbestos Type: Chrysotile Amount: 14 m2

Remove artex in accordance with the Control of Asbestos Regulations 2012 and dispose of as hazardous waste.

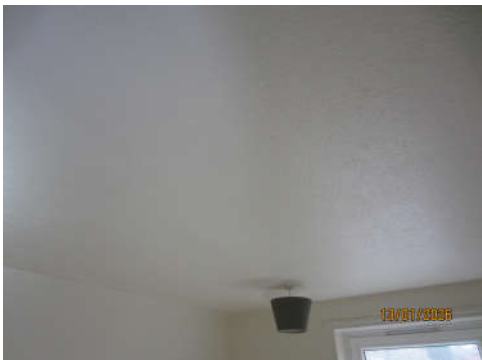
Level of ID:	Sampled	Ref:	S05
	Building / Floor: HPC / Fifth Area: Flat 71 R09 Bedroom Location: Ceiling Description: Artex on concrete Asbestos Type: Chrysotile Amount: 11 m2

Remove artex in accordance with the Control of Asbestos Regulations 2012 and dispose of as hazardous waste.

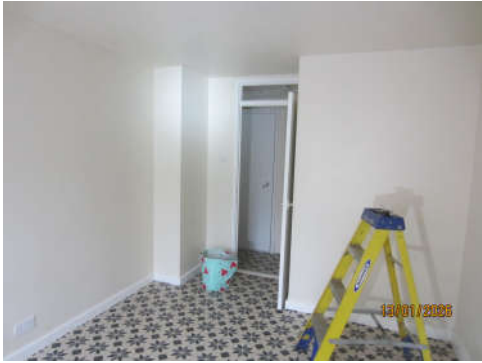
Level of ID:	Visually inspected	Ref:	As S06
	<p>Building / Floor: HPC / Fifth</p> <p>Area: Flat 71 R09 Bedroom</p> <p>Location: Floor</p> <p>Description: Bitumen on floor slab below floor covering</p> <p>Asbestos Type: Chrysotile</p> <p>Amount: 11 m2</p>

Remove bitumen in accordance with the Control of Asbestos Regulations 2012 and dispose of as hazardous waste.

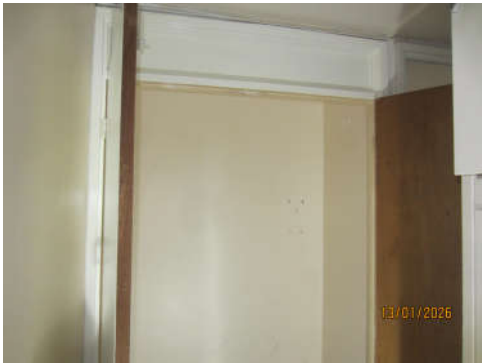
Level of ID:	Visually inspected	Ref:	As S05
	<p>Building / Floor: HPC / Fifth</p> <p>Area: Flat 71 R10 Cupboard</p> <p>Location: Ceiling</p> <p>Description: Artex on concrete</p> <p>Asbestos Type: Chrysotile</p> <p>Amount: 1 m2</p>

Remove artex in accordance with the Control of Asbestos Regulations 2012 and dispose of as hazardous waste.

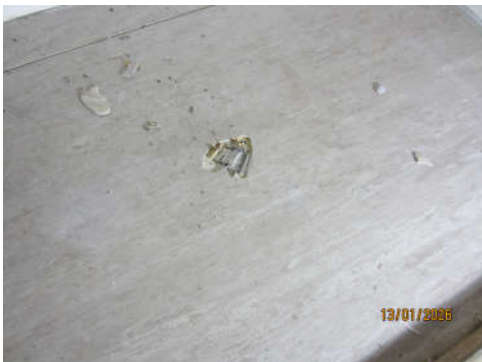
Level of ID:	Sampled	Ref:	S06
	<p>Building / Floor: HPC / Fifth</p> <p>Area: Flat 71 R10 Cupboard</p> <p>Location: Floor</p> <p>Description: Bitumen on floor slab below floor covering</p> <p>Asbestos Type: Chrysotile</p> <p>Amount: 1 m2</p>

Remove bitumen in accordance with the Control of Asbestos Regulations 2012 and dispose of as hazardous waste.

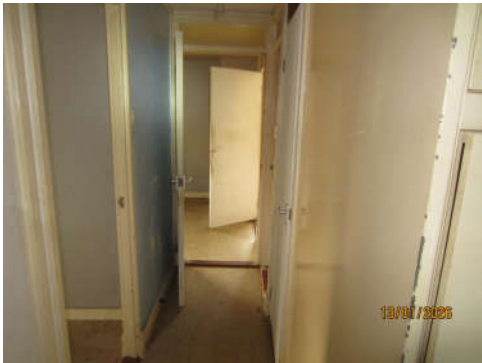
Level of ID:	Visually inspected	Ref:	As S06
	Building / Floor: HPC / Fifth Area: Flat 67 to 70 & 72 Location: Floor Description: Bitumen on floor slab below floor covering Asbestos Type: Chrysotile Amount: 163 m2			
Recommendations:				
Remove bitumen in accordance with the Control of Asbestos Regulations 2012 and dispose of as hazardous waste.

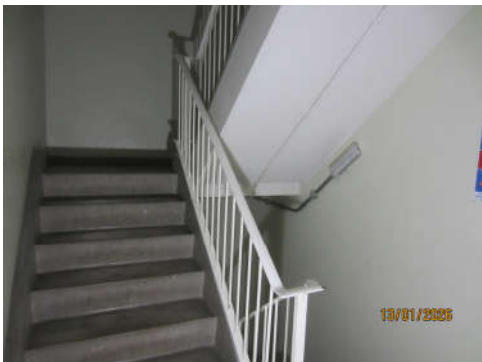
Level of ID:	Visually inspected	Ref:	As S05
	Building / Floor: HPC / Sixth Area: Communal areas Location: Ceiling Description: Artex on concrete Asbestos Type: Chrysotile Amount: 44 m2			
Recommendations:				
Remove artex in accordance with the Control of Asbestos Regulations 2012 and dispose of as hazardous waste.

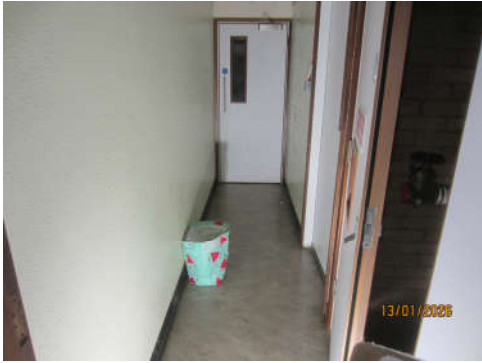
Level of ID:	Visually inspected	Ref:	As S02
	<p>Building / Floor: HPC / Sixth</p> <p>Area: Communal areas</p> <p>Location: Wall</p> <p>Description: Artex on concrete</p> <p>Asbestos Type: Chrysotile</p> <p>Amount: 101 m2</p>

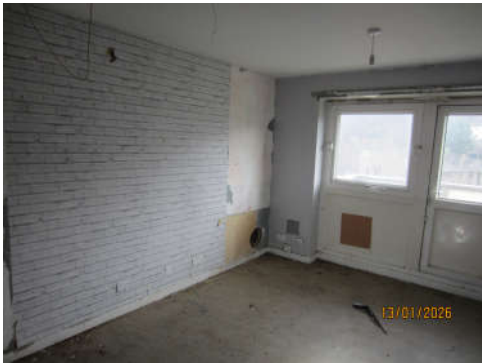
Level of ID:	Visually inspected	Ref:	As S05
	<p>Building / Floor: HPC / Sixth</p> <p>Area: Flats 61 to 66</p> <p>Location: Ceiling</p> <p>Description: Artex on concrete</p> <p>Asbestos Type: Chrysotile</p> <p>Amount: 205 m2</p>

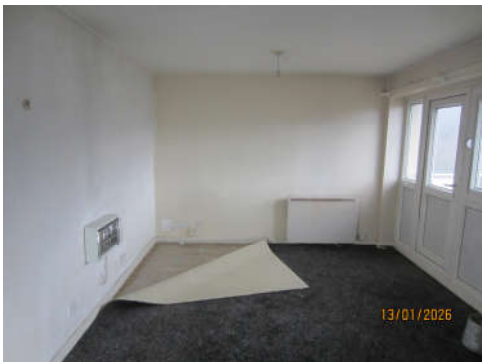
Level of ID:	Visually inspected	Ref:	As S06
	<p>Building / Floor: HPC / Sixth</p> <p>Area: Flats 61 to 66</p> <p>Location: Floor</p> <p>Description: Bitumen on floor slab below floor covering</p> <p>Asbestos Type: Chrysotile</p> <p>Amount: 199 m2</p>

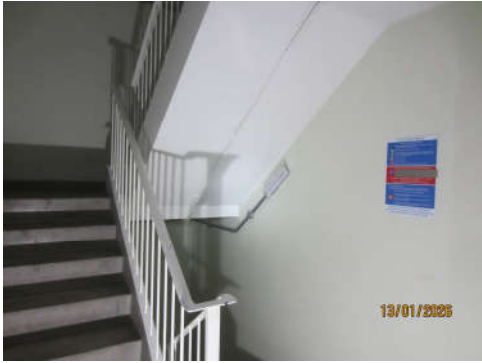
Level of ID:	Sampled	Ref:	S01
	<p>Building / Floor: HPC / Seventh Area: Communal, R02 Landing Location: Ceiling Description: Artex on concrete Asbestos Type: Chrysotile Amount: 4 m2</p>

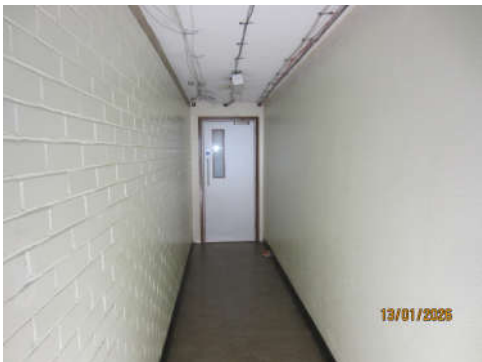
Level of ID:	Visually inspected	Ref:	As S02
	<p>Building / Floor: HPC / Seventh Area: Communal, R05 Corridor Location: Wall Description: Artex on concrete, masonry Asbestos Type: Chrysotile Amount: 20 m2</p>

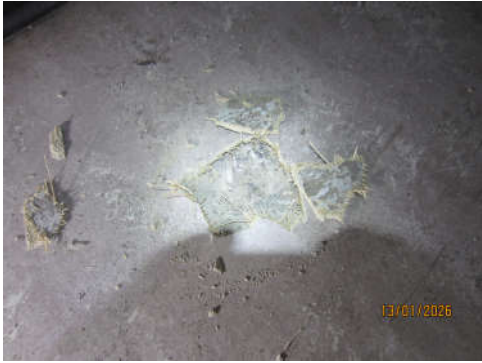
Level of ID:	Sampled	Ref:	S03
	Building / Floor: HPC / Seventh Area: Communal, R05 Corridor Location: Floor Description: Bitumen on floor slab below floor covering Asbestos Type: Chrysotile Amount: 10 m2

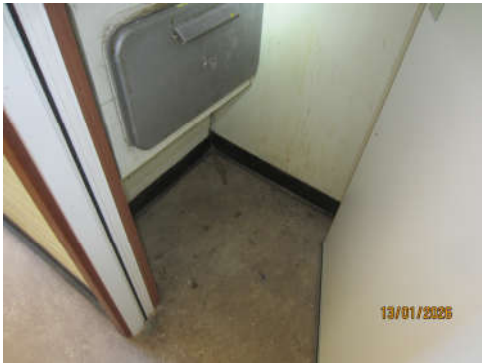
Level of ID:	Visually inspected	Ref:	As S03
	Building / Floor: HPC / Seventh Area: Communal, R07 Refuse chute room Location: Floor Description: Bitumen on floor slab below floor covering Asbestos Type: Chrysotile Amount: 2 m2

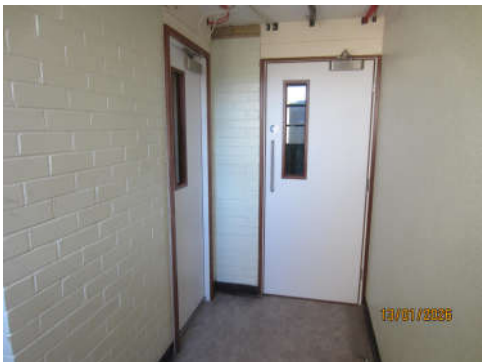
Level of ID:	Visually inspected	Ref:	As S02
	Building / Floor: HPC / Seventh Area: Communal, R08 Corridor Location: Wall Description: Artex on concrete, masonry, stud wall Asbestos Type: Chrysotile Amount: 8 m2

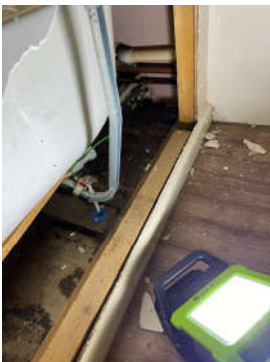
Level of ID:	Visually inspected	Ref:	As S03
	Building / Floor: HPC / Seventh Area: Flat 57, R02 Bathroom Location: Floor Description: Bitumen on floor slab below floor covering, modern sanitaryware & fittings Asbestos Type: Chrysotile Amount: 1 m2			
Recommendations:				
Remove bitumen in accordance with the Control of Asbestos Regulations 2012 and dispose of as hazardous waste.

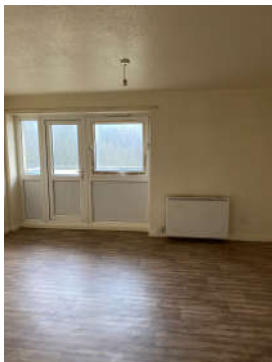
Level of ID:	Visually inspected	Ref:	As S04
	<p>Building / Floor: HPC / Seventh</p> <p>Area: Flat 57 R08 Lounge</p> <p>Location: Floor</p> <p>Description: Further samples indicate there is bitumen on the floor slab below floor covering</p> <p>Asbestos Type: Chrysotile</p> <p>Amount: 16 m2</p>			
Recommendations:				
Remove bitumen in accordance with the Control of Asbestos Regulations 2012 and dispose of as hazardous waste.

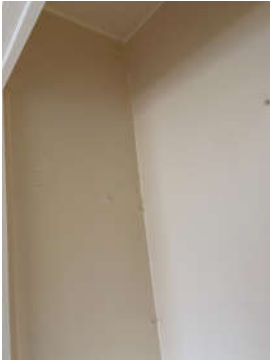
Level of ID:	Visually inspected	Ref:	As S05
	Building / Floor: HPC / Seventh Area: Flat 57 R09 Cupboard Location: Ceiling Description: Artex on concrete Asbestos Type: Chrysotile Amount: 0.5 m2

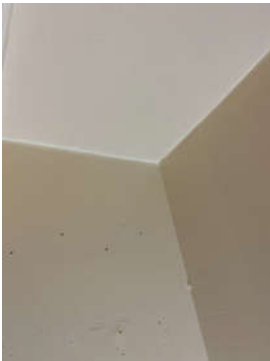
Level of ID:	Visually inspected	Ref:	As S05
	Building / Floor: HPC / Seventh Area: Flat 57 R10 Cupboard Location: Ceiling Description: Artex on concrete Asbestos Type: Chrysotile Amount: 1 m2

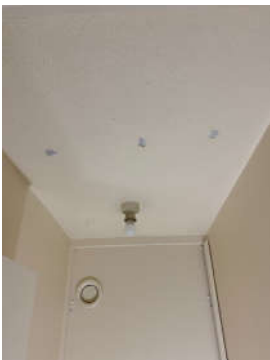
Level of ID:	Visually inspected	Ref:	As S05
	Building / Floor: HPC / Seventh Area: Flat 55, 56 & flats 59 to 60 Location: Ceiling Description: Artex on concrete Asbestos Type: Chrysotile Amount: 176.5 m2

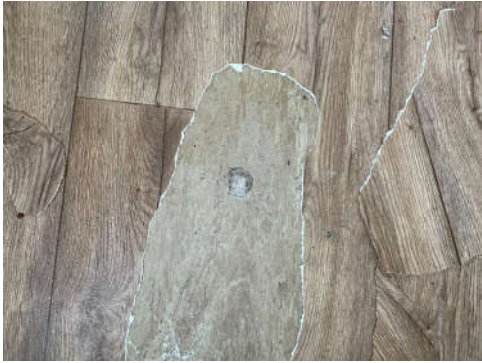
Level of ID:	Visually inspected	Ref:	As S04
	<p>Building / Floor: HPC / Seventh</p> <p>Area: Flat 55, 56 & flats 59 to 60</p> <p>Location: Floor</p> <p>Description: Bitumen on floor slab below floor covering</p> <p>Asbestos Type: Chrysotile</p> <p>Amount: 171.5 m2</p>

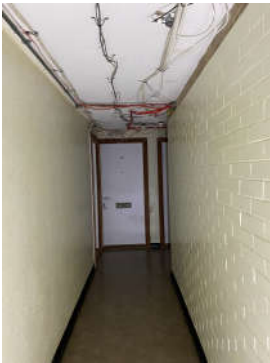
Level of ID:	Visually inspected	Ref:	As S05
	<p>Building / Floor: HPC / Eighth</p> <p>Area: Communal areas</p> <p>Location: Ceiling</p> <p>Description: Artex on concrete</p> <p>Asbestos Type: Chrysotile</p> <p>Amount: 44 m2</p>

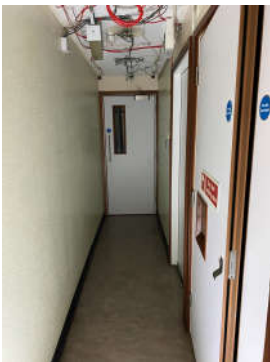
Level of ID:	Visually inspected	Ref:	As S02
	<p>Building / Floor: HPC / Eighth</p> <p>Area: Communal areas</p> <p>Location: Wall</p> <p>Description: Artex on concrete</p> <p>Asbestos Type: Chrysotile</p> <p>Amount: 101 m2</p>

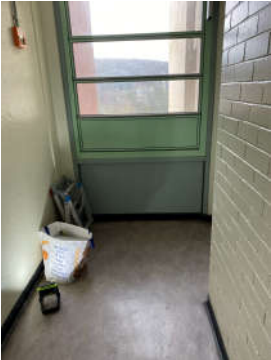
Level of ID:	Visually inspected	Ref:	As S04
	Building / Floor: HPC / Eighth Area: Communal areas Location: Floor Description: Bitumen on floor slab below floor covering Asbestos Type: Chrysotile Amount: 34 m2			
Recommendations:				
Remove bitumen in accordance with the Control of Asbestos Regulations 2012 and dispose of as hazardous waste.

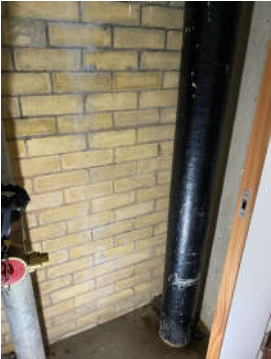
Level of ID:	Visually inspected	Ref:	As S01/6
	Building / Floor: HPC / Eighth Area: Communal, R09 Riser Location: Pipework Description: Pitch fibre S&V pipe Asbestos Type: Chrysotile Amount: 2.5 lin m			
Recommendations:				
Remove Pitch fibre pipe in accordance with the Control of Asbestos Regulations 2012 and dispose of as hazardous waste.

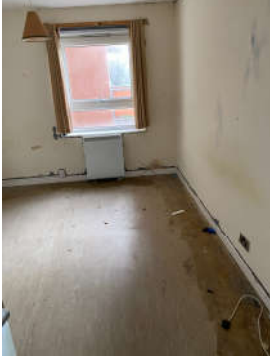
Level of ID:	Visually inspected	Ref:	As S06
	<p>Building / Floor: HPC / Eighth</p> <p>Area: Flats 49 to 54</p> <p>Location: Floor</p> <p>Description: Bitumen on floor slab below floor covering</p> <p>Asbestos Type: Chrysotile</p> <p>Amount: 199 m2</p>			
Recommendations:				
<p>Remove bitumen in accordance with the Control of Asbestos Regulations 2012 and dispose of as hazardous waste.</p>
