Martin Prescott Environmental Services

Initial Bat Survey of Barn at New Hey Farm, Marsden **Surveyor- Martin Prescott (lic. no. 2015-15466-CLS)**

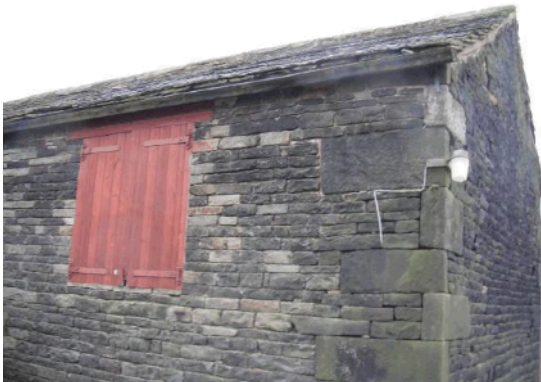
P1 East side and north gable

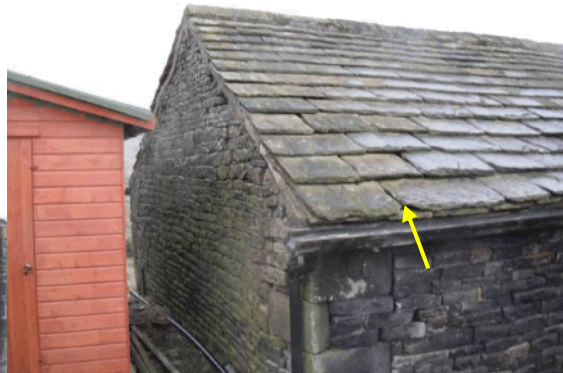
P2 East side and south gable, gaps under tiles

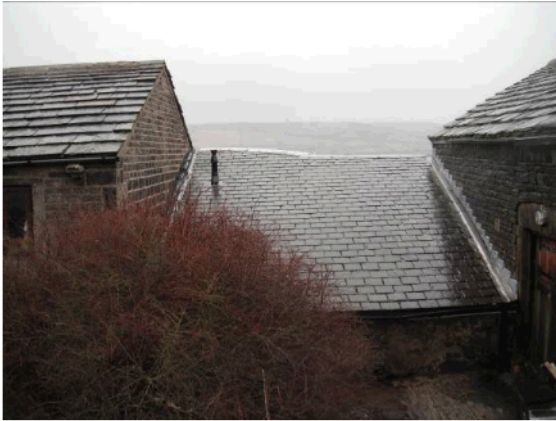
P3 Roof of link sections from south

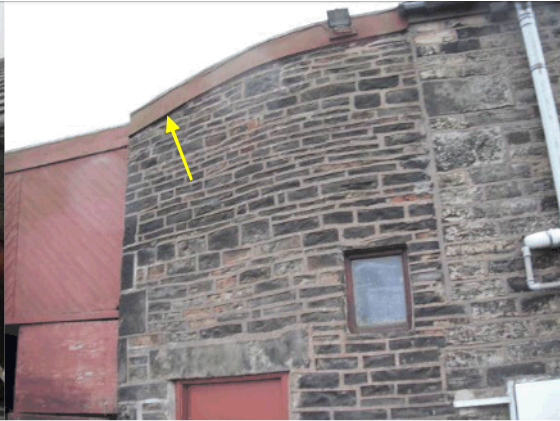
P4 North aspect link sections, gap under fascia

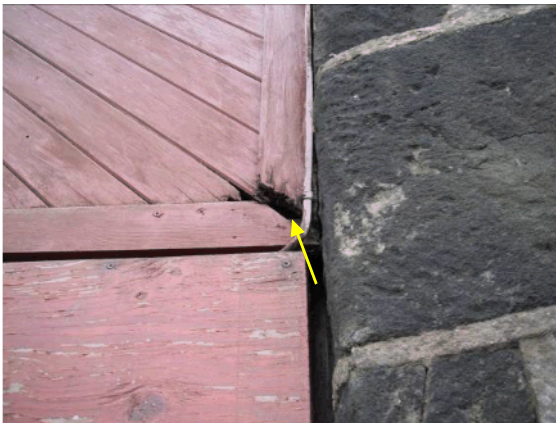
P5 North aspect link section, gap under cladding

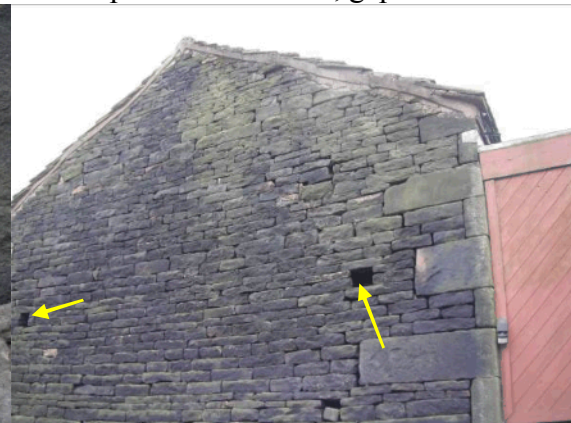
P6 north gable, gaps in masonry

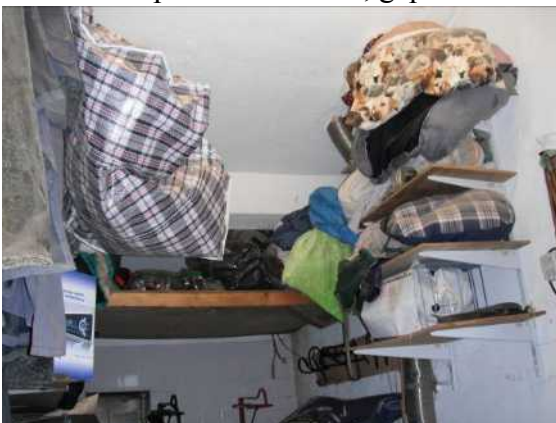
P7 Link part 1, boarded and well-sealed

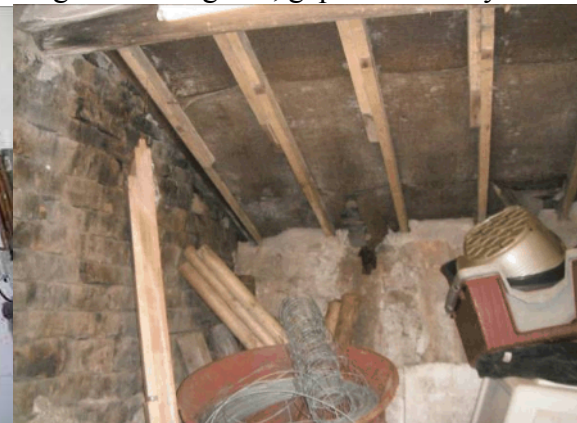
Link 1 was well sealed with board lining. Link 2 had a board-lined roof, but the walls were exposed and contained many crevices suitable for roosting bats.

P8 Link part 2, boarded, and with gaps

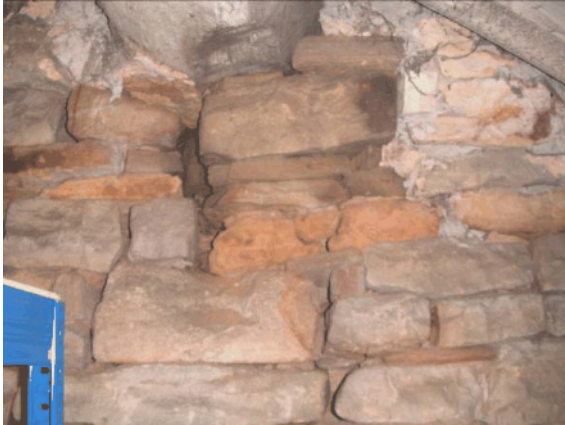
P11 Internal gaps in masonry, barn

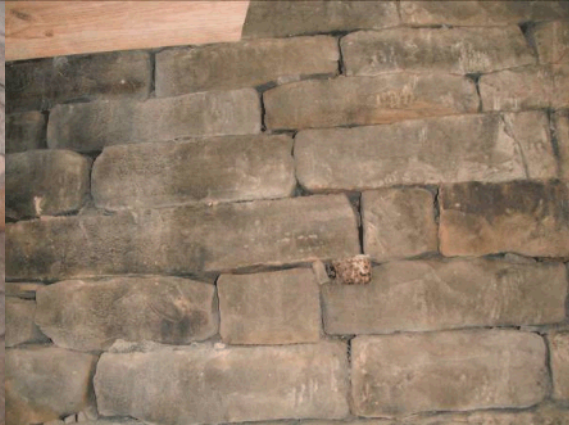
P12 Internal gaps in masonry, barn
