Ecology and Bat Survey Report – Initial  
Scoping Report

Spafield Mill

Batley

October 2014

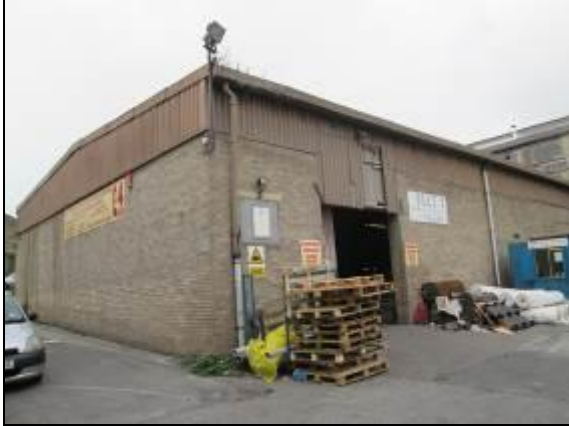
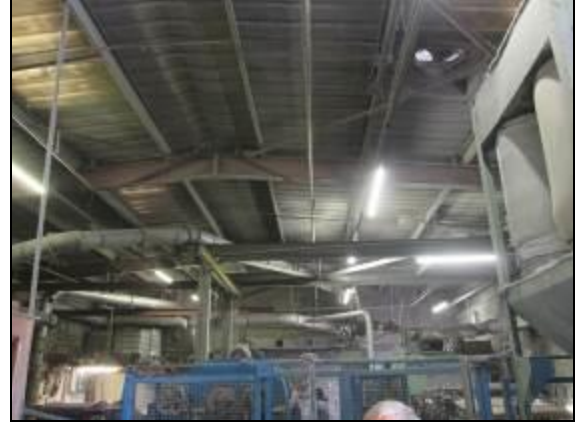
**Photo 1a:** Unit 1 Front Mill - exterior

The exterior and interior walls and floors were easily surveyed and all brick work and pointing appeared to be in good condition with few potential access points for bats observed.

Although some gaps and spaces may be present behind the corrugated steel panels attached to the exterior walls, the suitability of these features for bats is considered very limited due to the fluctuating temperatures and humidity of these spaces.

*These buildings are considered to have a negligible potential to support bats.*

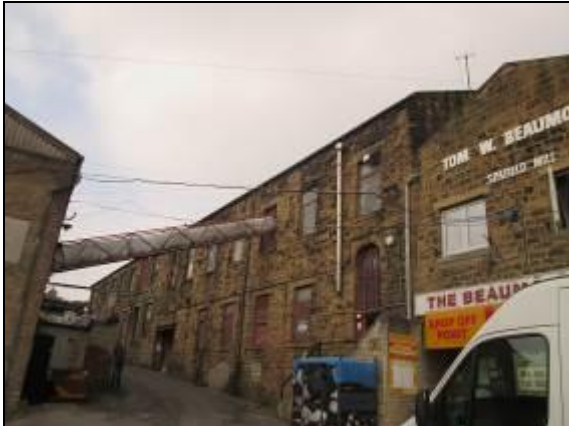
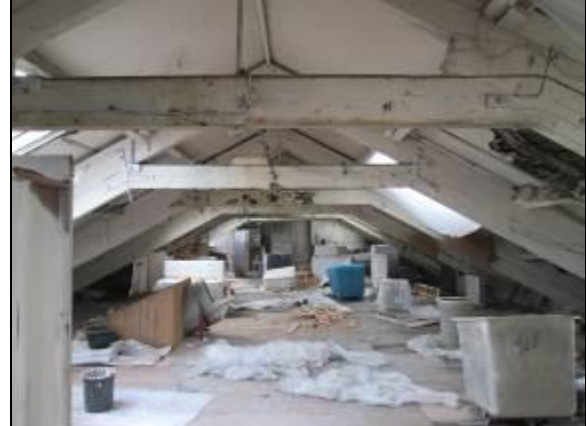
**Photo 3a:** Unit 3: Three Story Mill - exterior

The building is in a poor state of disrepair with many sections, including the upper floor almost derelict with collapsing ceilings; broken windows displaced masonry and pointing.

There are many areas of displaced masonry and mortar - on all exterior sides - creating many gaps and crevices potentially leading deeper into the cavity walls.

Gaps are present along the bottom of the exterior boards supporting the gutters, with further areas of missing mortar behind these boards, providing potentially suitable roosting features for bats and / or potentially leading into the cavity walls and internal roof structure.

Many lifted and displaced roof tiles were present with areas of lifted felt and flashing around several dormer windows.

The ceiling panels of the disused upper floor follow the pitch of the roof and several large holes are creating access into the spaces between the ceiling panels and the roof tiles. In addition several of the dormer windows were permanently open creating access into these potential roosting features.

*Although no evidence of bats was observed, given the high number of potential roosting features present this building is considered to have a high potential to support bats.*

It is recommended that a suite of bat surveys is carried out at Units 3 & 4: Three Story Mill, Unit 9: Laundry and the House between May and August.

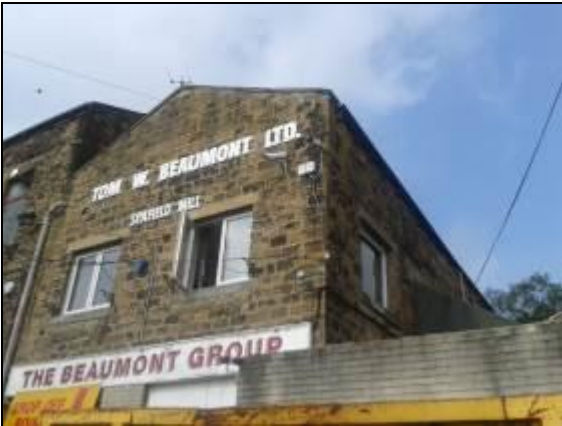
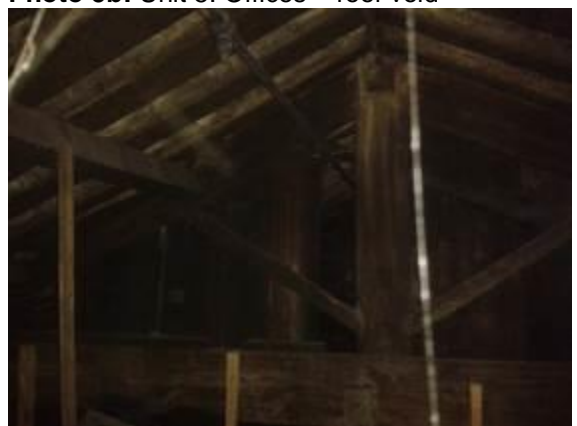
**Photo 5a:** Unit 5: Offices - exterior

Unit 5: Offices is a stone structure abutting Units 3 & 4: Three Story Mill. All brick work and pointing was intact with no potential access points for bats observed. Although the roof void was lined, all roof tiles and ridge tiles were tight with no lifted or displaced tiles and no cavities or gaps behind the exterior boards supporting the gutters were observed.

*These buildings are considered to have a negligible potential to support bats.*

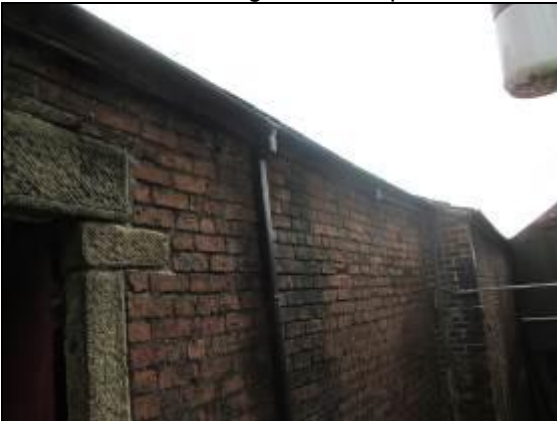
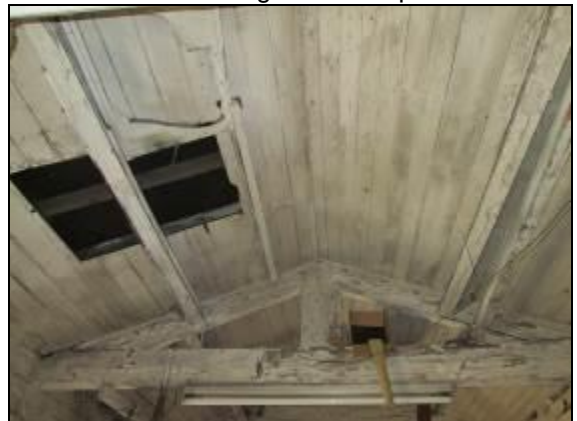
**Photo 6a:** Unit 6: Engineers Shop - exterior

Unit 6: Engineers Shop is a low building constructed of red brick with no cavity wall. All brick work and pointing was intact with no potential access points for bats observed. There were no cavities or gaps behind the exterior boards supporting the gutters and all roof tiles were tight with no lifted or displaced tiles observed.

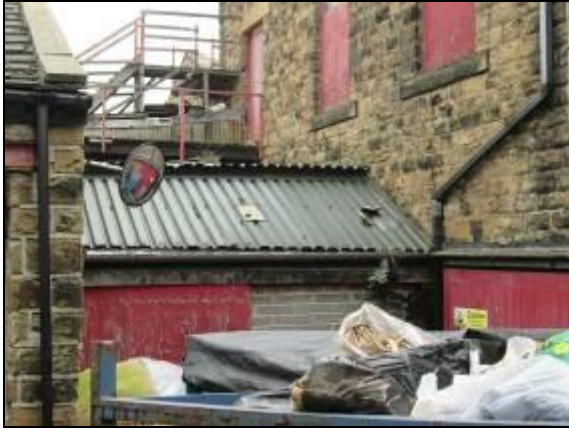
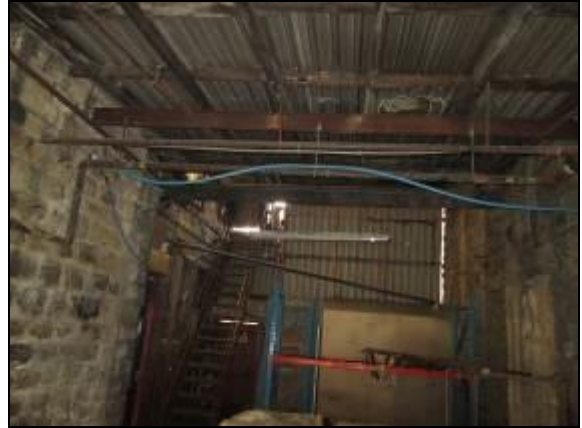
**Photo 7a:** Unit 7: Boiler Room - exterior

Unit 7: Boiler Room is a small structure located between Unit 3 and Unit 9. It has a corrugated the rear wall and roof are both constructed of corrugated plastic panels with breeze block front wall. All brick work and pointing was intact with no potential access points for bats observed.

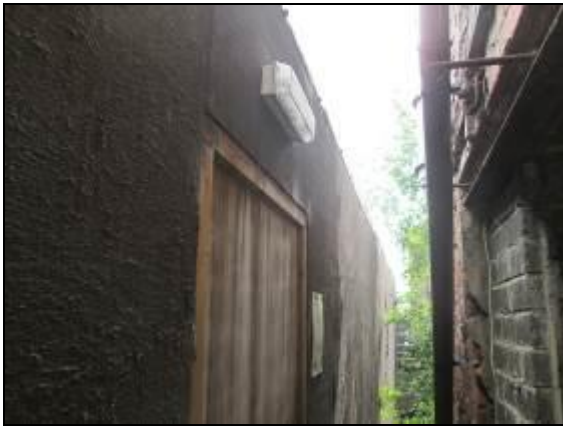
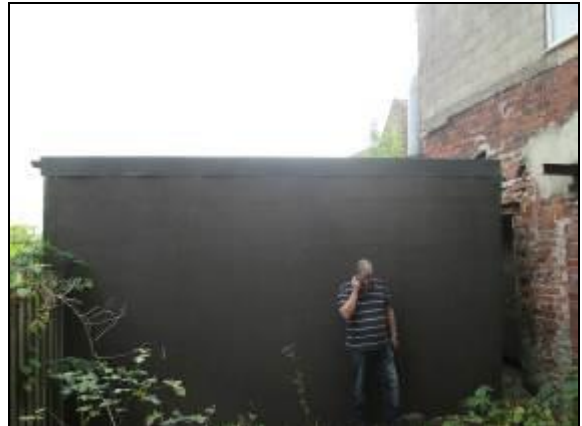
**Photo 8a:** Unit 8: Canteen - exterior

Unit 8: Canteen is a disused single story prefabricated structure constructed from plywood and a tin roof. The exterior panels, windows and roof are all intact and the structure is painted and sealed. No potential access points for bats were observed.

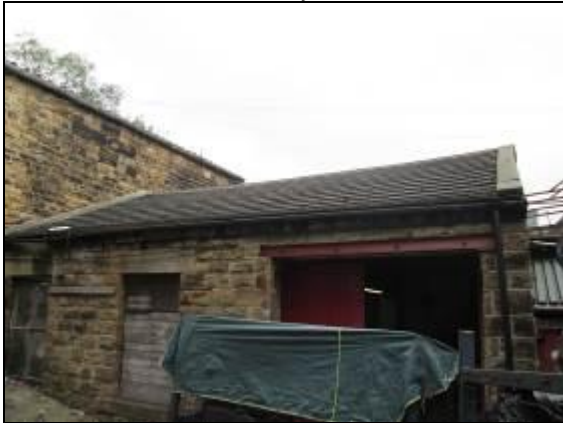
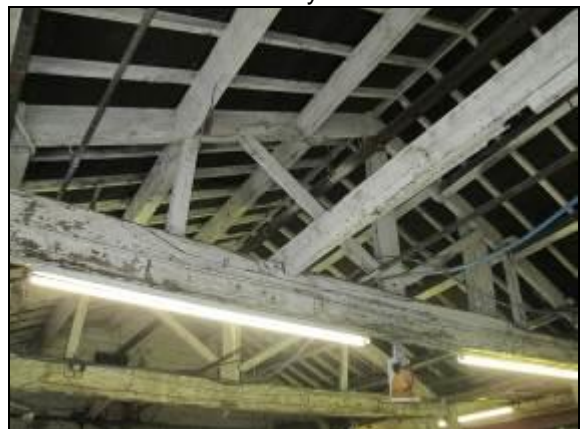
**Photo 9a:** Unit 9: Laundry - exterior

There are several areas of displaced masonry and mortar along the upper wall, several missing bricks at the top of the wall and some gaps present along the bottom of the exterior boards supporting the gutters. These features may provide suitable roosting features for bats and / or potentially lead into the cavity walls and internal roof structure.

*Although no evidence of bats was observed, several features were observed that may provide, or lead to, potential roosting features. This building is considered to have a moderate potential to support bats.*

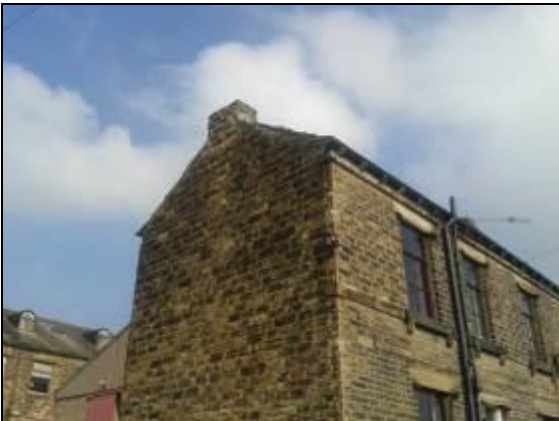
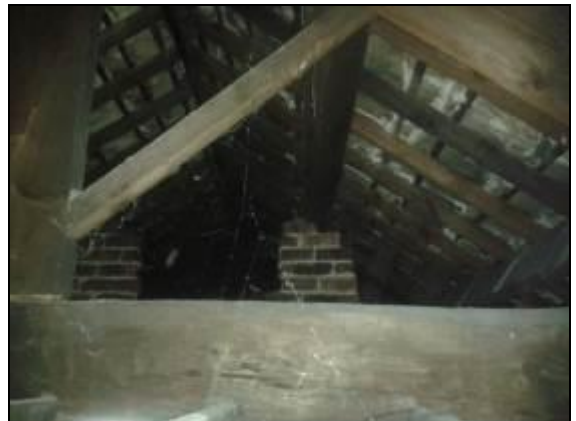
**Photo 12a:** House - exterior

This is a two story, three bedroom house located in its own grounds within the mill complex. The exterior walls were easily surveyed and all brick work and pointing appeared to be in good condition with few potential access points for bats observed.

The ridge tiles and western rake edges appeared to have been recently re-pointed although there were several gaps between the stone roof tiles at the east rake edge and on the north and south sides of the roof.

The roof void was unconverted and unlined with the tiles back pointed from within.

*This building is therefore considered to have a low potential to support bats.*

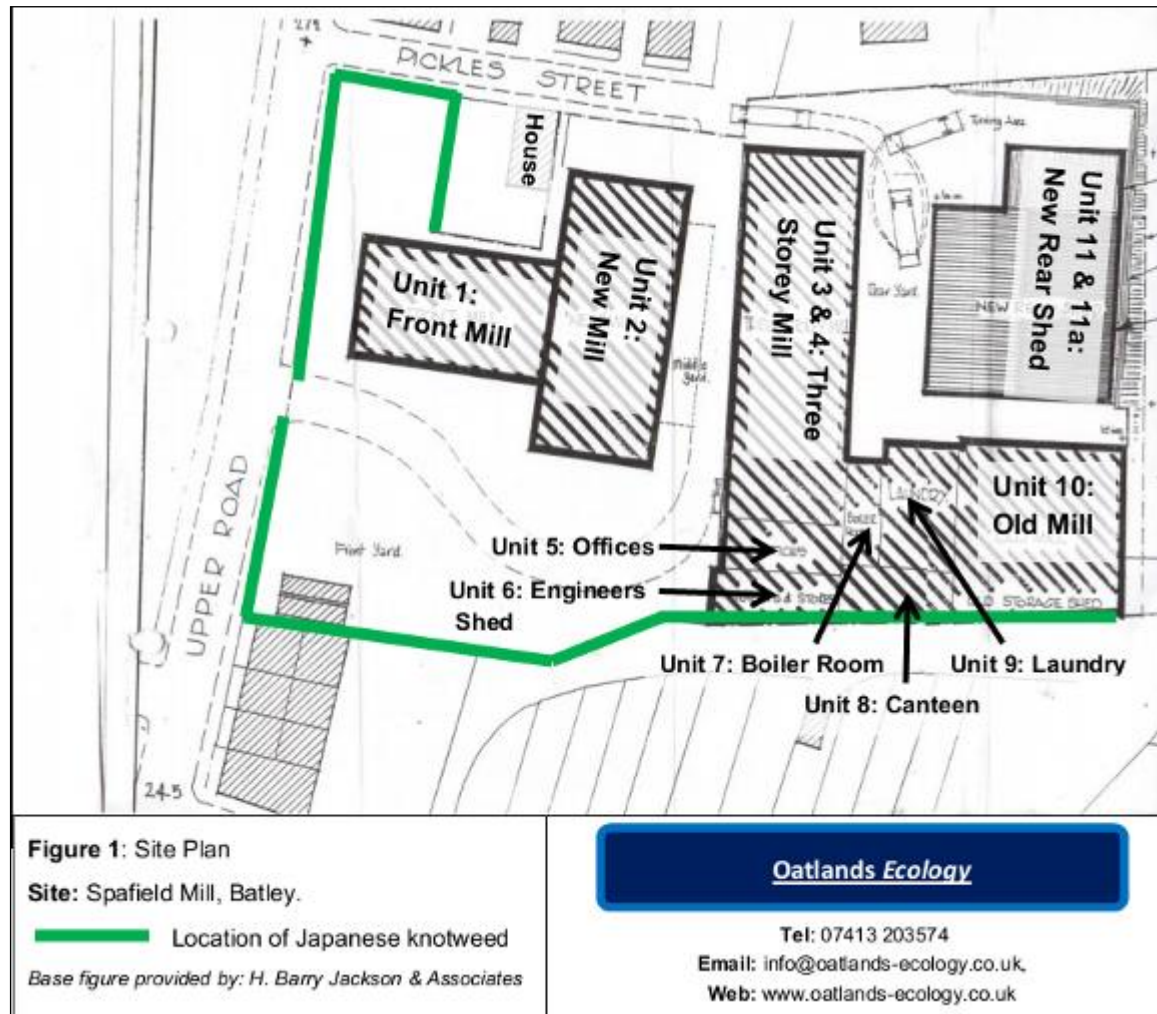
A mature and established growth of Japanese knotweed *Fallopia japonica*<sup>1</sup> is present along the entire south and east boundaries of the mill complex.

Eradication / removal of the Japanese knotweed will be required prior to development.

It is recommended that a specialist consultant is engaged to produce an appropriate Japanese Knotweed Management Plan.
