## INTRODUCTION

This section of the Conservation Management Plan considers the significance of specific rooms, elements and outbuildings and makes recommendations for the future management of the school as a heritage asset.

Royds Mount was constructed sometime between 1862 and 1867, the architect and contractor are unknown.

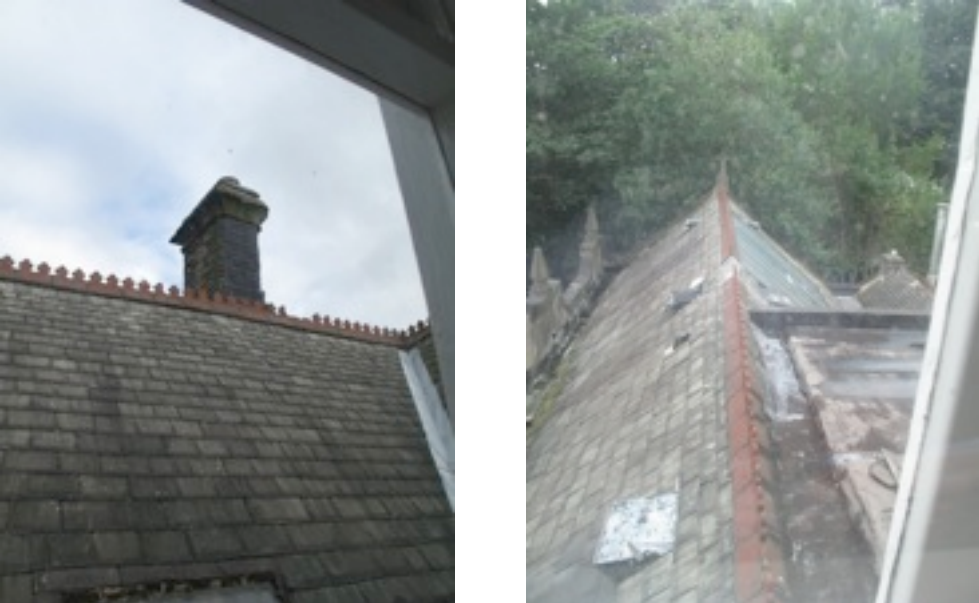
| Element | Significance |
|---|---|
| <b>Notes:</b> <p>The pitched roofs of the house are Westmorland green slate, with terracotta ridge tiles. Later additions also are roofed to match. The west elevation pitch retains its snow guards which were to protect a glass building below.</p> <p><b>Recommendations:</b> <i>Unless stated otherwise finishes and fittings should be retained.</i></p> <p>Where reslating is to be carried out, matching slates should be used, fixed with copper, not galvanised nails. Flashings should be renewed in lead of a suitable code, at least equivalent to that which is removed. Given the trend for lead theft alternative materials such as terne coated stainless steel maybe considered, particularly for lower roof flashings if they are regularly stolen.</p> | |

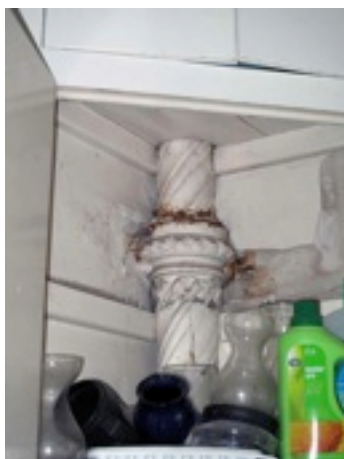
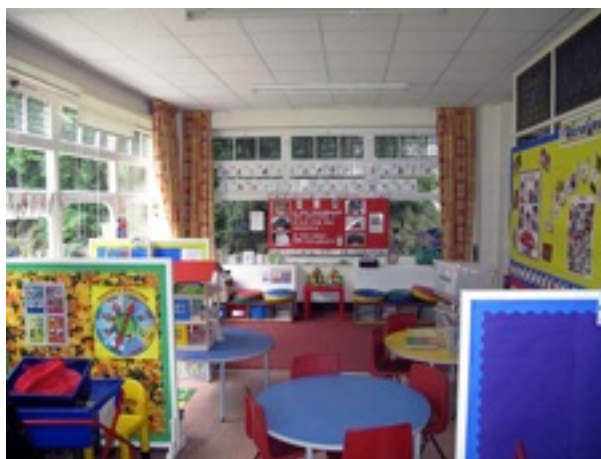
| Room | Location | Use | Original Use | Significance |
|---|---|---|---|---|
| 006 | Ground Floor | Classroom | | |

The addition replaced a conservatory and probably postwar when the house became a school. An original cast iron, barley twist rainwater pipe is hidden within a cupboard while another cupboard hides the former external wall to the Heads Study (this wall has been painted and pointed with modern cement). This room leads to the Heads Study and the hall. Quarry glass windows between this room and the former billiard room also remain in situ and probably date from c.1893. The room has a modern false ceiling.

The walls and roof above the plinth are a later addition. If major roof repairs, glazing repairs or other changes are proposed, consider a simpler less fussy solution, more in keeping with the houses original design intent.

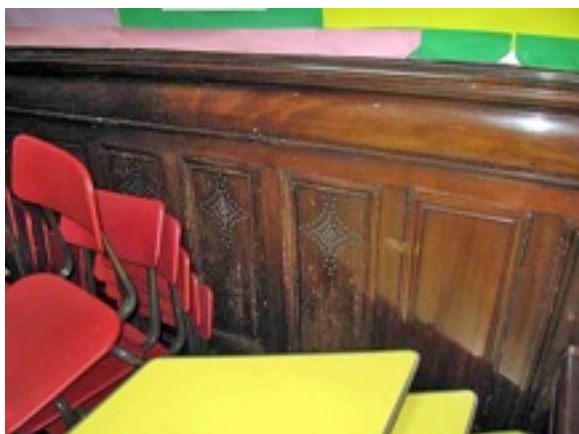
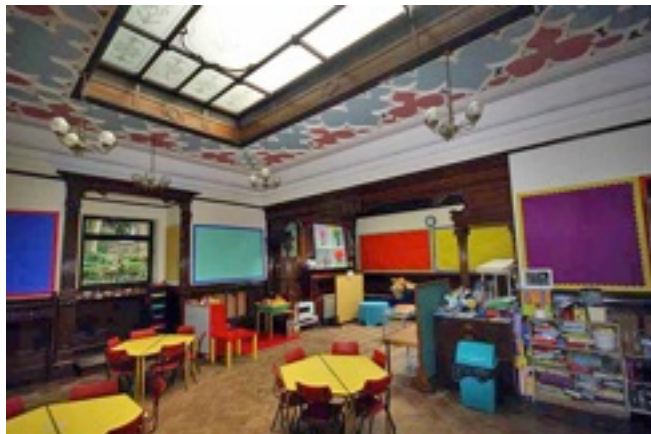
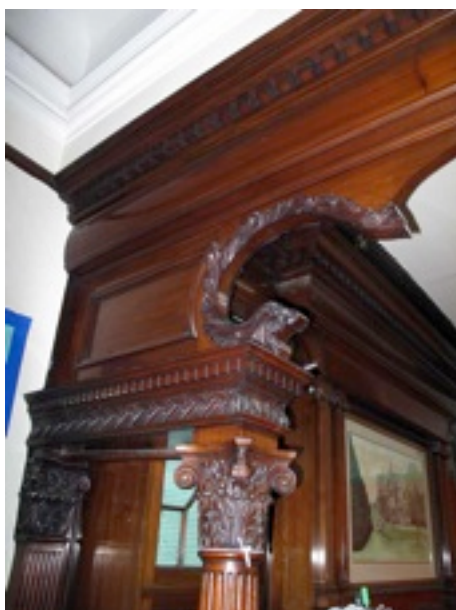
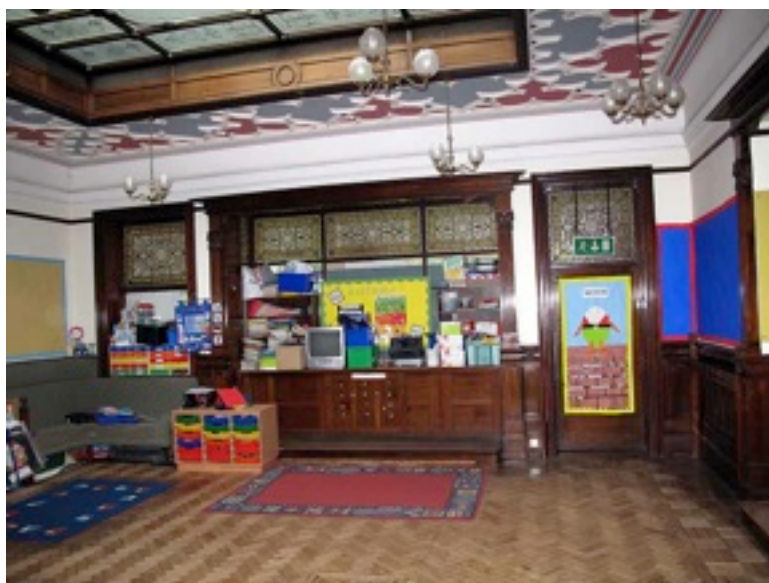
| Room | Location | Use | Original Use | Significance |
|---|---|---|---|---|
| 007 | Ground Floor | Classroom | Billiard Room | High |

Room part of c.1893 extension. Historic fabric remains in situ, including - borrowed light with etched glass, doors, joinery and the fireplace. Curved seating is also likely to be original. Some modern fretwork panels have replaced some of the original hardwood radiator panels.

If refurbishing consider replacing modern fret work radiator panels with historically correct panels.

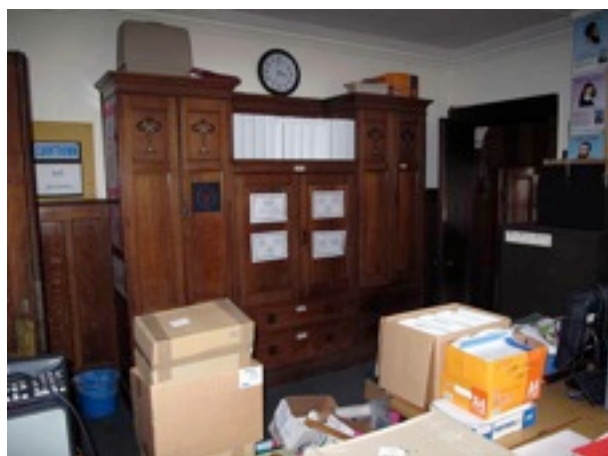
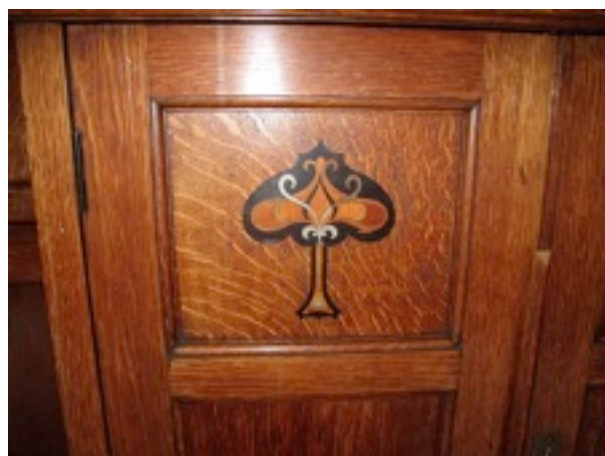
The room retains its original plaster cove, windows, fire place, joinery which includes doors, skirting and panelling in oak. Also within the room is oak furniture inlaid with Art Nouveau flowers in the door panels and therefore post dates the original construction date of the house. An electric push bell is retained. The heavy formica top detracts from the rooms historic appearance.

**Recommendations:** *Unless stated otherwise finishes and fittings should be retained.*  
*If room is to be refurbished, consider removing formica top above the corner sink*

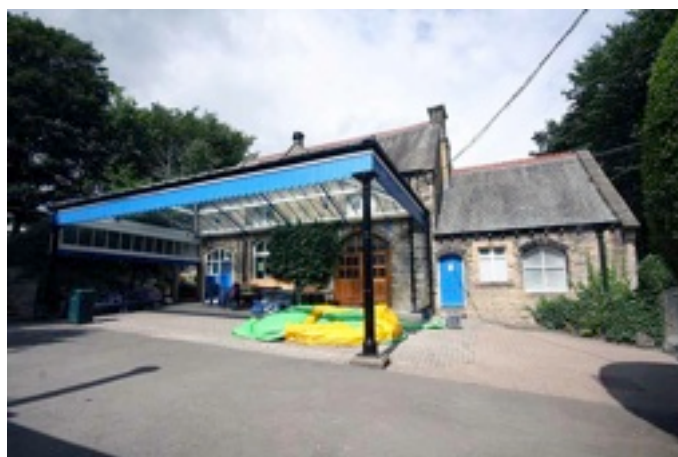
Externally the building is constructed with the same quarry faced sandstone as the house with cast iron rainwater goods. The main elevation incorporates a gable with carved stone bird perched on the apex. The windows and door openings to the original building have pointed segmental arch however the doors and windows are modern timber replacements.

Repairs should be sympathetic in traditional materials as noted for the exterior of the house. The long valley gutter presents a maintenance liability. It should be regularly cleaned to prevent leaks into the building.

The interior has been much changed over time. Features and fittings which predate school use should be retained where practicable.

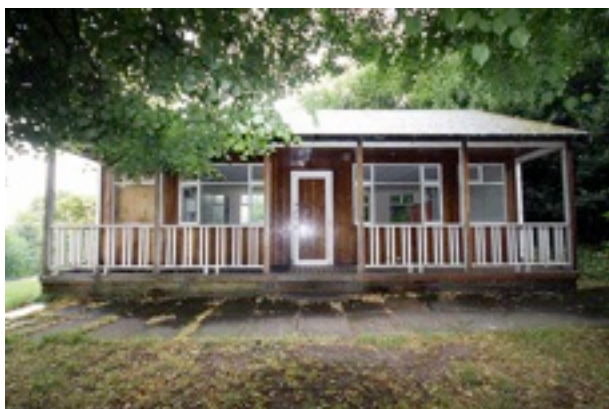
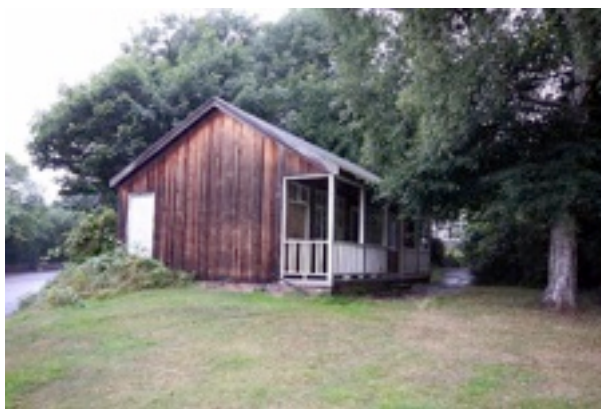
A small timber prefabricated pavilion, with a verandah. Possibly dating from the 1950's, in style and appearance it is typical of many found on small sports pitches throughout the country. Now almost completely shielded from the school and all play areas by planting, it is of no particular evidential, historical and aesthetic value, but may be of social significance through association with past school sports events. Due to the growth of tree planting it sits outside its original context.

The building has a quaint charm, but constructed in relatively short life materials is approaching its life expiry. Due to the tree growth, the location is unsuitable for use as a sports pavilion. Due to the history of small incidental buildings serving both the house and school on the site, there may be validity in placing another small building in or near this location.

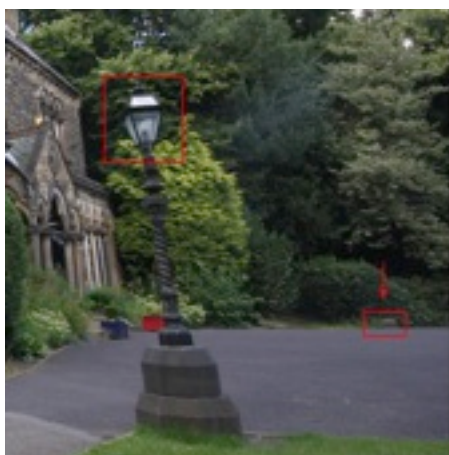
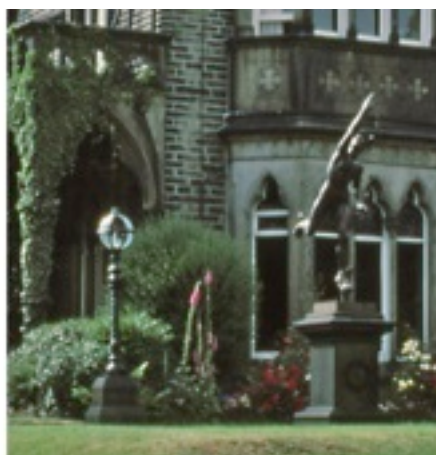
A pair of mid 19<sup>th</sup> century lampposts were situated to the front of the house. They are listed separately in their own right, but also affect the setting of the listed house. Only one lamp post has been retained, whilst the base for another is still in situ. On enquiry we were informed that the missing post was broken by a car and is retained on site.

The retained lamp post has been altered, the glass globe seen on a 1977 photograph has been replaced with a lantern. The lamp post is not visible on the 1867 photograph of the house however it is probable such a feature would of been implemented soon after.

Replacement of the missing lamppost should be considered. Dependent on condition, a new lamppost may need to be cast.
