**ARBORICULTURAL REPORT**  
**to BS 5837:2012**  
**at**  
**Flockton Green Working Mens Club**  
**Barnsley Road**  
**Flockton**  
**West Yorkshire**  
**WF4 4AA**

**Client:**  
Barratt David Wilson Yorkshire West

**JCA Ref:**  
12734/ChC

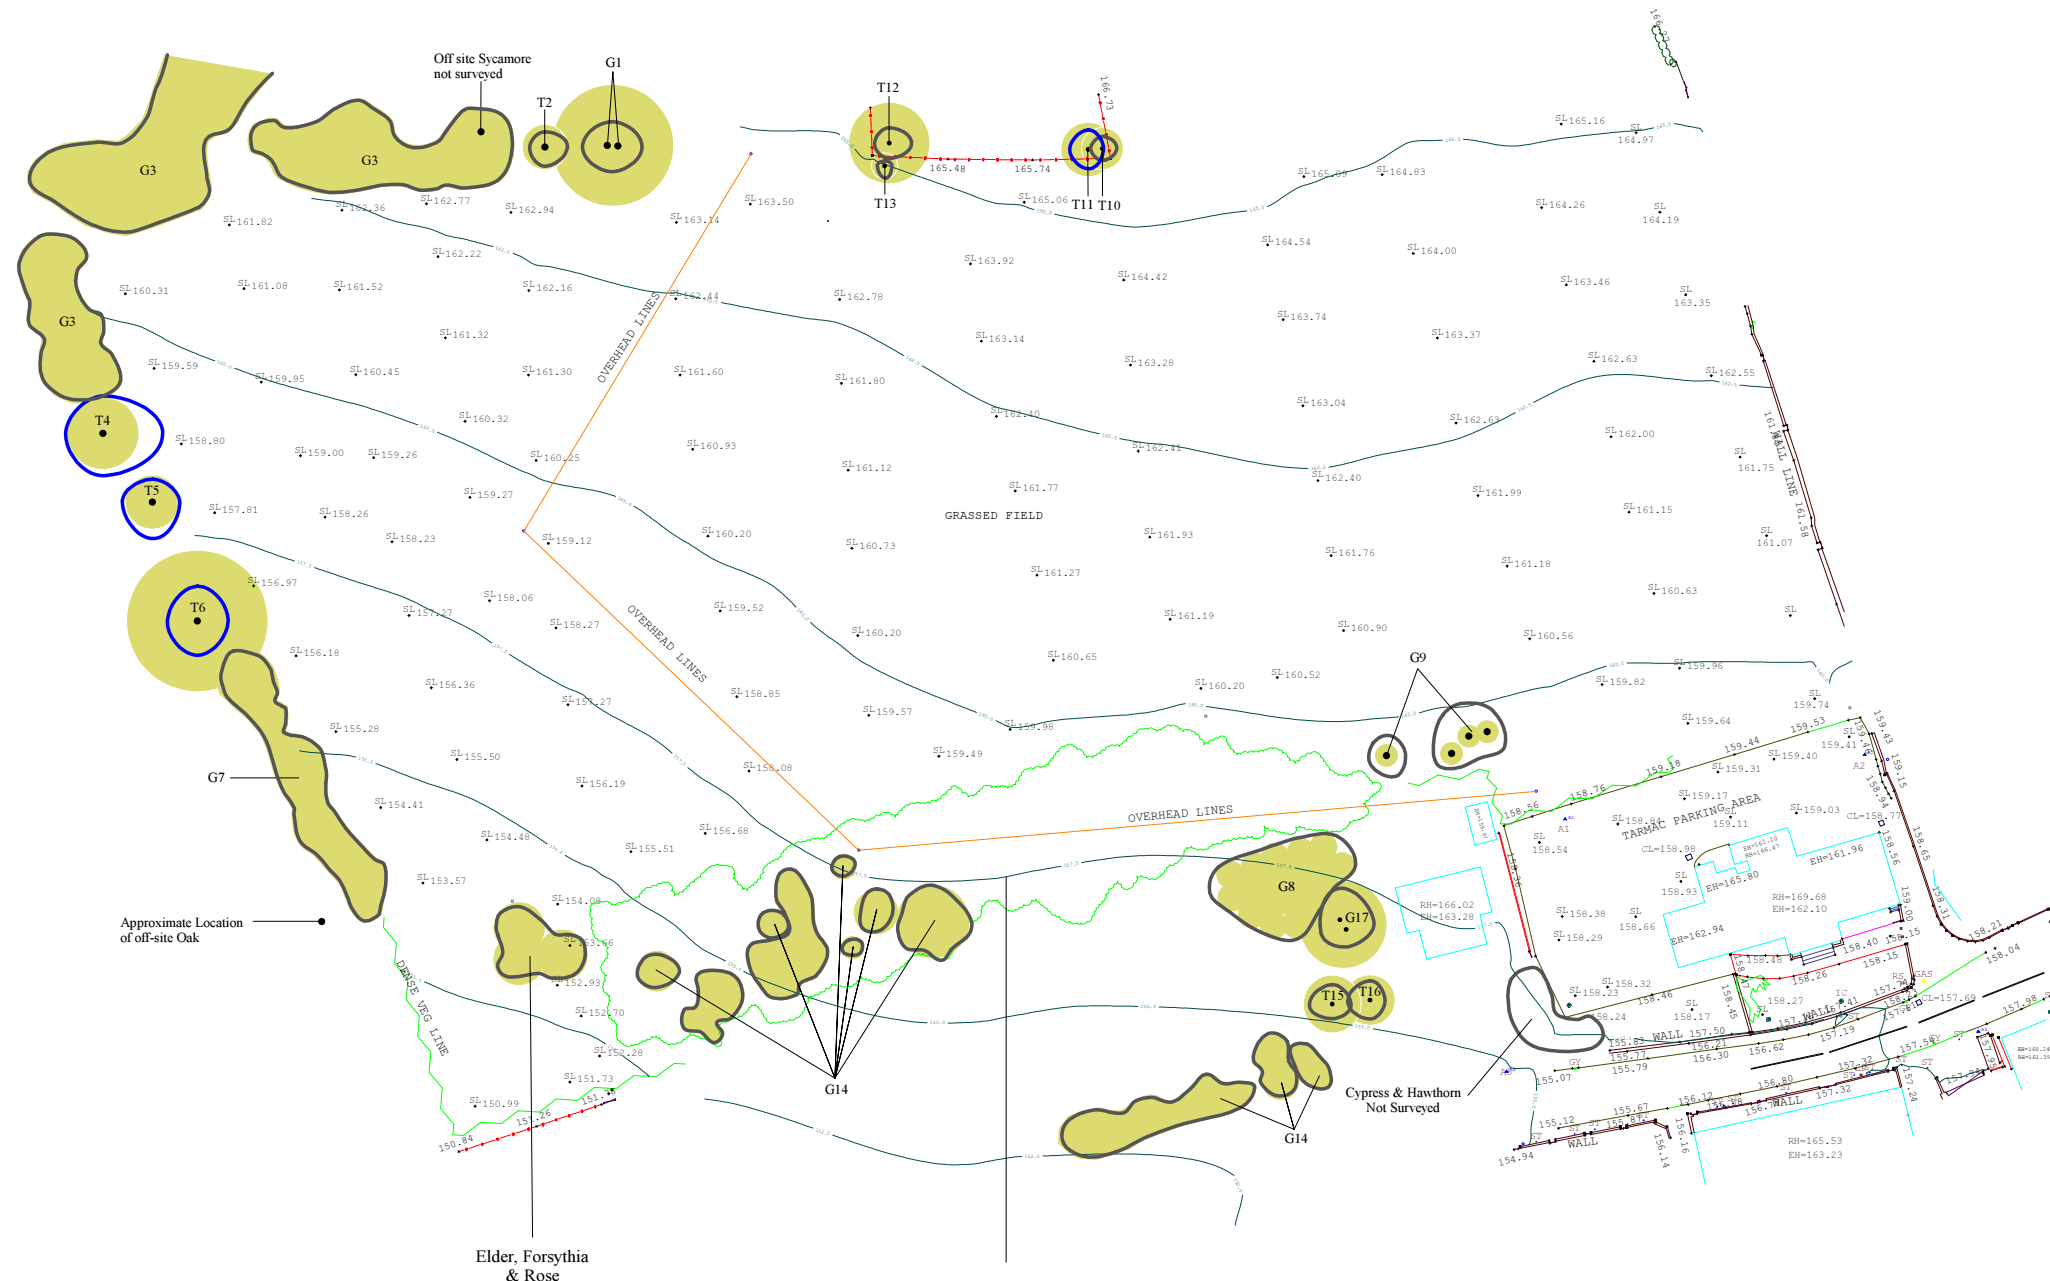
Elder, Forsythia  
& Rose

A dense area of Brambles, Raspberry, Rose,  
Elder, Rhododendron. Some specimens  
growing over 2m in height. Very restricted  
access. All canopy spreads within this area  
are estimates only and should not be scaled  
from. No large specimens were growing  
within this area.
