# **FLOOD RISK ASSESSMENT**

**Land at  
Cellars Clough,  
Nr Marsden,  
Huddersfield,  
West Yorkshire  
HD7 6NB**

**E15/6518/FRA001A**

**April 2016  
REVISED September 2017**

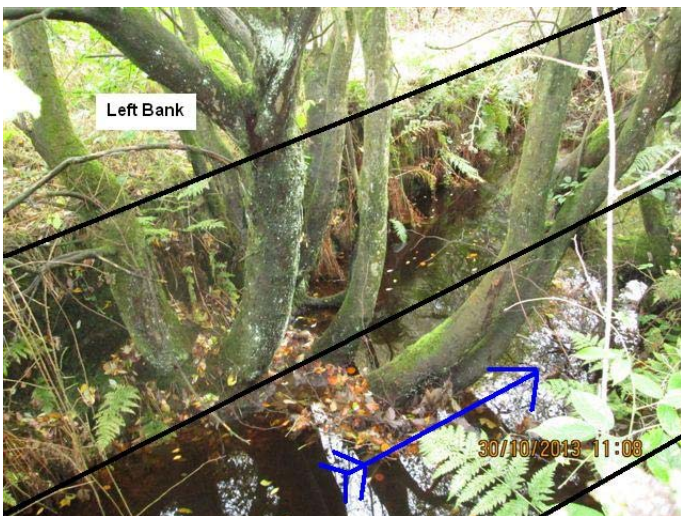
**5. Tree in inlet channel reducing capacity**

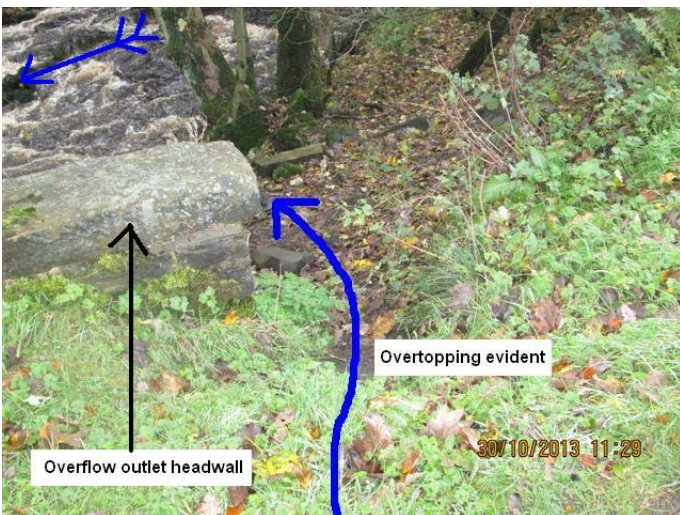
**11. Possible overtopping flow path**

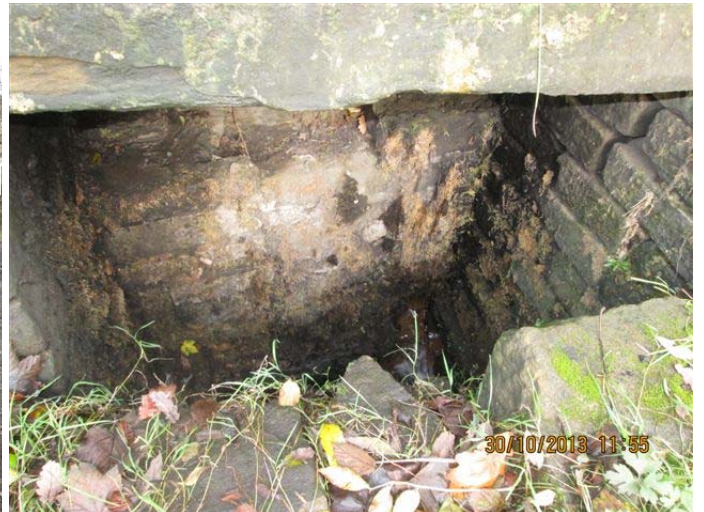
22. Chamber in masonry retaining wall

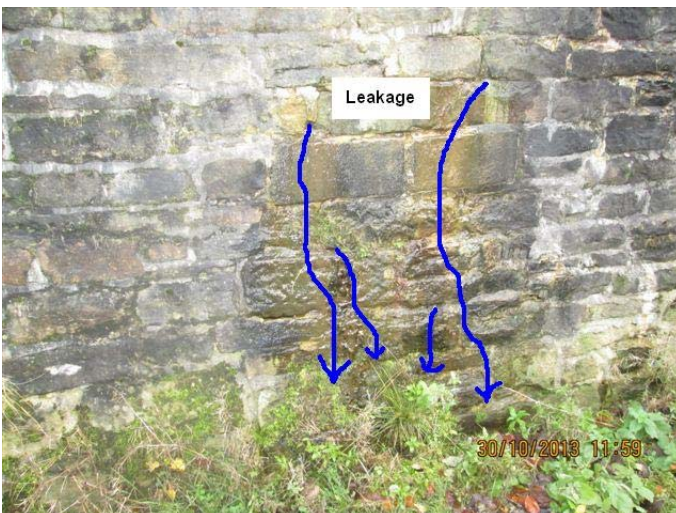
Cellars Clough Pond is considered to be a high priority due to the residential properties in the surrounding area and the recorded condition of the pond. Of particular concern is the evidence of leakage and movement in the masonry walls alongside the adjacent canal, which is causing erosion of the canal towpath. For this reason we are also sharing our findings with the Canal & Rivers Trust.

23. Leakage through masonry wall

- Remedial works to stop the leakage from the northern dam along with repairs undertaken to Canal towpath (picture 28)
- Removal of the submerged boat within the reservoir.
- Maintenance of overflow spillway to reinstate missing masonry.
- Management and maintenance of trees within the inlet channel, on the upstream face and dam crest. (picture 5)
- Consideration given to the removal of the fencing panel on the overflow arrangement to reduce blockage risk. (picture 18)

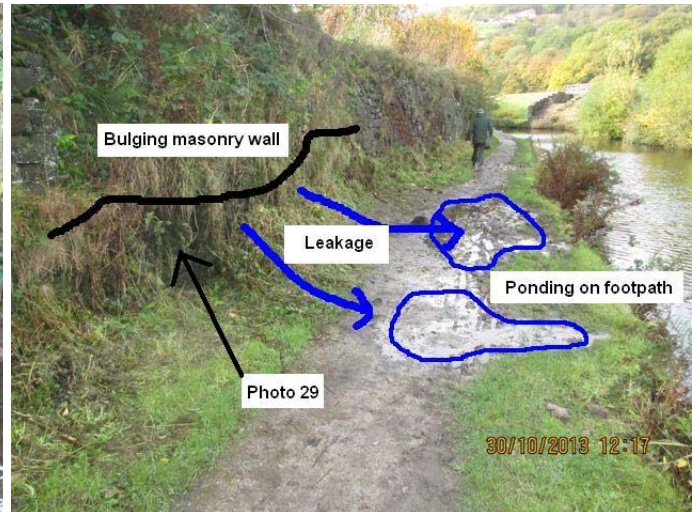
28. Leakage and bulging masonry

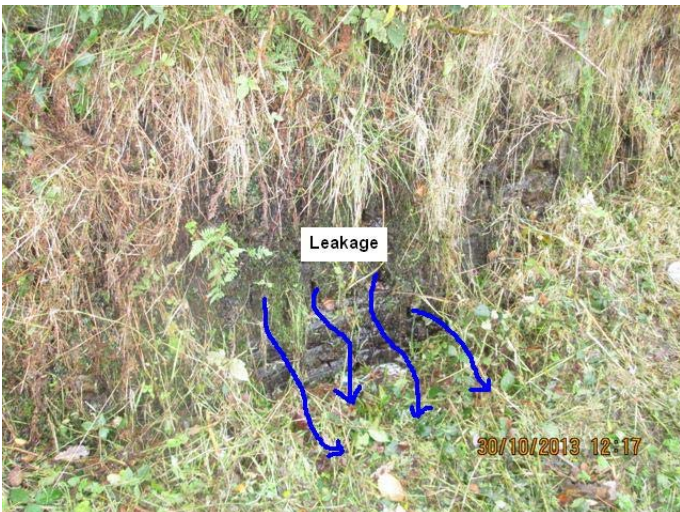
29. Leakage flow

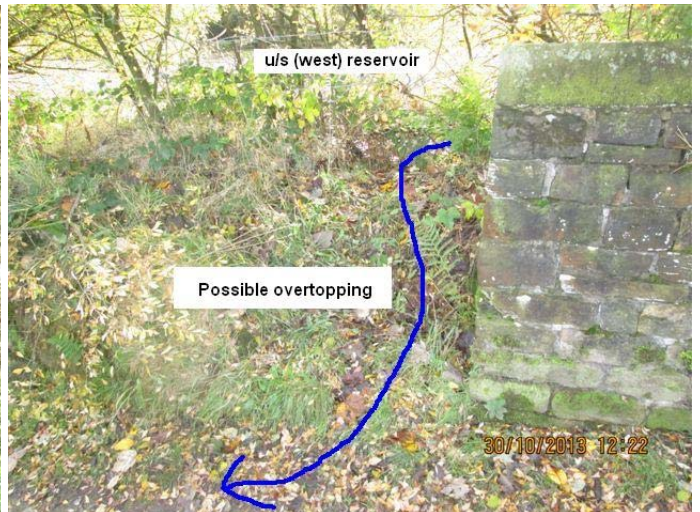
Retaining Structure (Northern Bank)	Construction	Masonry dam and earth crest.		
		Freeboard	<ul style="list-style-type: none"> <li>▪ Freeboard estimated to be 500mm.</li> </ul>		
		Upstream Face	Not visible during site inspection.		
		Crest	Not visible during site inspection.		
		Downstream Face	<ul style="list-style-type: none"> <li>▪ Masonry retaining wall with leakage identified in 3nr locations resulting in ponding and erosion of canal towpath (Photo 28 &amp; 29).</li> <li>▪ Bulging identified in a number of locations along its length (Photo 28).</li> <li>▪ Possible overtopping flow path identified opposite Sparth reservoir discharge point (Photo 30).</li> </ul>

30. Possible Overtopping
