COAL MINING RISK ASSESSMENT  
AT  
HD1 PROJECT, STADIUM WAY,  
HUDDERSFIELD  
FOR  
Kirklees Stadium Development Ltd  
REPORT REF: KSDL 3282

REPORT REF: KSDL 3282

SEPTEMBER 2016

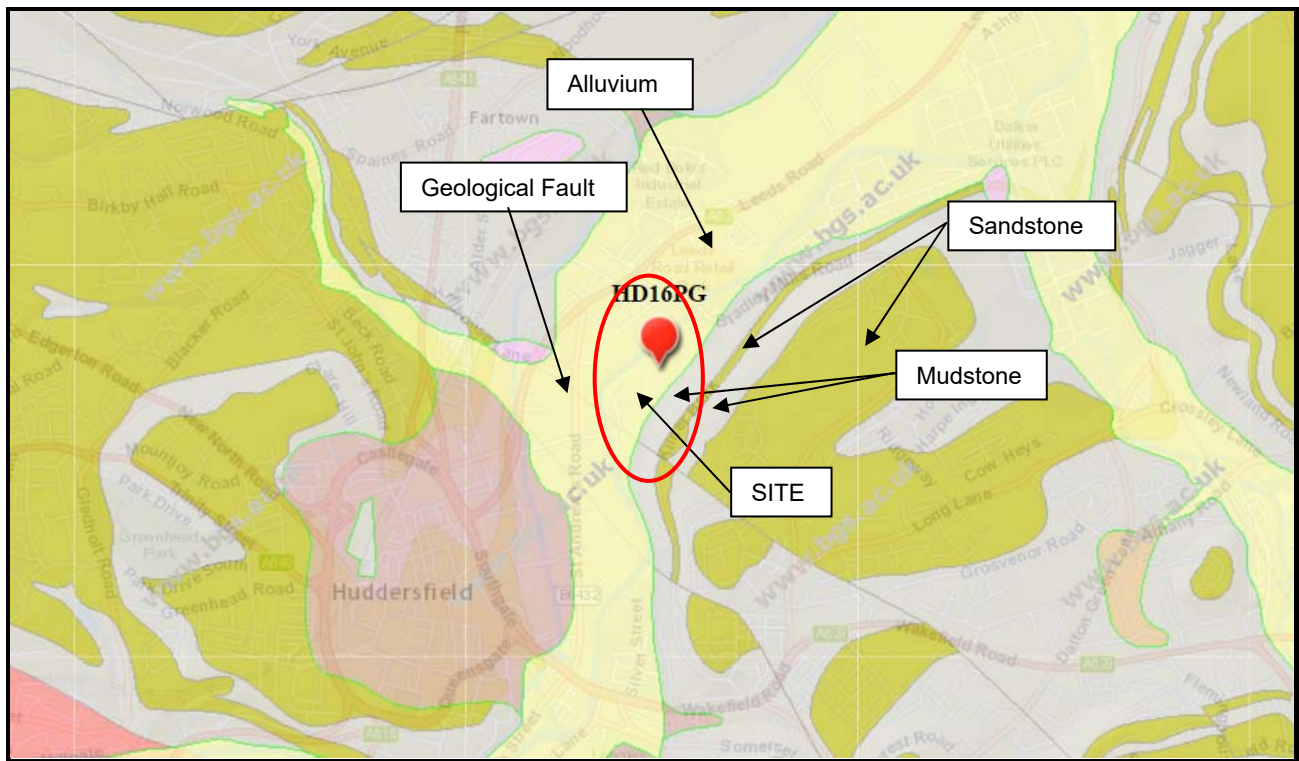
Figure 6 Geology and BGS Borehole Location Plan

The geological maps indicate the presence of several known geological faults. There are two NW-SE trending faults that cross the central area of the site. These faults dip to the northeast and have downthrown younger strata to the north east compared to older strata to the south west.

The Coal Measures strata are heavily faulted from past tectonic activity and small unrecorded faults may also be present.

The faults are unlikely to detrimentally affect the stability of the site unless shallow mined ground is present beneath the site.

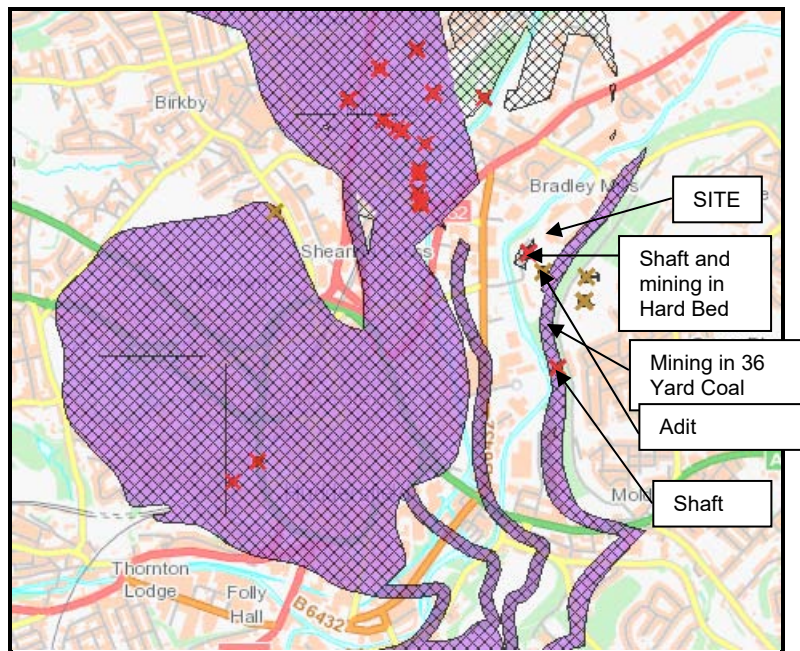
Figure 8 Coal Mining Plan

As there are two coal seams and a fireclay seam within the upper 30m below rockhead beneath the site, one of which the Coal Authority record as mined and two which may have been mined, there is a **high risk** that the site could suffer ground subsidence in the future if voids migrate to the ground surface. If there is sufficient overlying competent rock strata to prevent voids migrating to the surface then ground stabilisation may not be required. This will depend on the depth of the coal seam and which seams have been mined. Alternatively there may be insufficient cover and ground stabilisation may be required for development to proceed.

The Coal Mining Plan in Figure 8 illustrates the known and expected mining in the local area including the site.

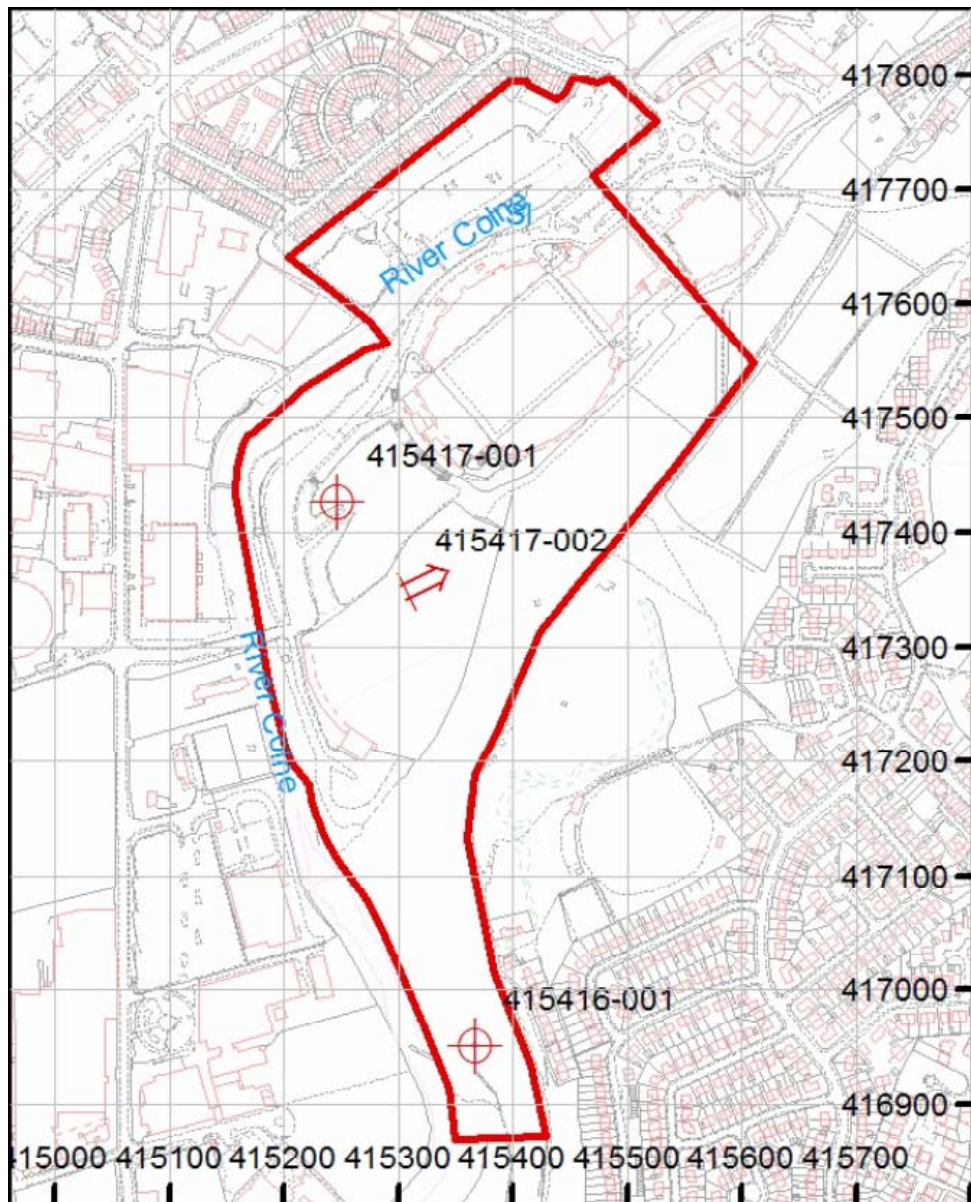
Figure 9 Mine Shafts and Adits

The second shaft lies at NGR 415368E 416951N at the southern end of the site beyond the area of proposed development. There are no records at the Coal Authority for this shaft, its presence is noted on the 2<sup>nd</sup> Edition Geological map. It is likely that it was sunk to mine the 36 Yard Coal which lies at shallow depth in this area. There are no records to suggest that the shaft has been stabilised.

The presence and depth of any made ground requires investigating by drilling to determine the closest distance that development can be undertaken to the shaft.

Alternatively, if development is proposed close to or over the shaft or adit, then they both require to be located by closely spaced boreholes drilled to rockhead. Once located, they will need to be drilled to the base and then stabilised by injection of a mix of pfa and cement. The shafts will then need a reinforced concrete cap constructed that is twice the diameter of the shaft or adit and at least 0.45m in thickness. The cap is usually constructed at rockhead, however this may be impractical for the shaft due to the 13.50m of overlying landfill. Negotiation will therefore be required with the Coal Authority to design an acceptable solution to the shaft stabilisation for development to proceed.
