Bat Survey to Egypt Farm Cliffe Lane

Cleckheaton
BD19 4EU

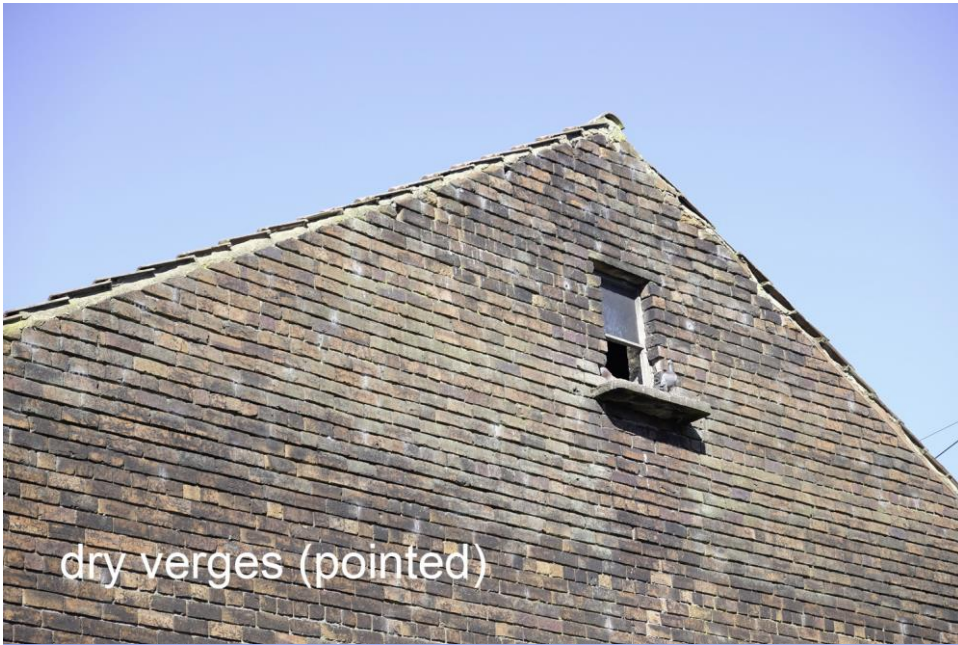
dry verges (pointed)

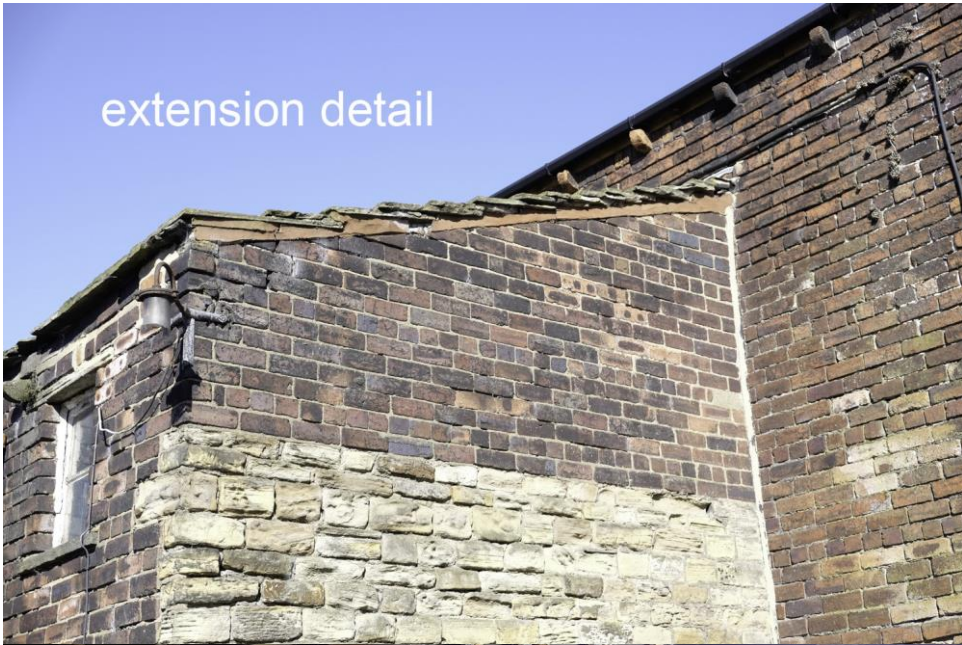
On the front of the barn is a small extension which has a stone tiled roof. Internal inspection shows this to be unlined but very heavily covered with cobwebs. It is unlikely a nursery roost would exist here though individual bats could find shelter beneath the overlapping sections of the stone tiles.

The small extension to the front of the barn has a stone roof but is unlined. Inspection suggests bats are not using the roof but individual animals could roost between the stone tiles where they overlap. Cautionary measures have been outlined in section 11.

extension detail

The removal of the stone roof tiles on the small extension should be undertaken by hand by lifting the tiles vertically to avoid any possible crushing injuries in the unlikely event of bats being present.

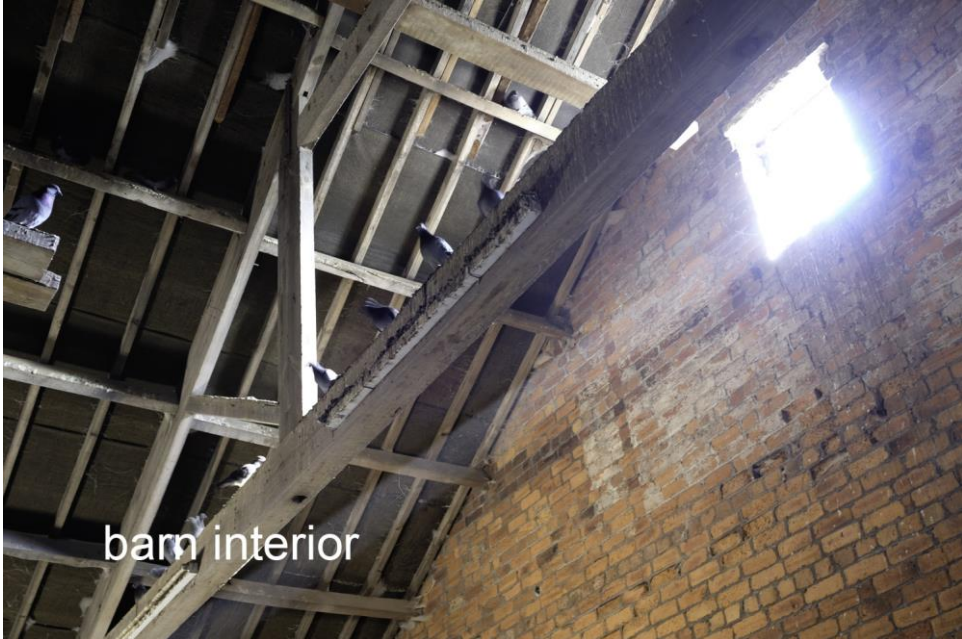
barn interior

Over the years, the roof has been renovated and weather proofed and replaced with a traditional hessian felt and covered with interlocking Marley tiles which have very few gaps. The ridge tiles have all been re-bedded and there are no gaps that would allow bats access to the ridge area. Internally, there is no light ingress in the ridges and most of the ridges are very heavily covered with cobwebs. The barn is full of pigeon and the entire interior is heavily covered in pigeon guano making it impossible to search for bat droppings.

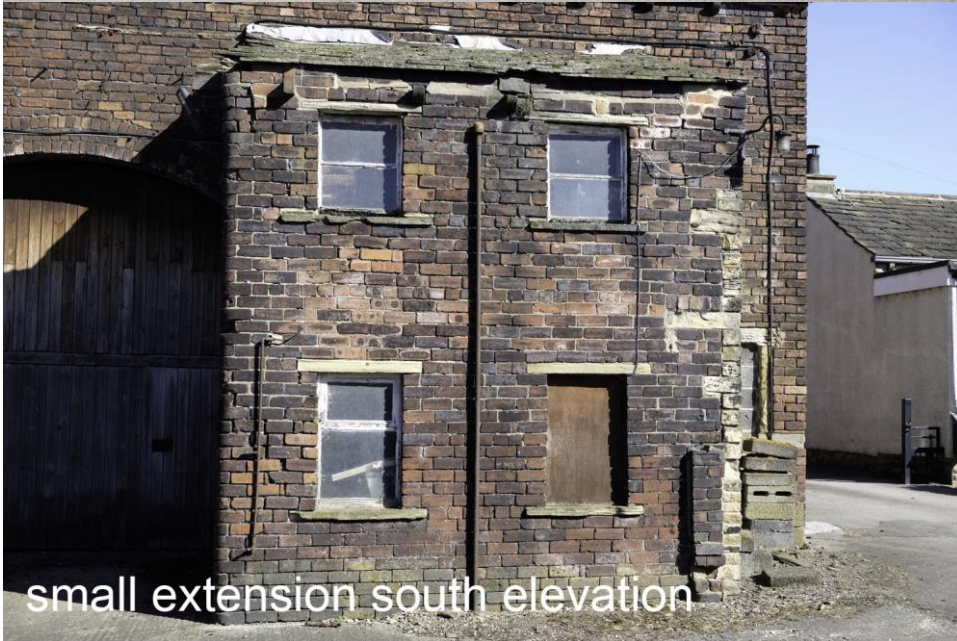
small extension south elevation

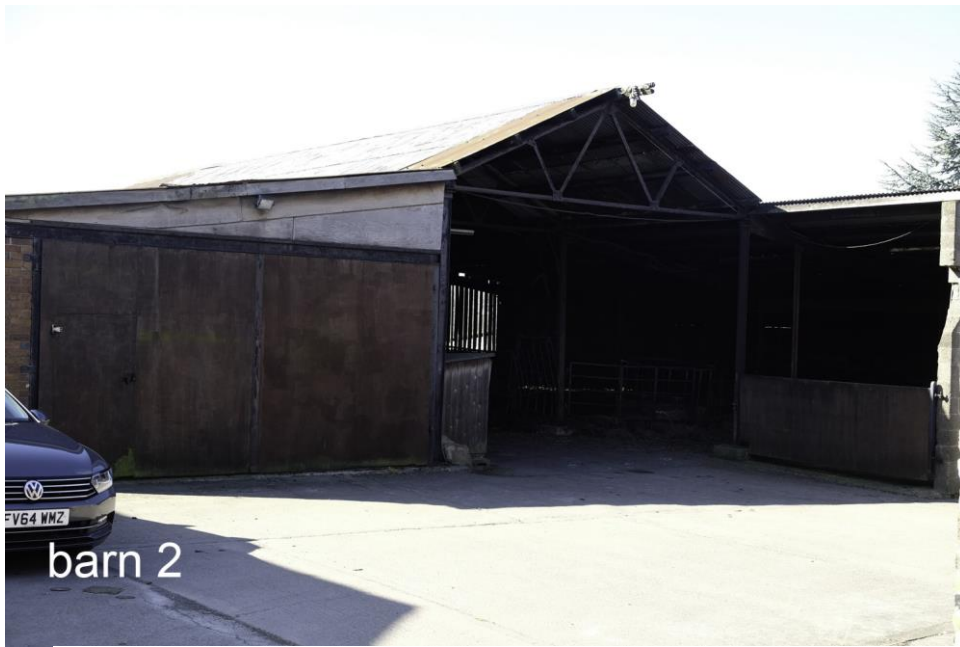
barn 2

The second barn on site is a large, open-fronted livestock barn which is constructed from single thickness block walls with some wooden sections and a tin roof. The wooden section of walls and the roof are supported on thin angle iron frames and the whole building is considered to be of no value to bats in terms of possible roosting sites.

The building has no obvious roost sites and is considered to have **negligible** roost potential.
