**ARBORICULTURAL IMPACT ASSESSMENT
to BS 5837:2012
at
Washpit Mills
Choppards Lane
Holmfirth
West Yorkshire
HD9 2RD**

Client:
Prospect Estates

JCA Ref:
13024-A/AJB

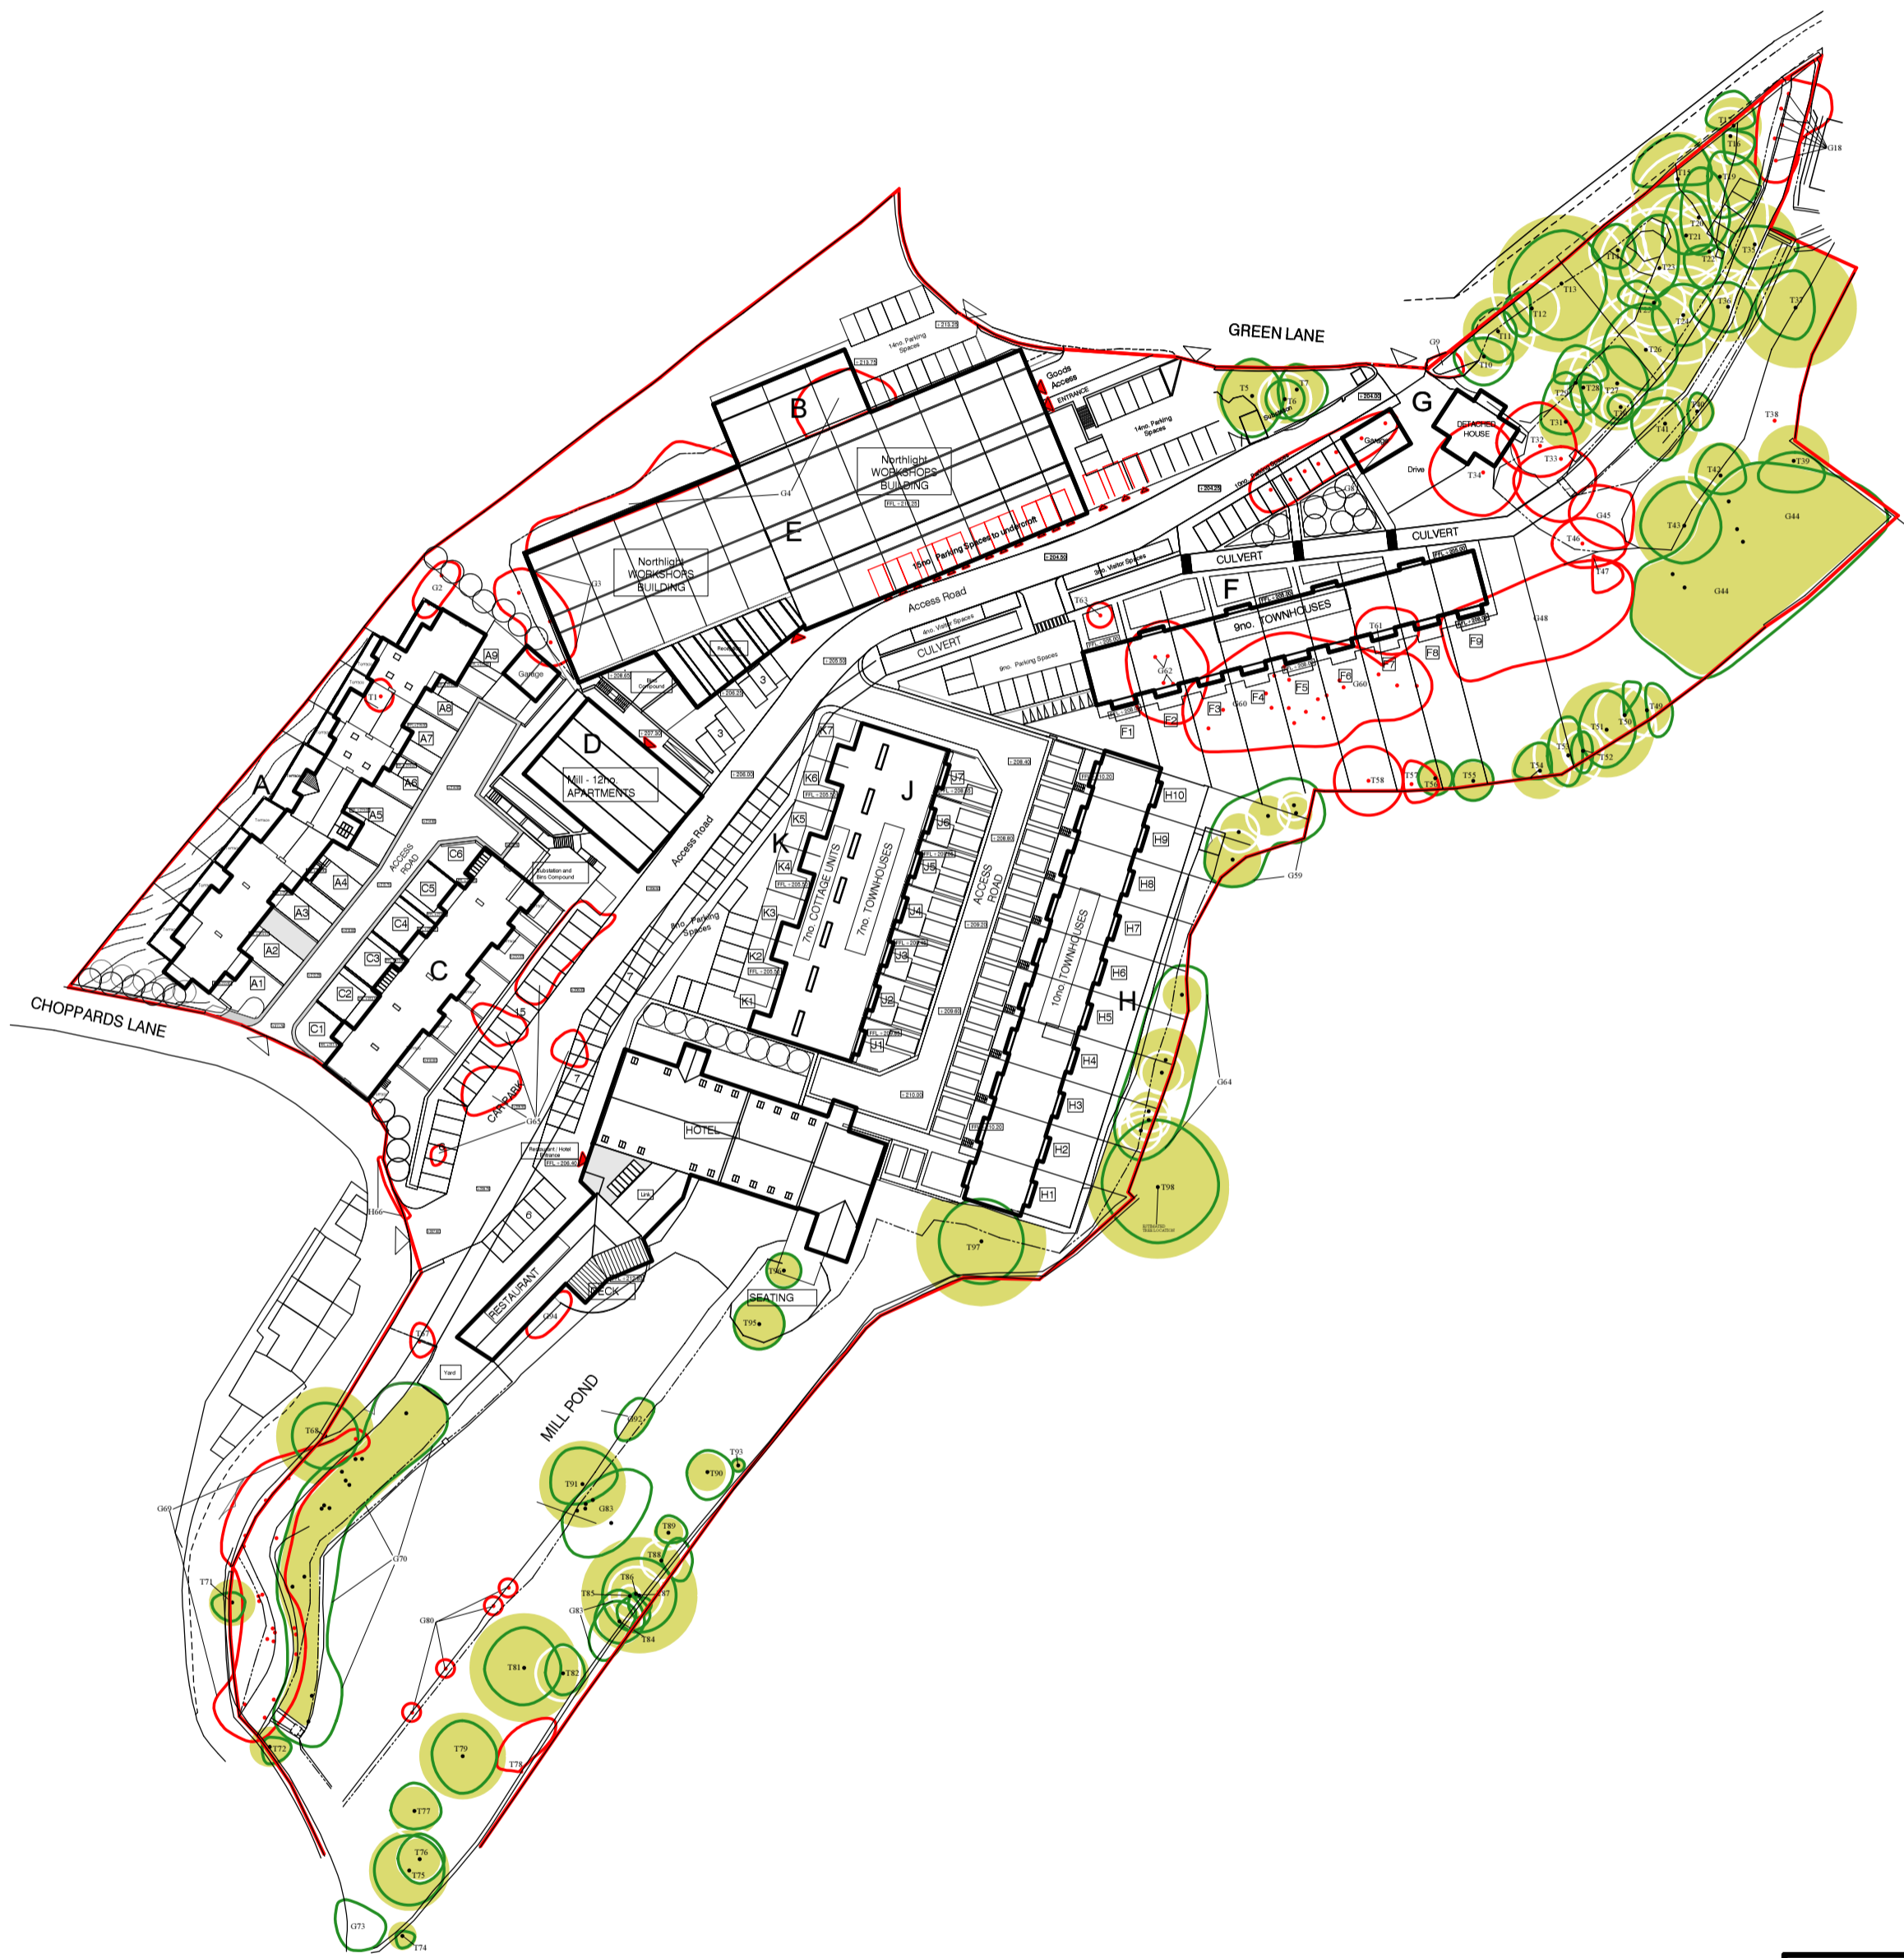
**Appendix 7:
Development Proposals**

- 3.2.1 **T1, G2, G3, G4, G8, G9, T32, T33, G45, T46, T47, G48, G60, G62, T63, G65** and **H66** are proposed to be removed, either to directly facilitate the proposed development, open up useable garden space or as they are not considered to be worthy of post-development retention.
- 3.2.2 Of these, all items of vegetation proposed to be removed fall into retention category 'C' and can be removed without significantly affecting the visual amenity of the surrounding area.
- 3.2.3 Whilst the development will require the removal of some trees within the site, it should be noted that a planting scheme is included within the proposals. This will act to mitigate tree losses, improve the visual benefits of the site and the surrounding area, and will improve the localised tree stock.
