**ARBORICULTURAL IMPACT ASSESSMENT  
to BS 5837:2012**

**Holme House  
Oxford Road  
Cleckheaton  
West Yorkshire  
BD19 4LA**

**JCA Ref:**  
13931c/ChC

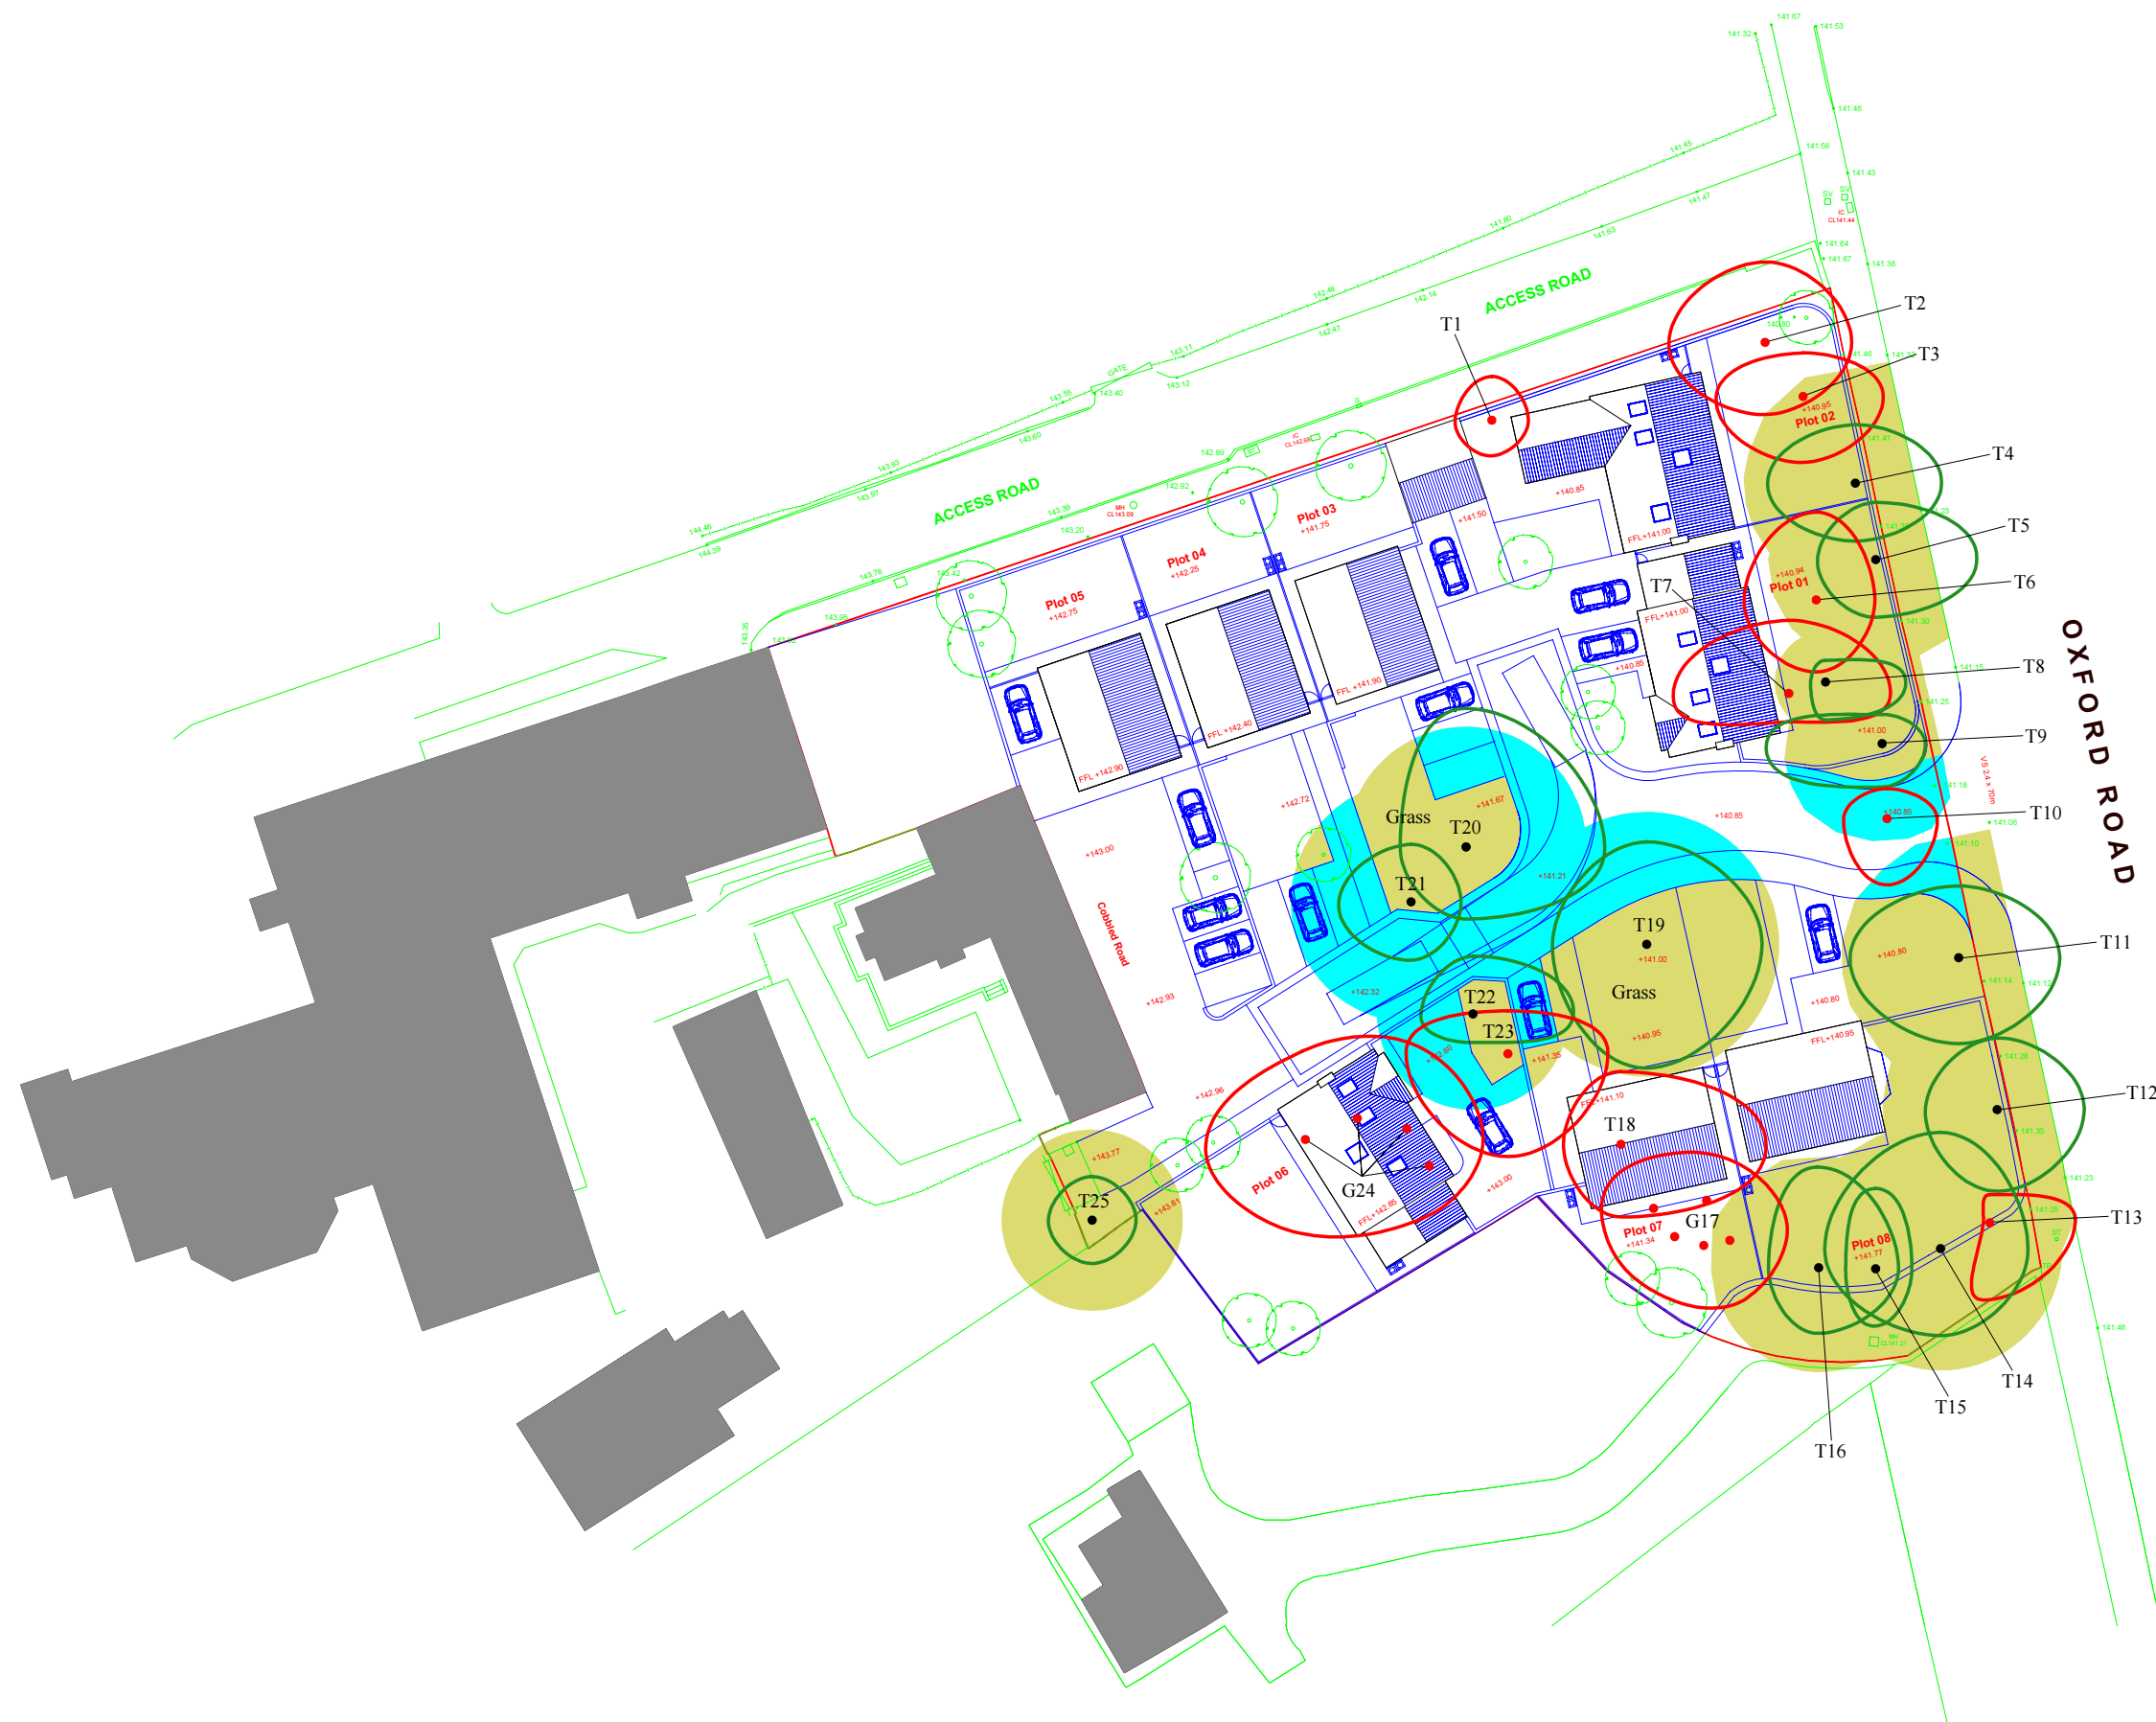
**Appendix 7: Arboricultural Implications Plan**

- 3.4.1.3 Where work is required within the RPA of a tree which is to be retained, specialist measures must be adopted during the construction phase to avoid ground compaction and minimise root damage. Such areas are highlighted on the Arboricultural Implications Plan at **Appendix 7**.

- 3.4.2.1 The proposed development entails the construction of a hard surfaced internal access road within the RPA of several trees to be retained. In order to prevent foreseeable damage to tree roots, a 'no-dig' method of construction will be utilised and has been agreed upon during the design stage.

- 3.5.1 In order to protect the retained trees during the construction phase, protective fencing needs to be installed. Protective fencing specifications and on site positioning, along with details of any necessary specialist construction methods can be provided in an Arboricultural Method Statement (AMS).
