New Hey Road Outlane

Road Safety Audit

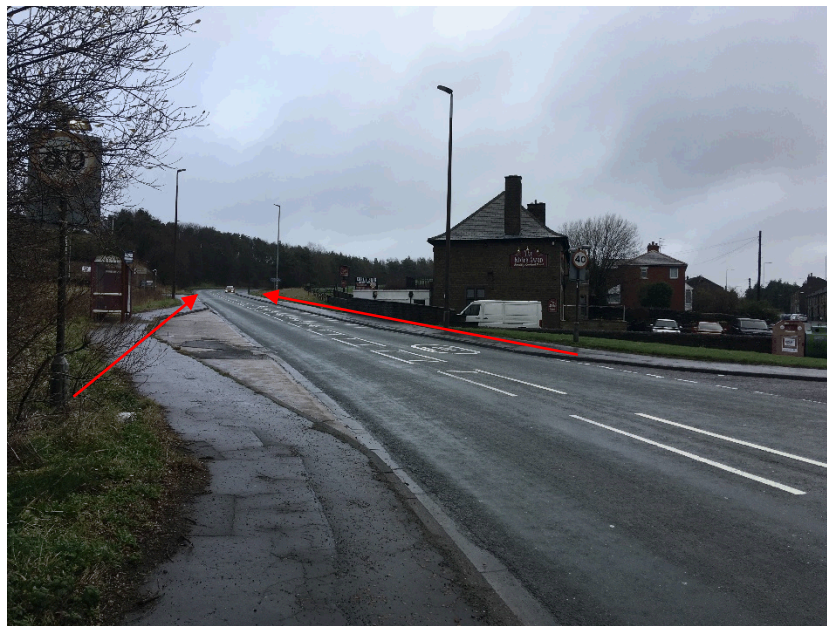
Design Team Response (1):

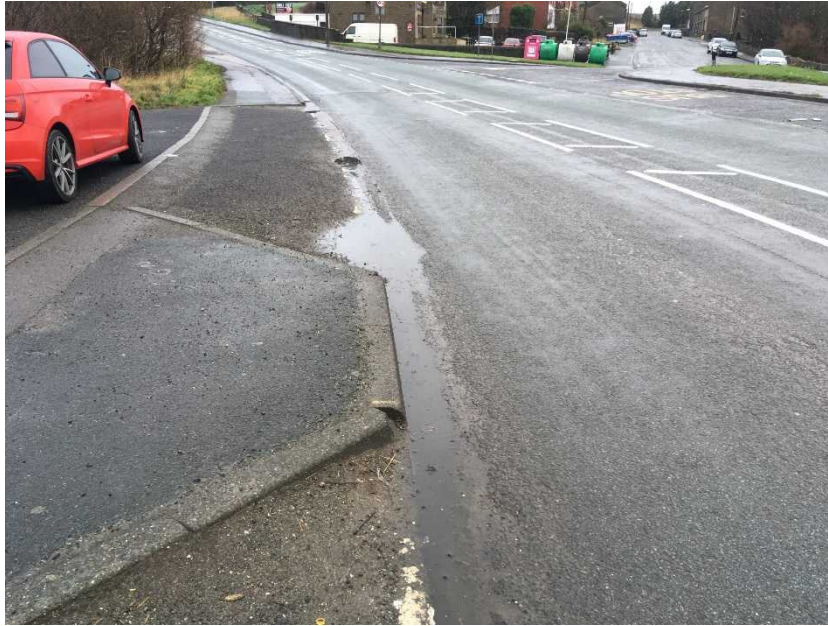
Recommendation: Ensure there is adequate drainage especially at the junction and at any low spots within the highway.

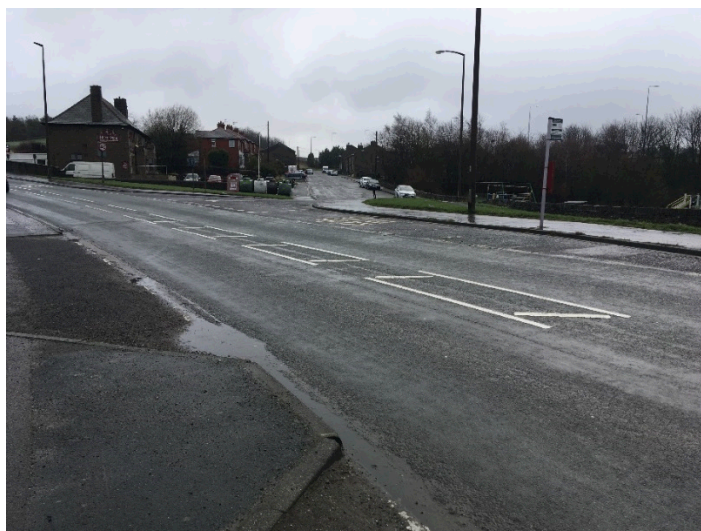
Recommendation: Alter the lining on New Hey Road and provide a right turn pocket within the central hatching if possible.
