# **ARBORICULTURAL REPORT & Impact Assessment to BS 5837:2012 at:**

*Land at*  
**Plane Street,  
Huddersfield,  
West Yorkshire  
HD4 6DF**

Date: *June 2020*

Reference: AWA3228

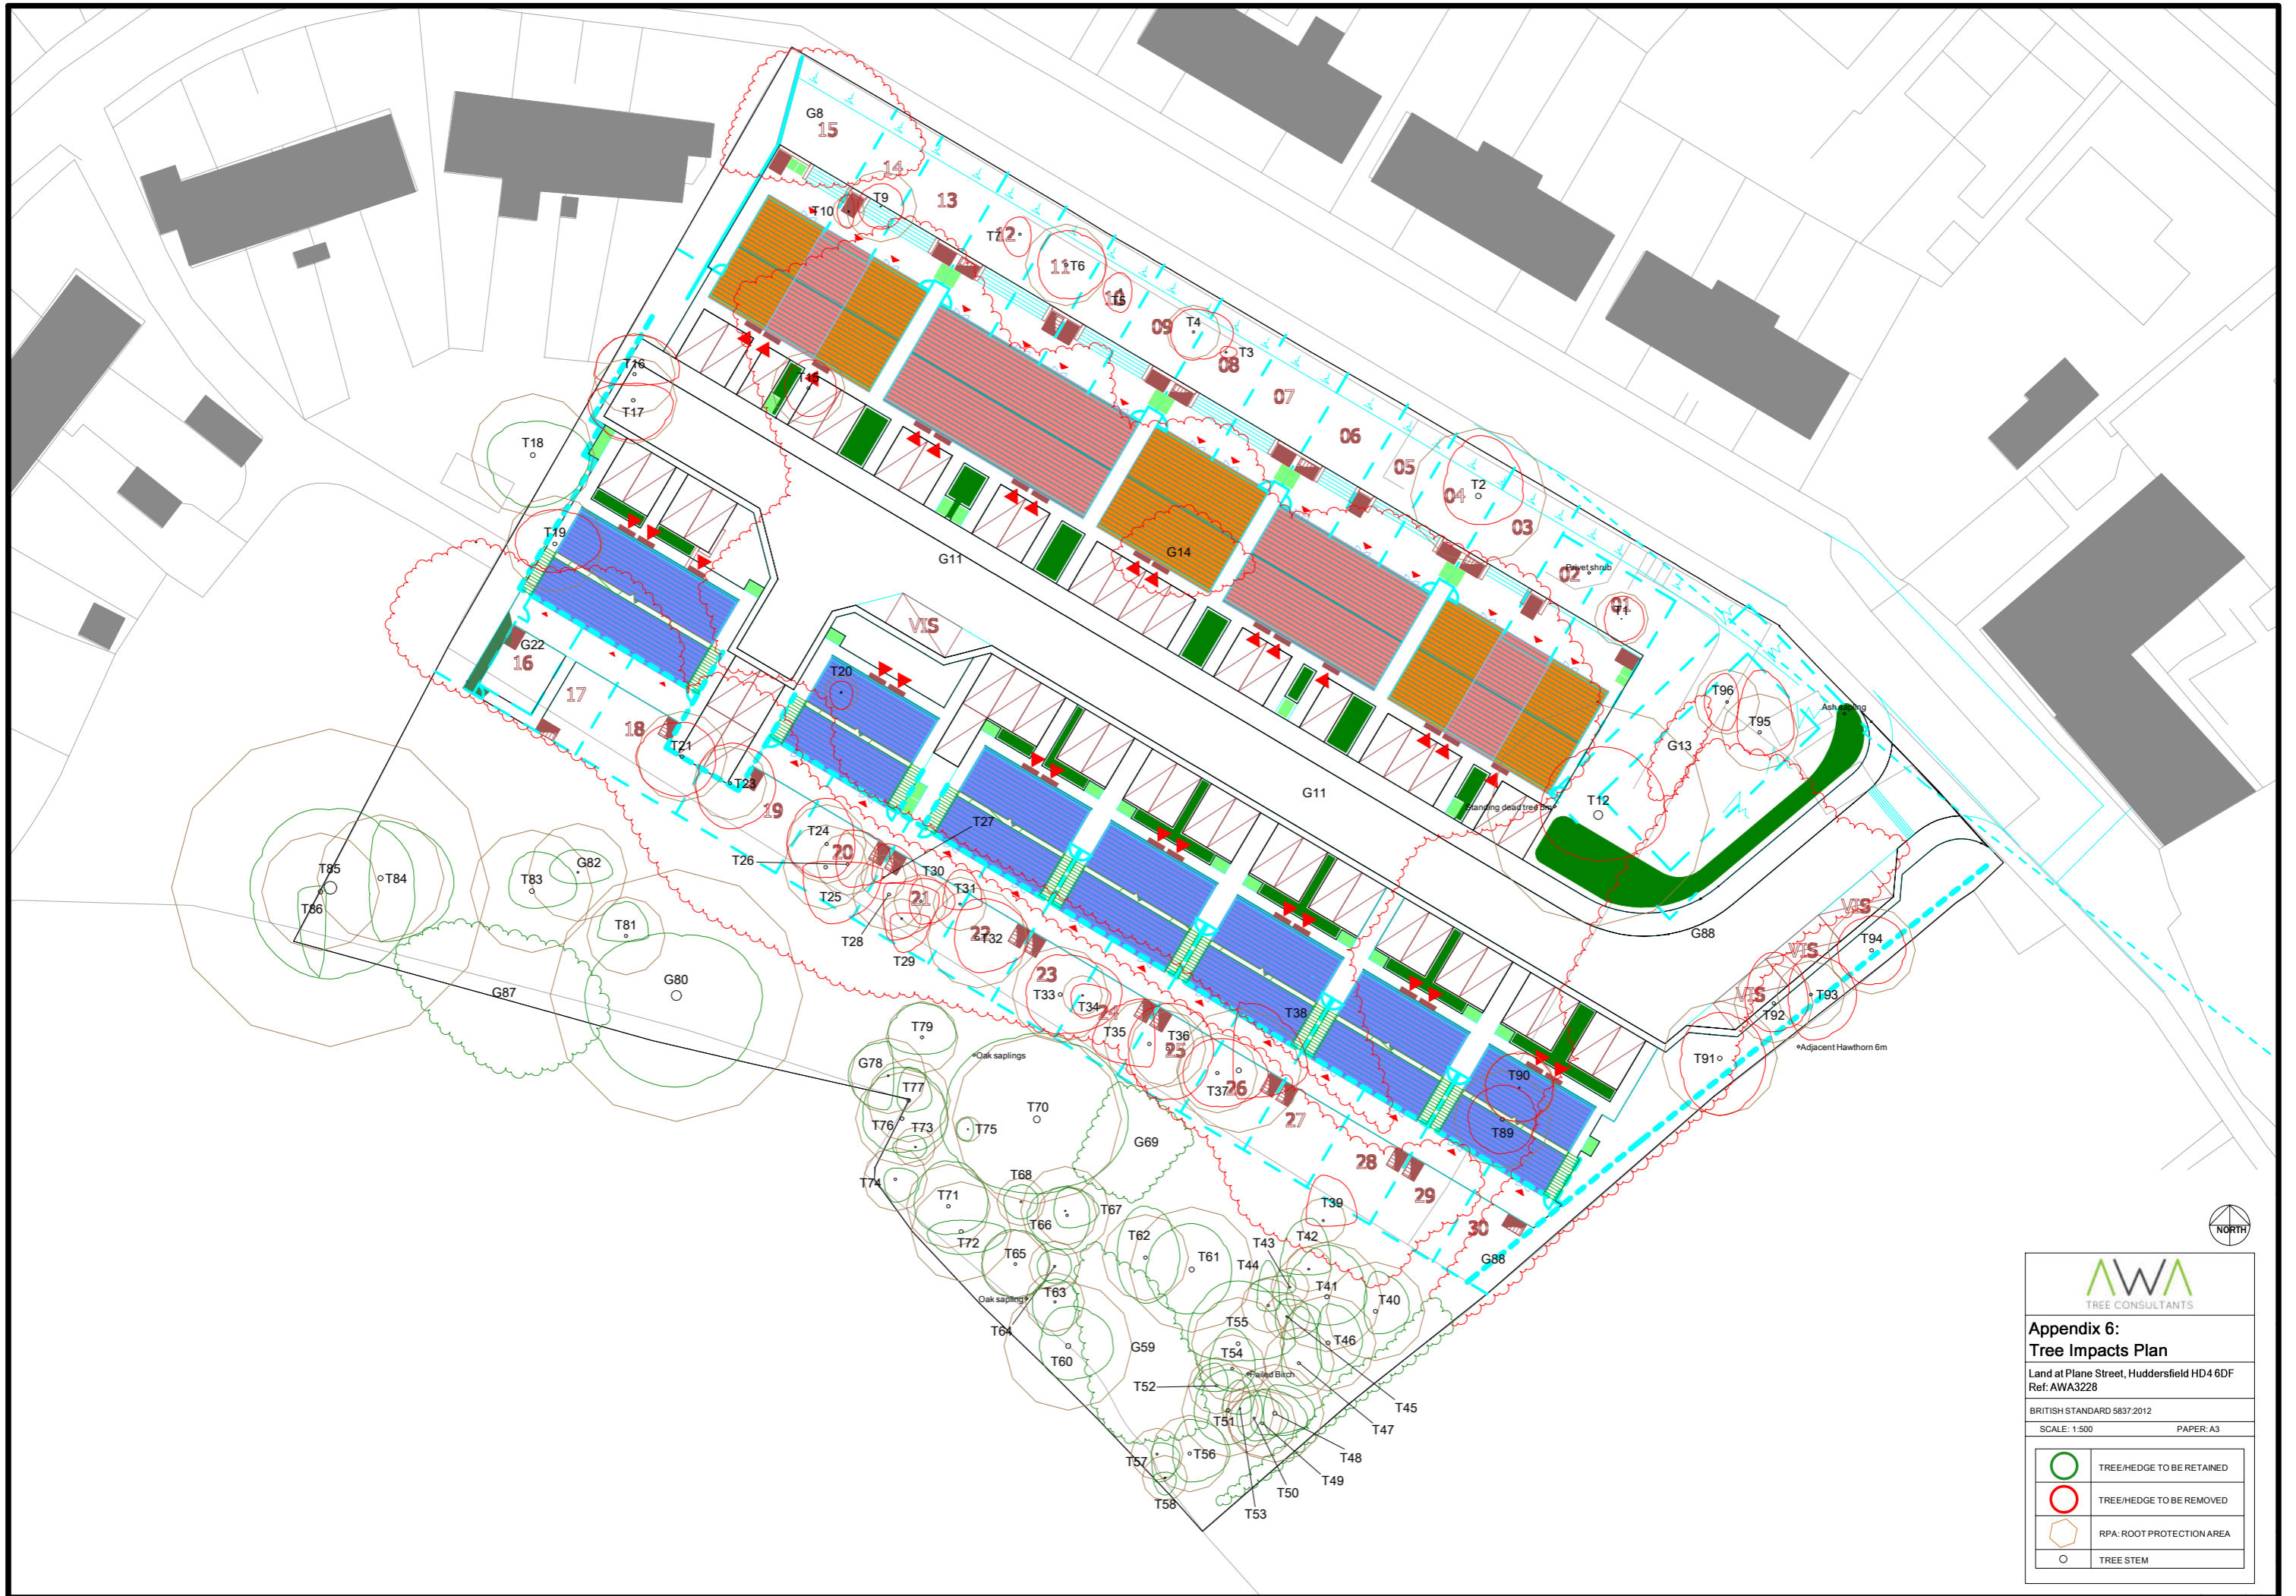
**Appendix 6:**  
**Tree Impacts Plan**  
 Land at Plane Street, Huddersfield HD4 6DF  
 Ref: AWA3228  
 BRITISH STANDARD 5837:2012  
 SCALE: 1:500 PAPER: A3

4.2.1 From assessing the new development proposals, 44 trees or tree groups will require removal as they are situated in the footprint of the structure or their retention and protection throughout the development is not suitable.

4.2.2 The trees that require removal are T1, T2, T4, T6, G8 to T17, T19 to T39 and G88 to T96.

4.3.2 New boundary landscaping is proposed that encroaches into the edge of the RPA of retained trees T18 and T70. However, the encroachment is very minor and the encroachment into the trees' RPAs should not significantly adversely impact on the health or future condition of the trees, provided posts and panels type footings are used as opposed to strip footings within the retained trees' RPAs. The holes for the fence posts should be dug by hand within retained trees' RPAs, avoiding severing or damaging significant

- 4.4.1 The retained trees will require protection by fencing in accordance with BS 5837: 2012, during the development phase.
- 4.4.2 If required by the Local Planning Authority, an associated Arboricultural Method Statement, detailing protective fencing specifications and construction methods close to the retained trees can be provided.
