Reference: 20200913-Mark\_Kosanovic-LPA\_additional\_info-Doc  
Applicant: Mark Kosanovic  
Agent: Ben Goodacre  
Date: 13/09/2020

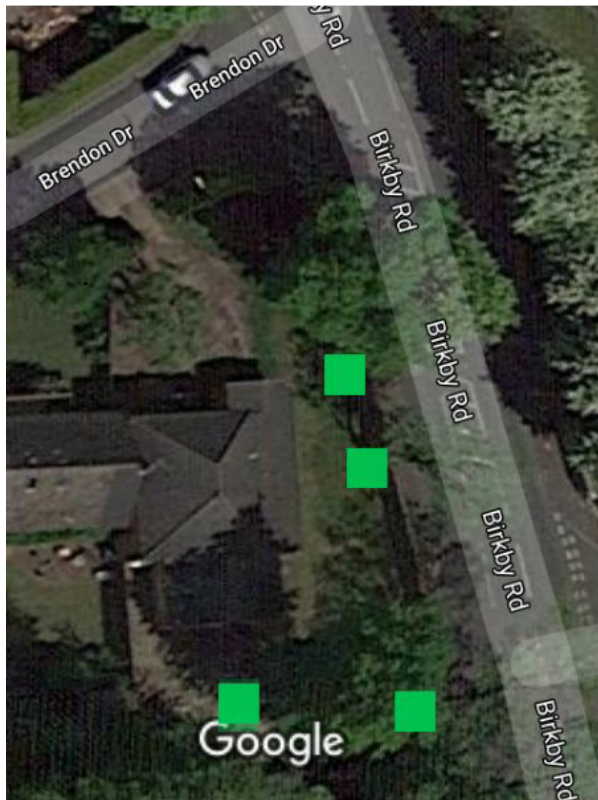
Anticlockwise from the bottom left the green squares denote T1, T2, T3 and T4. Access to the work location is via the customers drive from Brendon Drive. There is no work to be carried out from Birkby Road.

- A. T1 - Lime Tree. To be reduced in height in order to reduce the likelihood that in highwinds limbs will fall from the tree and damage property. This has happened previously and damage was caused to an adjacent property.
- B. T2 - Sycamore tree. Complete removal of the tree as it is diseased and will become a public safety hazard with a high risk of injury or property damage due the tree dying.
- C. T3 - Horse Chesnut Tree. Remove limbs overhanging Birkby road will be removed inline with the property boundary to reduce the risk of limbs falling on the public footpath.
- D. T4 - Lime Tree. Remove limbs overhanging Birkby road will be removed inline with the property boundary to reduce the risk of limbs falling on the public footpath.
