## **Arboricultural Impact Assessment Report**

Red Lea  
27 Church Lane  
Mirfield  
West Yorkshire  
WF14 9HX

**Date of report:** 29<sup>th</sup> October 2020

**Reference:** OWA084 AIA Rev 1

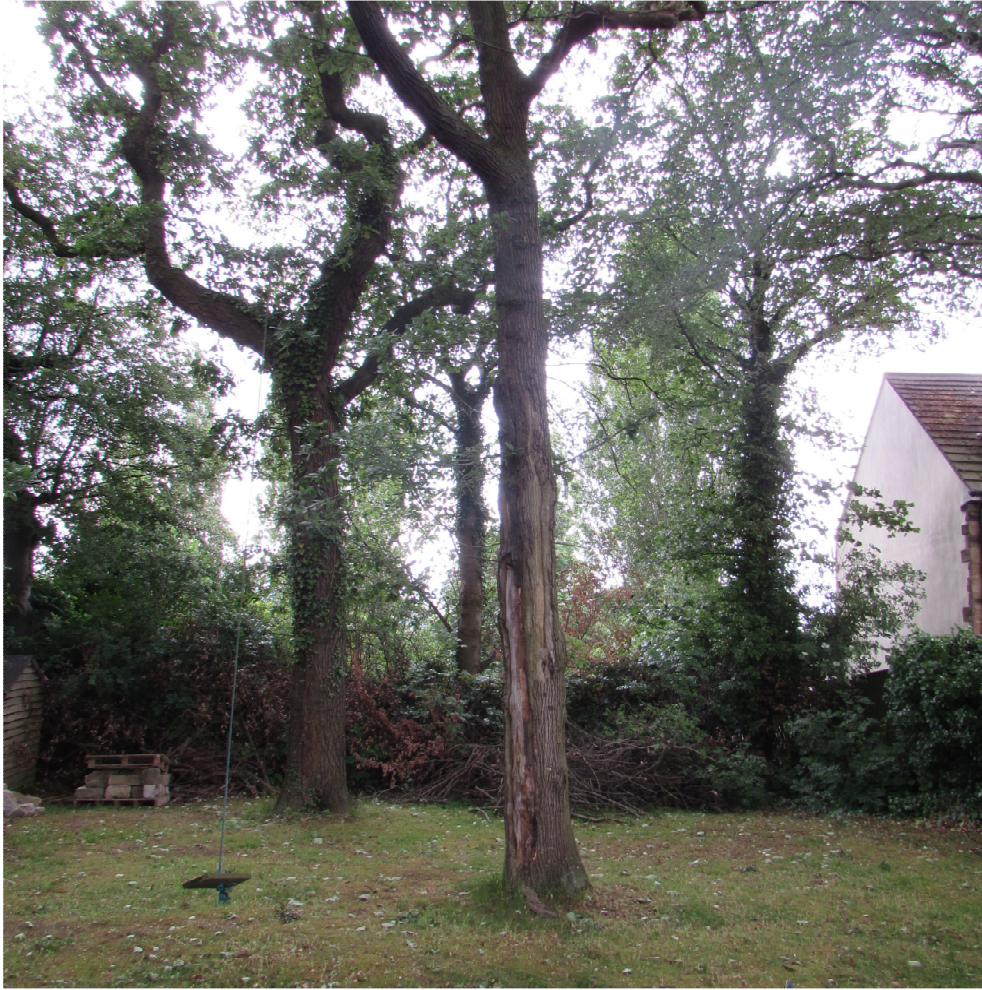
**Photo 1 –**  
The front garden to the west of the property, looking towards the south. T8 and T9 are in the forefront of the shrubbery, with T6 and T7 behind them.

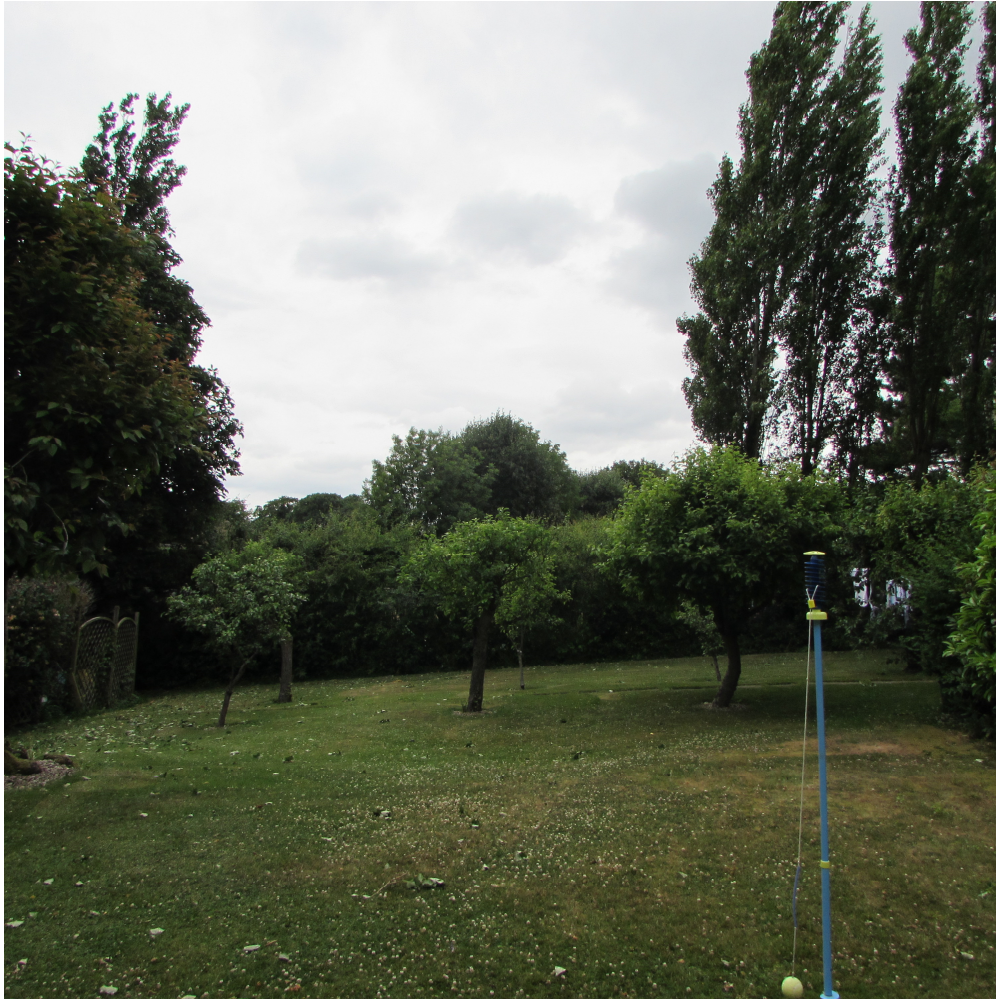
**Photo 2 –** Some of the land in the rear garden where the dwelling will be situated, looking west from behind the existing property.

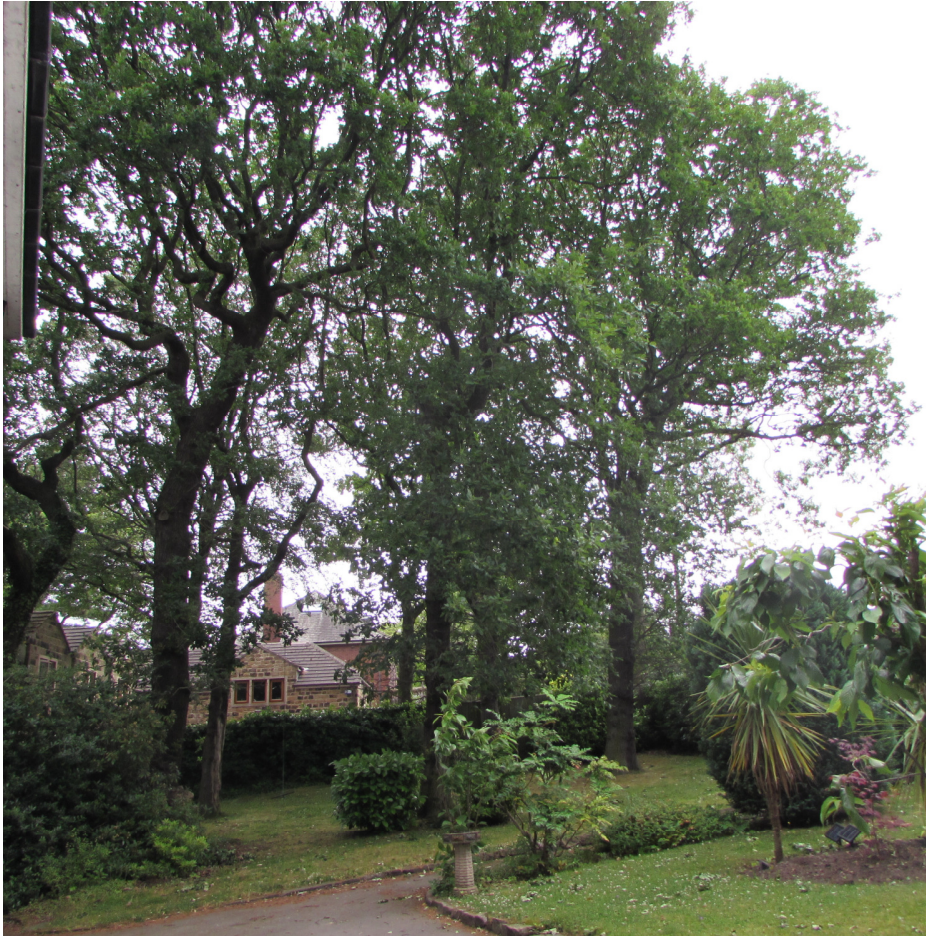
**Photo 3** – View north-west from the house, where the driveway to the development will be.
