## **Arboricultural Impact Assessment Report**

Red Lea  
27 Church Lane  
Mirfield  
West Yorkshire  
WF14 9HX

**Date of report:** 19<sup>th</sup> May 2021

**Reference:** OWA084 AIA Rev 2

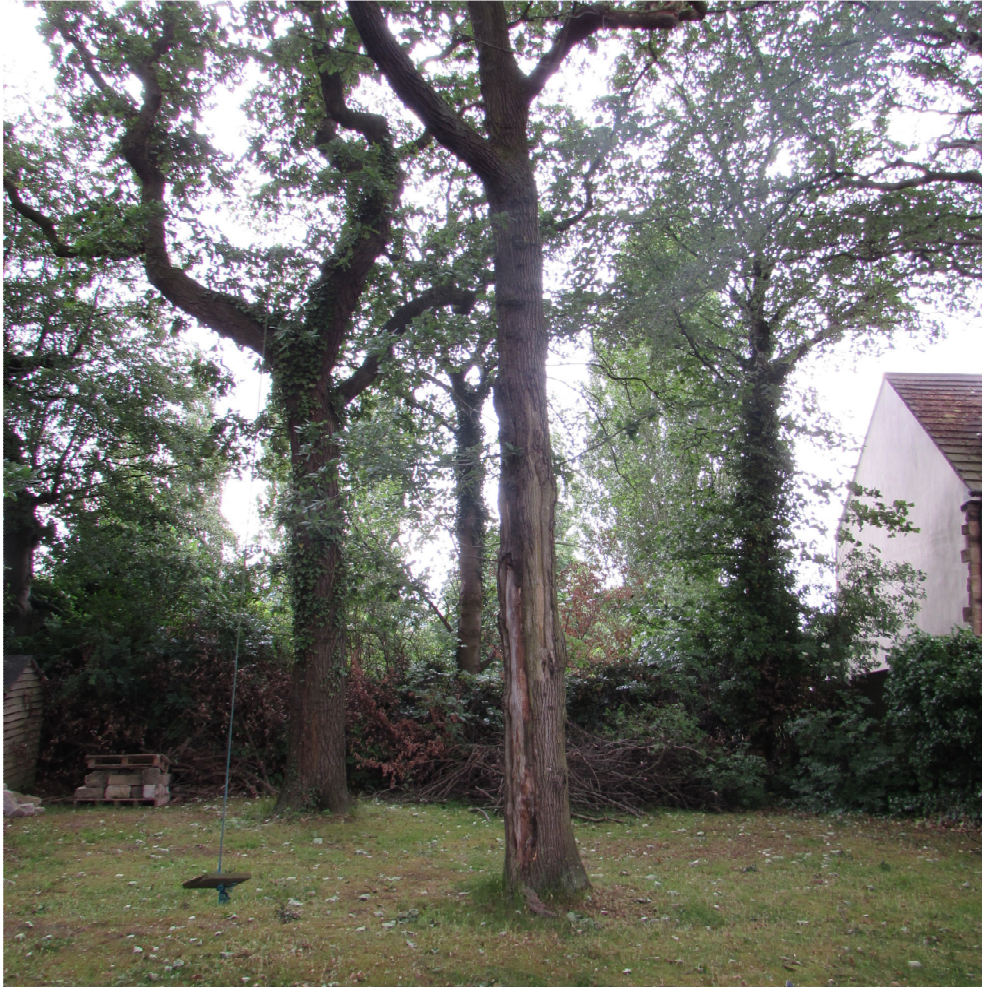
**Photo 1** – The front garden to the west of the property, looking towards the south. **T8** and **T9** are in the forefront of the shrubbery, with **T6** and **T7** behind them.

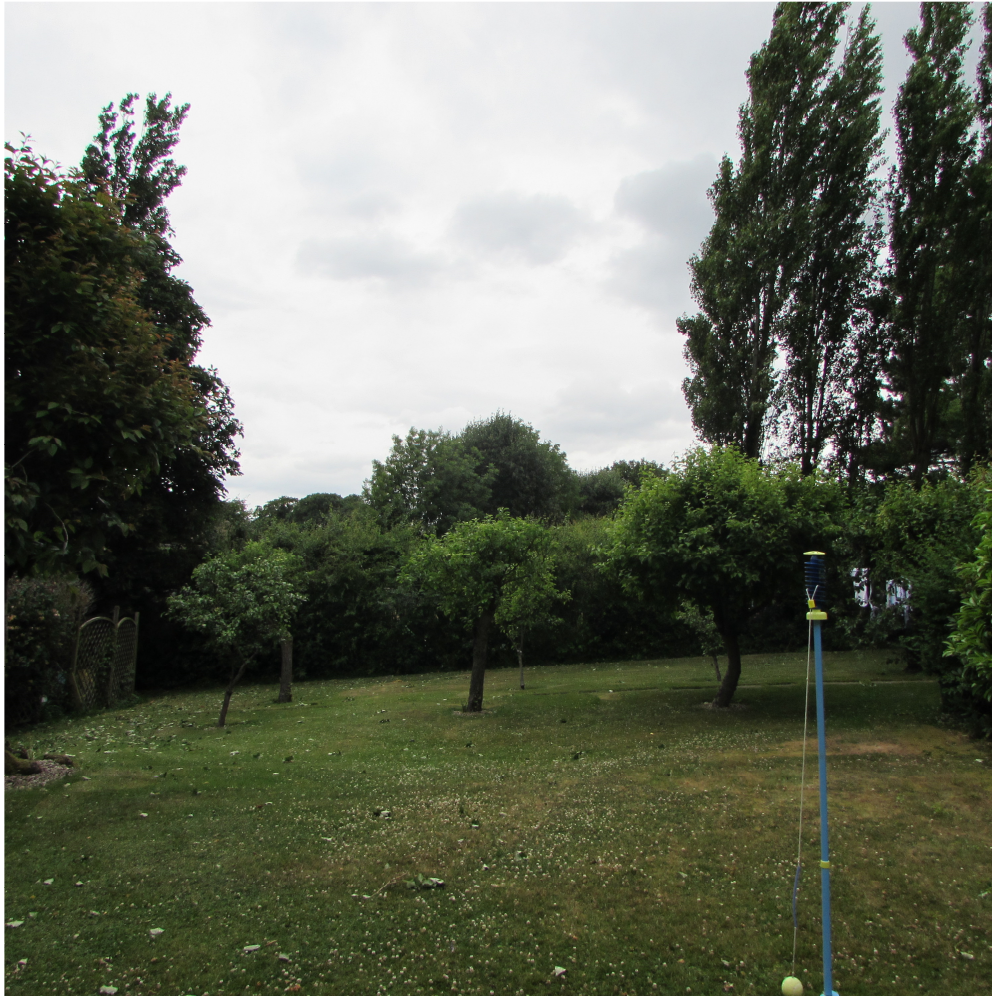
**Photo 2 –** Some of the land in the rear garden where the dwelling will be situated, looking west from behind the existing property.

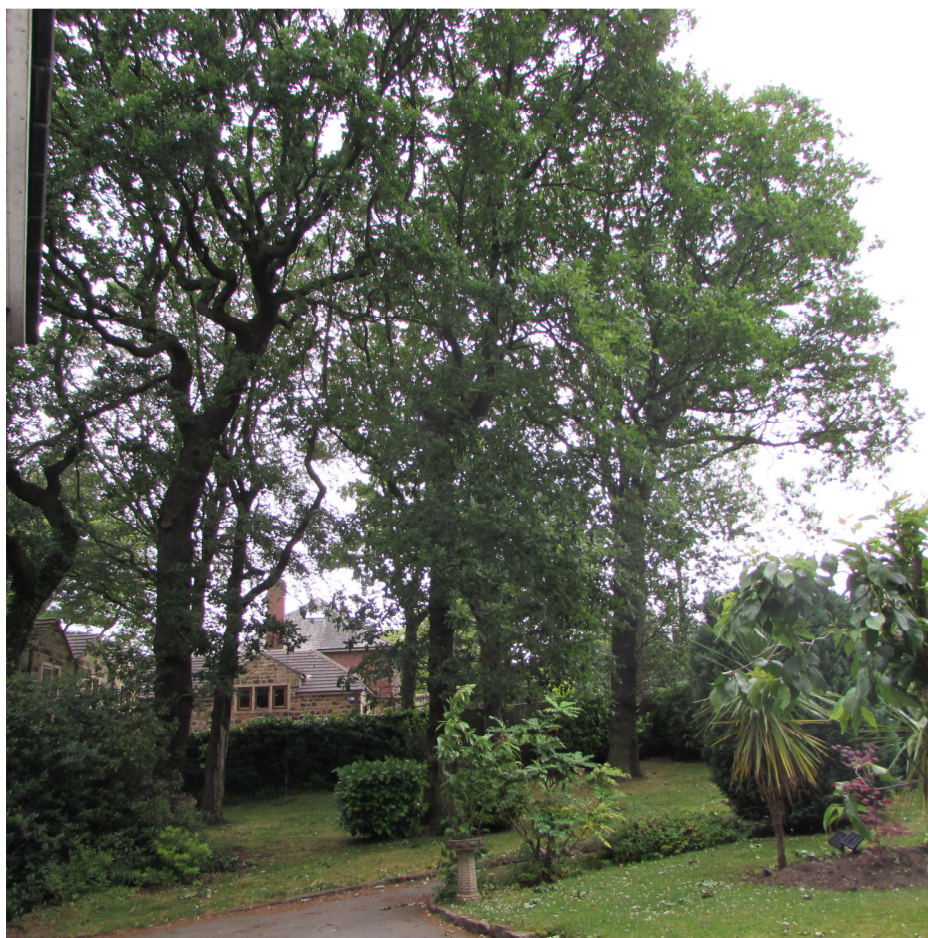
**Photo 3** – View north-west from the house, where the driveway to the development will be.
