**ARBORICULTURAL REPORT  
to BS 5837:2012  
at  
Springwood House  
Sheffield Road/Butterley Lane  
New Mill  
Huddersfield  
West Yorkshire  
HD9 7EX**

**Client:**  
Northern Design Partnership

**JCA Ref:**  
11574/LP

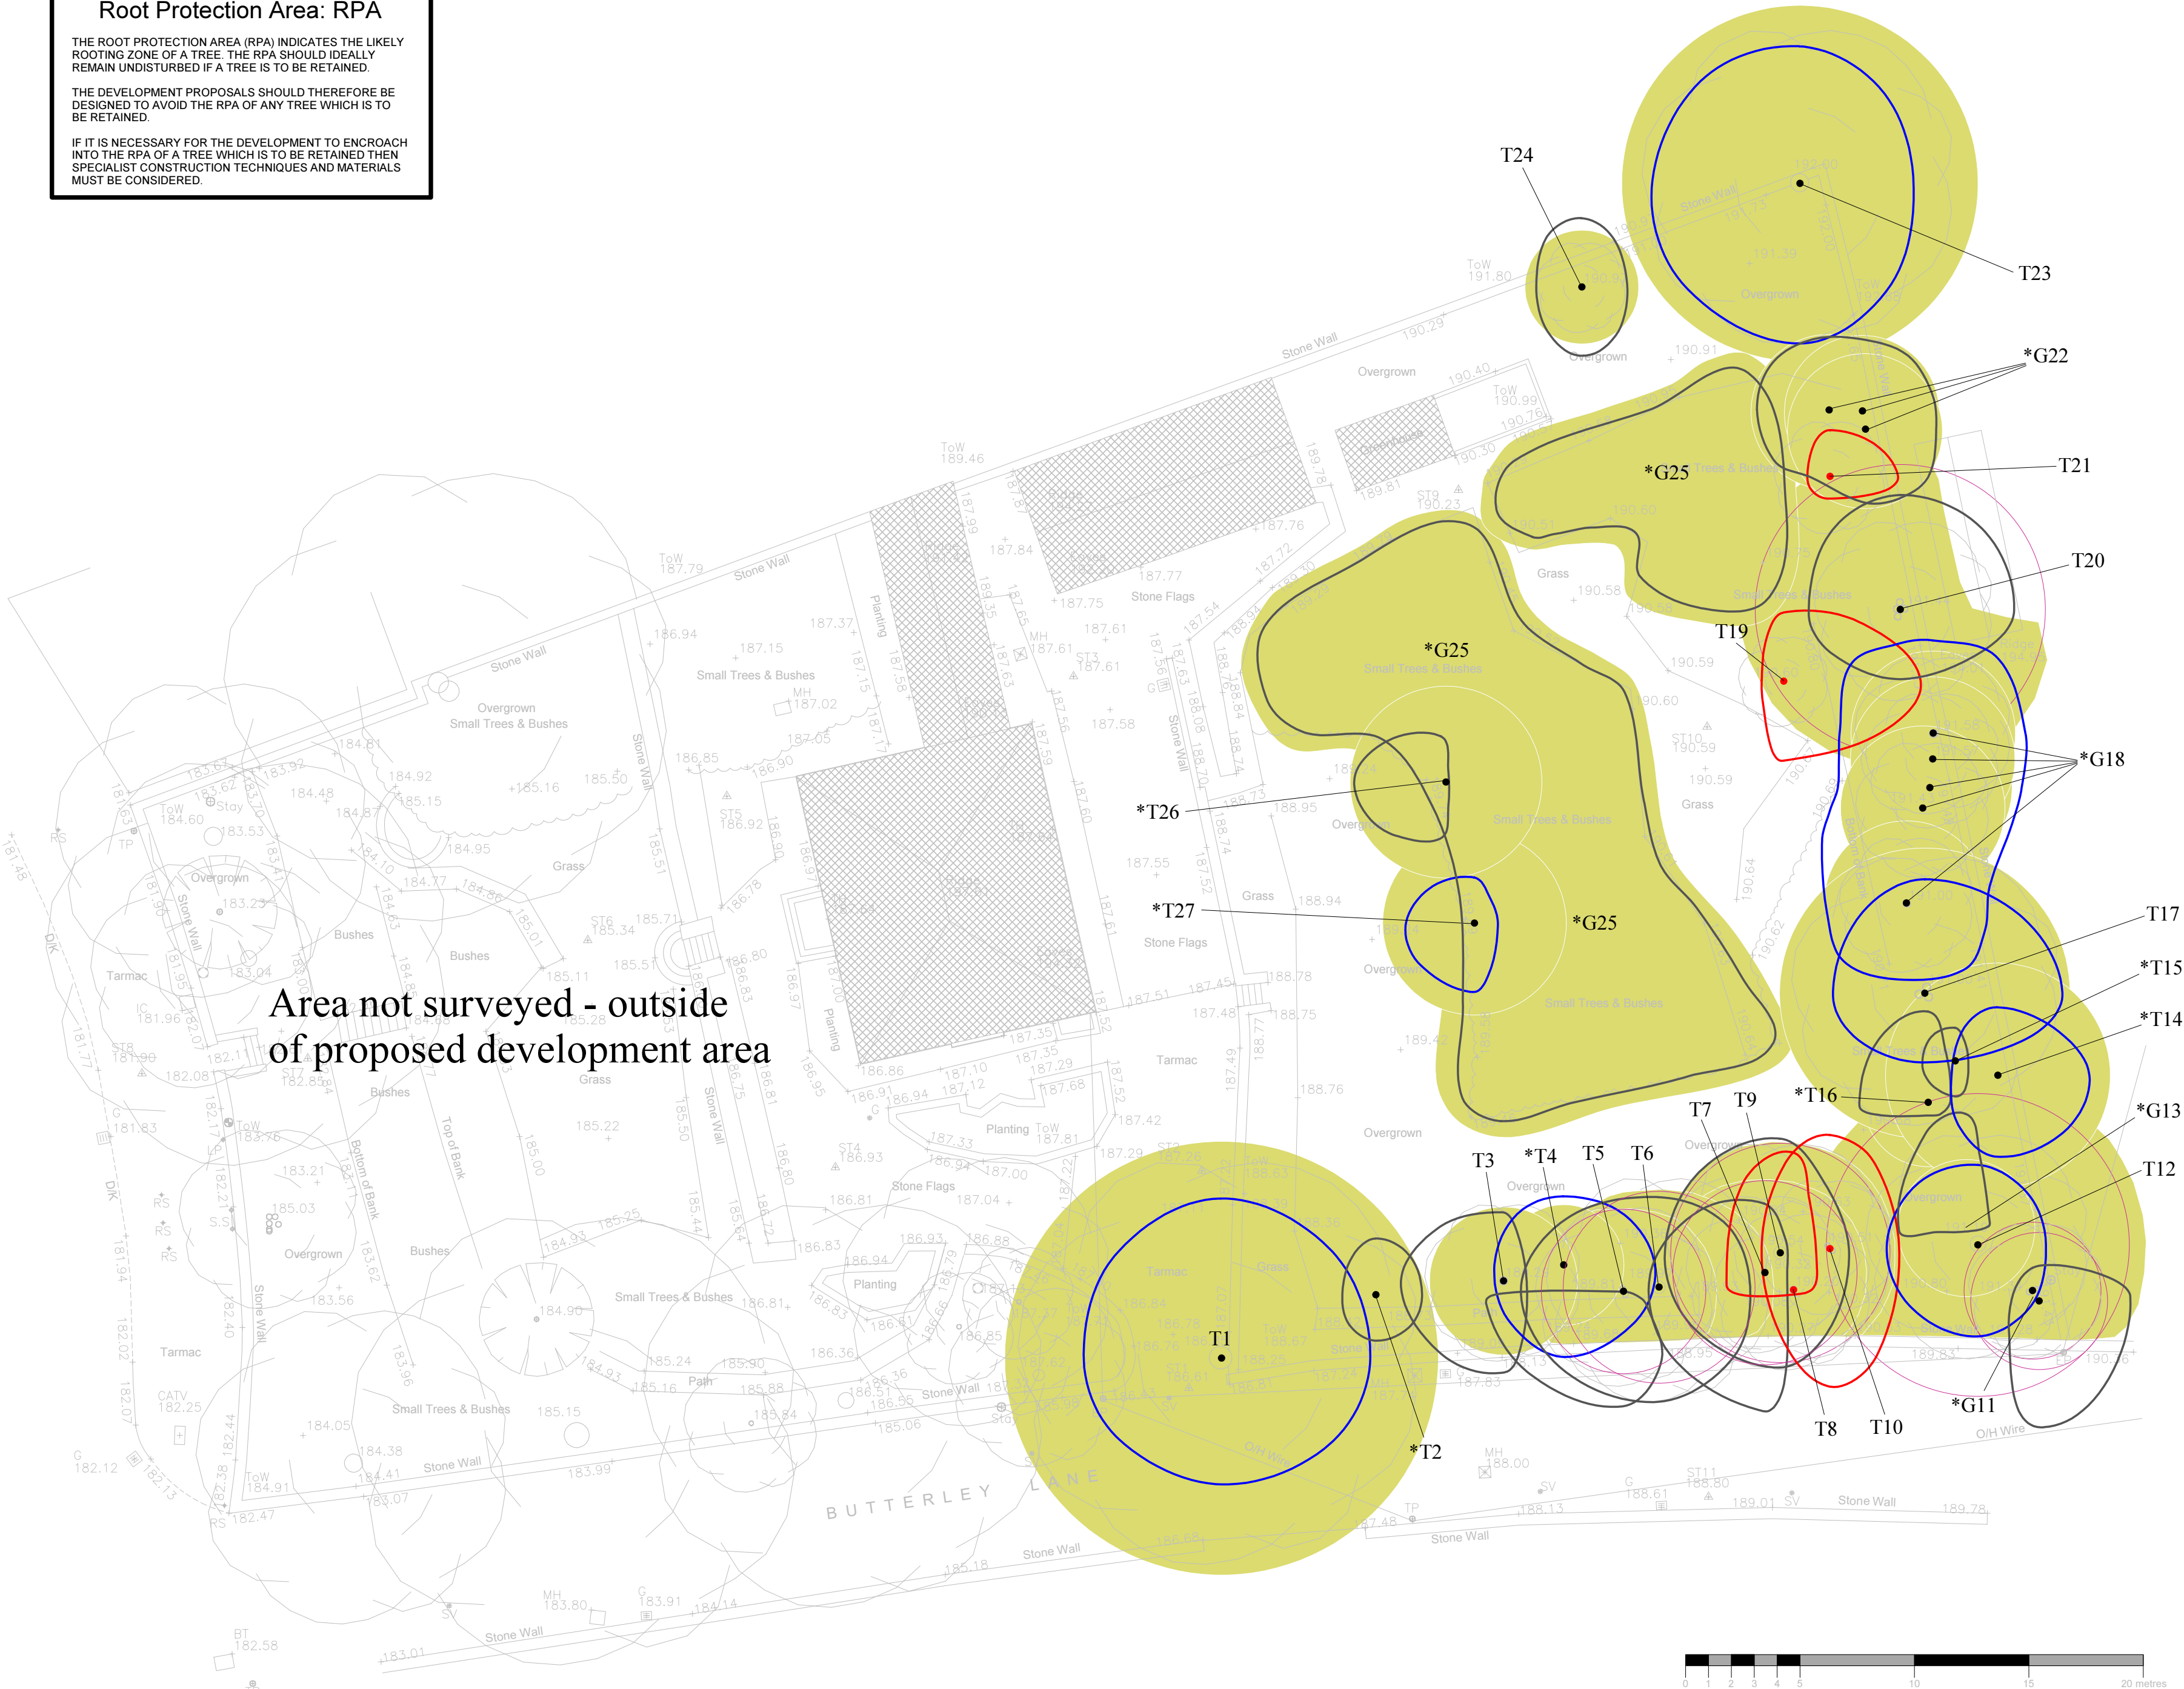
**Appendix 6:**  
**Tree Constraints Plan**

Area not surveyed - outside of proposed development area
