Re: Proposed development at Clough House, Leeds Road, Batley

Further to your request, Haigh Huddleston Associates have undertaken investigation works to confirm whether soak-a-ways would be a suitable long term method of surface water disposal for the proposed residential development.

SITE INVESTIGATION PLAN

Scale	Dwn	Chkd	Date	Dwg No.
1:500	MD		Oct'20	E17/6960/03

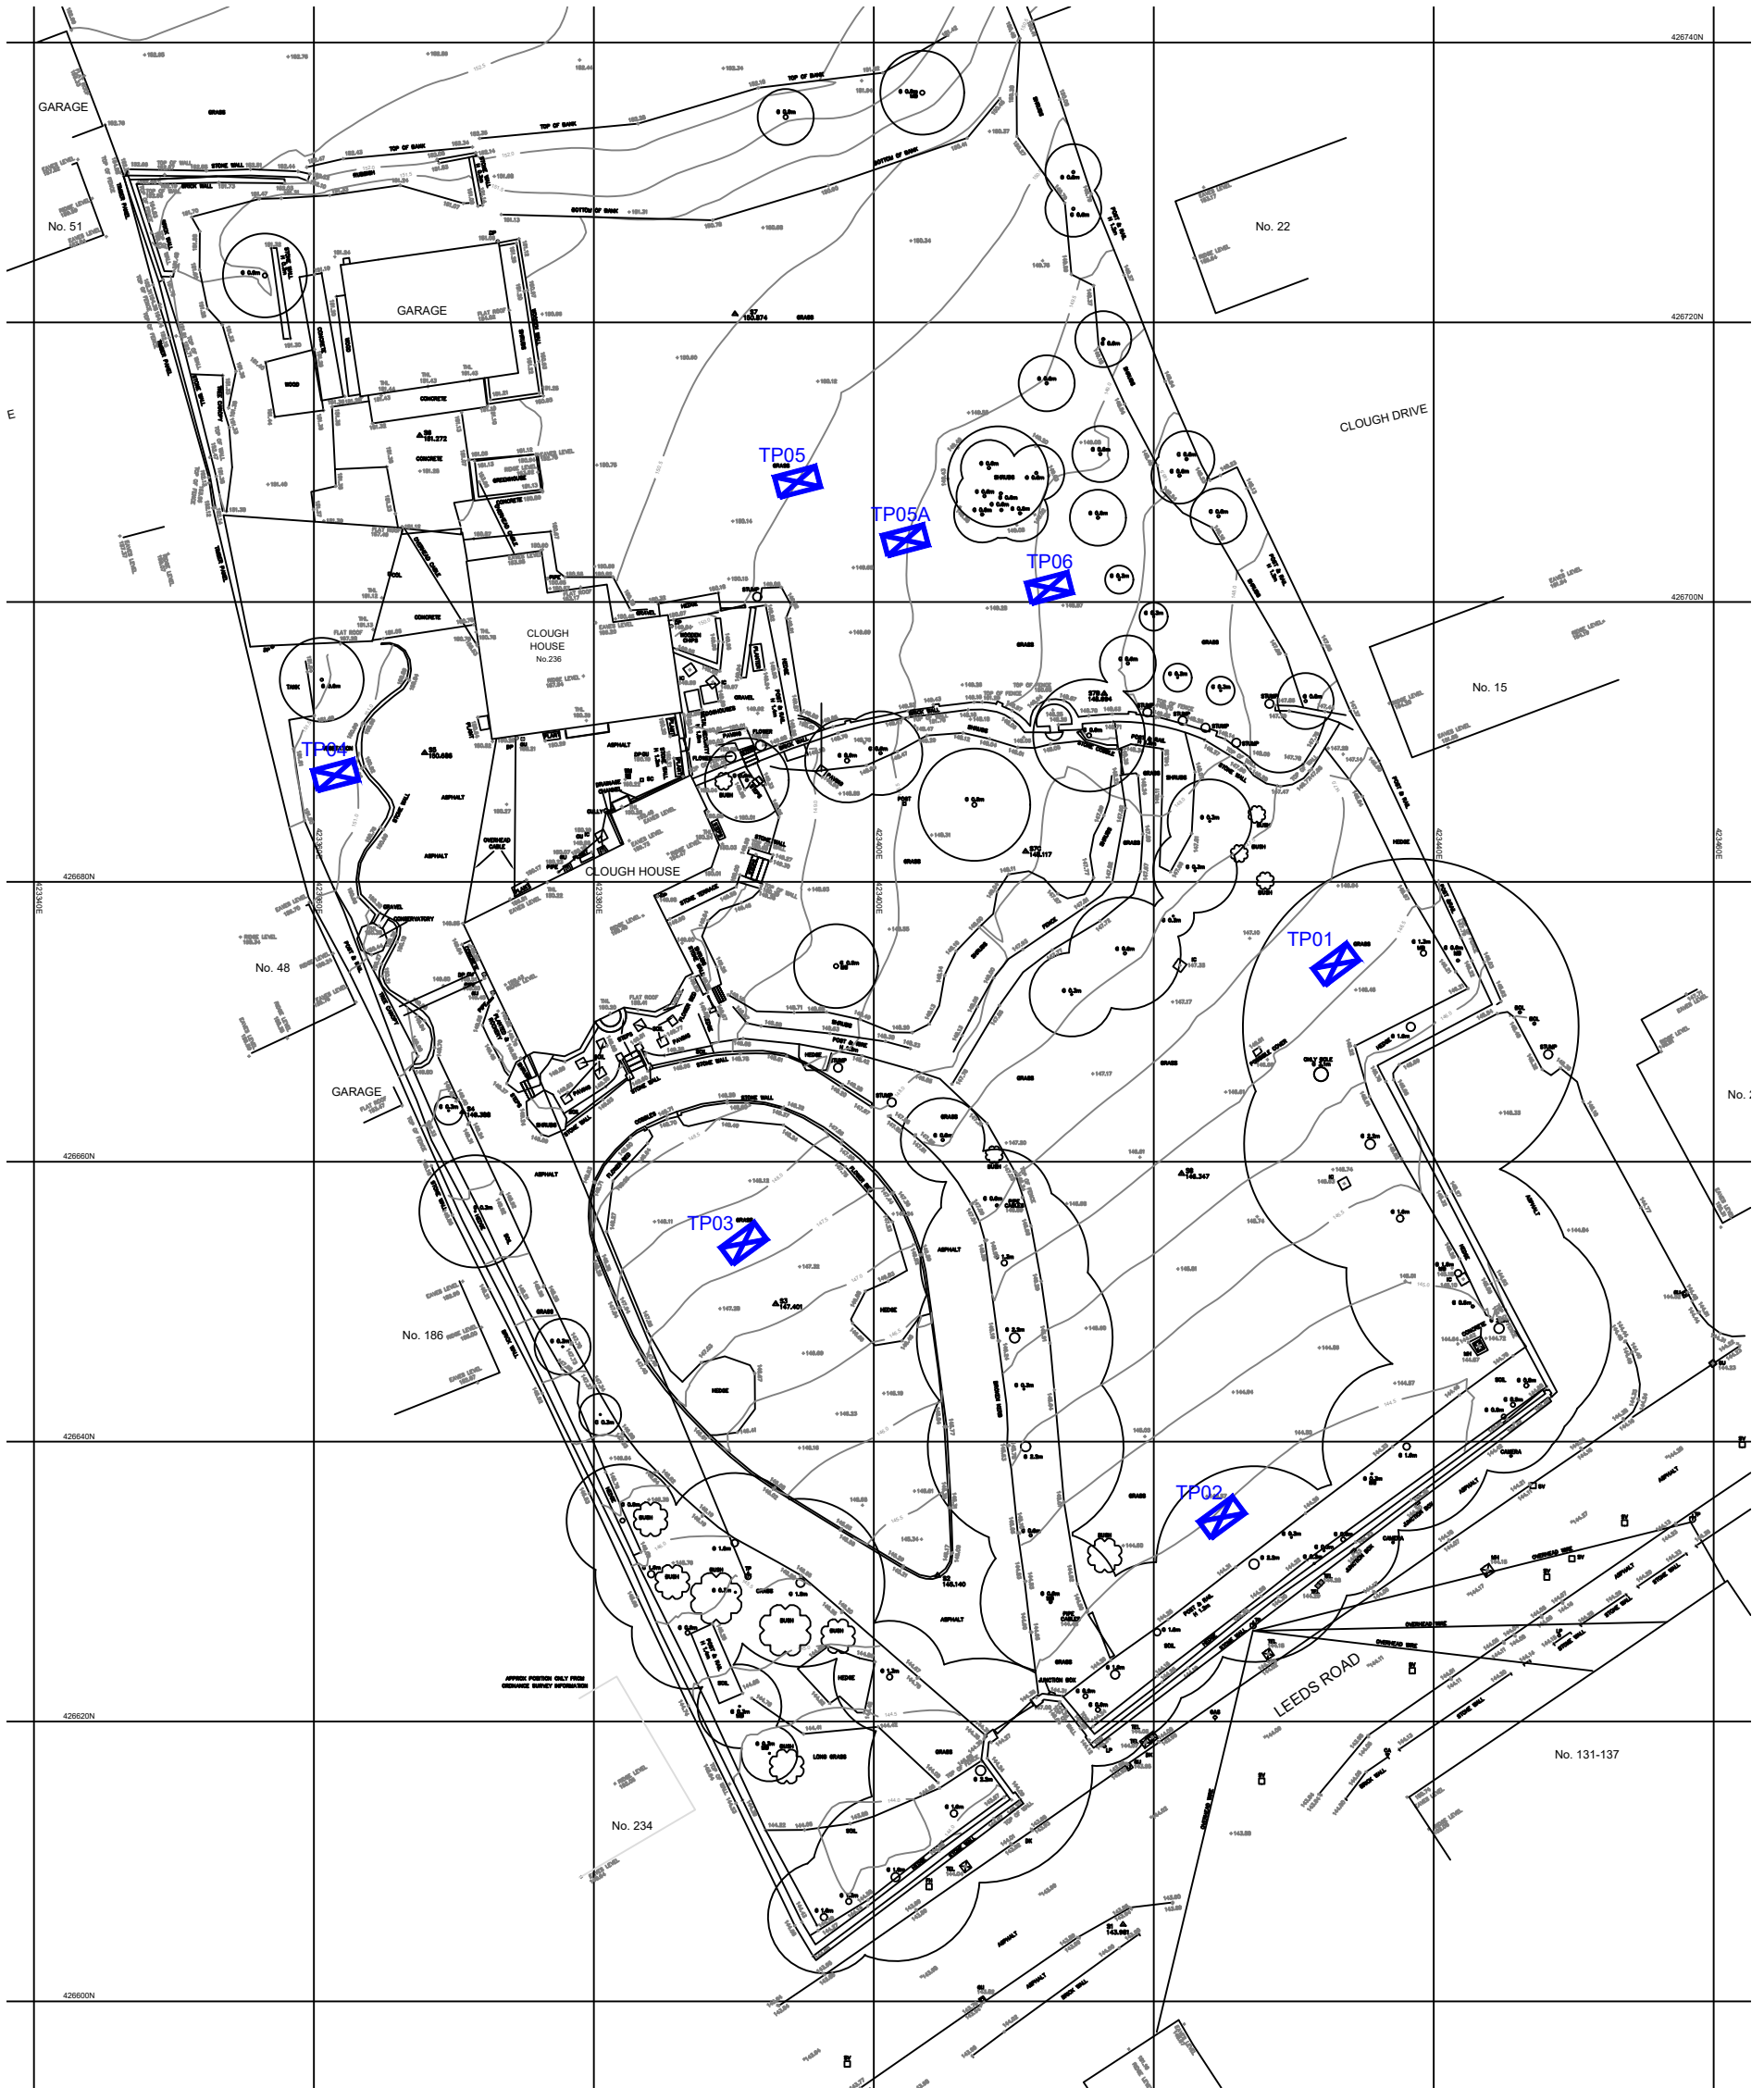
1.1 The fieldwork comprised of a three trial holes undertaken using a JCB 3CX with back actor and 600mm wide bucket. The trial pit locations were restricted by the existing buildings and services within the access to the site. The location of the trial pits are indicated on drawing E17/6960/03 at the rear of the report.
