# Design, Access and Heritage Statement

**Address:** 13 Cuckoo Lane, Honley, HD9 6AS

**Application Number:** PP-09472569

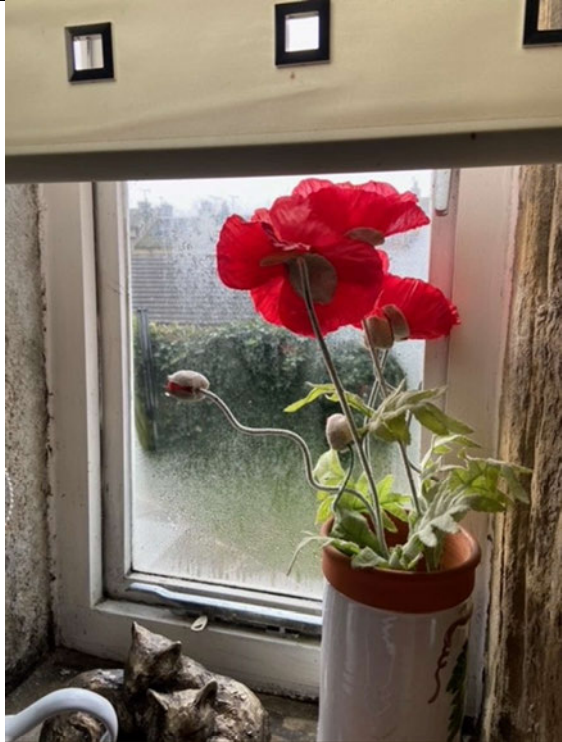
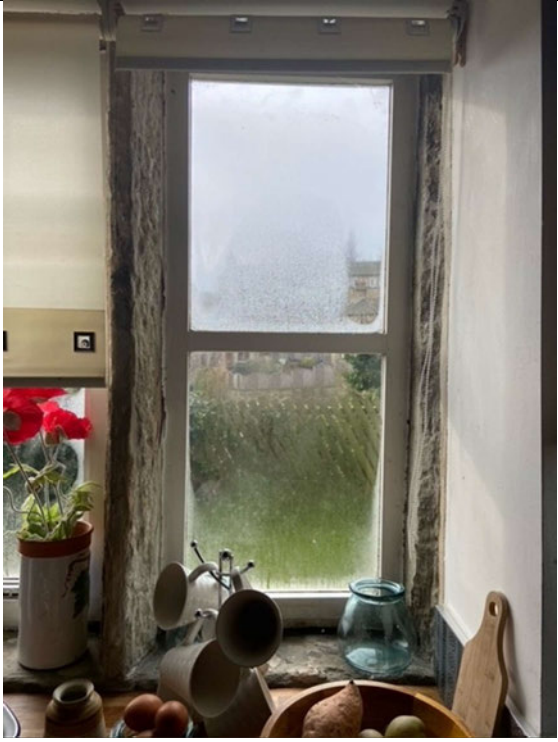
| Existing Kitchen (basement) windows: | |

Basement- 2 single glazed windows which are split and one has a top opener. The frames are rotting and they can leak inside and are damaging the stone surround.

| Existing Kitchen (basement) windows: | |
|---|---|
| Left hand side (internal) | Right hand side (internal) |

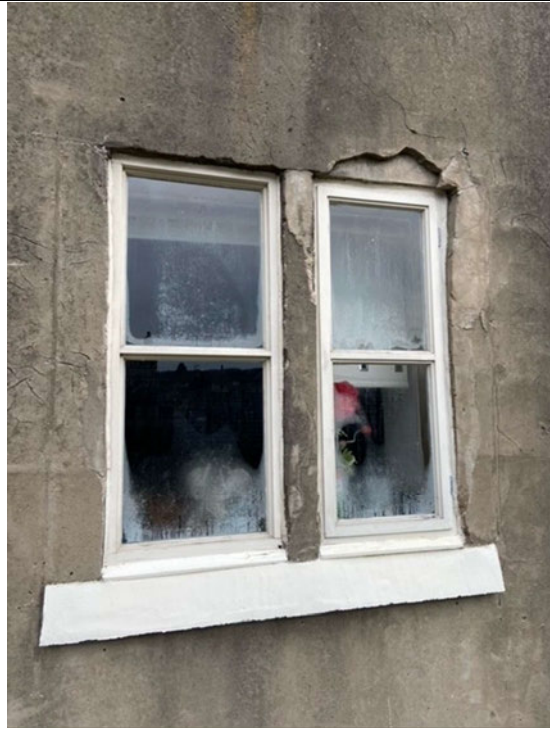
Both windows (external)

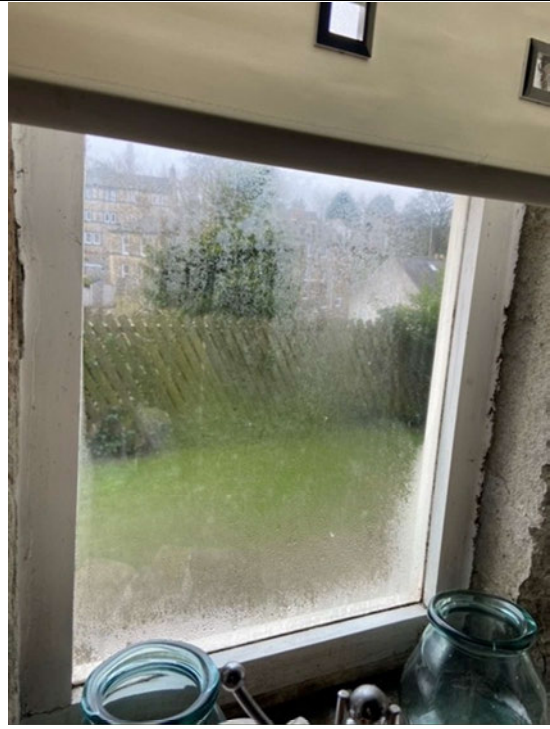
Right hand side internal showing single glazed

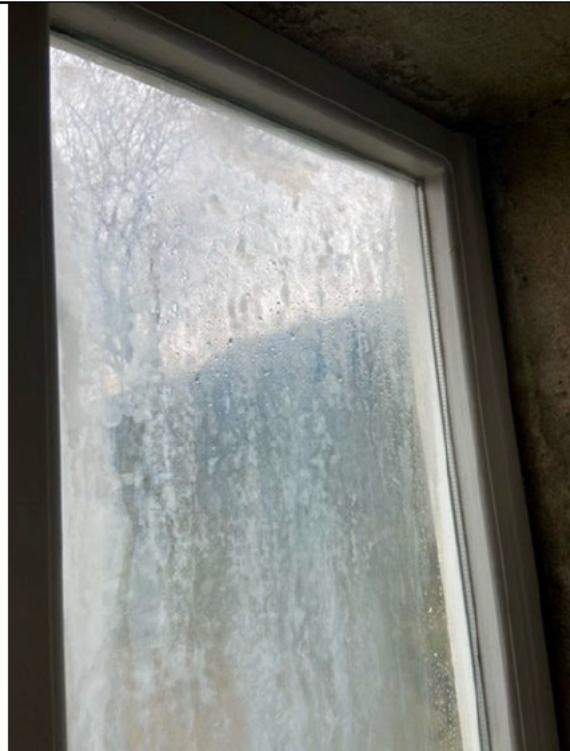
Ground floor- Front aspect has 5 double glazed windows, two are split with top openers. The frames are rotten (quite badly in some places) and one window has blown. To the side

Internal lounge window showing blown glass

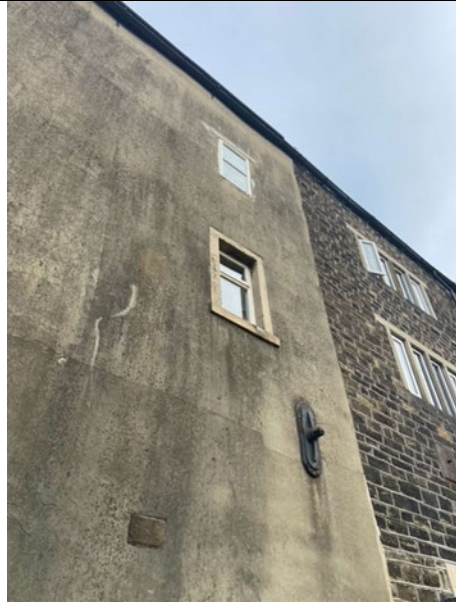
aspect there is a small double glazed window which is split with a top opener. The window has been silicon sealed as it leaks in bad weather and has caused internal damage. The frames are rotten.

External side lounge window (Ground floor/first floor to back elevation) The window is the lower one

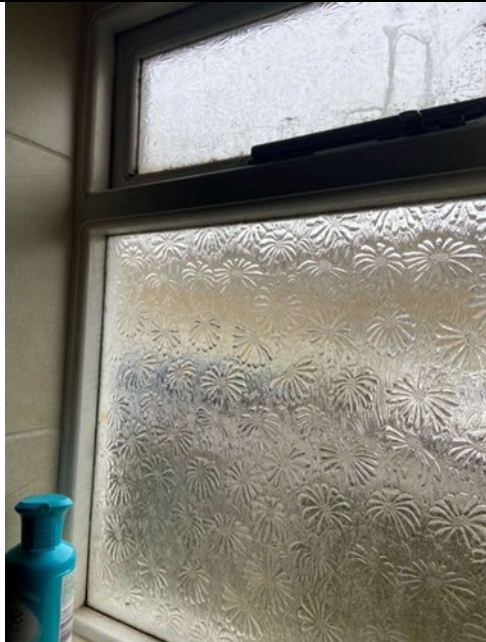
Internal Bathroom

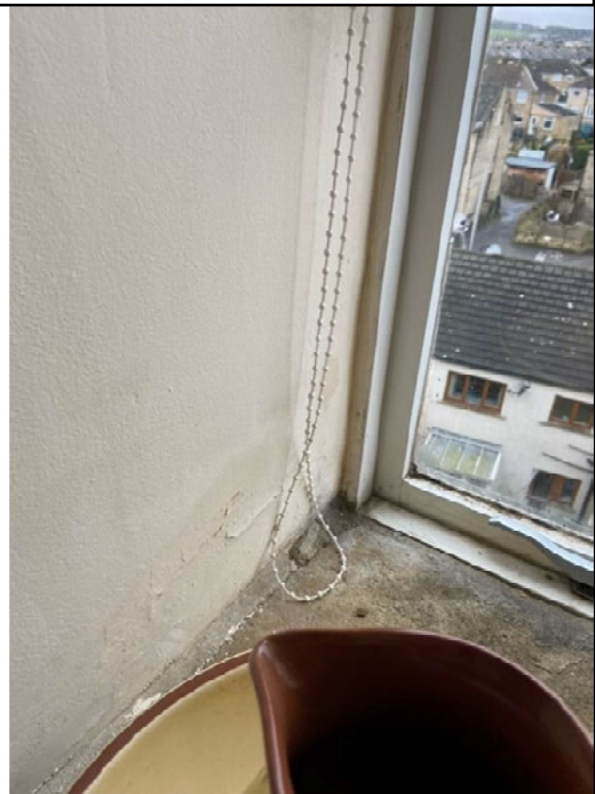
First Floor- The two bedrooms have sets of 3 double glazed windows, the middle one being split with a top opener. The frames are starting to rot. The bathroom has a single glazed patterned window. The frame is very rotten. The landing has a small double glazed window which is split with a top opener. The window has been silicon sealed as it leaks in bad weather and has caused internal damage. The frame is very rotten and the window sill outside has fallen off.

First floor (second floor when looking at back elevation) Internal showing damage to wall and stone due to leaks

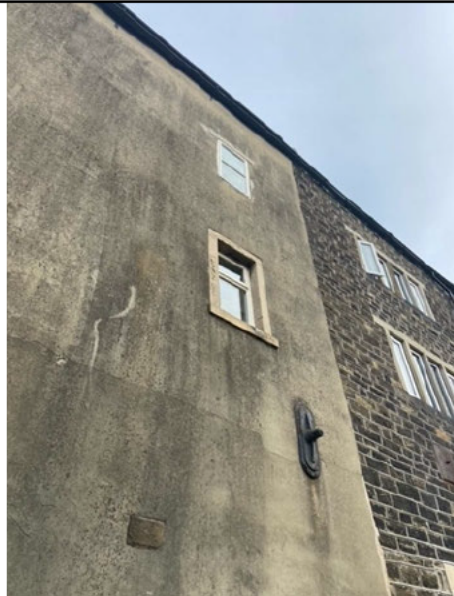
External view from back of the house showing second floor window externally. The window sill has fallen away with rot (Window is the top one)
