# Mine Entry Interpretive Report

9 RILEY LANE, KIRKBURTON, HUDDERSFIELD, HD8 0RZ

| Our reference: | 51001424330002 |

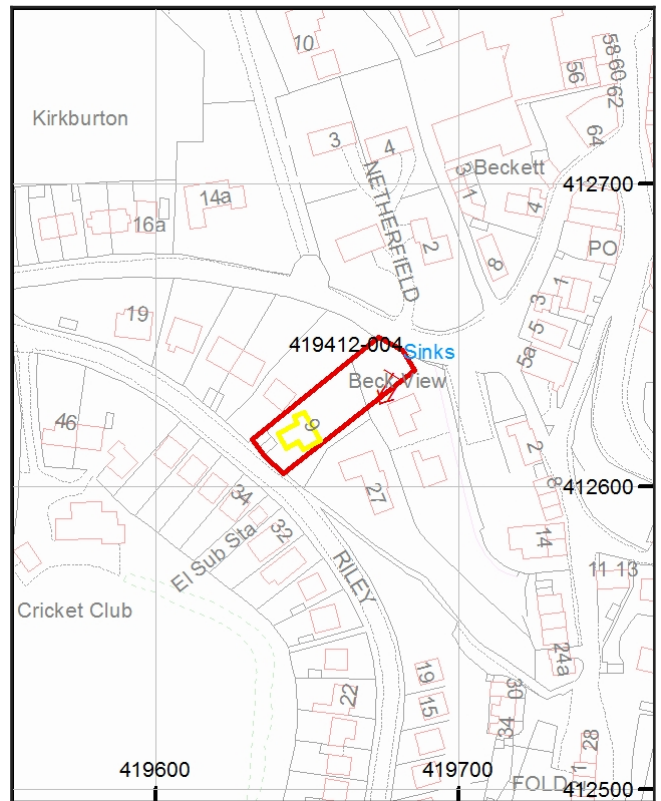
# Enquiry boundary

If coal mining subsidence was to occur because of ground movement due to the mine entry, the main building (as shown on the plan) is outside the area likely to be affected. Our opinion takes into account the thickness of the superficial deposits, the potential difference between the actual and the plotted positions of the mine entry and its diameter/maximum width.

In our opinion, the main building (as shown on the plan) is not at risk of coal mining subsidence damage from the subject mine entry. This is because it is not within the area of possible ground movement.
