Report on **Phase 1 Desk Top Study**

Land off Fullwood Drive,  
Golcar,  
Huddersfield, HD7 4JH

Ref. **NG8480/FUL/PH 1**

**NG8480/FUL: Land off Fullwood Drive, Golcar, Huddersfield, HD7 4JH**

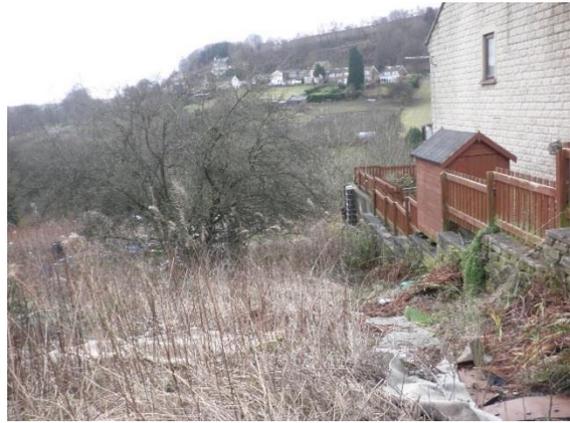
Fig 2: Photograph showing Western boundary close to Fullwood Drive

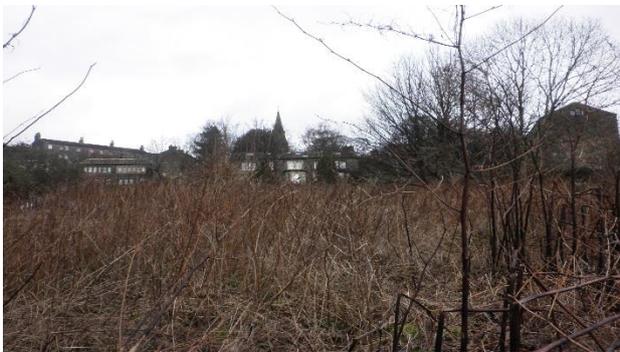
Fig 3: View Looking North (Site Rises)

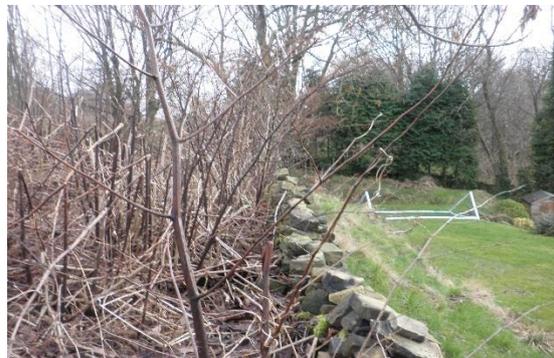
Fig 4: Southern Boundary (Gardens to the South)

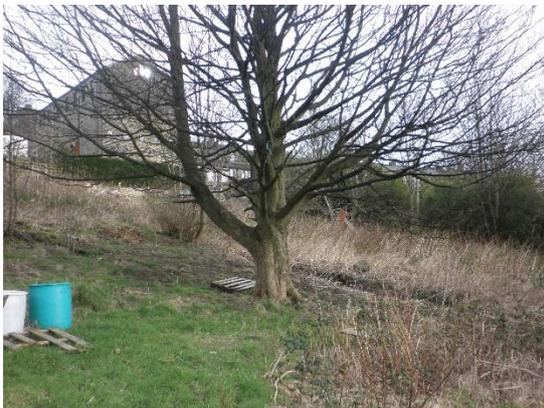
Fig 5: View in middle of site looking NE. Mature tree and second spring behind tree

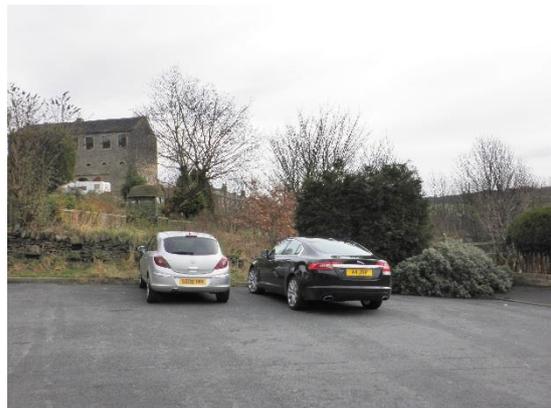
Fig 6 : Entrance to site off Fullwood Drive

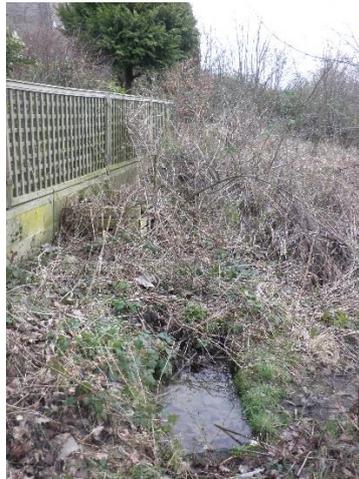
Fig 7: Northern Boundary (Showing spring and stone trough)
