COAL MINING RISK ASSESSMENT
AT
WINDMILL FARM
1 BUSKER LANE, SKELMANTHORPE
FOR
MRS H HAIGH
REPORT REF: MHH 3492

COAL MINING RISK ASSESSMENT

WINDMILL FARM
1 BUSKER LANE, SKELMANTHORPE

REPORT REF: MHH 3492

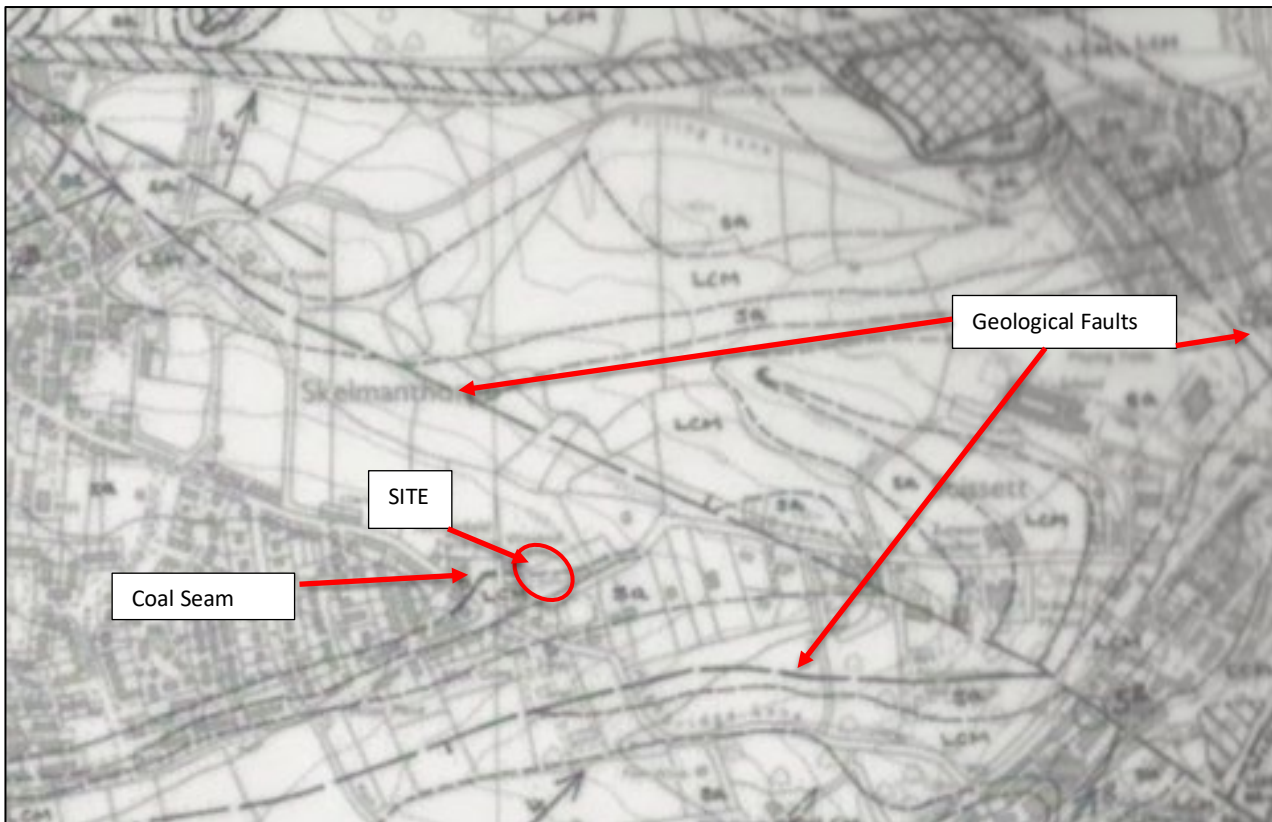
Figure 4 Detailed Coal Seam Geology

A thin coal seam is shown to outcrop across the site underlain by mudstone and sandstone.

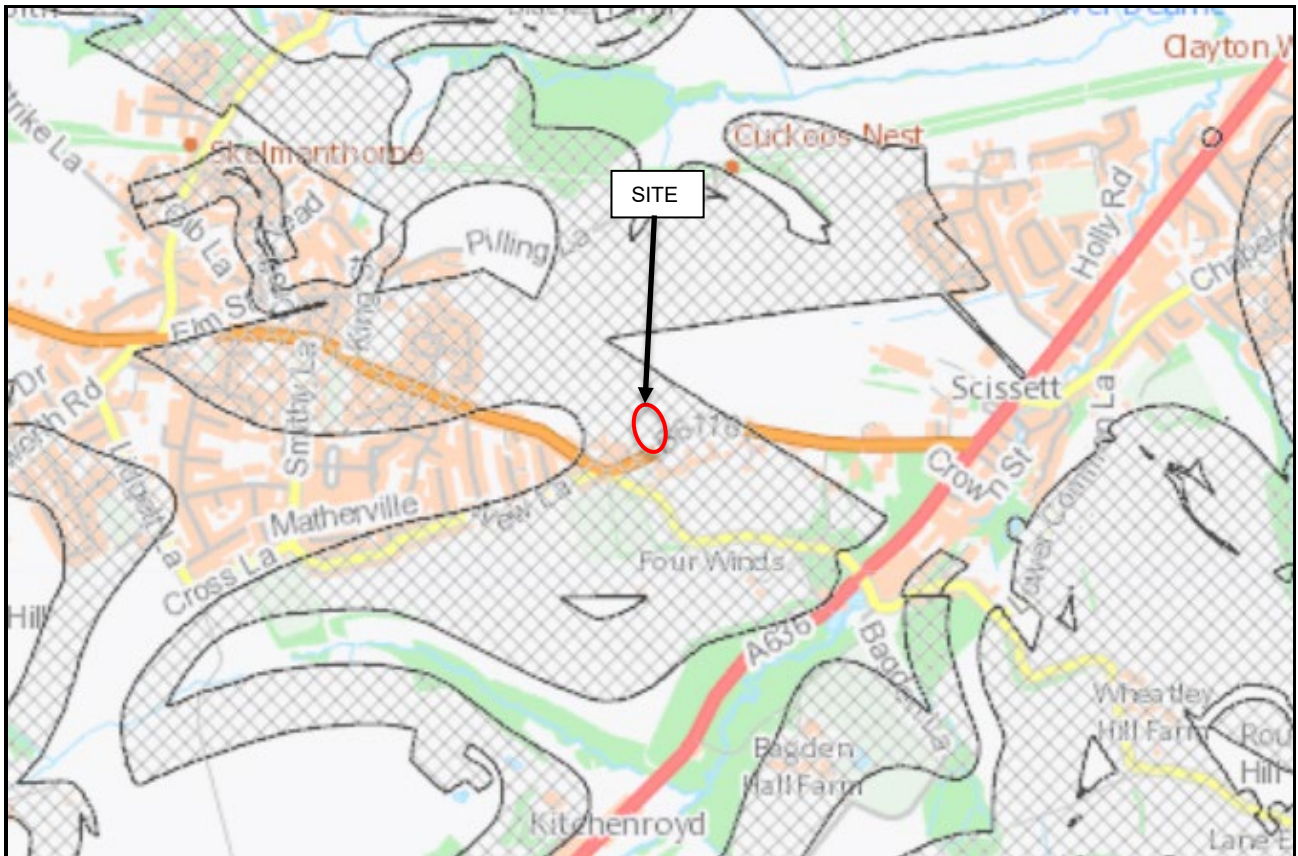
Figure 6 High Risk Development Areas

The site lies within a high risk area for development as shown in Figure 6 and within an area of probable shallow coal mine workings as shown in Figure 9. Probable shallow coal mine workings contain locations and estimated extents of probable shallow underground workings for which no recorded plan exists, but where it is possible that workable coal at shallow depths has been mined before records were kept.

There is a **medium to high risk** that the site has been undermined at <30m depth bgl. Any voids remaining in workings at this depth may migrate by successive roof collapse and reach the ground surface to cause subsidence in the future and damage to overlying structures.

mining investigation is undertaken to assess the depth and condition of any coal seams. The investigation should comprise 3 openhole water flush boreholes to 30m bgl with installations to enable monitoring for methane gas. If voids or loose ground and evidence of mining is detected a grouting programme may be required to enable development. Foundation design would need to take into account any grouted mine workings as the grout prevents roof collapse, but does not have bearing strength to support buildings.

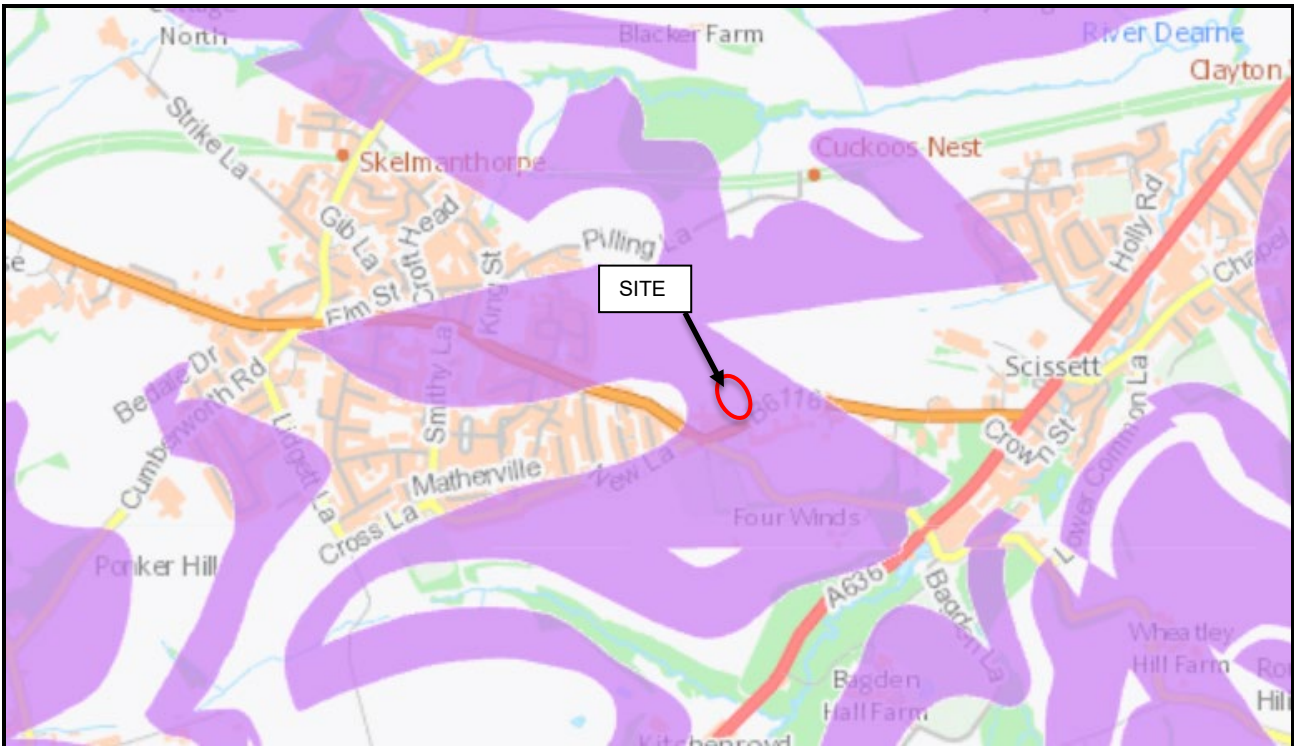
Figure 9 Areas of Probable Shallow Coal Mine Workings

In summary there is a **medium to high risk** that ground subsidence may occur on the site due to shallow mining in the Black Bed Coal seam. Although the Coal Authority hold no records of such mining, mining may have occurred before the date of 1872.

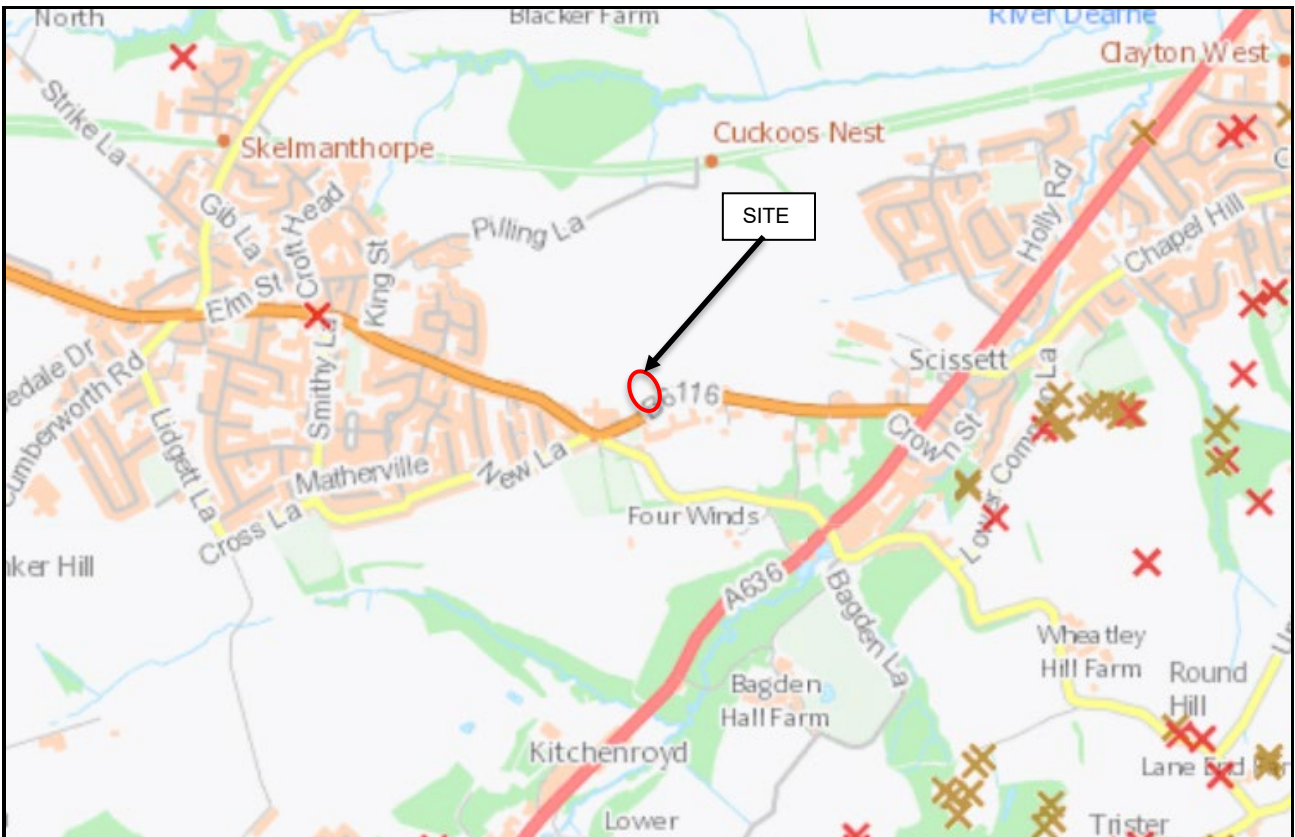
Figure 11 Plan of Mine Shafts

The closest Mine Shafts are presented in Figure 11 to the east and west of the site and lie at a distance where they will not detrimentally affect stability of the site.

There is a **low risk** that mine shafts and adits may cause ground subsidence and affect the stability of the site in the future. The Coal Authority records are incomplete and any circular features detected on site should always be assessed by an engineer in case it represents an unrecorded mine shaft.
