**ARBORICULTURAL IMPACT ASSESSMENT
to BS 5837:2012
at
894 Huddersfield Road
Mirfield
West Yorkshire
WF14 9HS**

Leyton Homes (Mirfield) Ltd.

18064-A/AJB

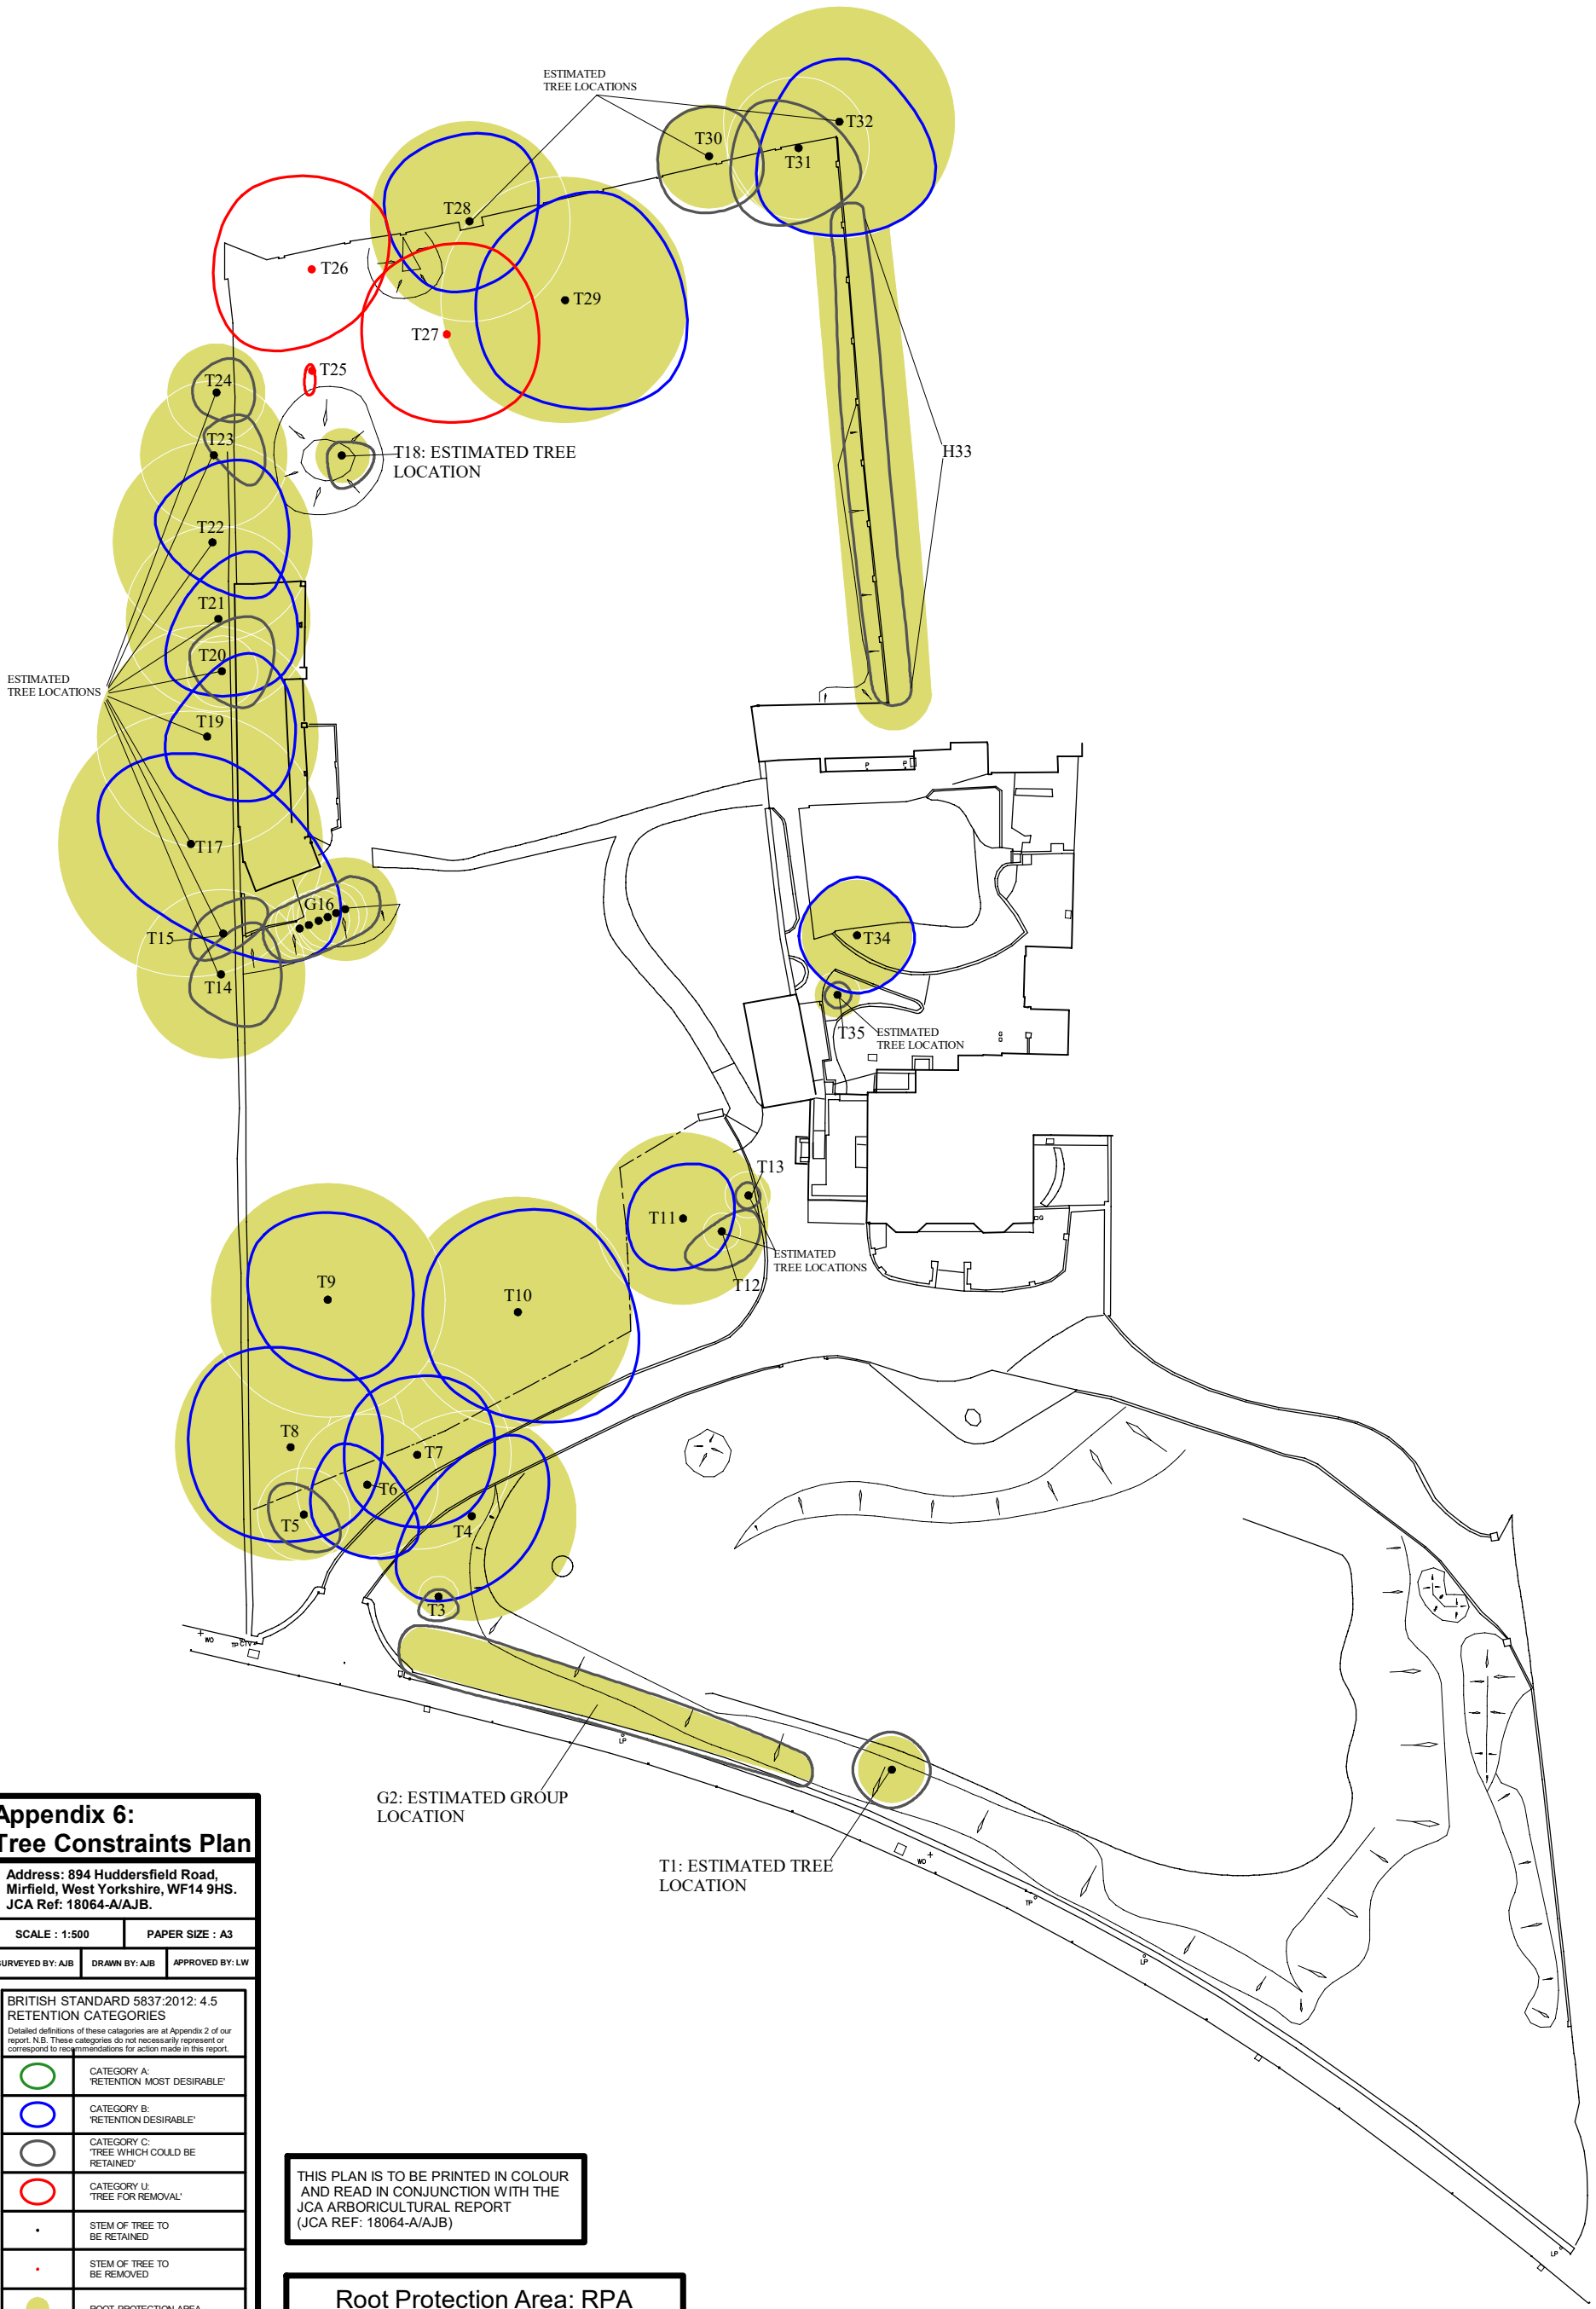
**Appendix 6:
Tree Constraints Plan**

- 4.7 The protection of retained trees can be achieved by the creation of a Construction Exclusion Zone based on the Root Protection Area of a tree. The Root Protection Area of each tree or group is marked on the Tree Constraints Plan at **Appendix 6**.

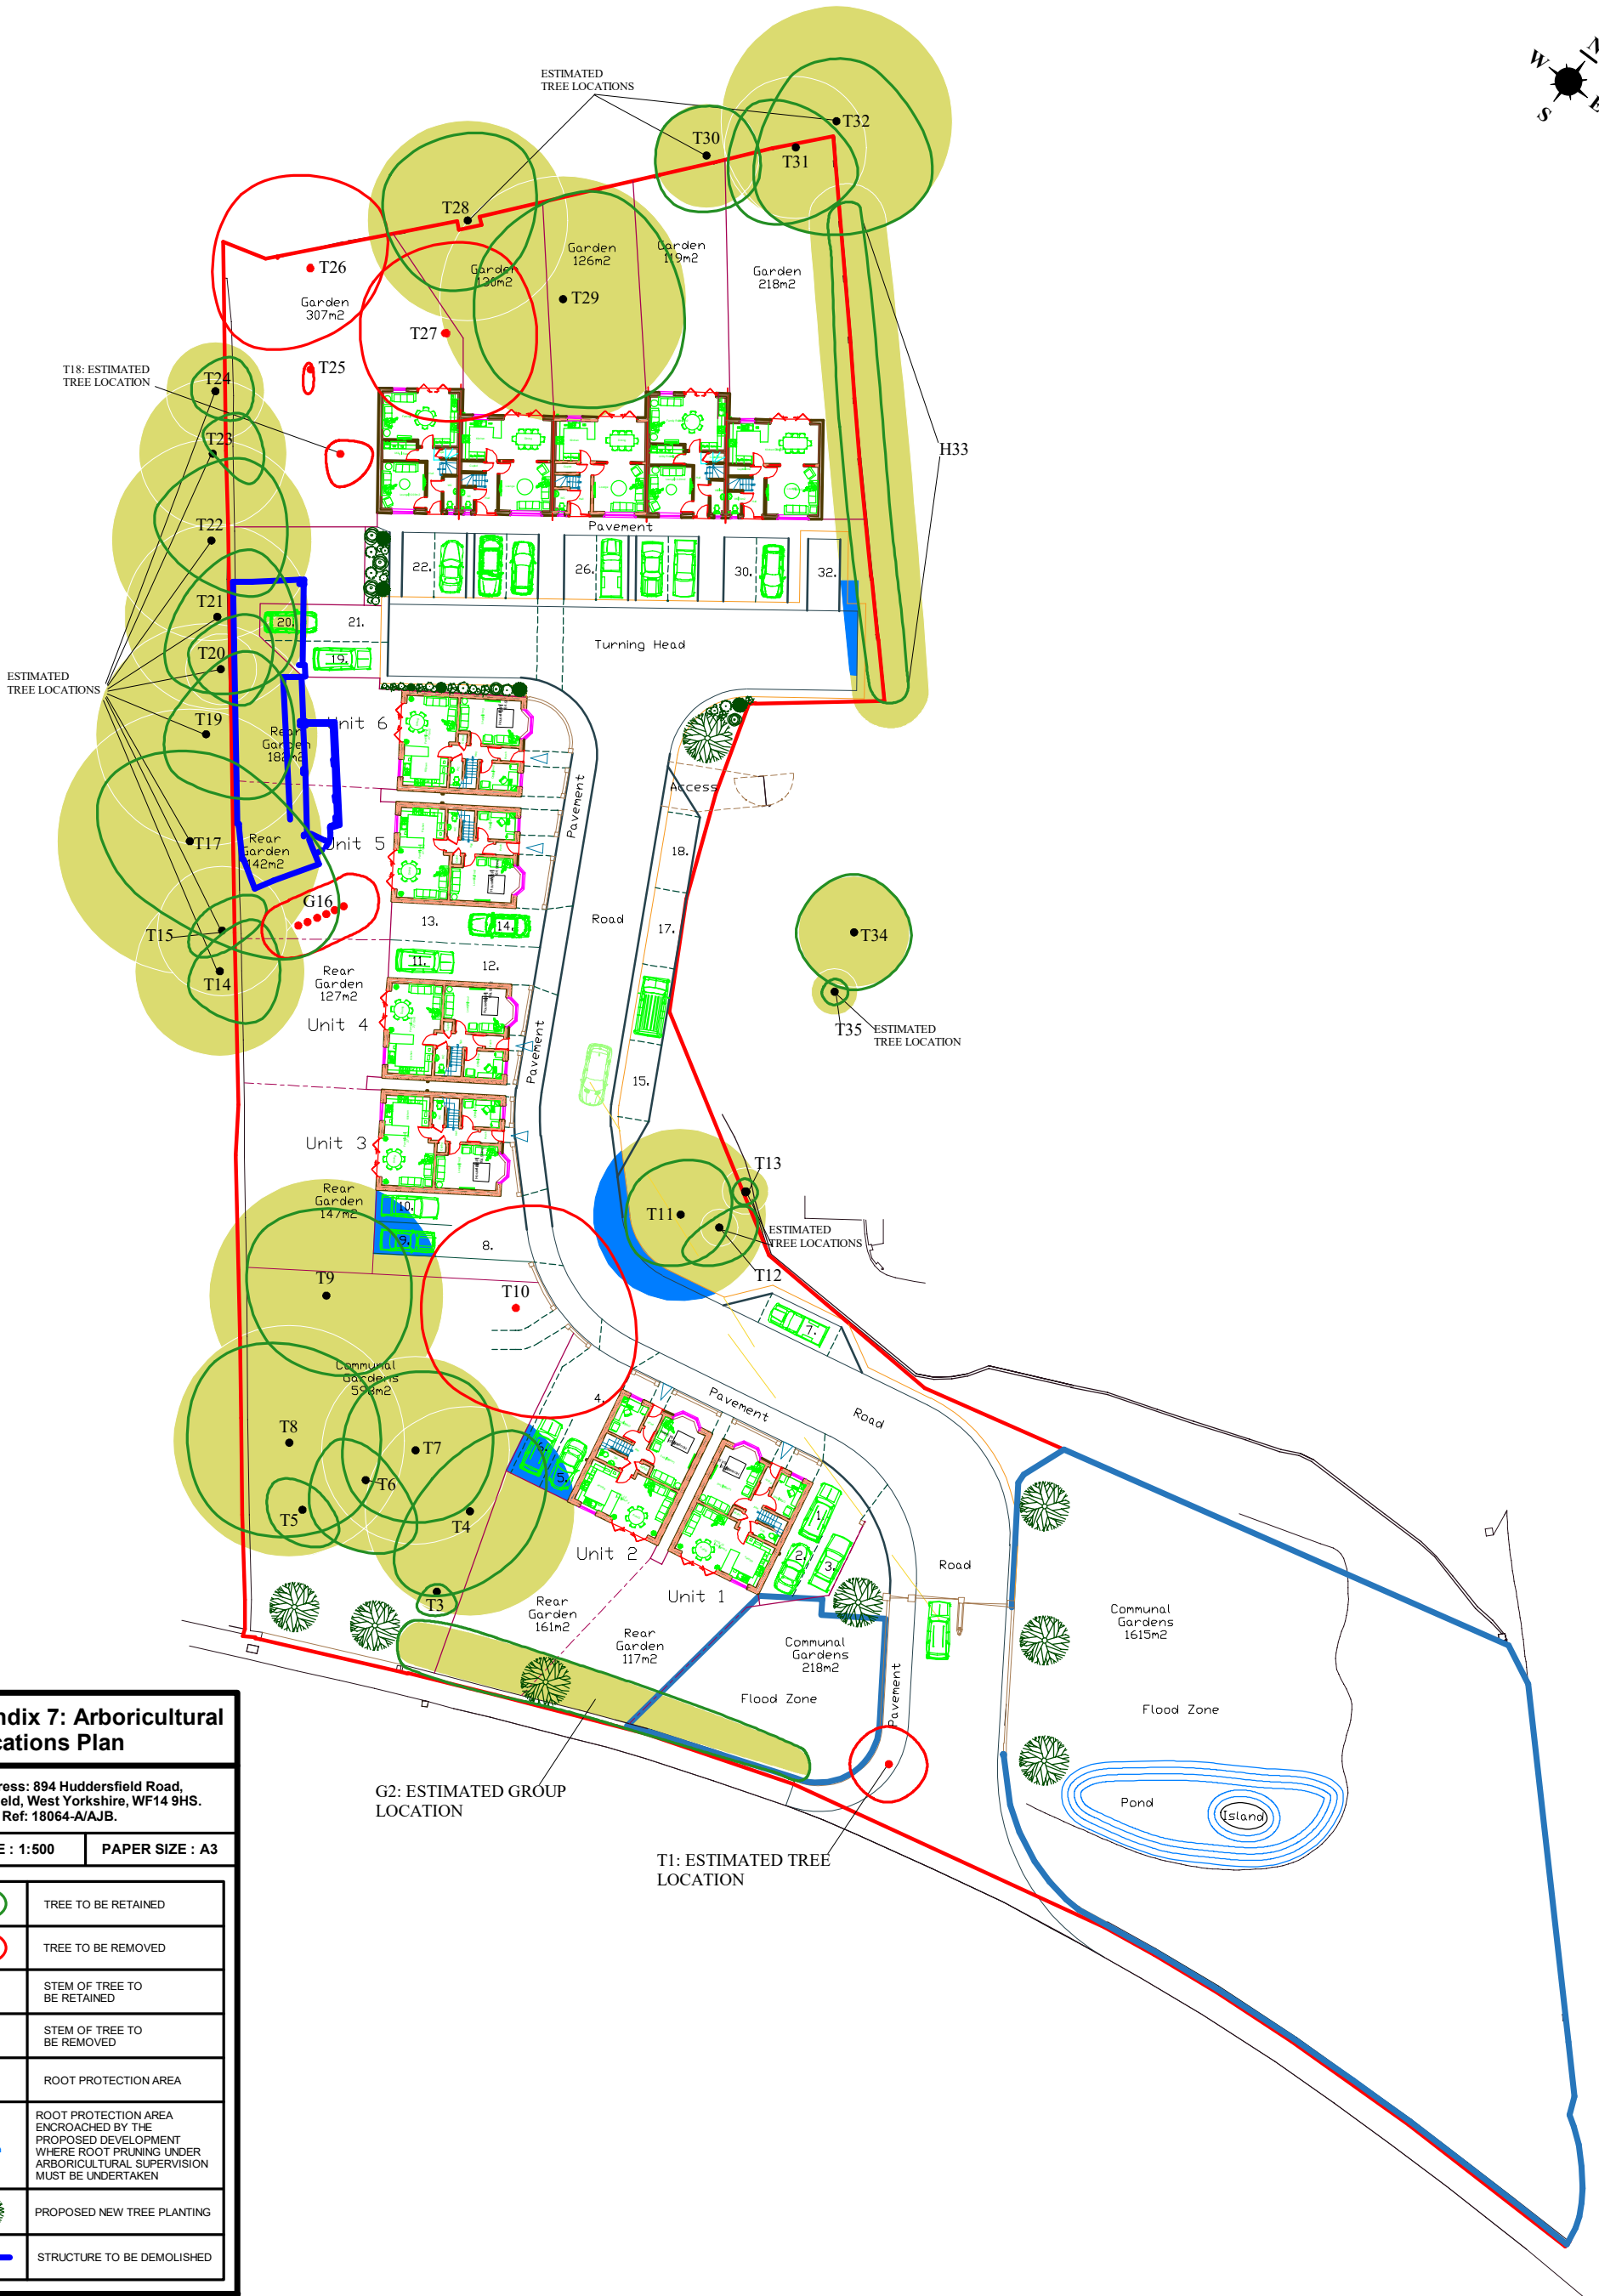
Appendix 7: Arboricultural Implications Plan

- 3.5.2.1 In order to meet the needs of this proposal, demolition of existing structure is required adjacent to **T17, T19, T20, T21** and **T22** (as shown in a blue line on the plan at **Appendix 7**). Due to this, specialist demolition methods will be required to prevent damage. This may include collapsing structures in a direction away from trees, utilising hand digging methods, working within RPAs etc. Full details on such methods should be included in an Arboricultural Method Statement, including where arboricultural supervision is necessary.

3.5.3.1 Proposed hard surfacing is located within the RPA of **T4, T9, T11** and **H33** (as shown in blue shade on the plan at **Appendix 7**). In these areas, root pruning will be undertaken under the supervision of an appointed arboriculturist to prevent ‘ripping’ damage, which is commonly associated with mechanical excavation.

- 3.6.1 Part of the proposed development will encroach into the RPA's **T4, T9, T11** and **H33**, resulting in possible root loss. It would therefore be prudent to apply appropriate mycorrhizae fungi to the soils around these trees after the construction phase is complete. Certain mycorrhiza fungi form a symbiotic relationship with tree roots. A tree root associated with such mycorrhiza will take up nutrients more effectively and this will therefore help the tree to produce new roots more effectively, so benefitting their recovery.
