Bat Survey to
Hillhouse & Birkby Bowling Club
King Cliffe Road
Huddersfield
HD2 2RR

20th November 2022

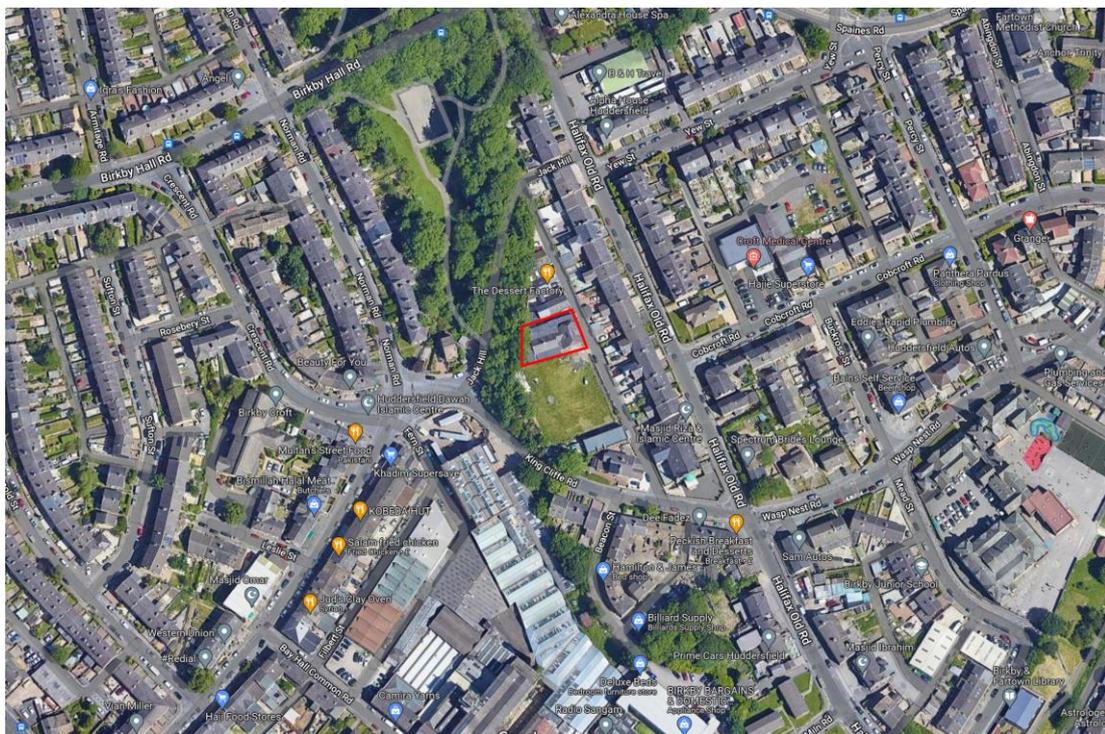
Figure 2 Aerial view of the site, surrounds and specific buildings surveyed

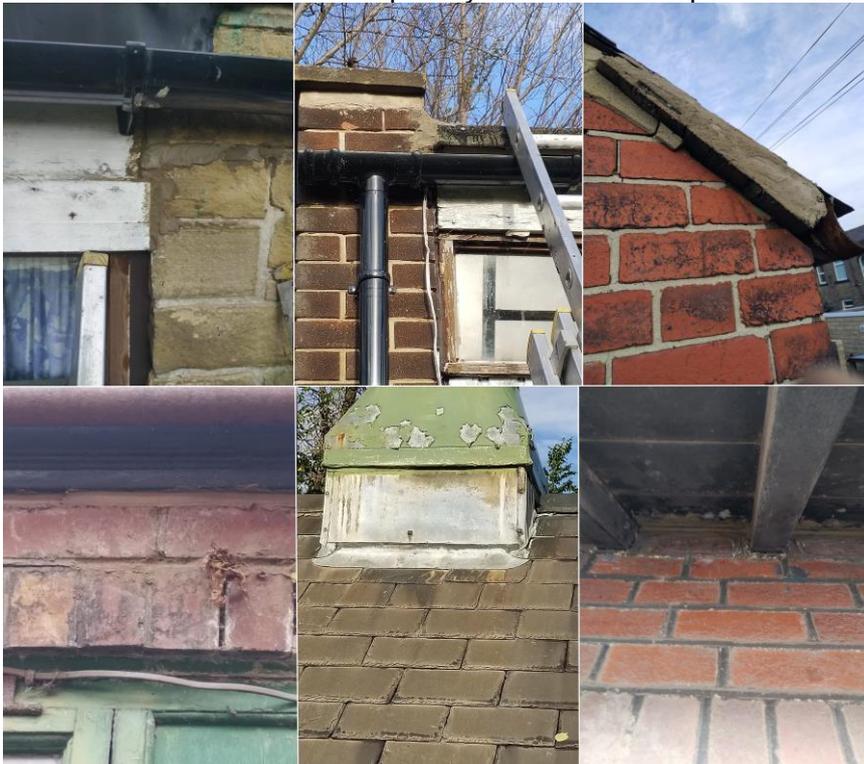
The building is a former clubhouse constructed of brick with blue slate roof. The roof is sound and now has no missing or slipped tiles as all such tiles noted by JCA have been repaired along with the larger gaps noted in the roof verge. The roof is unlined so it is less likely that bats would have roosted beneath the raised tiles that were identified. The walls of the main building are brick and are header and stretcher style and therefore, there is no wall cavity. There were only minor structural cracks noted in the original PEA and these have since been repaired. The gable walls have no decorative wooden features (facia etc) though there are deep overhanging wooden soffits. There are no gaps that would allow access to the wall tops and any gaps noted in the original PEA have since been repaired.

There were small sections of raised felt along the flat roofed sections which were highlighted as being of potential interest to bats but as with the main building, these have all been repaired. A larger gap on the west elevation where the flat roof meets the end wall has also been repointed though this was ostensibly too large for use by bats and is more likely to have been used by sparrows etc. The following photographs illustrate the remedial works that have taken place to all features identified in the report by JCA and this report can be cross referenced.

Photo 1 showing remedial works that have taken place (cf. JCA report)

Due to the fact that all the identified potential roosting features have been repaired and blocked by mortar or mastic, the building is now assessed as being of negligible value as all PRFs have been destroyed. In its current state, the building seems unlikely that it would support roosting bats and there is little point in carrying out an activity survey. As potential roost features have been lost, there should be some form of compensation included in the proposed development. It would be beneficial to include at least two permanent bat roosting features during the construction phase.

- A permanent bat roosting feature will be added to both the south and west elevations of the building and can be either integral or an external fitting (Schwegler have a wide range available). External fixtures are inexpensive and easy to incorporate – Schwegler 1FQ bat houses would be ideal. These should be placed high up at eaves level and should be in place prior to the re-opening of the site.
