**Arboricultural Impact Assessment
749 New Hey Road
Outlane
Huddersfield, HD3 3YL**

Report Reference: AIA-1749-1
October 2023

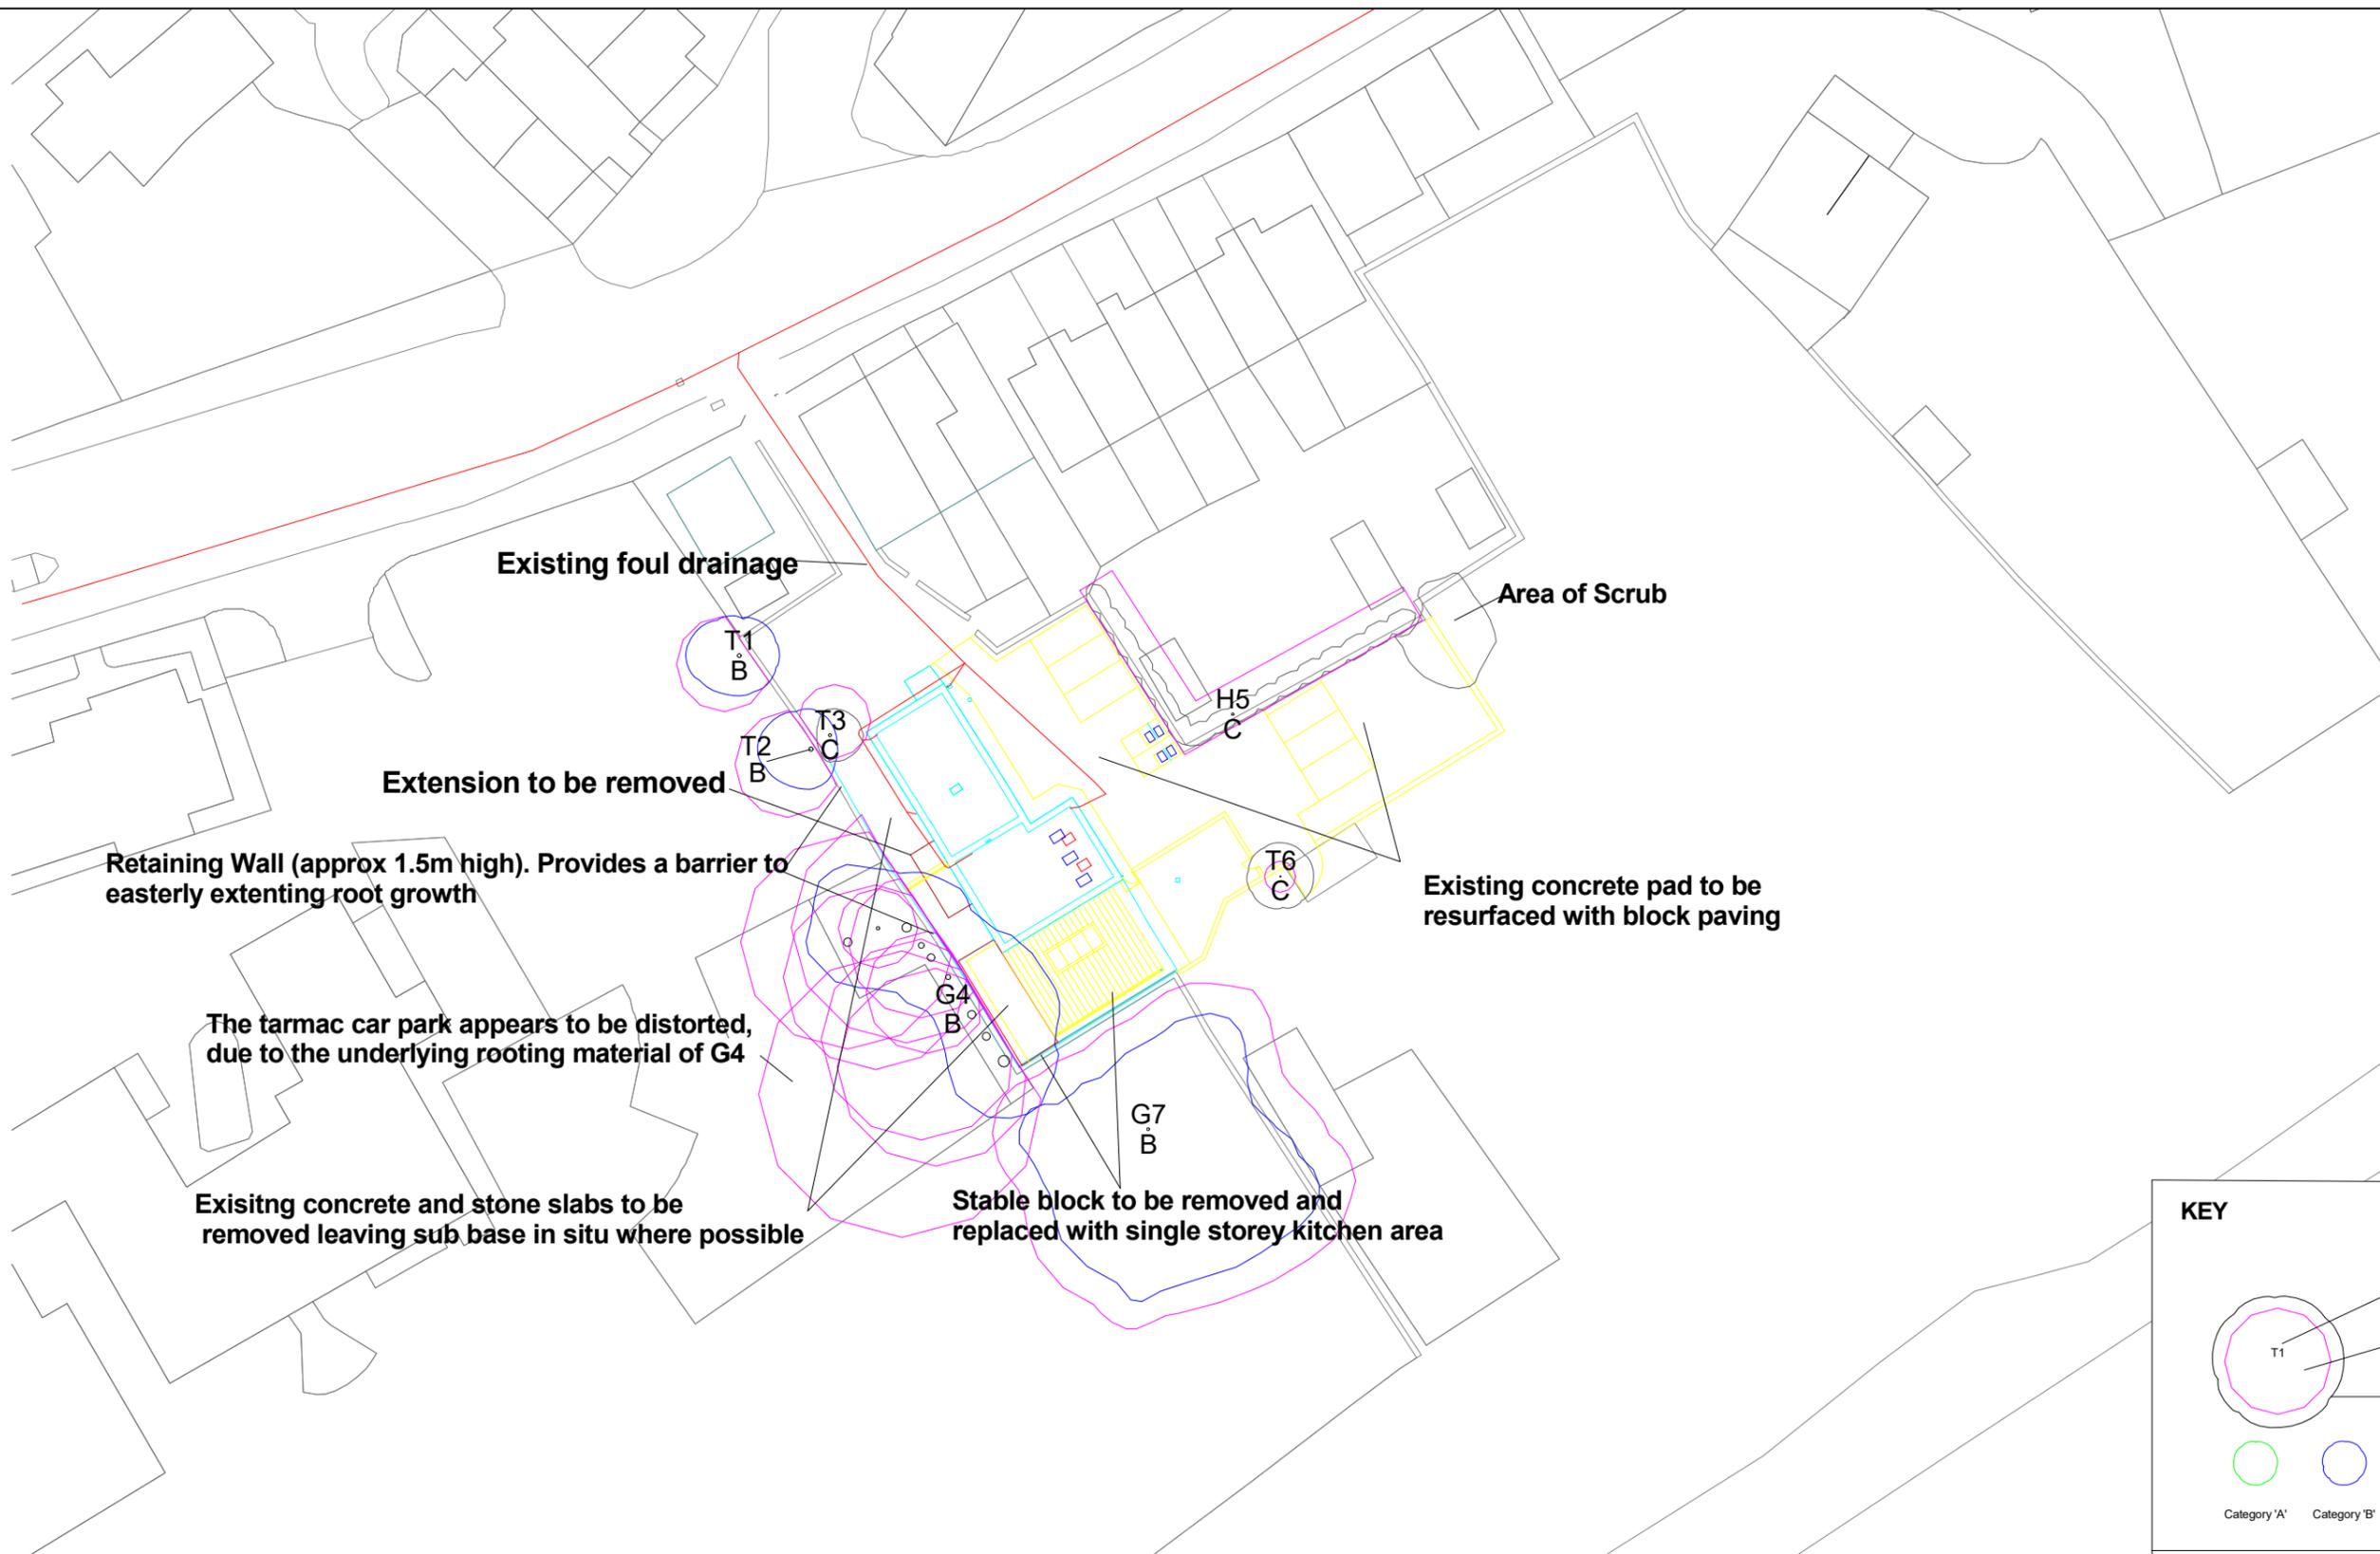
Tree Constraints/Impact Plan
749, New Hey Road, Outlane, Huddersfield, HD3 3YL

- 3.4.1 The area of roots that need to be protected around a tree to try to ensure it does not suffer damage during the construction process is called the Root Protection Area (RPA).
- 3.4.2 As recommended in BS5837 we have plotted the RPAs (in magenta) onto the attached Tree Constraints/Impact Plan taking full account of the surrounding topographical factors, adjoining structures, tree condition and probable root disposition.

3.4.4 The RPA's of T1, T2, T3 and G4 have been shown to reflect the presence of the wall and its likely constraint to root growth. As such it is considered limited rooting material will be present below the existing building and concrete hard-standing that stands to the rear of the dwelling. Taking account of the above, there is no requirement for foundation or excavation work to take place within the prescribed RPA's of trees highlighted for retention.

- 3.10.1 As demonstrated on the attached Tree Constraints/Impact Plan, the existing drainage has been identified in red and will continue to serve the proposed development. The existing services will also continue to serve both properties.
