Subject: Planning Application 2023/91212 Erection of 21 dwellings to the West of Bankfield Drive , Holmbridge

I would like to object to this Planning Application on the grounds of Insufficient Technical Information regarding Water Drainage.

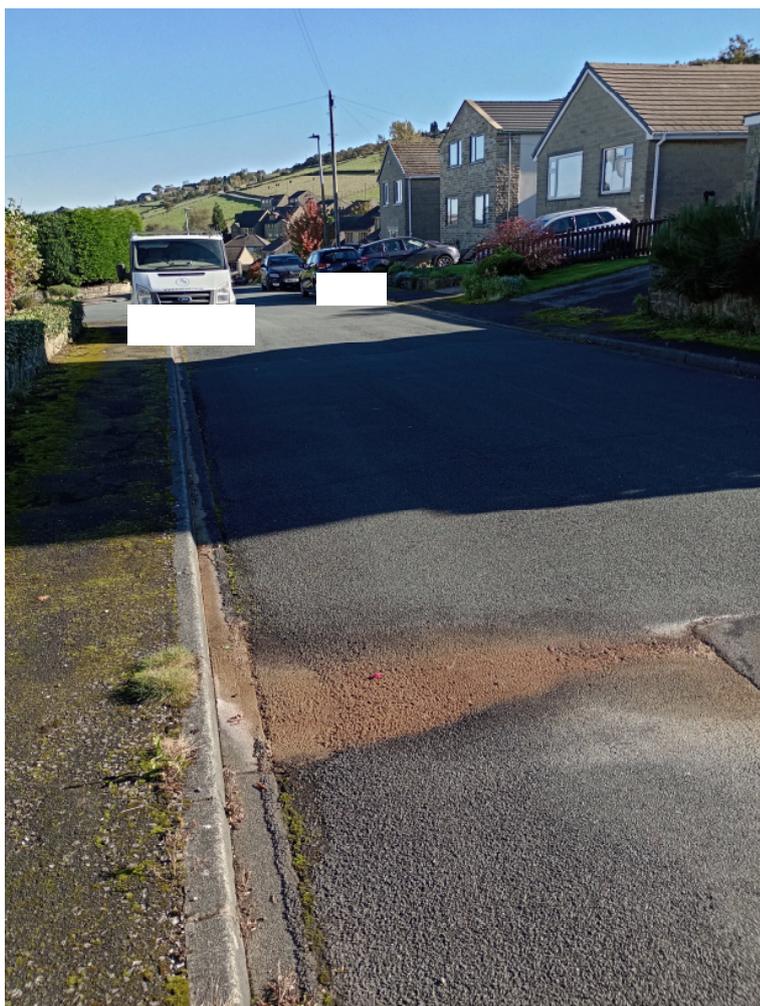
1. There are numerous natural "Springs" in and around site HS183 . These springs can have moveable outlets and directions of travel . One such Spring has recently surfaced through the Tarmac close to No 12 Laithe Avenue , which is the actual approach road to Site HS183..

These springs can also generate a considerable amount of water .[In fact , until quite recently Bankfield Farm , on the West side of HS183 , relied on spring water as its ONLY water supply.] Due to its slope , all spring water emerging from field HS183 or adjacent fields to the South ,travels in a Northerly direction towards Dobb Top Road.

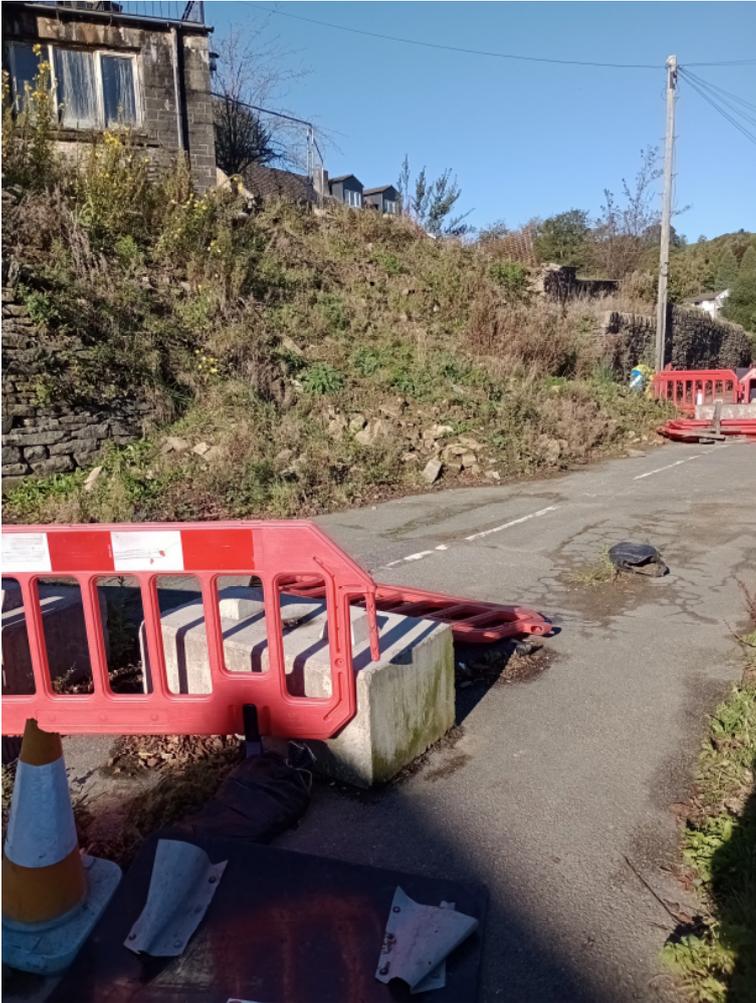
2. A landslip occurred on Burnlee Road in 2021 when a garden supported by a dry-stone wall collapsed and caused a road closure . Due to the high costs involved , this road has still not been re-opened .

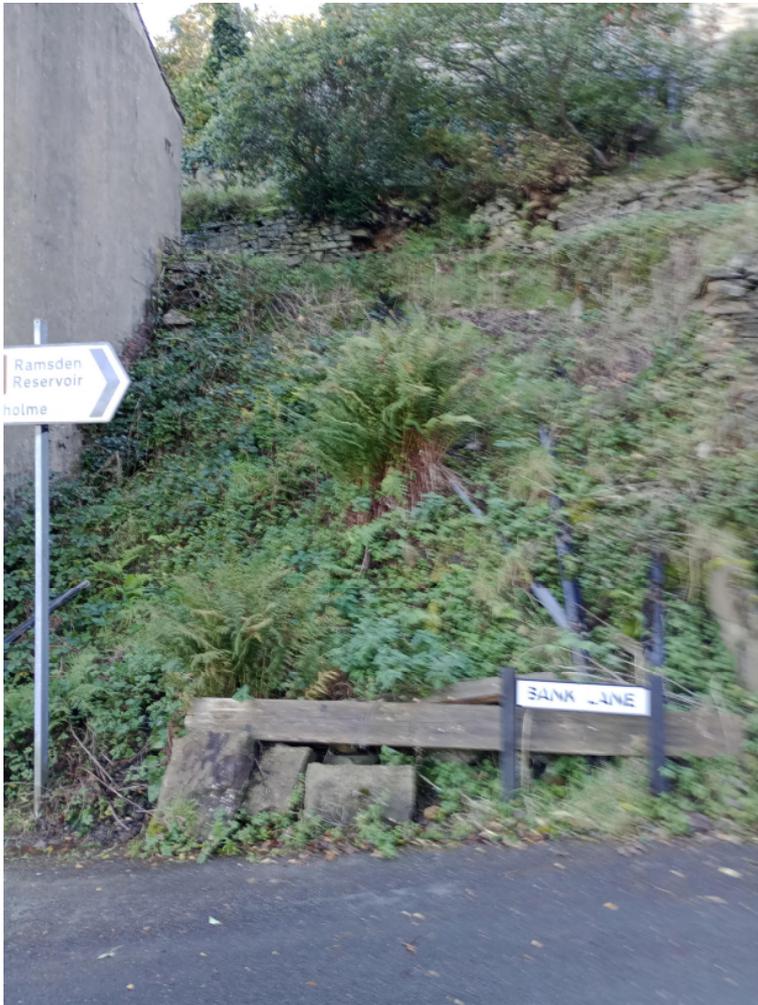
3. Dobb Top Road has collapsed near to Netherley House . This required a new supporting wall to protect the houses below it on Bank Lane plus road reconstruction and the fitting of gully drains. Presumably the absence of gully drains contributed to the road collapsing .(No gully drains are fitted along the rest of this road , the water drainage off Dobb Top Road relies solely on that which soaks through the soil verges at either side of the road.)

4. The garden alongside Bank Top Cottage (below HS183) has recently collapsed . There is a former Public spring water collection point on Bank Lane close to this garden..

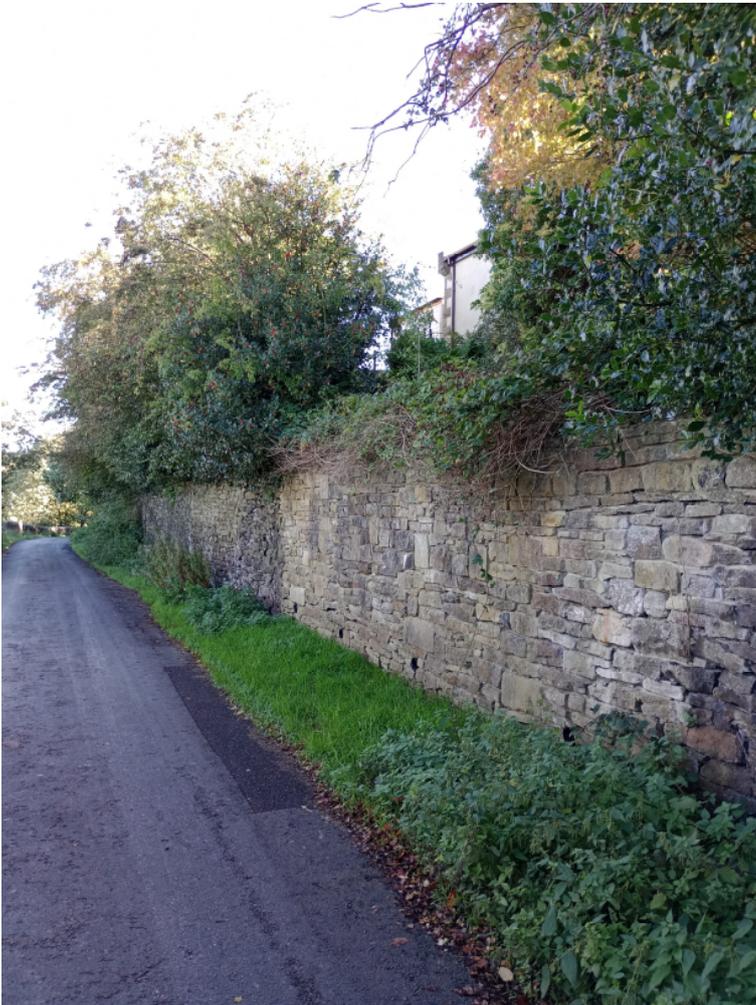
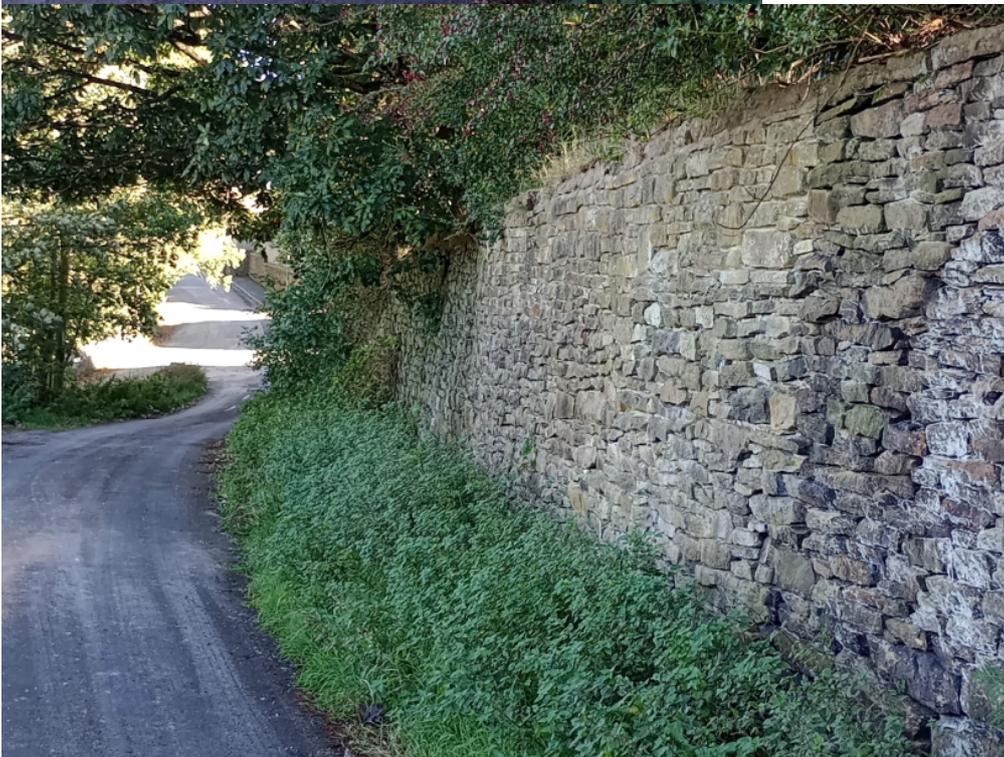
5. Site HS183 frequently floods , presumably due to natural spring water plus extra surface water from higher fields to the South. (Ducks have been seen swimming on the ponds formed on this site.) . Current plans do not show any methods for diverting this EXTRA water from reaching Site HS183

6. The dry-stone supporting wall on the South side of Dobb Top Road (formerly a cart-track known as Bank Top Lane) has had to be re-built in several places . Drainage holes have been built into the bottom of these new sections of wall suggesting that water has caused this wall to collapse..

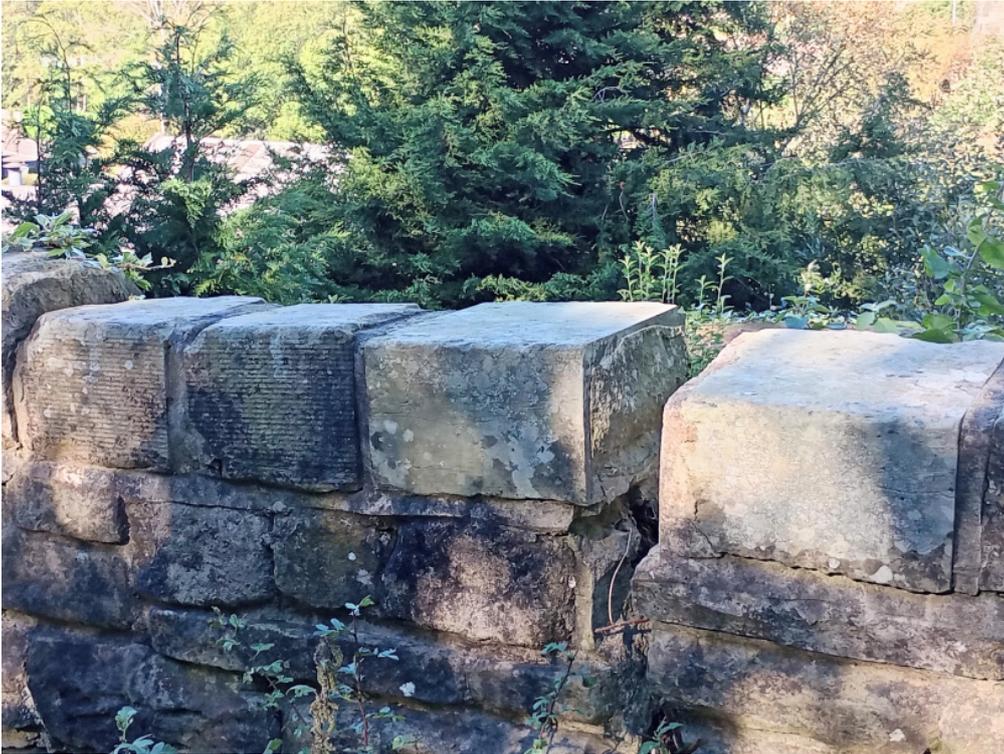
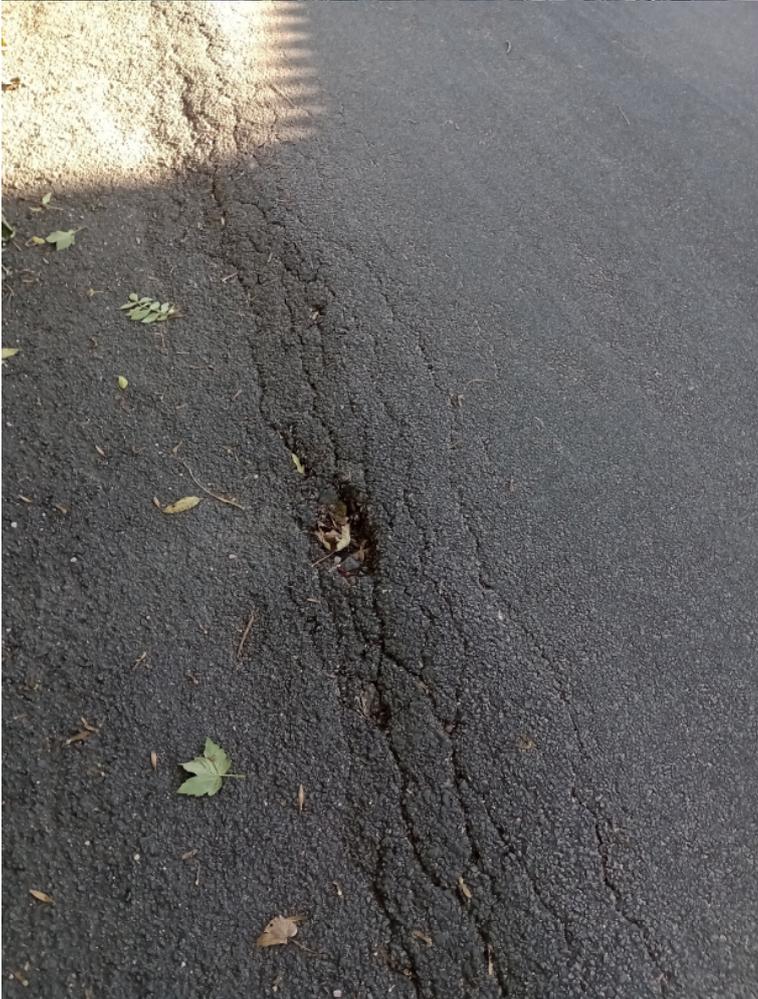
7 . Dobb Top Road can be seen to be gradually subsiding down the hillside in various other places .For example (a) The road has sunk by 18 inches 20m East of its junction with Laithe Bank Drive . (Presumably due to the removal of trees stabilising the embankment above the Sculpture Lounge) . (b) The wall close to the old Clarence Mill chimney has cracked by about 4 inches .Presumably again due to road subsidence .
