Arboricultural Impact Assessment

WC-160.1a

Linthwaite Methodist Church,
31 Chapel Hill, Huddersfield HD7 5NR

Report type:	Arboricultural Impact Assessment
Report reference:	WC-160.1
Revision:	a
Client:	ABM Developments Ltd
Site address	Linthwaite Methodist Church, 31 Chapel Hill, Huddersfield HD7 5NR
Grid reference:	SE 09567 13991
Report prepared by:	Jack Delaney FdSc MArborA
Date:	9 th May 2023

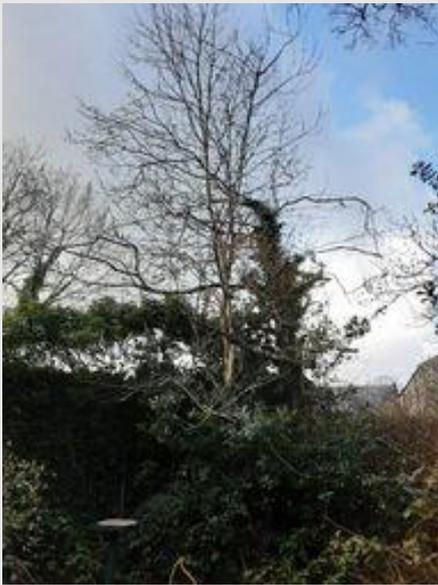
Plate 1: T001 & T002

Tree Ref:	Species	Age	SULE	Ht.	DBH	CS				CC	Comments	V	SC	BS 5837:2012 Category	Recommendations
						N	E	S	W						
T001	Wild Cherry (<i>Prunus avium</i>)	EM	< 5	7	380	1	2.5	5	3	5	Dense ivy (<i>Hedera helix</i>) established on main stem and structural branches, obscuring tree features and potential defects. Extensive deadwood < 100 mm throughout the with general appearance of low vitality and vigour.	P	D	C1	Remove tree
T002	Common Ash (<i>Fraxinus excelsior</i>)	SM	20-40	10	180	1.5	2.5	3	1.5	2	Bifurcates at 3 m into two co-dominant primary stems; union appears included with slight lateral broadening of parent stem directly beneath.	F	PD	C1	Remove tree

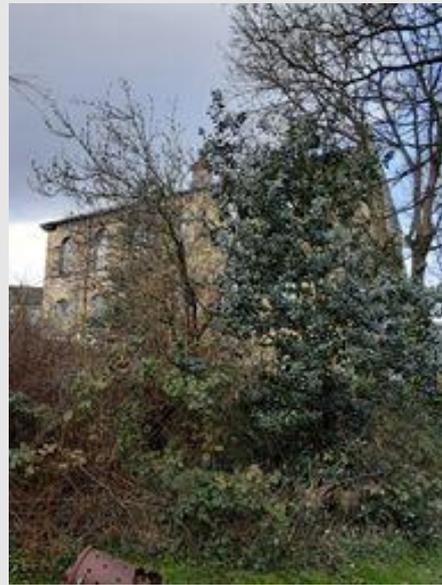
Plate 2: T003 & T004

Tree Ref:	Species	Age	SULE	Ht.	DBH	CS				CC	Comments	V	SC	BS 5837:2012 Category	Recommendations
						N	E	S	W						
T003	Common Holly (<i>Ilex aquifolium</i>)	Y	40-80	6	130	2	2	2	2	0	No obvious significant defects, though lacks qualities for higher BS 5837 categorisation.	G	G	C1	Remove tree
T004	Elder (<i>Sambucus nigra</i>)	Y	5-10	5	190	1	5	1.5	1	0	Main stem leans heavily to south, likely due to partial failure of root plate historically.	F	PD	C1	Remove tree
T005	Common Holly (<i>Ilex aquifolium</i>)	Y	40-80	6	100	1	1	1	1	0	No obvious significant defects, though lacks qualities for higher BS 5837 categorisation.	G	G	C1	Remove tree
T006	Sycamore (<i>Acer pseudoplatanus</i>)	M	40-80	20	940	10	9#	10	9	4.5	Dense ivy (<i>Hedera helix</i>) established on main stem and structural branches, obscuring tree features and potential defects. Minor deadwood < 100 mm in diameter scattered throughout crown	F	G	B2	Sever ivy at base to facilitate future inspections

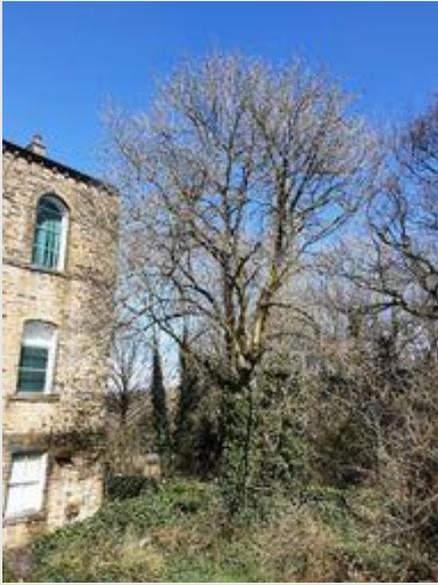
Plate 5: T007

T007	Common Ash (<i>Fraxinus excelsior</i>)	M	40-80	21	760	9	7	9	10	3.5	Dense ivy (<i>Hedera helix</i>) established on main stem, obscuring tree features and potential defects. Deadwood > 100 mm in diameter scattered throughout crown. Bifurcates at 4.5 m into two co-dominant primary stems union is acute, though detailed inspection was obscured by ivy.	F	F	B2	<ul style="list-style-type: none"> • Crown lift/reduce branches extending northwest to allow for installation of scaffolding • Remove deadwood > 50 mm in diameter • Sever ivy at base to facilitate future inspections
T008	Elder (<i>Sambucus nigra</i>)	Y	5-10	4	160	0.5	0.5#	1	2	0	Asymmetrical crown spread and leaning main stem to west, anticipated to have developed due to proximity with adjacent trees.	F	F	C1	Remove tree

- 4.2.1. Branches extending north-west from T007, and west from T009 and T010 encroach upon the existing building, and will therefore necessitate reduction and/or crown lifting to create circa 2 m clearance. These works will allow for the installation of scaffolding during construction and will reduce future nuisances relating to branch encroachment upon completion of the development.
- 4.2.2. To facilitate future inspections of T006, T007 and T009, it is also recommended that ivy (*Hedera helix*) which is established on the main stems is severed at ground level.
- 4.2.3. To reduce nuisances from falling tree debris, it is recommended that all deadwood > 50 mm in diameter - which is positioned over the car park and building - is removed from the crown of T007.

¹ Note, that LPA consent is not usually required to sever or remove ivy, as is recommended to T006, T007 and T009, or to remove deadwood, as is recommended to T007.

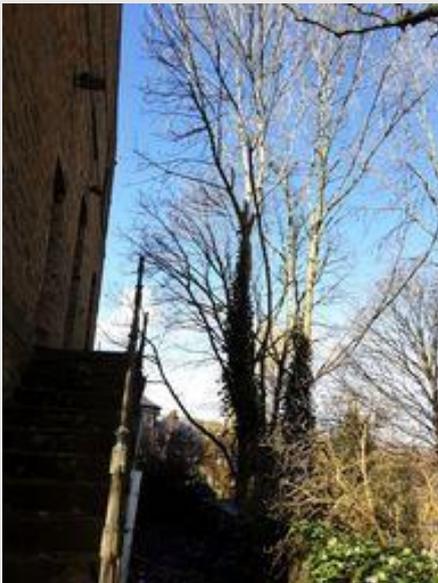
Plate 7: T009

Tree Ref:	Species	Age	SULE	Ht.	DBH	CS				CC	Comments	V	SC	BS 5837:2012 Category	Recommendations
						N	E	S	W						
T009	Common Ash <i>(Fraxinus excelsior)</i>	SM	40-80	18	350# 350#	3.5	4#	5	4	9	Positioned on neighbouring third-party property, approx. 1m below site levels: RPA offset by 40% to the east. Bifurcates at ground level into two co-dominant primary stems. Dense ivy (<i>Hedera helix</i>) established on main stem and structural branches, obscuring tree features and potential defects. Minor deadwood < 100 mm in diameter scattered throughout the crown. Branches extending west are within 0.5 m of property.	F		B1	<ul style="list-style-type: none"> •Sever ivy at base to facilitate future inspections •Crown lift/reduce branches extending west by approx. 2 m, to allow installation of scaffolding
T010	Sessile Oak <i>(Quercus petraea)</i>	SM	80+	15	400# 280#	6#	3#	3	5	9	Positioned on neighbouring third-party property, approx. 1.5 m below site levels: RPA offset by 60% to the east. Bifurcates at ground level into two co-dominant primary stems. Asymmetrical crown spread to north due to proximity with adjacent tree. Branches extending west are within 0.5 m of property.	F		B1	<ul style="list-style-type: none"> •Crown lift/reduce branches extending west by approx. 2 m, to allow for installation of scaffolding

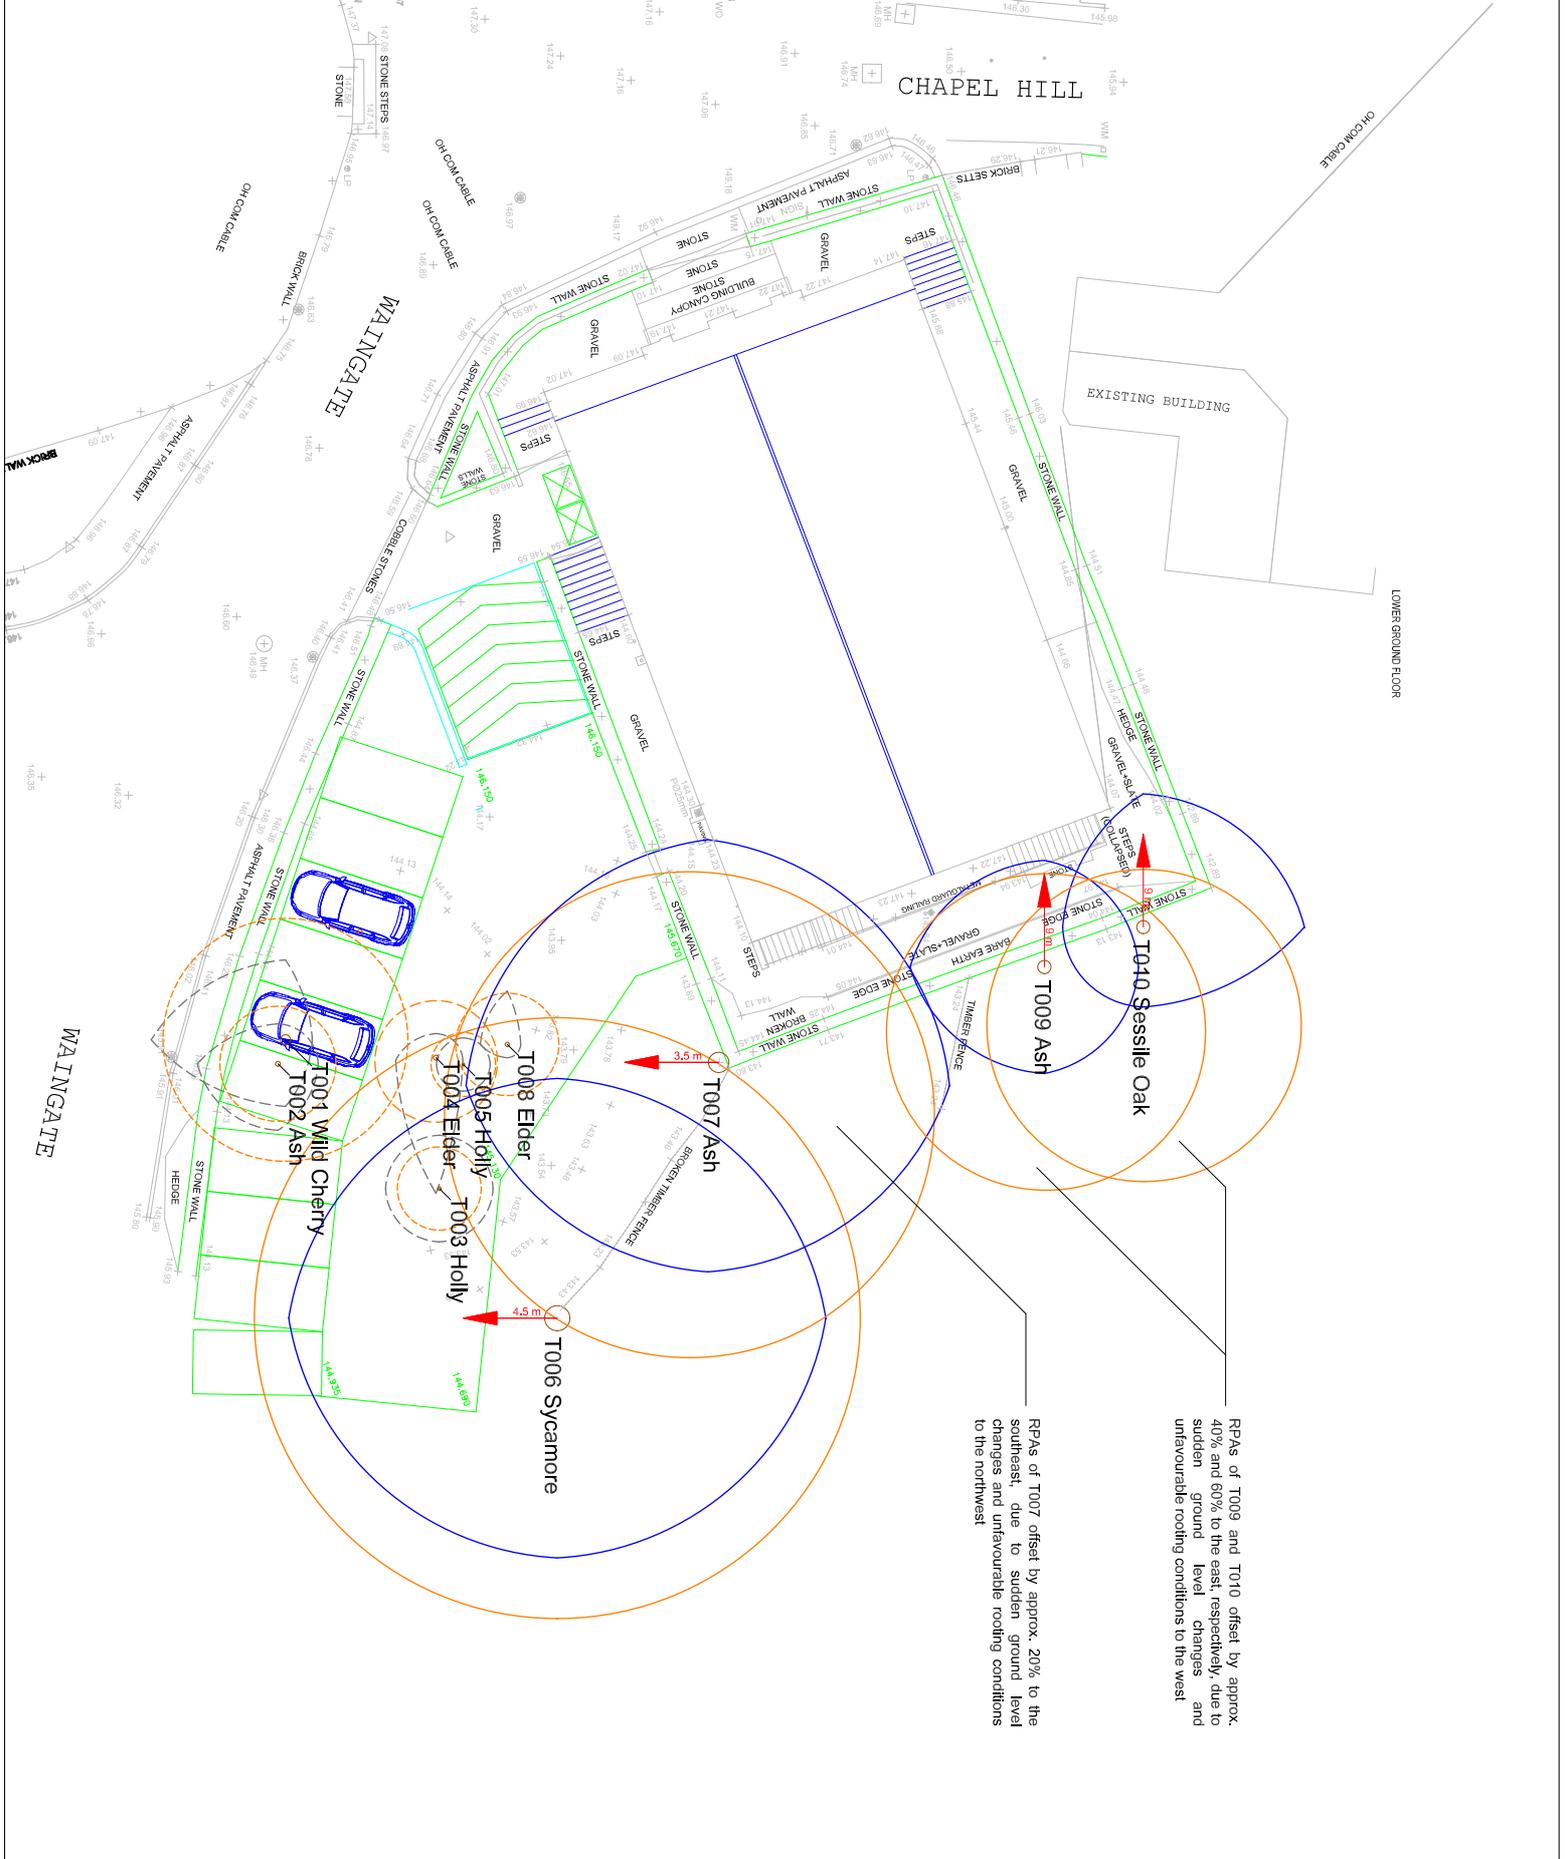
RPA's of T009 and T010 offset by approx. 40% and 60% to the east, respectively, due to sudden ground level changes and unfavourable roofing conditions to the west

RPA's of T007 offset by approx. 20% to the southeast, due to sudden ground level changes and unfavourable roofing conditions to the northwest

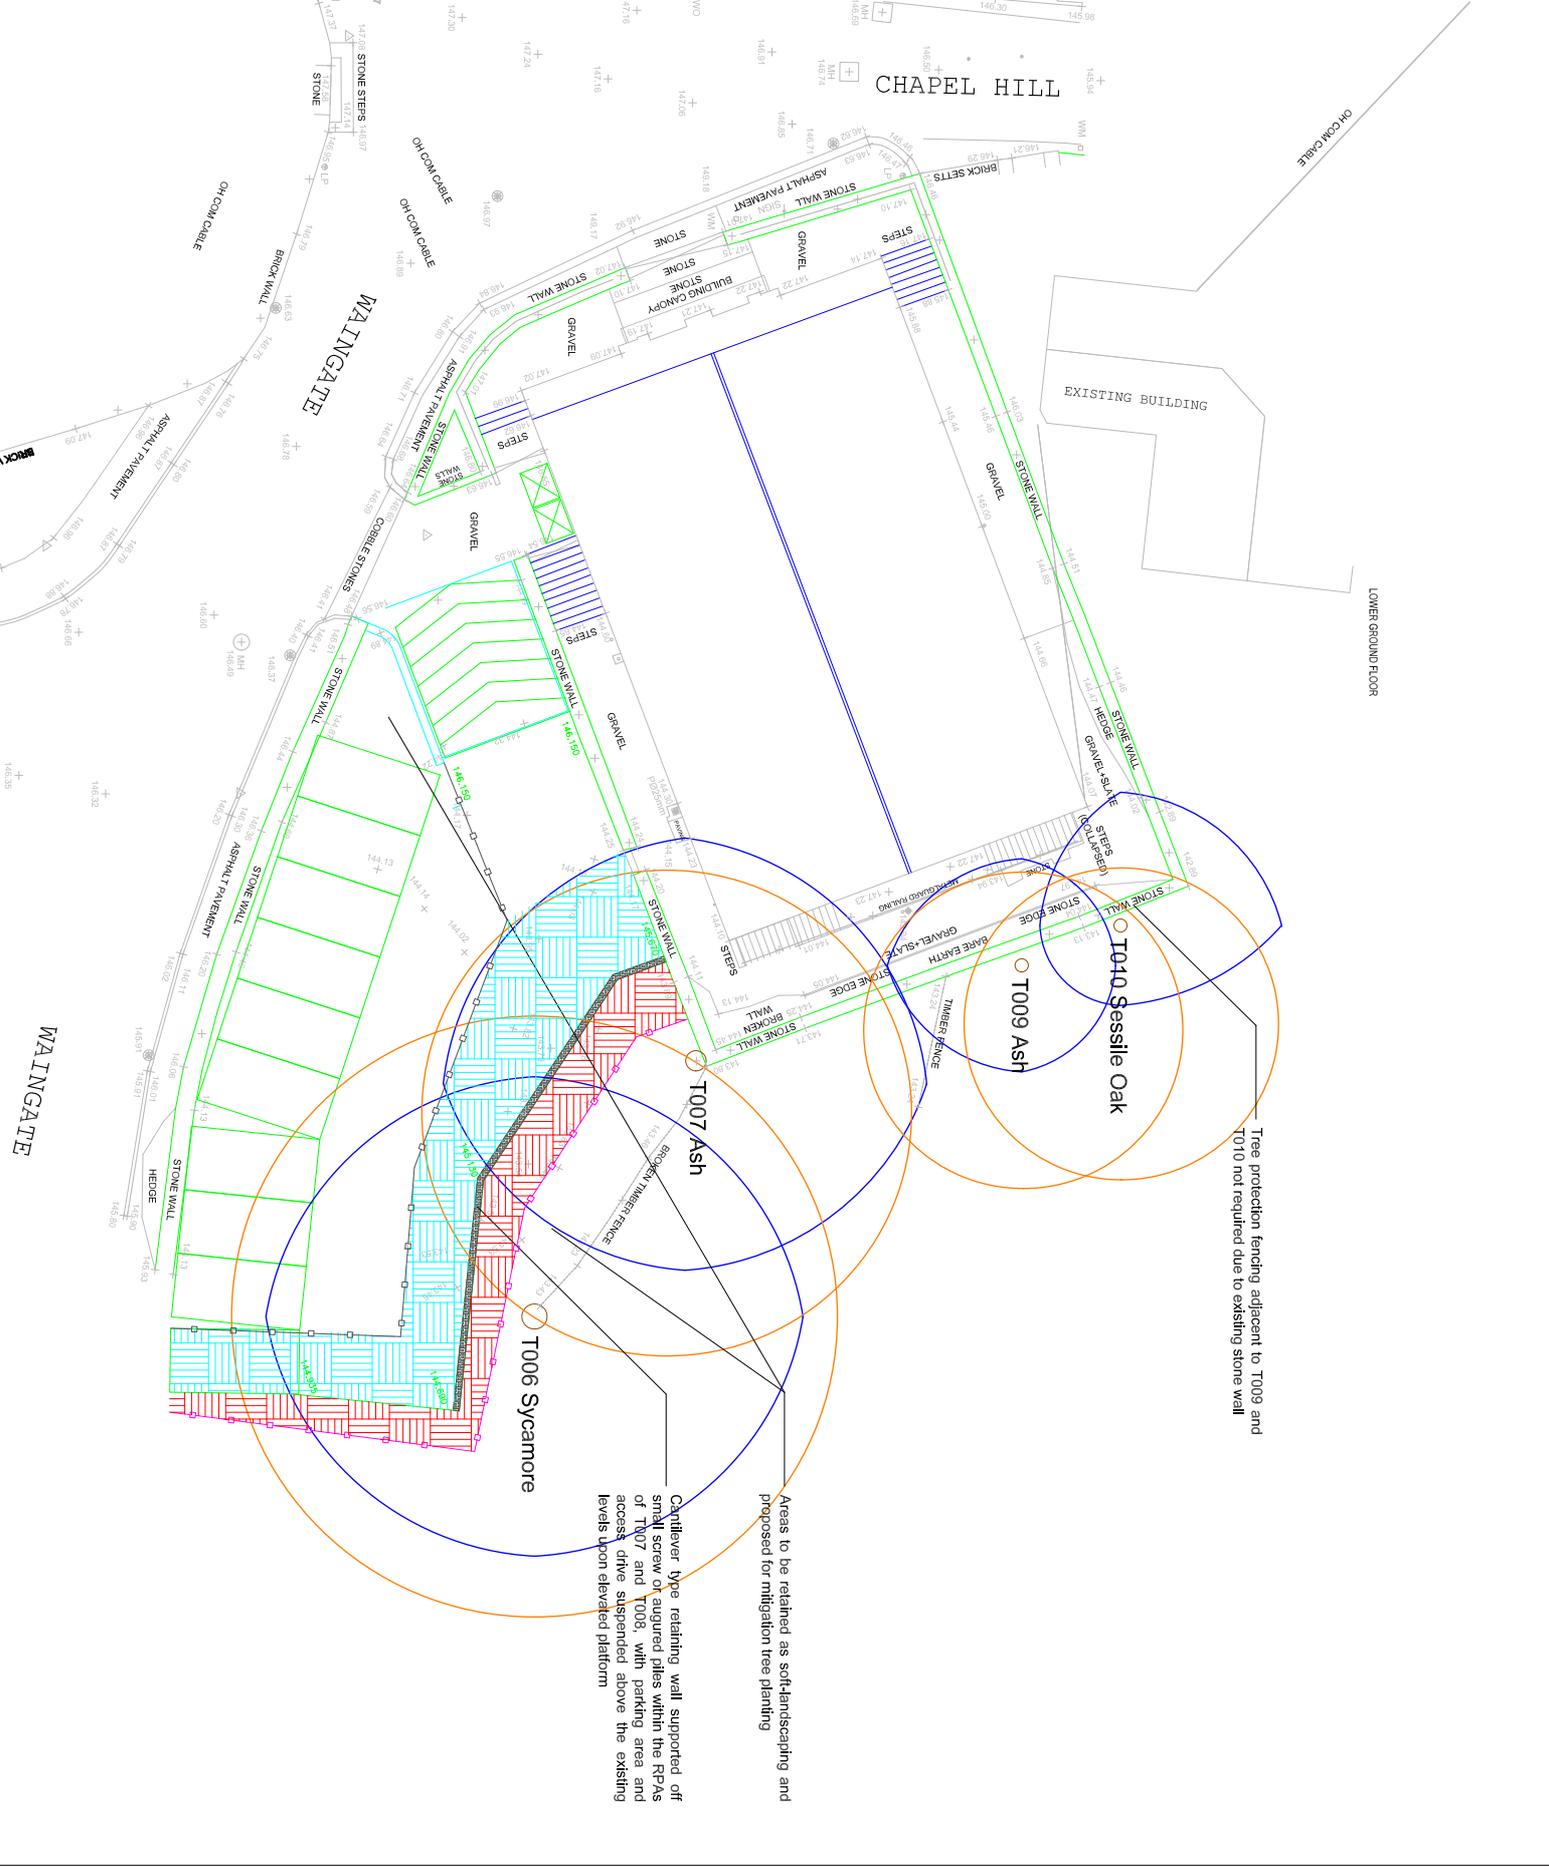
Tree protection fencing adjacent to T009 and T010 not required due to existing stone wall

Areas to be retained as soft-landscaping and proposed for mitigation tree planting
