Heritage Impact Assessment

**Thornbush Farm,
Miry Lane,
Liversedge,
WF15 8JJ**

Prepared By
Code L6 Architecture Ltd
May 2023
Ref: 23-211-21

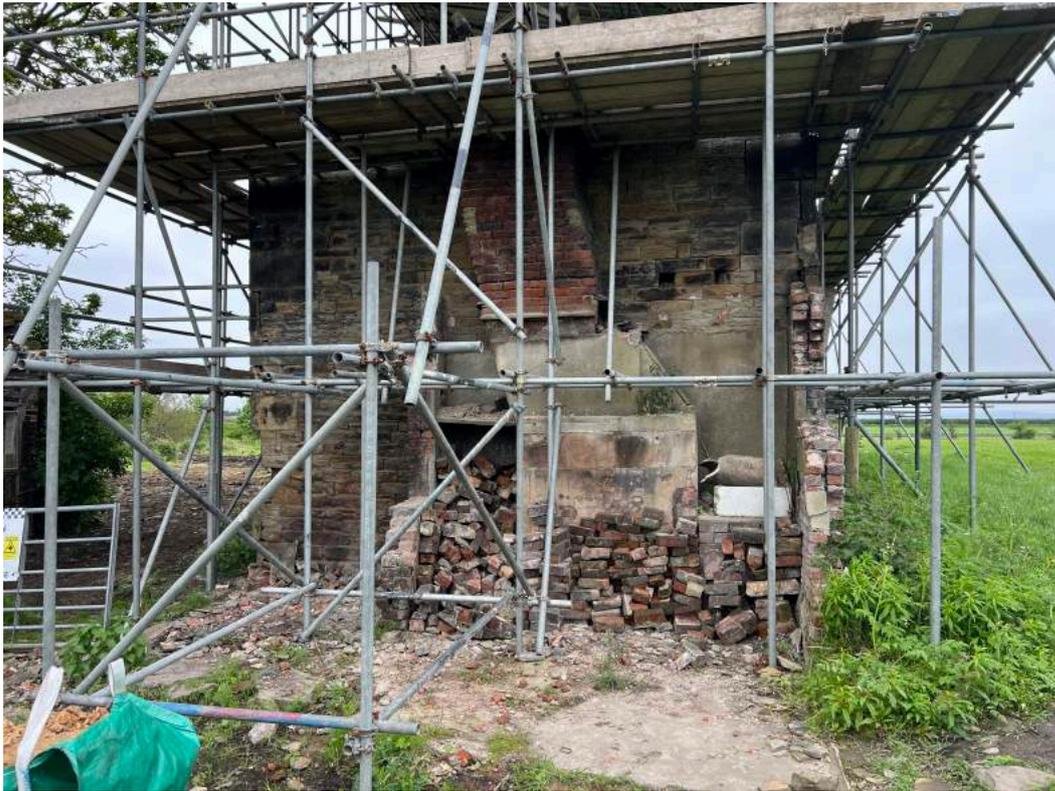
Single Storey extension to north elevation removed.

- i. Install previously set aside stone work to the windows and doors, cleaning and repairing as work progresses.
- j. Rebuild small extension that appears to have originally been oven room or kitchen. Complete the roofing inline with the main roofing works.

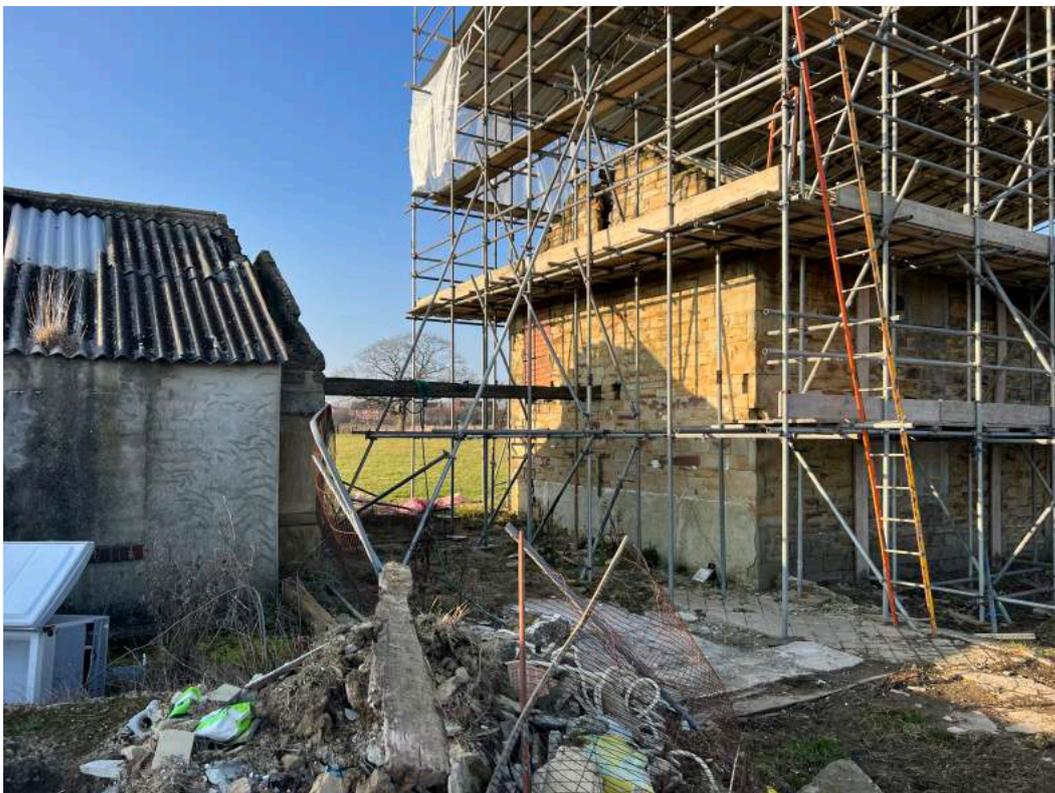
Two storey extension between unit 01 and 02 removed

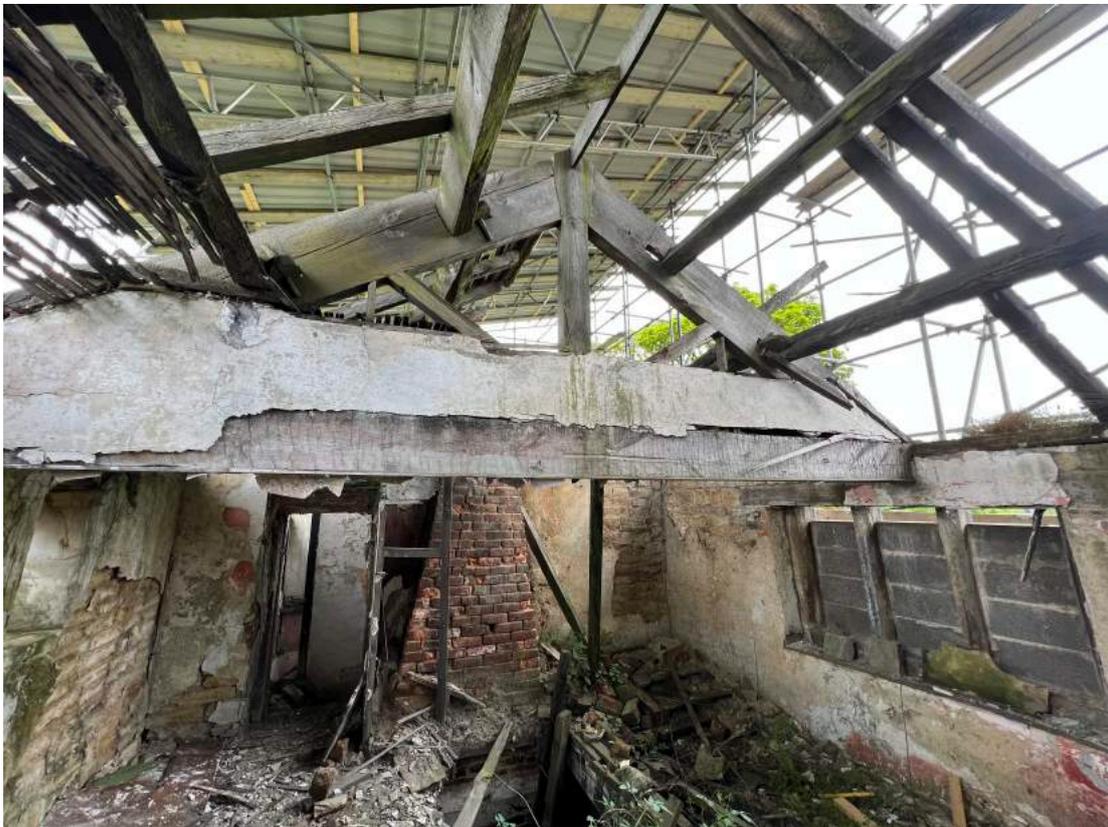
The buildings are in extremely poor condition and in need of total renovation and restoration. The roof tiles are missing to Unit 01, 03 and 04 with rafters exposed for around 5 years, which has led to their structural failure. The walls to unit 01 are bowing and will require rebuilding. A single storey lean too extension to the northern end of unit 01 has been removed and a two storey building between unit 01 and 02 and also been demolished with all materials removed from site. The isolated nature of the site has led to the demolition and theft of all material. The farm house is built in natural coursed stone, which would have had a stone slate roof now missing and was historically arranged as two dwellings. The piggery is built in redbrick to the west and south elevations and render to the east with a corrugated cement base roof. The two outbuildings are in red brickwork, which would have originally had natural slate roofs, now missing.

Farmhouse – Stone slates removed and first floor collapsed.

- n. Over lay with breathable membrane to roof structure and re-roof in imitation stone slates, of diminishing sizes. Imitation is proposed to reduce the stress on the roof and allow the retention of as many original timbers, rather than replace all with the consideration of potentially using steel to take the weight of stone.

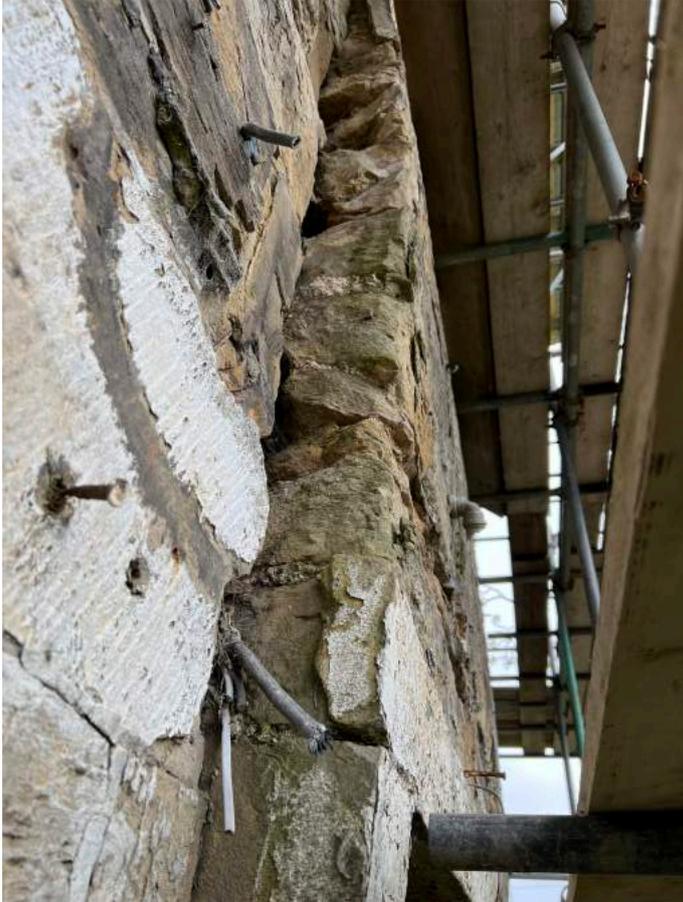
Farmhouse – Front wall bowing and near to collapse

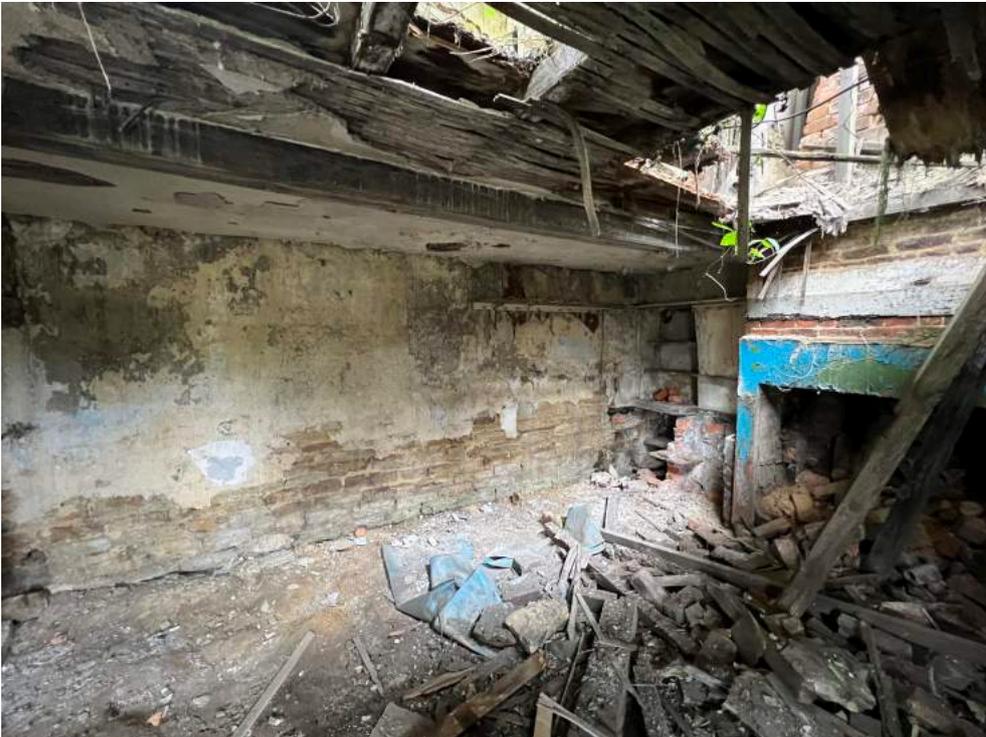
Farmhouse – First floor collapsed

- h. Install floor joists using as many of the original units where possible, it should be noted that a majority of materials have been removed by others nefariously, where installation is taking place structural elements must be adhered to and allow for strapping of joists where possible.

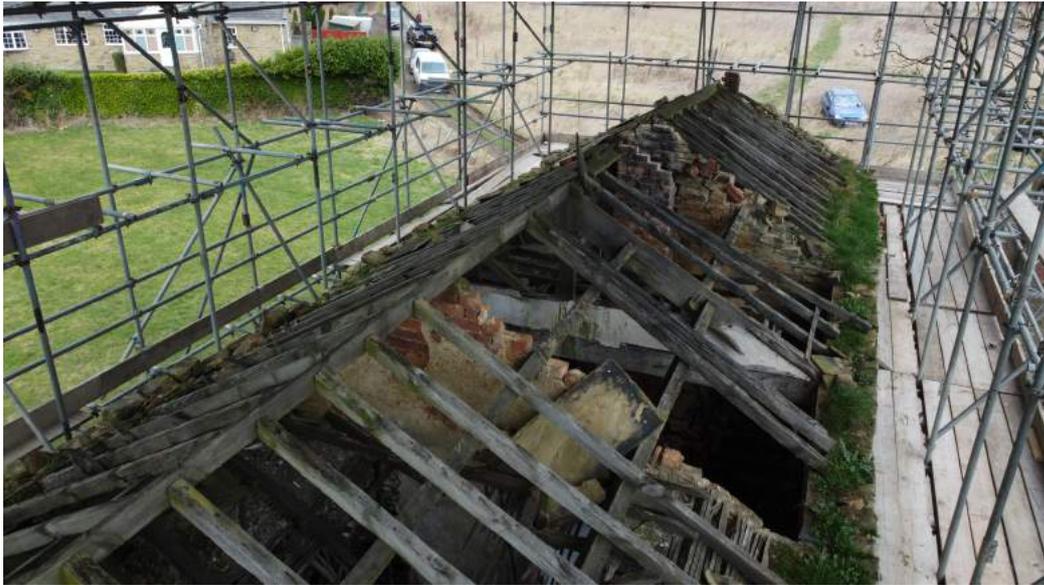
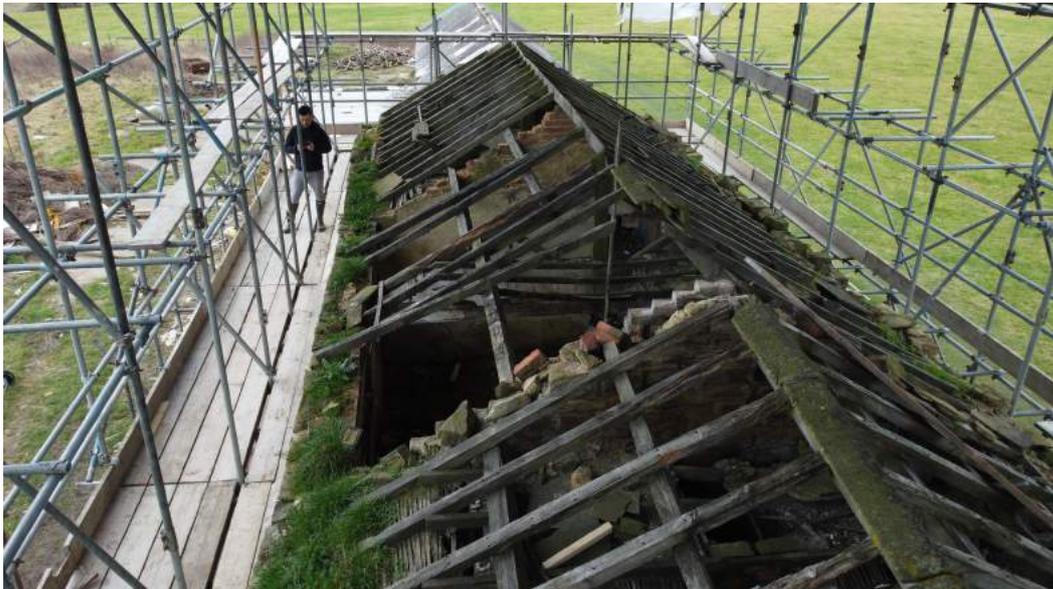
Farmhouse – Roof Removed

- k. At roof level, install wall plates and structurally attached in the approved method.
- l. Carry out installation of roof trusses, using as much of the original units as possible, noting the conditions from the structural reports, considering that one is beyond repair. Install infill rafters, again using as many of the original rafters as possible. Install new ridge plate.

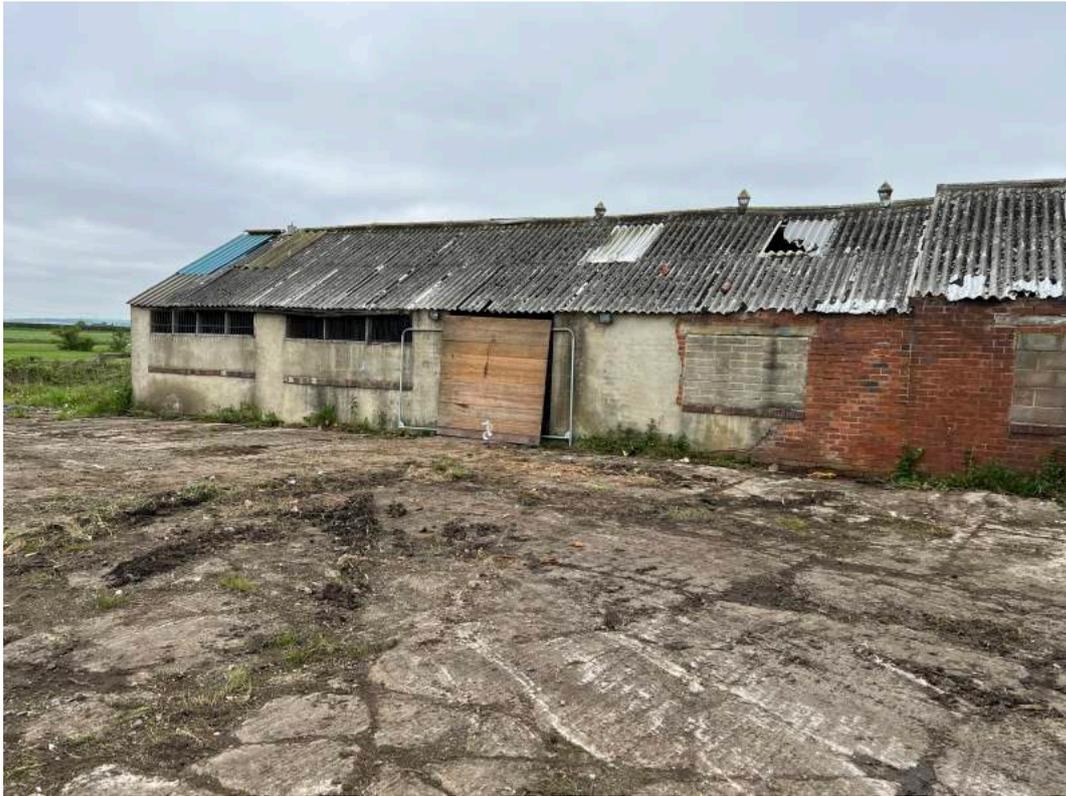
Piggery – Front Elevation 01 – Southern wing

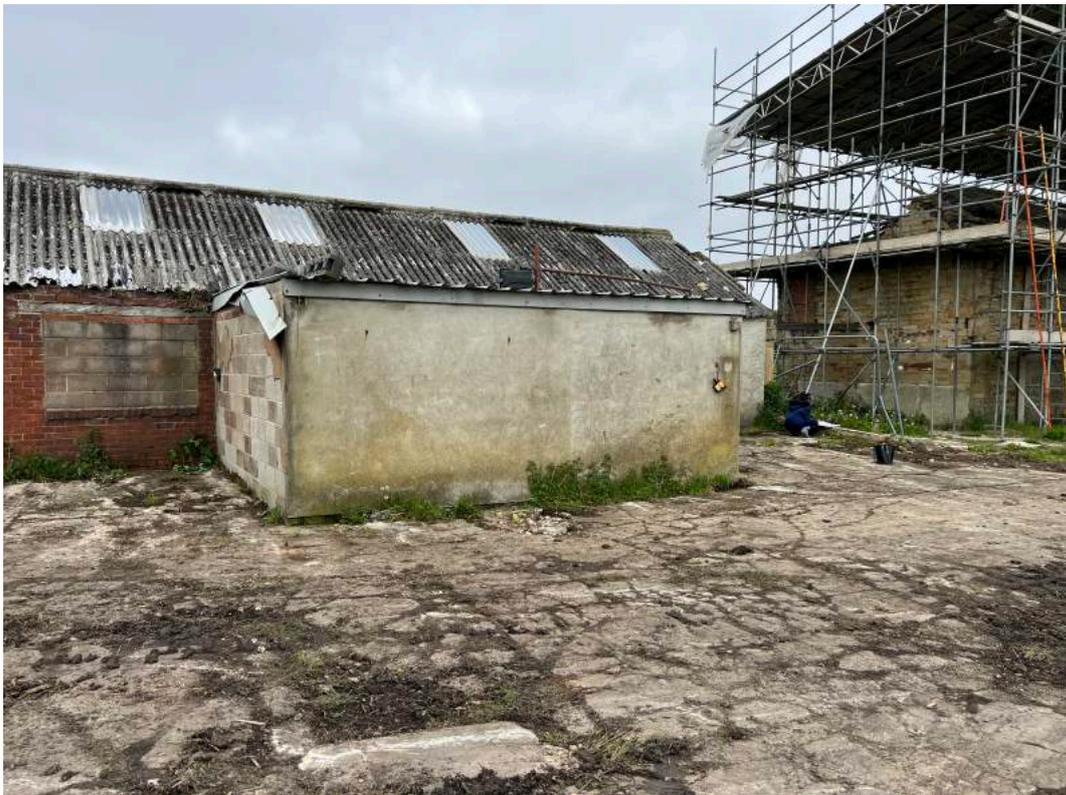
Piggery – Front Elevation 01 –Northern wing

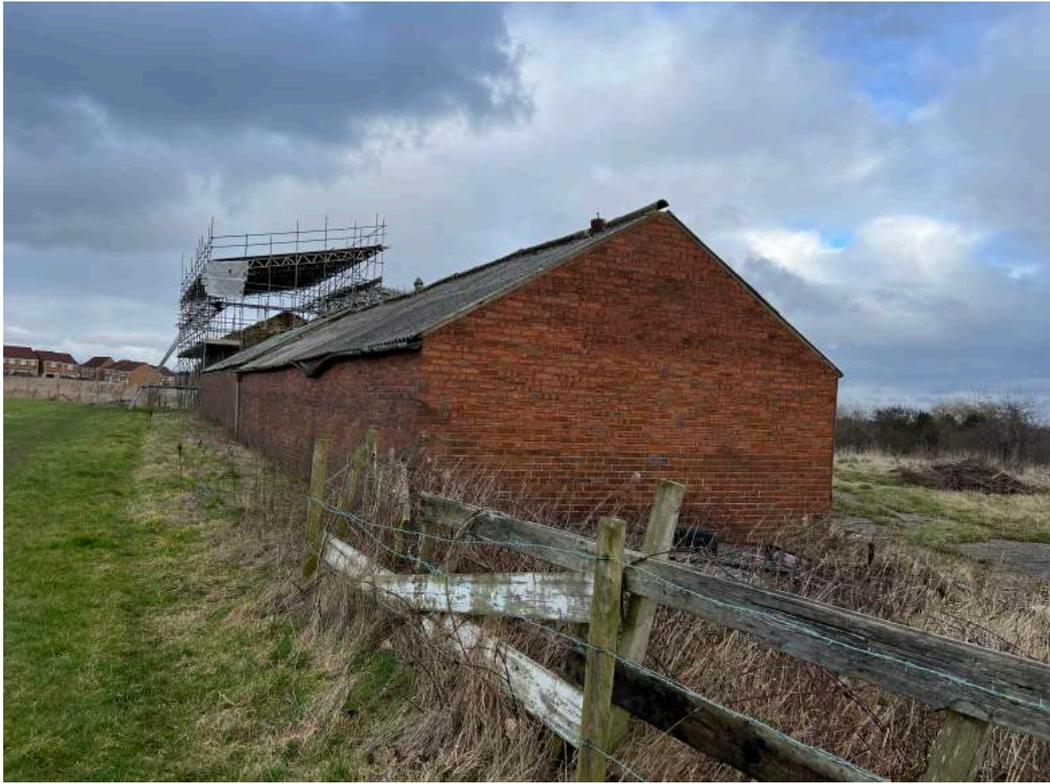
Piggery – South Elevation

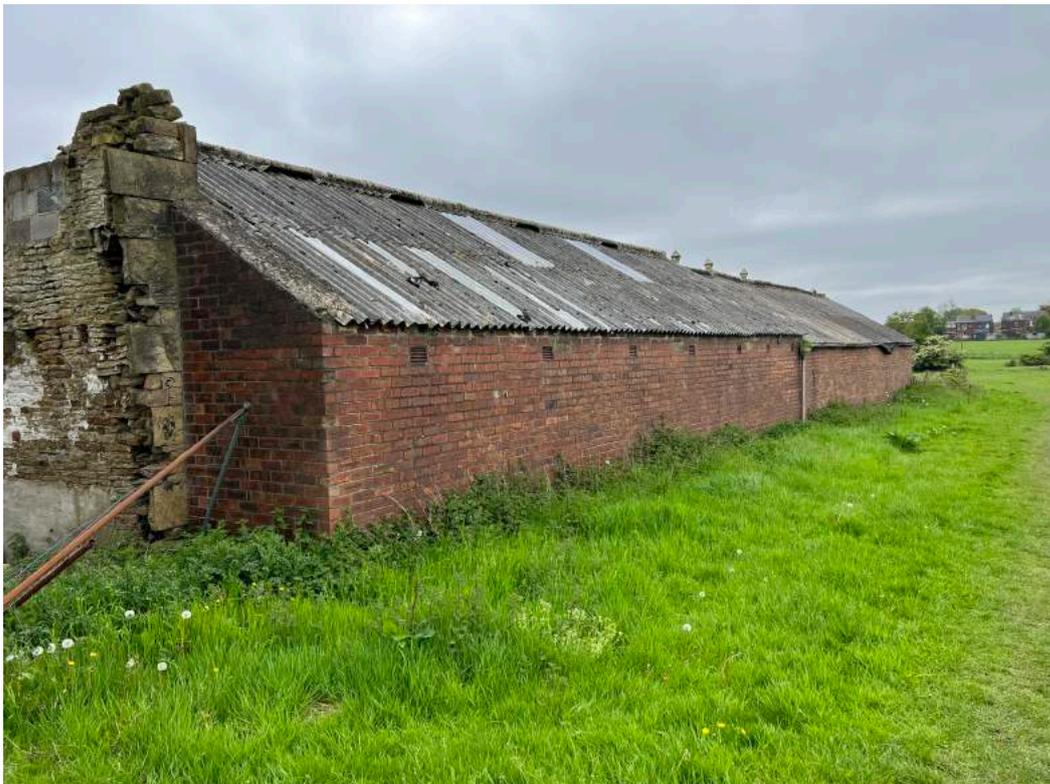
Piggery – West Elevation

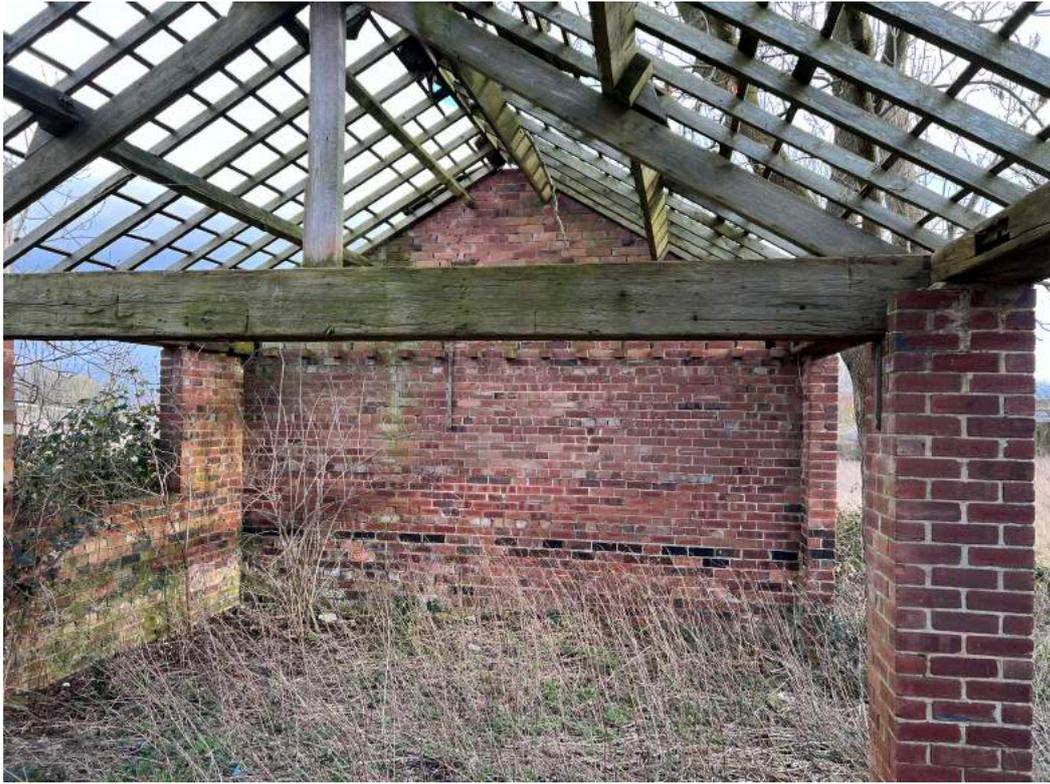
Outbuilding 01 - Internal

2. Outbuilding 01 – Unit 03
 - a. Remove rotten roof trusses and dispose.
 - b. Remove rotten frames and steel door.
 - c. Remove any damaged brickwork.
 - d. Remove existing floor.
 - e. Install new concrete floor in C30 Concrete to 150mm thick and appropriate dpm
 - f. Repair brickwork in 1:1:4 mortar using retained bricks from minor demolition and retained from site. Repointing retained masonry.
 - g. Install lintels were missing.
 - h. Install new windows and doors.
 - i. Install wall plates and rafters, to Structural Engineer's design,
 - j. Apply Breathable membrane to rafters and fit imitation blue slate, fixing to manufacturers fixing schedule.
 - k. Complete eaves, ridge and verge detail.
 - l. Complete internal works and second fix works

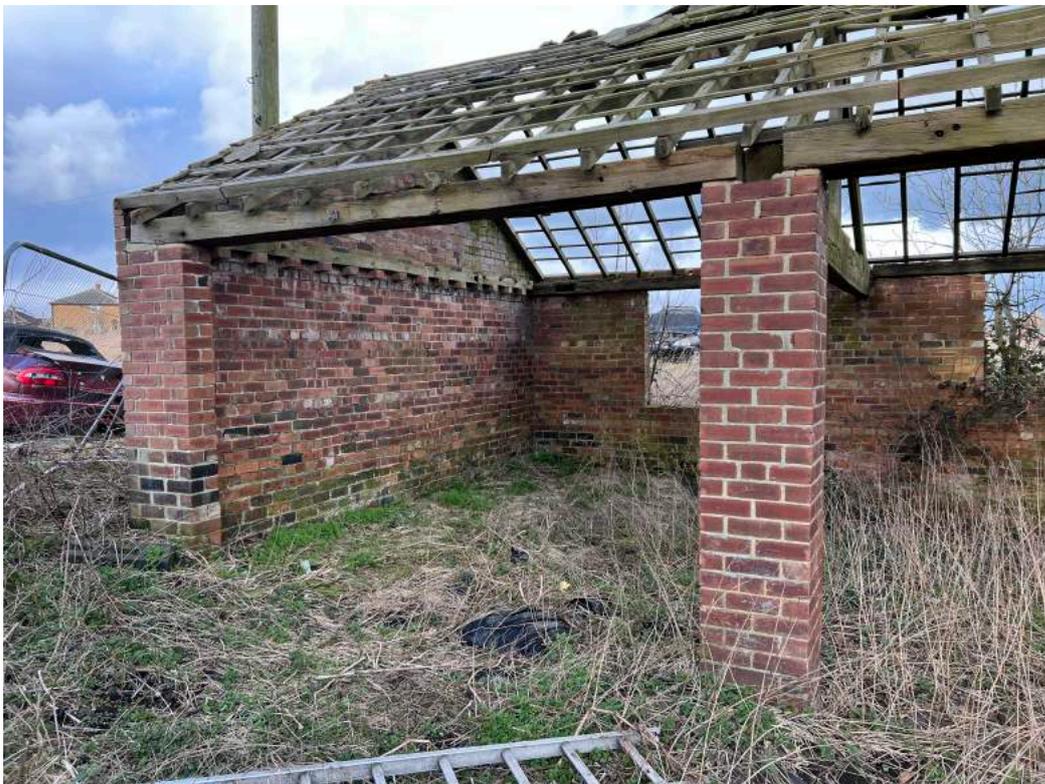
Outbuilding 01 – External
