**Arboricultural Impact Assessment
Stephen and Ian Bond**

Report Reference: AIA-1550-1
1 September 2023

Prepared For:
Stephen and Ian Bond

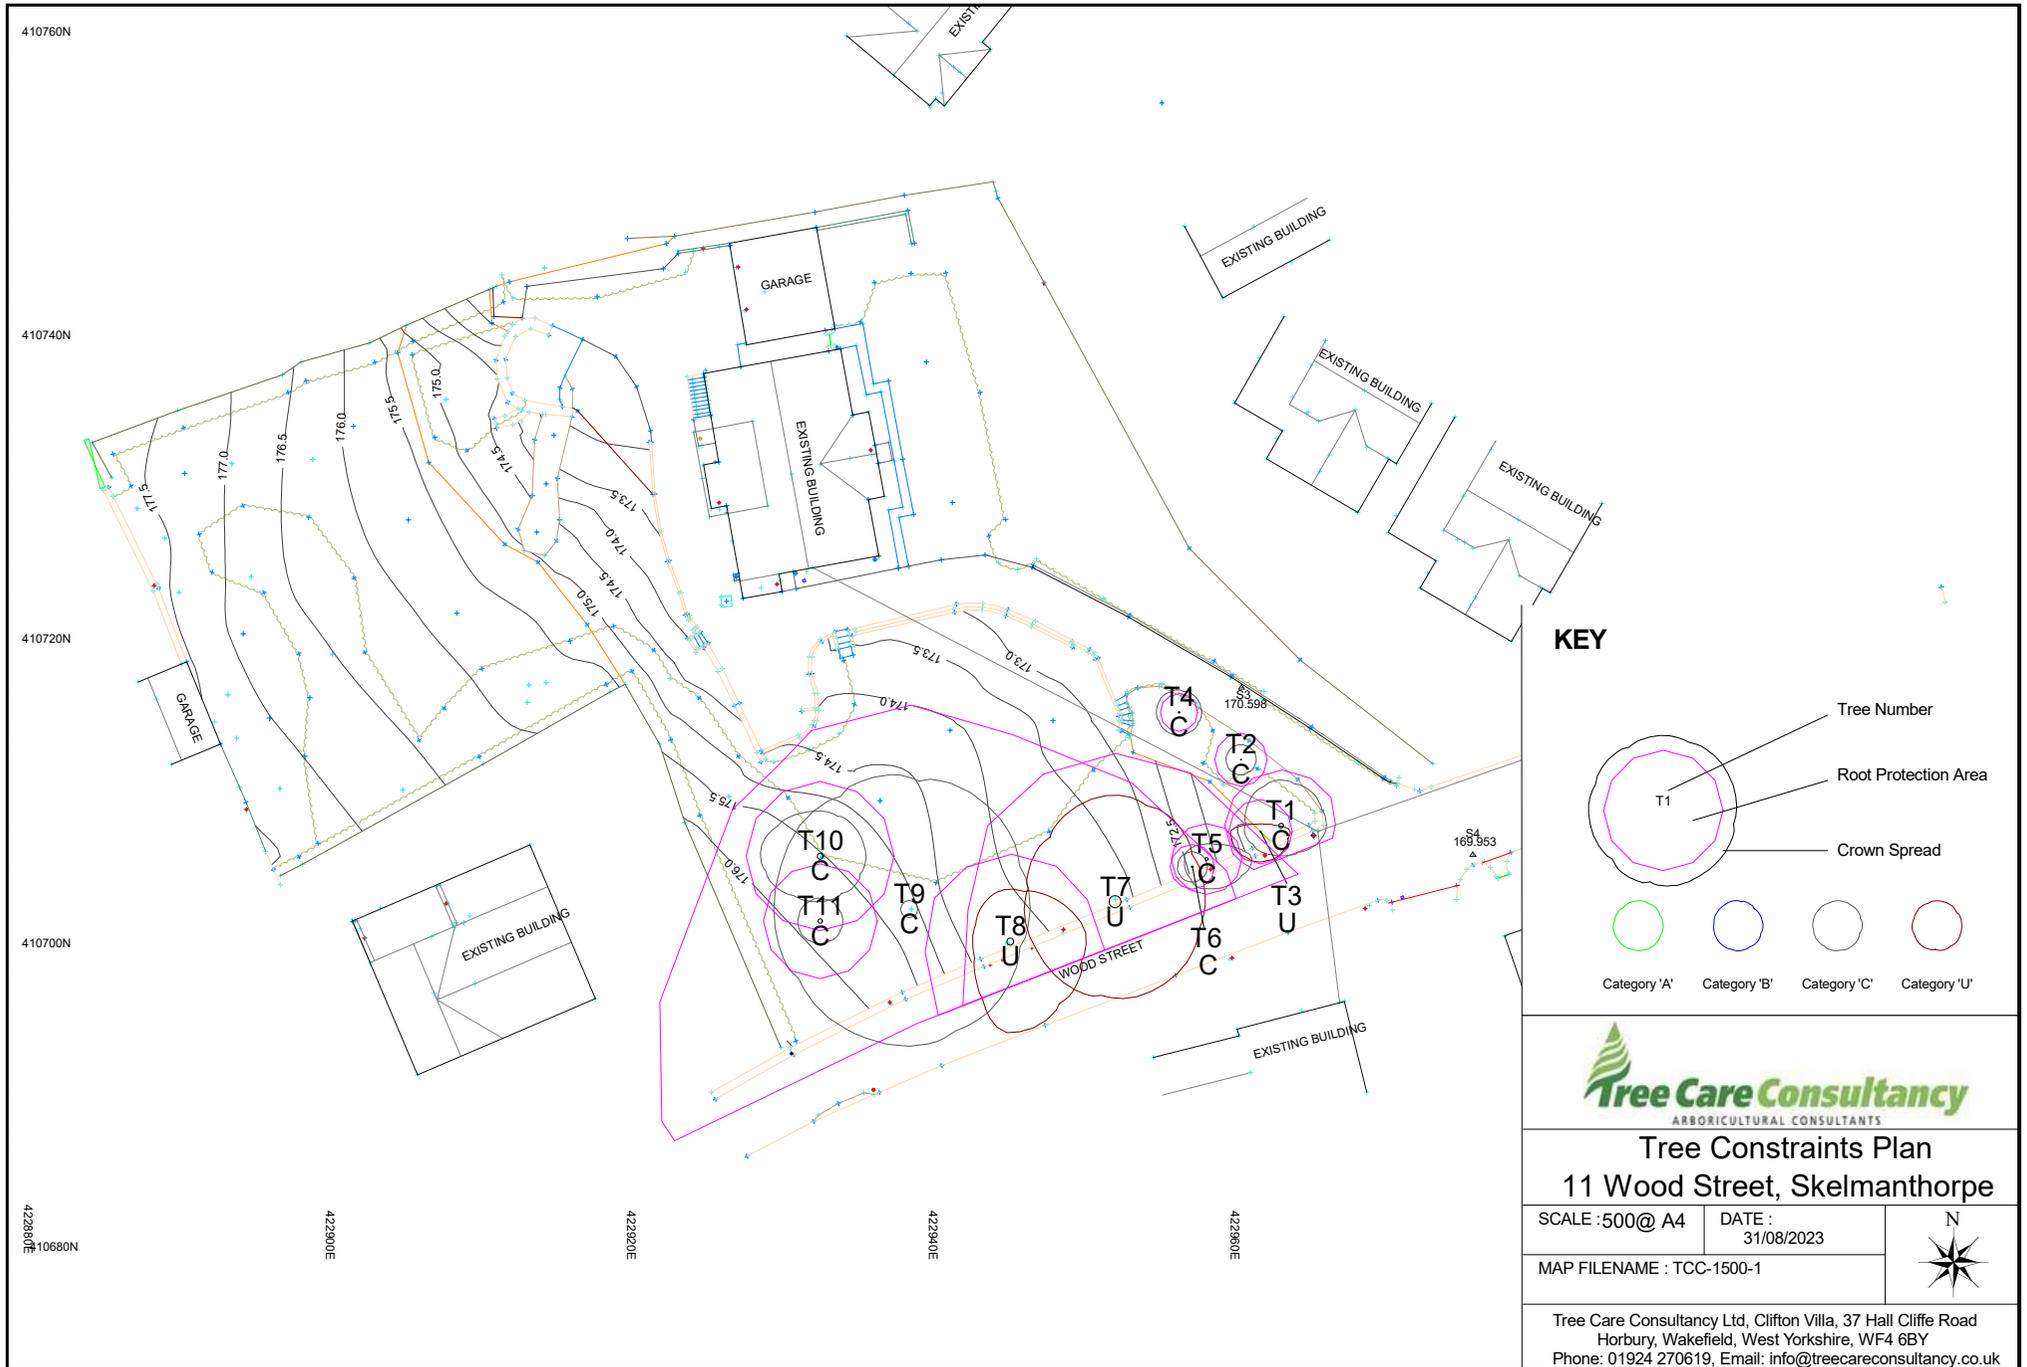
Tree Constraints Plan
11 Wood Street, Skelmanthorpe

- 3.1.4 It will be apparent from viewing the Tree Constraints Plan that 4No. low category C trees and 2No. category U trees are to be removed for the purpose carrying out the proposed development. A further Category U tree is recommended for removal on arboricultural management grounds alone. It could equally be argued T7 and T8 constitute a loss on arboricultural management grounds. These issues are discussed in further detail at paragraphs 3.2 and 3.3.

- 3.4.1 The area of roots that need to be protected around a tree to try to ensure it does not suffer damage during the construction process is called the Root Protection Area (RPA).
- 3.4.2 As recommended in BS5837 we have plotted the RPAs (in magenta) onto the attached Tree Constraints Plans (TCP) taking full account of the surrounding topographical factors, tree condition and the likely root disposition.

- 3.4.3 In order to limit disturbance to the rooting volume of the retained trees T2, T4, T10 and T11 it will be necessary to protect the trees RPA during the construction phase. It is presumed this is a matter the Local Planning Authority would be agreeable to conditioning as part of a detailed planning permission.

- 3.6.1 A protective fence will be erected prior to the commencement of any site works e.g. before demolition and the delivery of materials to site. The fence will have signs attached to it stating that this is a Construction Exclusion Zone (CEZ) and that NO WORKS are permitted within the CEZ. The protective fence may only be removed following completion of all construction works.
- 3.6.2 The positioning and implementation of protection can be effectively controlled by imposition of a suitably worded planning condition.

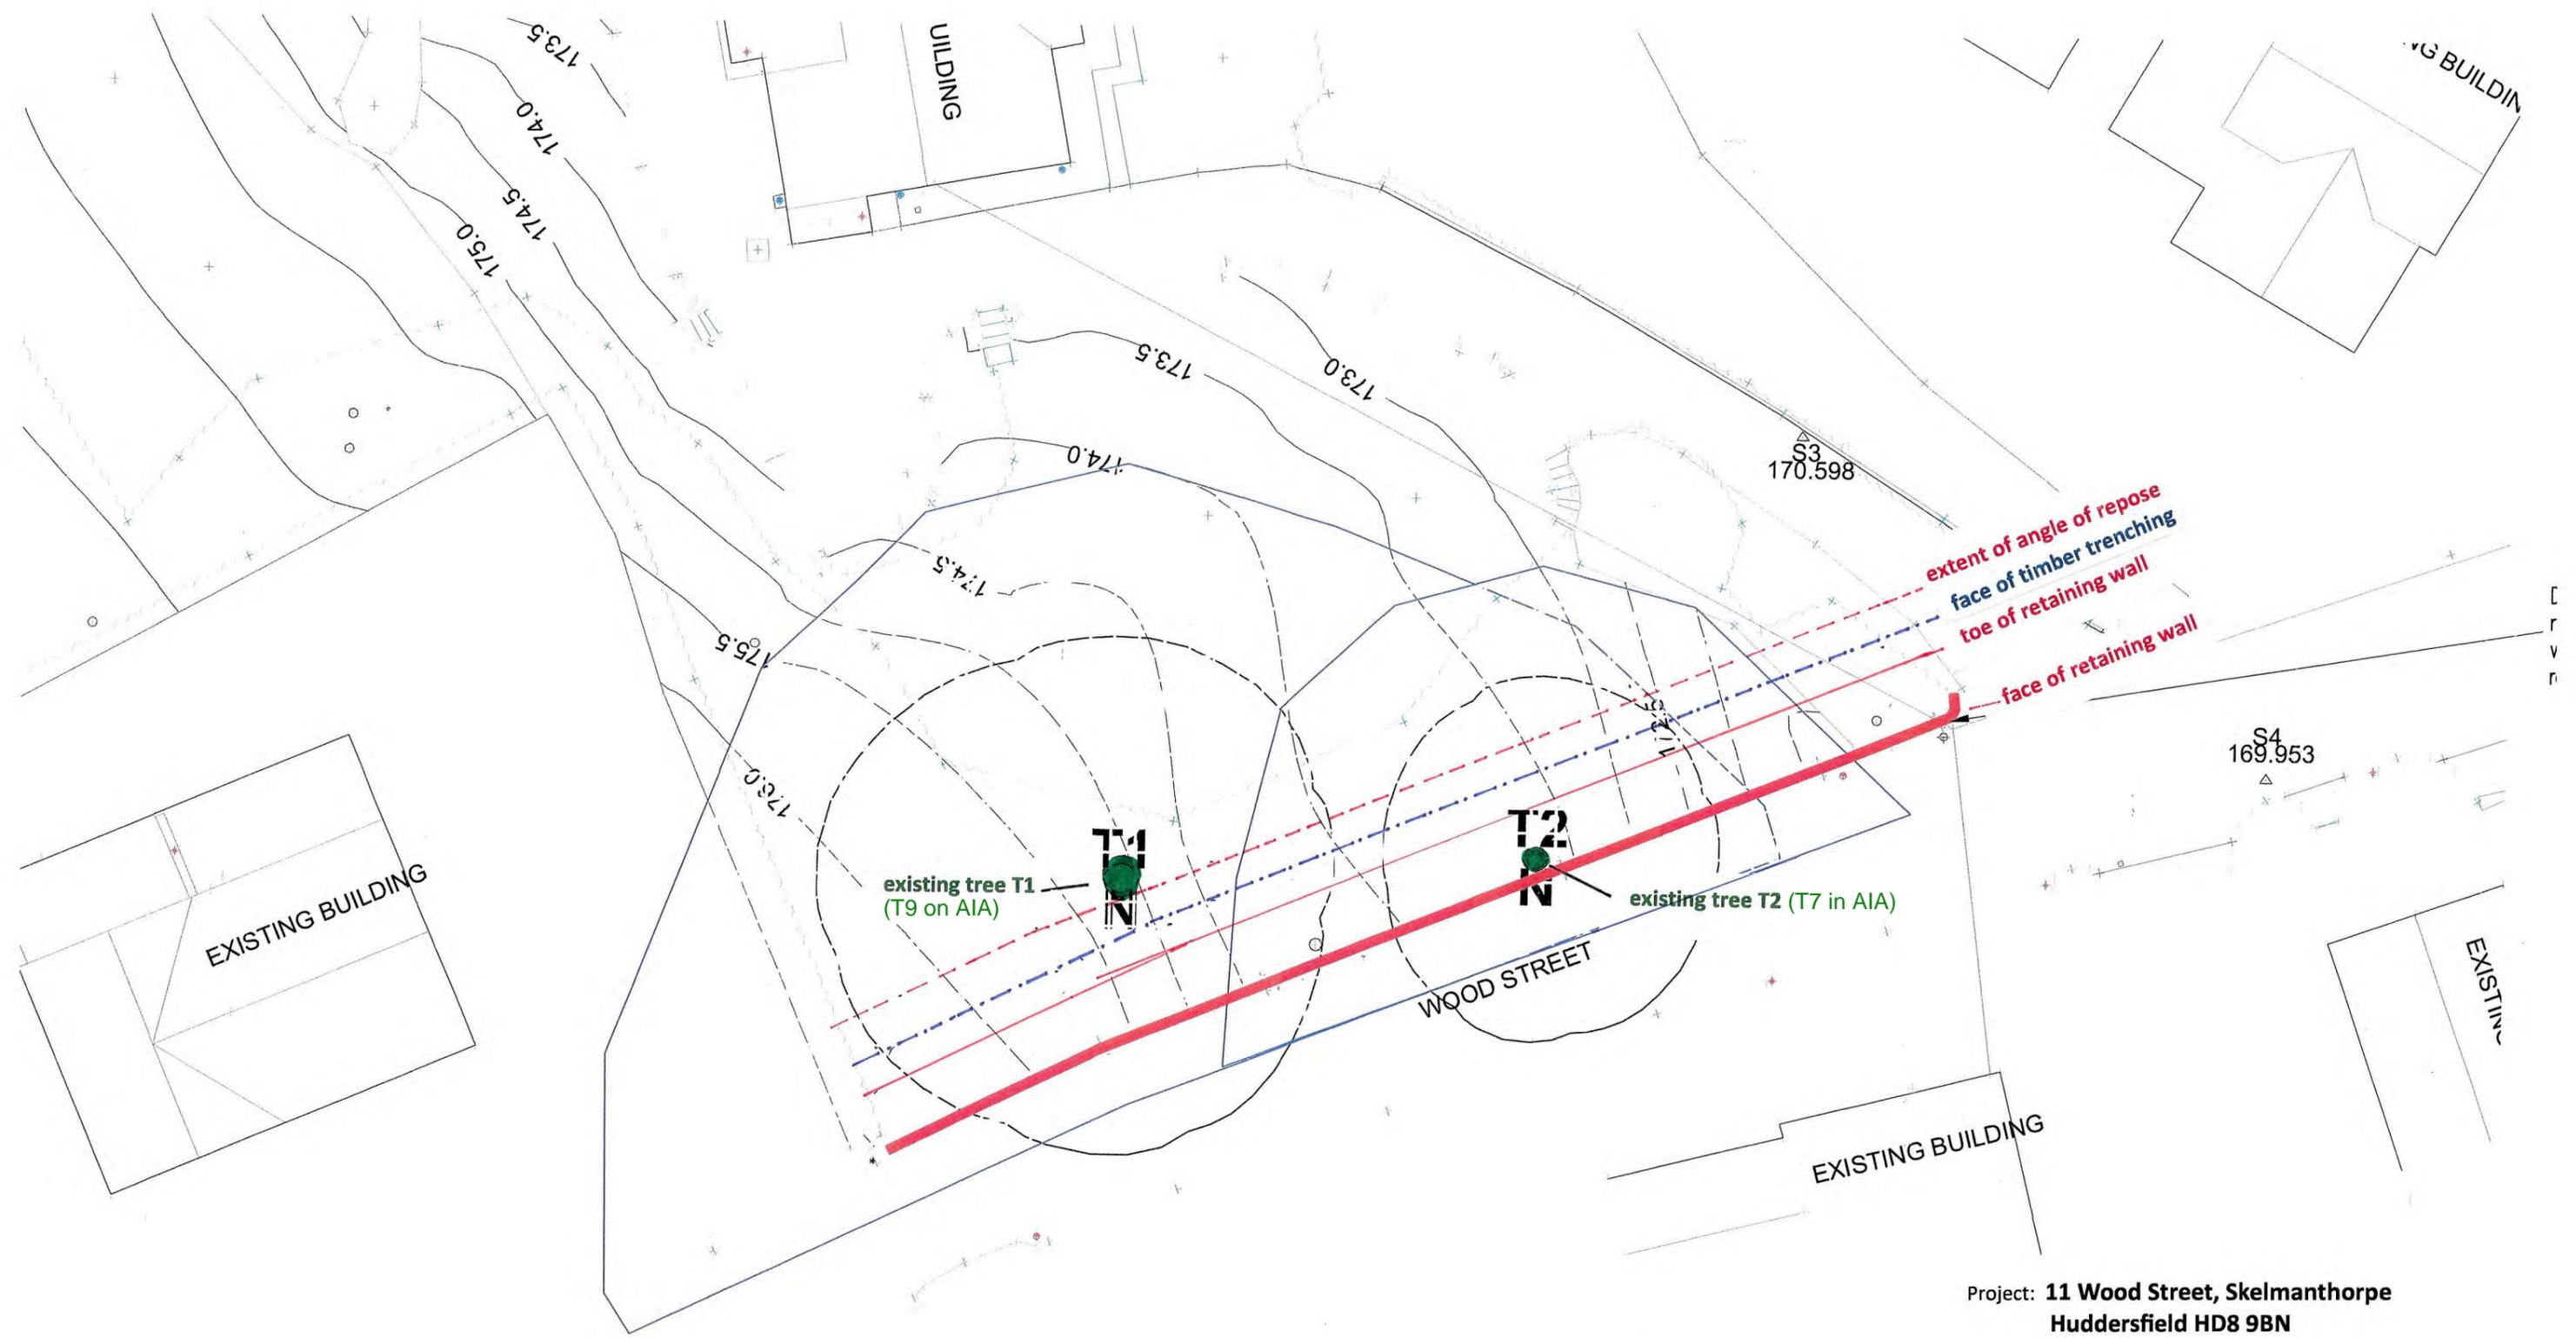
Drwg No: **SB/104**

- 3.2.3 In terms of T1, T3, T5, T6, T7, and T8 the excavation necessary to construct the toe of the retaining structure with its related angle of repose will require the removal of each of these trees (refer to Appendix 5 and 6). In the case of T9 it may be suggested a lesser form of excavation would avoid the need to remove this tree. Unfortunately even the removal of a relatively small amount of soils from the rear face of the wall will result in the loss of structural roots and smaller fibrous roots creating a significant root shoot imbalance. The likely consequence of root loss or injury occurring would at best give rise to the trees terminal decline or at worst lead to the its catastrophic failure in extremes of weather.

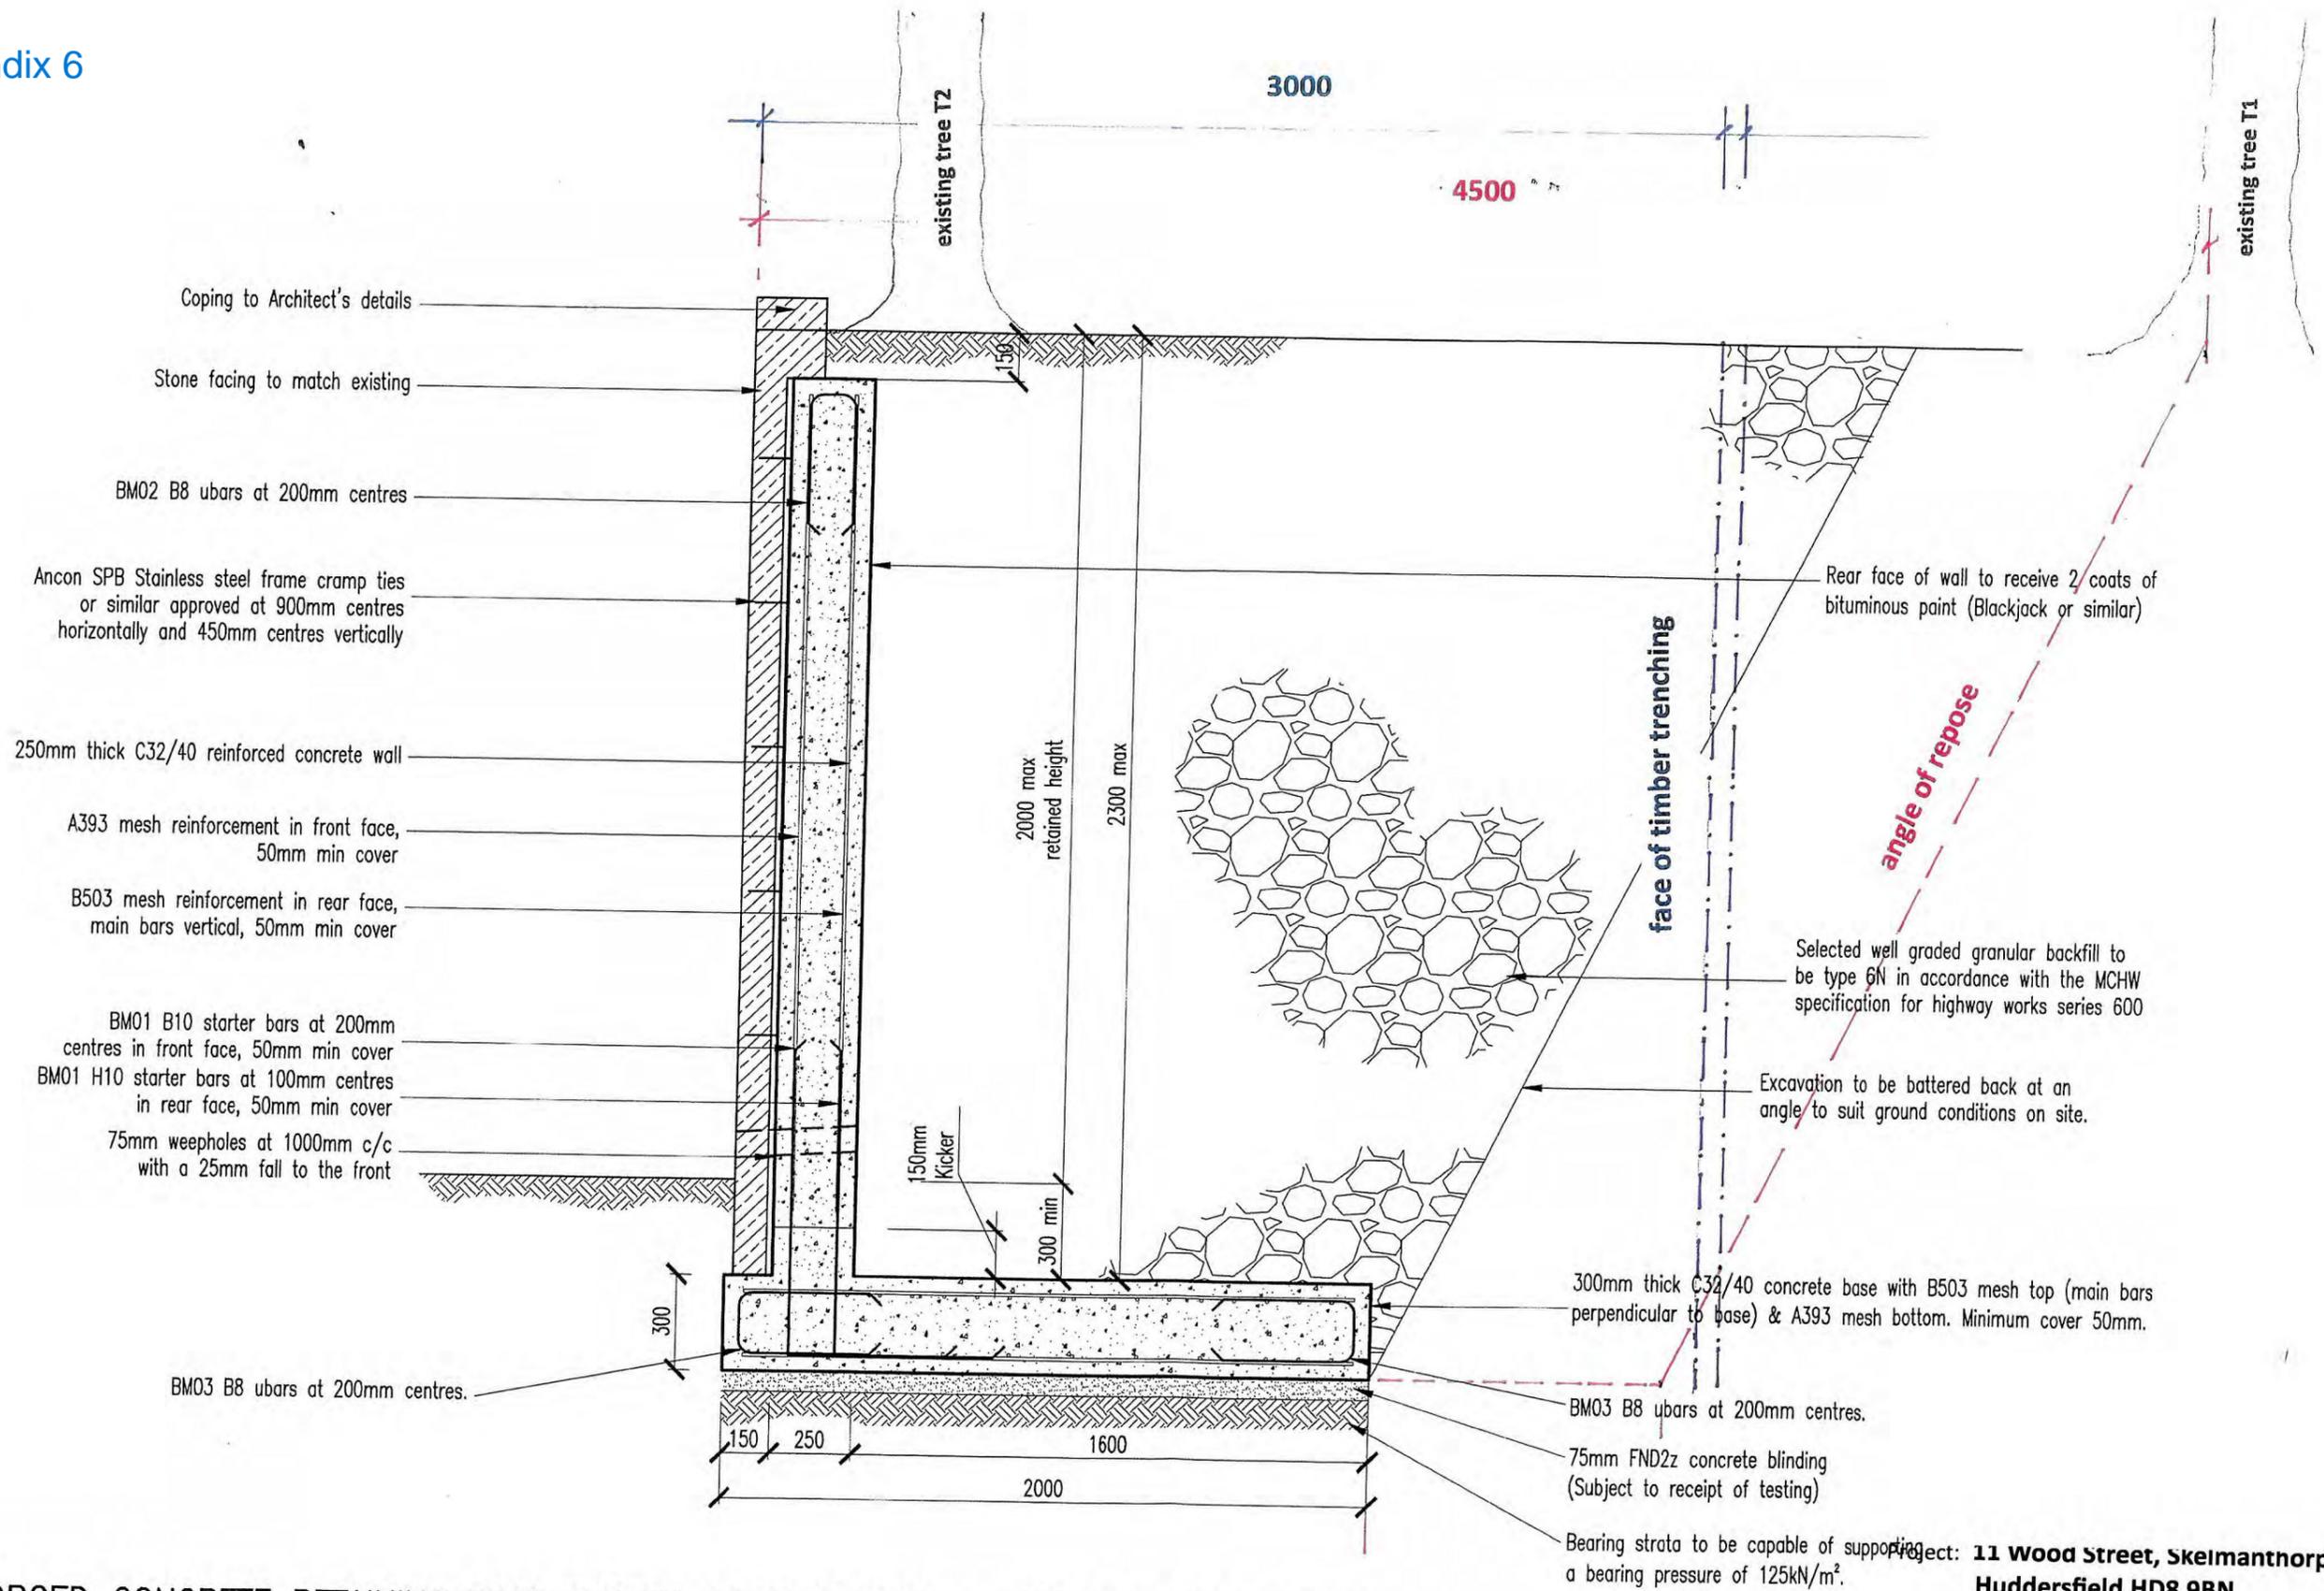
1 REINFORCED CONCRETE RETAINING WALL-TYPICAL SECTION 2000mm MAX RETAINED HEIGHT
1:20

- 3.1.2 The existing wall appears to be of dry stone construction, in places retaining up to 2m of ground. The wall fronts the highway boundary with Wood Street. Several patched repairs associated with past wall failures have been undertaken. More recently an inspection undertaken by OEC Consulting Engineers has found several areas where the face of the wall is uneven: both horizontally and vertically. The Engineers view is that the wall lacks sufficient robustness to retain the earth behind it. In order to guarantee the long term stability of the wall a full rebuild is required that would accord with the latest design codes.
